Infrared Thermography Report

Gold Strike August 2021 Infrared Inspection

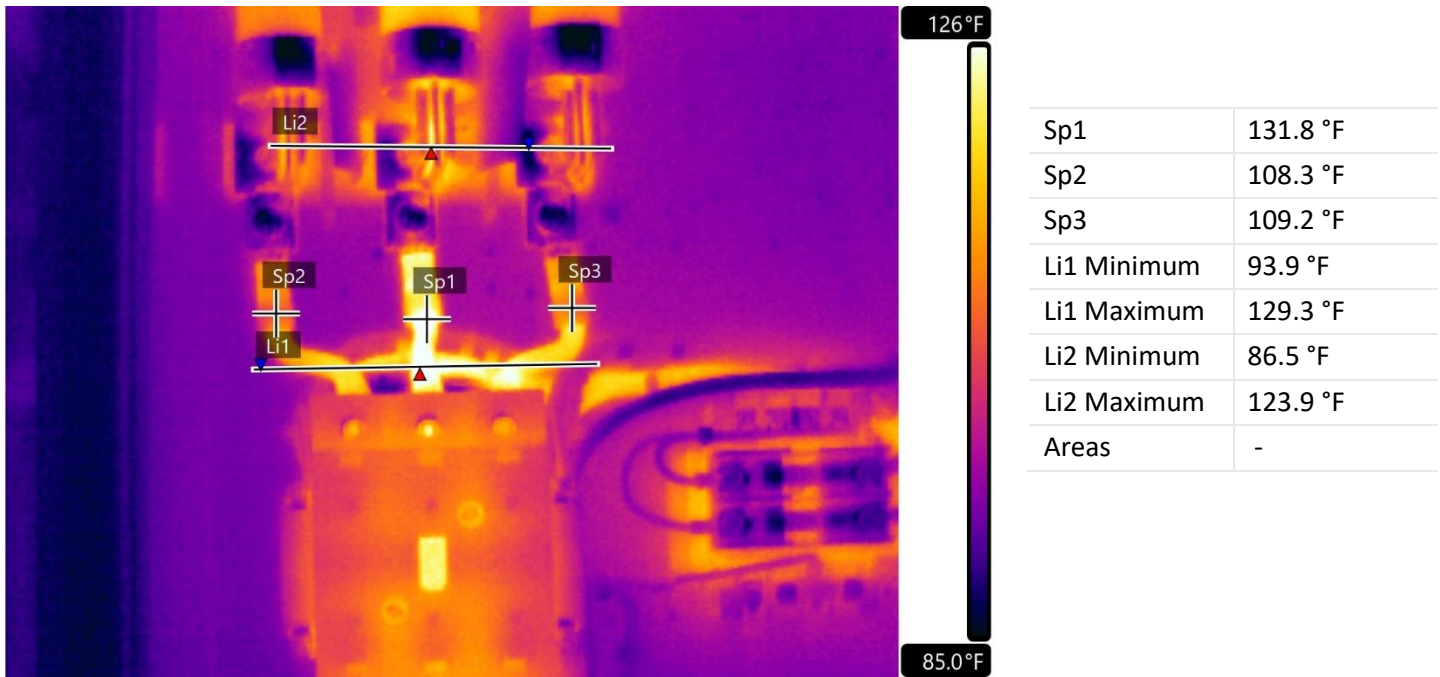
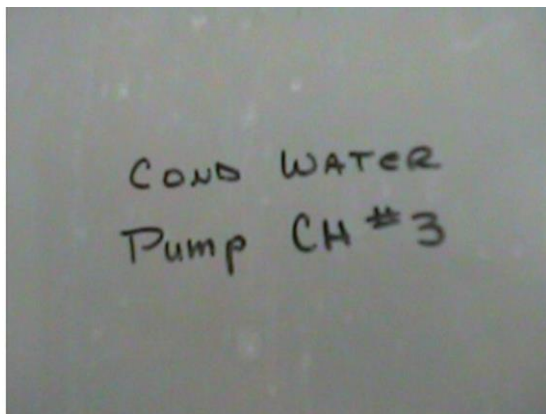
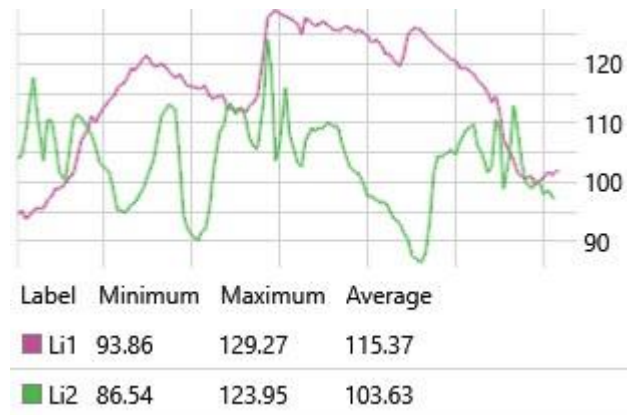
Component	B phase conductor below fuse
Equipment/Bucket ID	Chiller room motor control 13/ cond water pump ch 3

Fault	Temperature delta between phases
Defect Rating	II

Recommendations
The center phase conductor below the fuses appears to have a localized hot spot on the starter line side lug. There could be a loose connection or an unbalanced loading condition. Inspect all connections, clean and repair, or replace any defective components. Torque all lugs to specification.

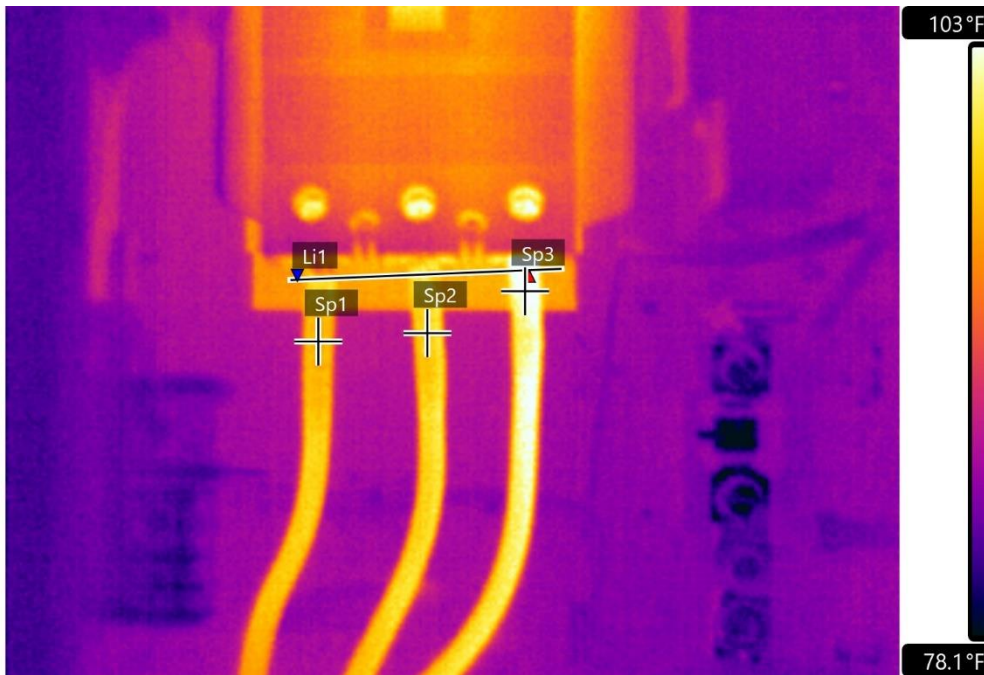
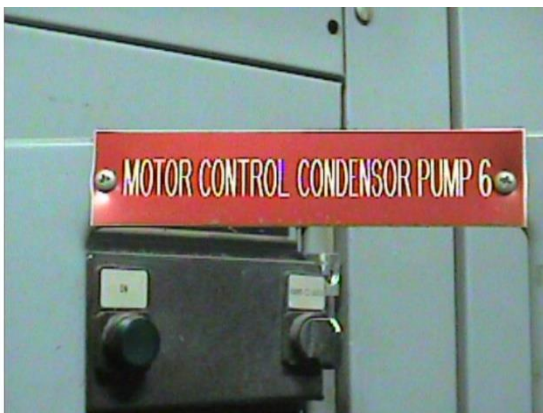
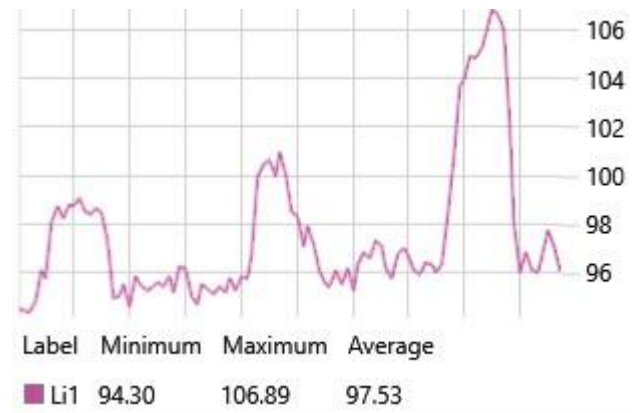
Component	C phase conductor on load side of starter
Equipment/Bucket ID

Sp1	95.2 °F
Sp2	98.2 °F
Sp3	103.4 °F
Li1 Minimum	94.3 °F
Li1 Maximum	106.9 °F
Areas	-

Fault	Temperature delta between phases
Defect Rating	I

Recommendations	The C phase conductor below the starter appears to have a localized hot spot on the starter load side lug. There could be a loose connection or an unbalanced loading condition. Inspect all connections, clean and repair, or replace any defective components. Torque all lugs to specification.
-----------------	--

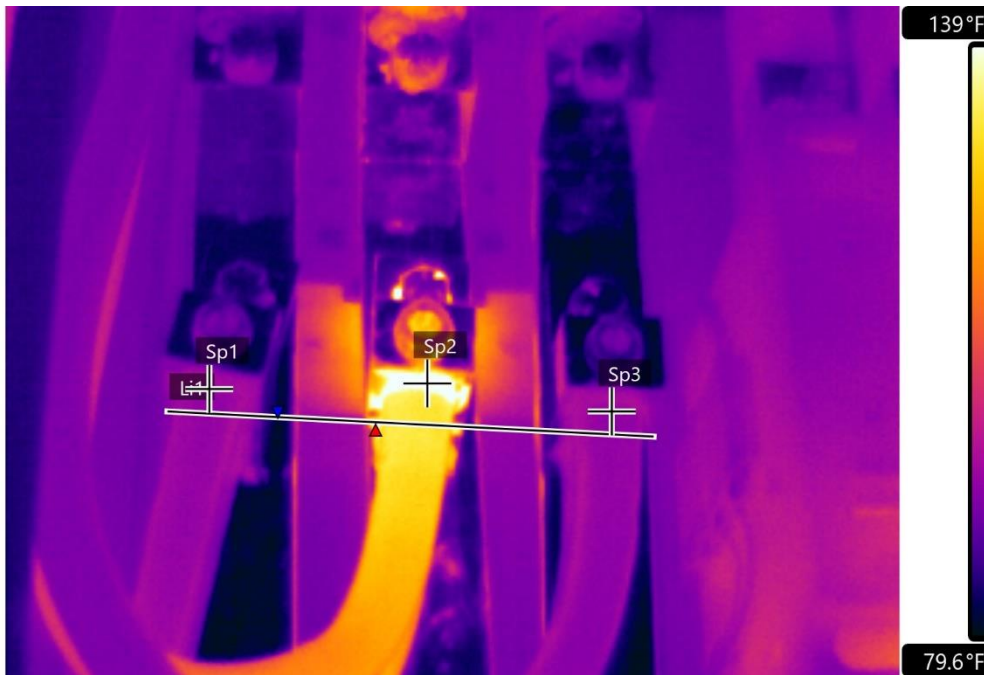
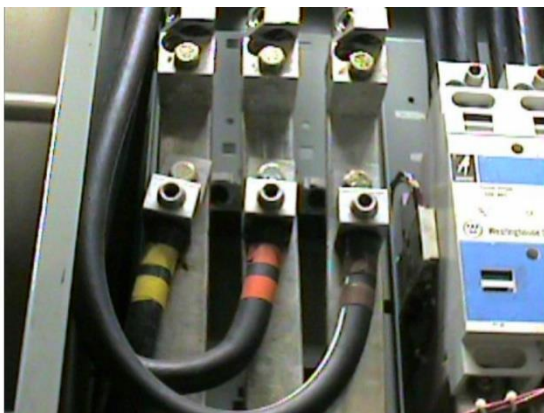
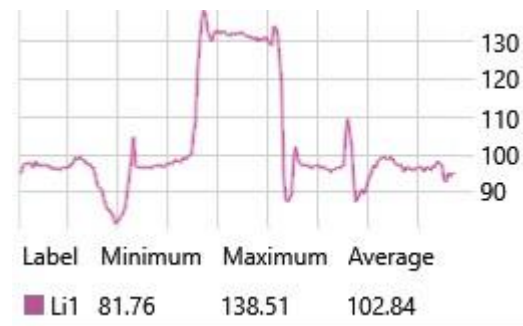
Component	B phase conductor at component lug
Equipment/Bucket ID	Chiller Room/ Chiller #2

Sp1	97.2 °F
Sp2	145.0 °F
Sp3	96.7 °F
Li1 Minimum	81.8 °F
Li1 Maximum	138.5 °F
Areas	-

Fault	Large temperature delta between phases
Defect Rating	III

Recommendations	The center phase conductor appears to have a localized hot spot on the component load side lug. There could be a loose connection or an unbalanced loading condition. Inspect all connections, clean and repair, or replace any defective components. Torque all lugs to specification
-----------------	--

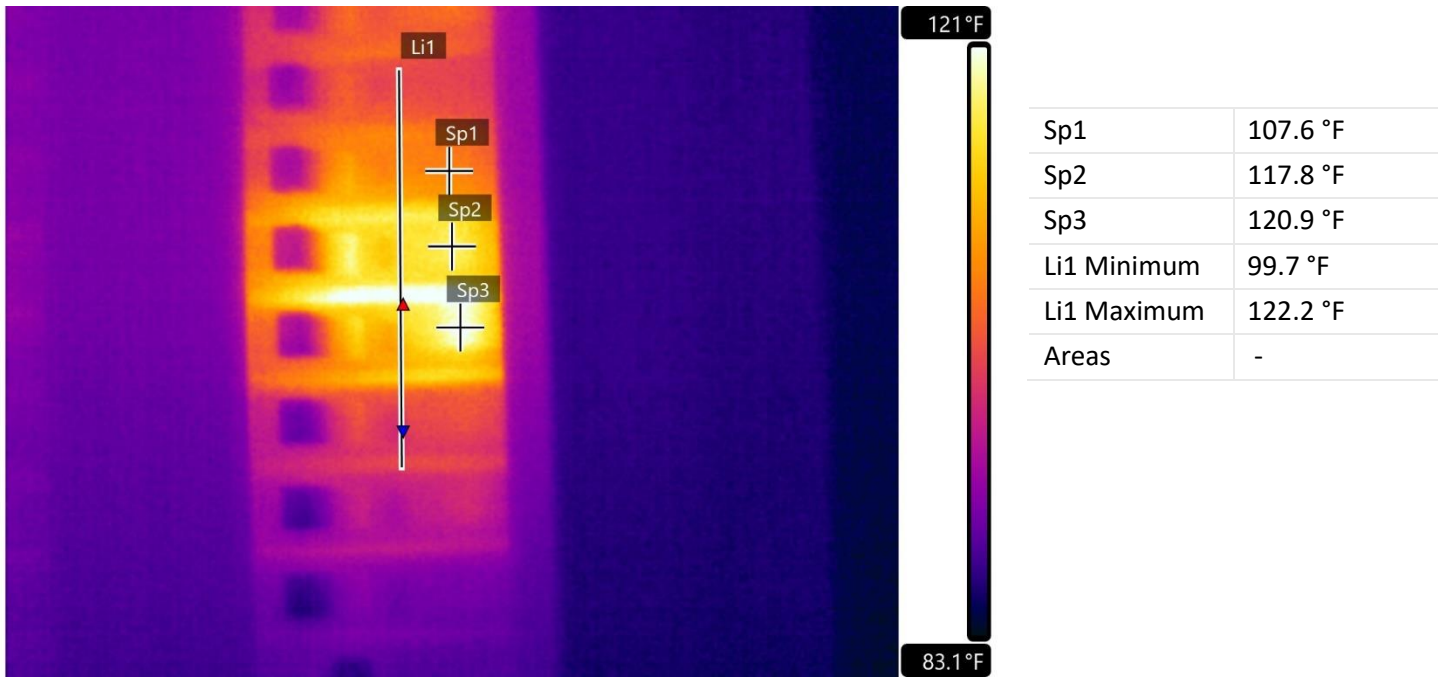
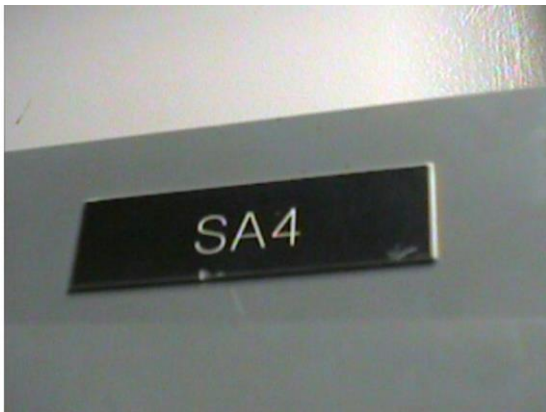
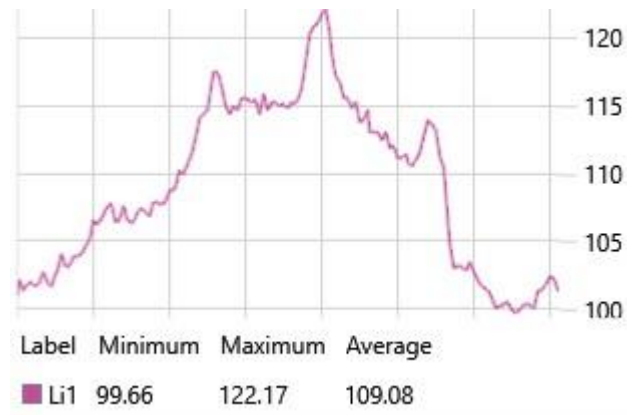
Component	Circuit Breakers 26 and 28
Equipment/Bucket ID	Casino Panel SA4

Fault	Elevated temperature delta between breakers
Defect Rating	II

Recommendations	One or possibly both circuit breakers could be defective, have loose connections or have an over current condition. Inspect all connections, clean and repair, or replace any defective components. Torque all lugs to specification suffer from multiple issues. Ensure the current does not exceed NEMA guidelines.
-----------------	---

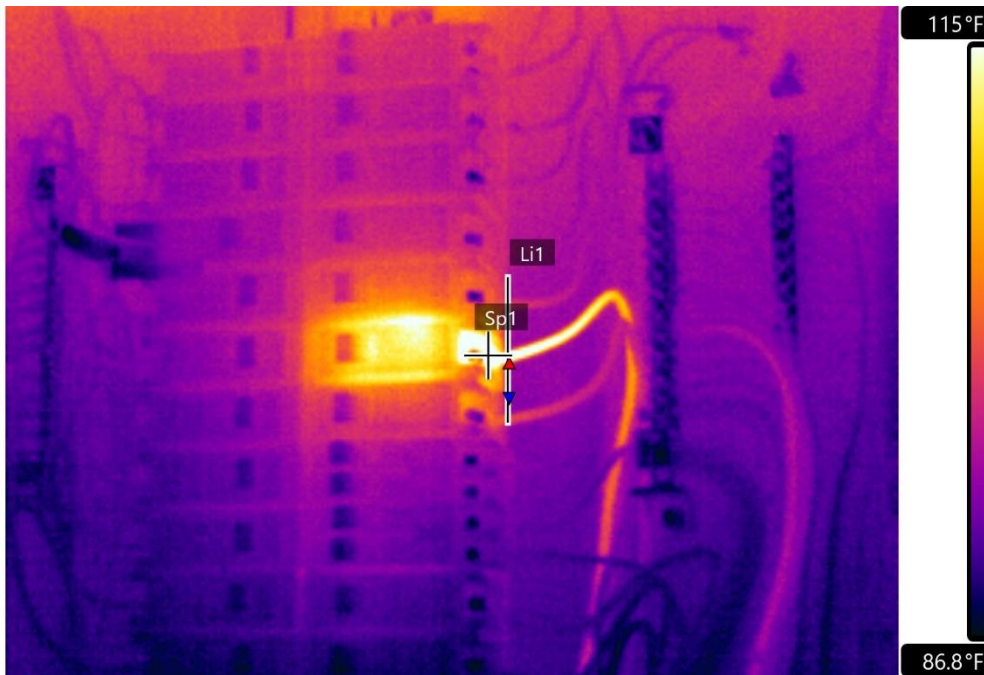
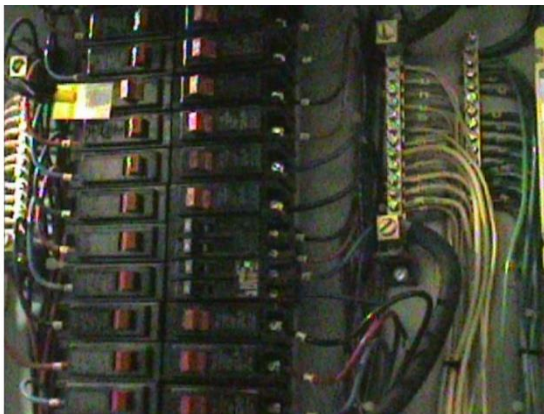
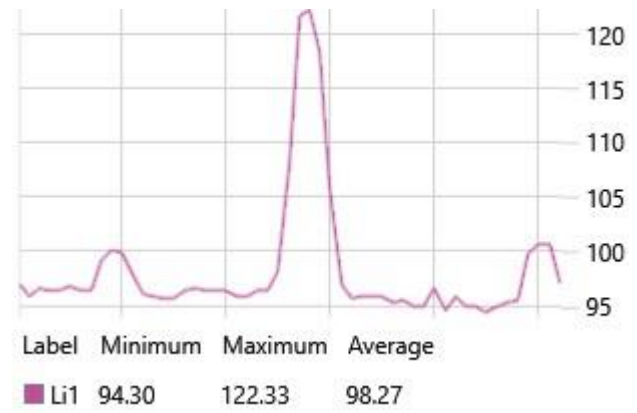
Component	Circuit Breaker 12
Equipment/Bucket ID	2nd Floor Electrical Room Panel UP2E

Sp1	128.1 °F
Li1 Minimum	94.3 °F
Li1 Maximum	122.3 °F
Areas	-

Fault	Temperature delta at breaker and conductor
Defect Rating	II

Recommendations	The #12 circuit breaker could be defective, have loose connections or have an over current condition. Inspect all connections, clean and repair, or replace any defective components. Torque all lugs to specification. Ensure the current does not exceed NEMA guidelines.
-----------------	---

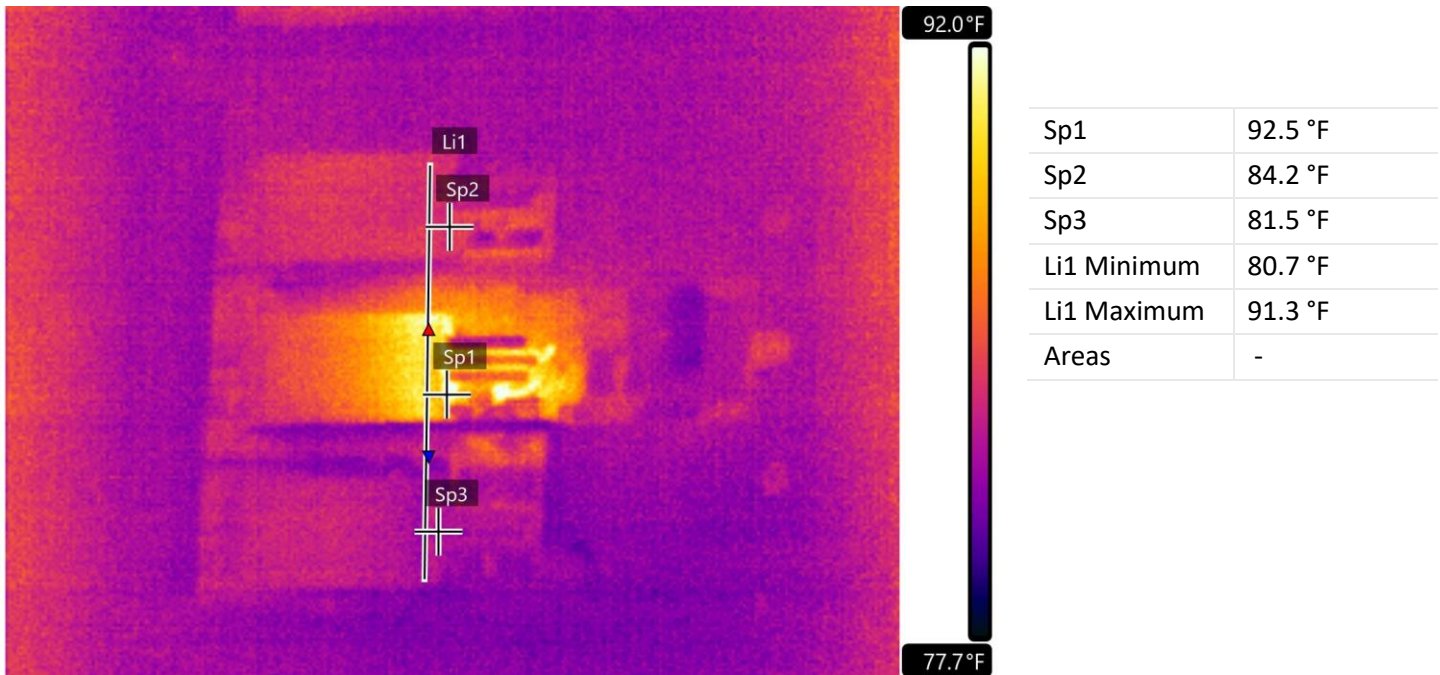
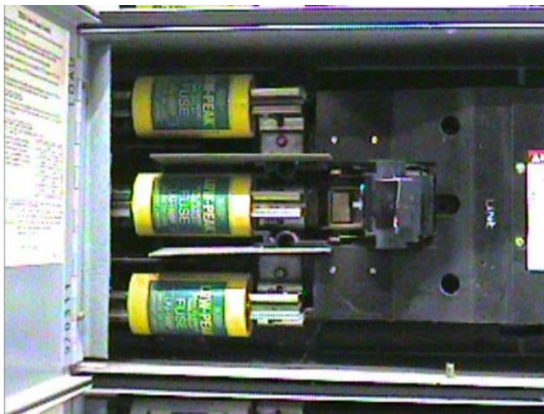
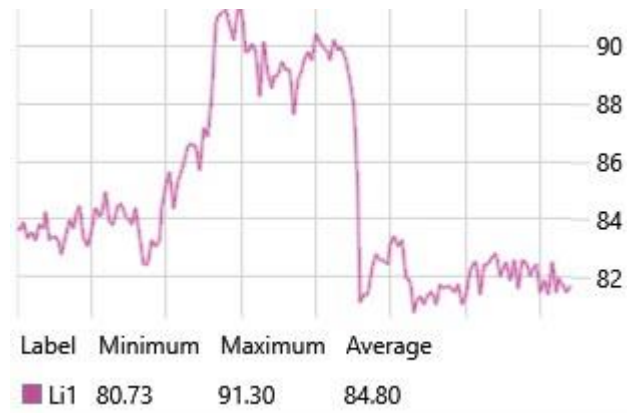
Component	Fusible Switch
Equipment/Bucket ID	Hotel Main Electrical Room MCC3 Bucket T3C

Fault	Temperature delta at B phase fuse clip
Defect Rating	I

Recommendations	There appears to be localized heating at the right side fuse clip of B phase or switch contact. Inspect all connections, clean and repair, or replace any defective components. Torque all lugs to specification
-----------------	--

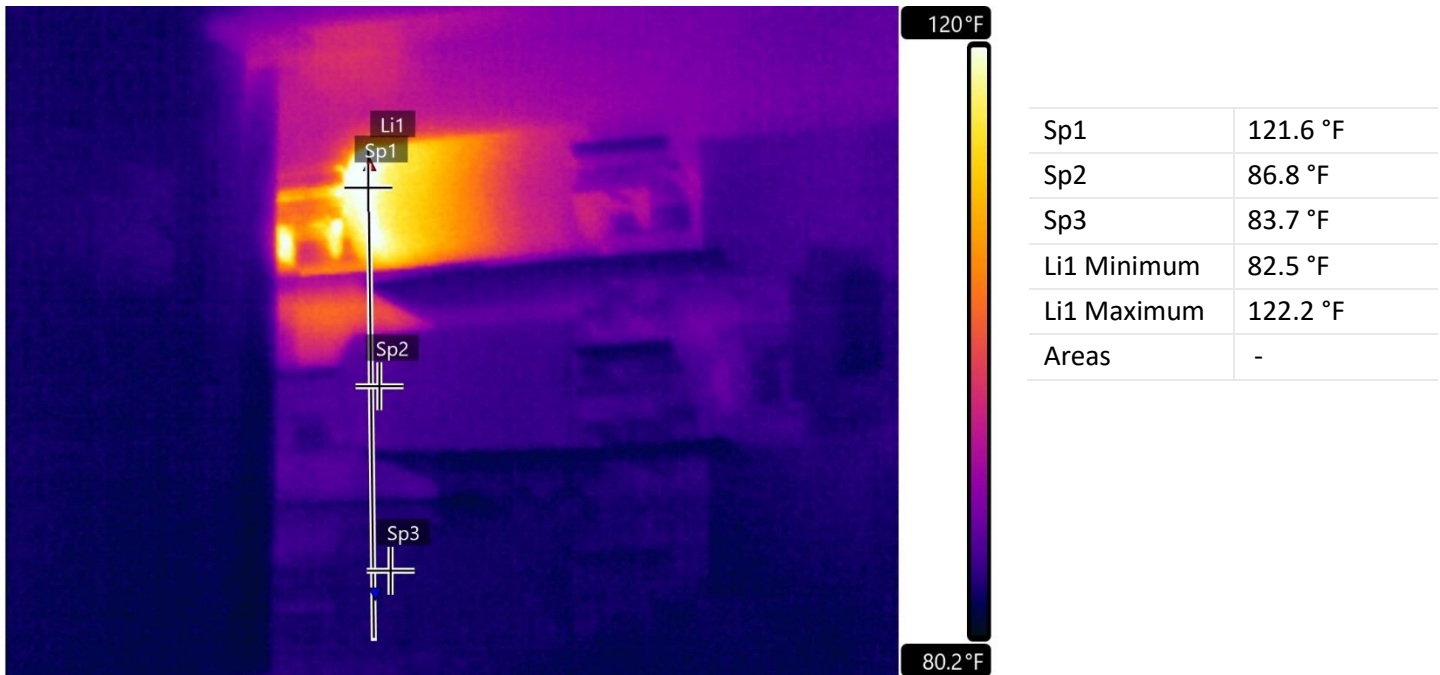
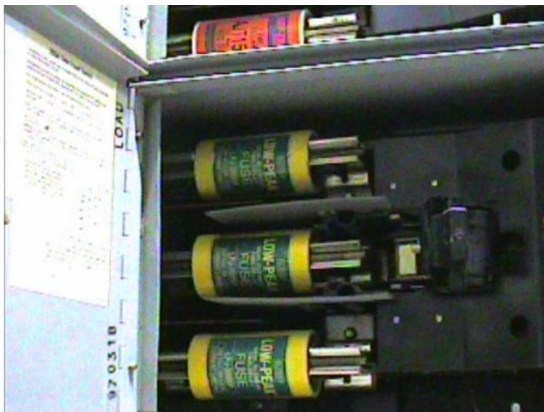
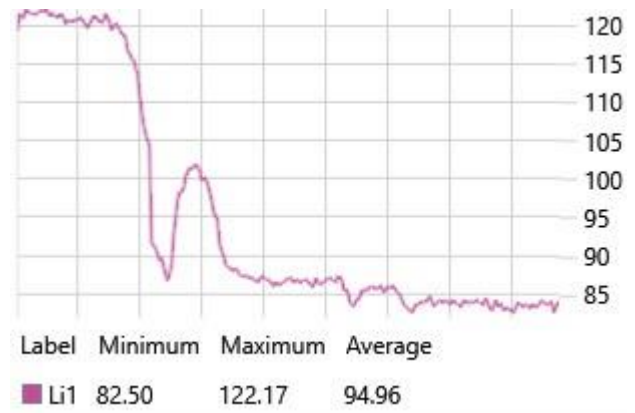
Component	Fusible Switch
Equipment/Bucket ID	Hotel Main Electrical Room Gear LSB2 panel T3L

Fault	Poor connection at A phase fuse clip left side
Defect Rating	II

Recommendations	The A phase fuse clip on the left side appears to have a localized temperature delta. We suspect poor contact at the clip or switch. Inspect and clean the fuse clip contact, switch contacts; or replace the unit as needed. Torque all connectors.
-----------------	--

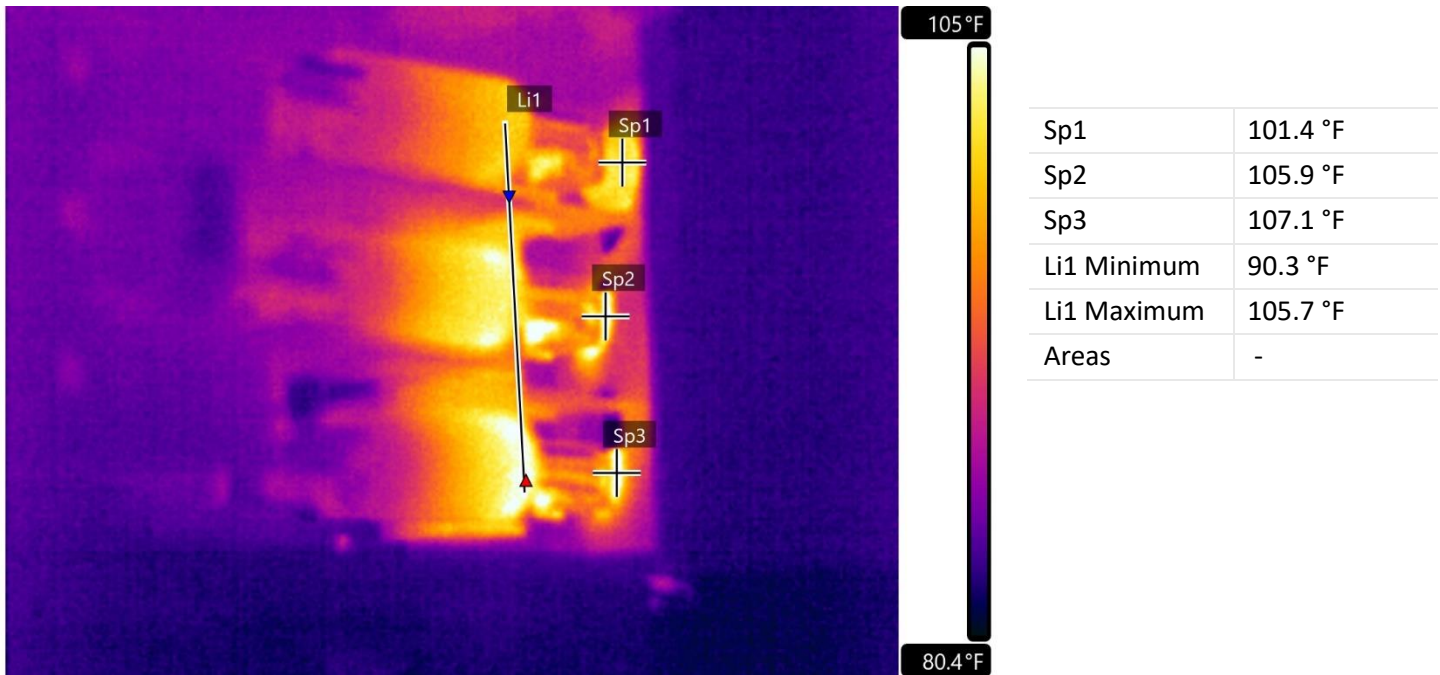
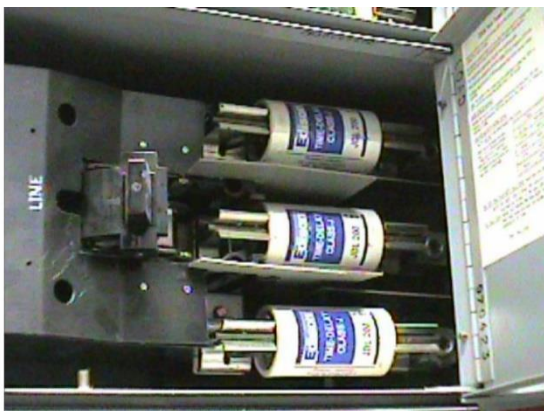
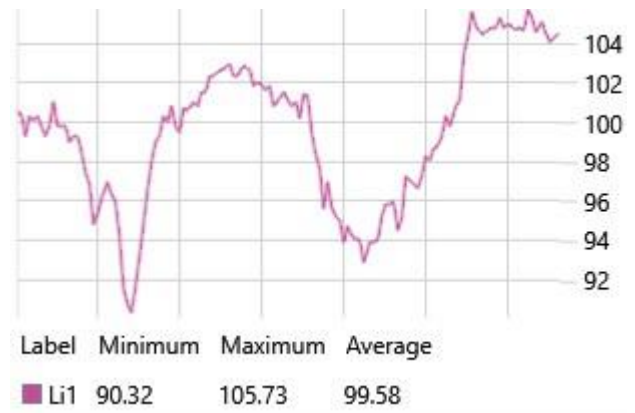
Component	Fusible Switch
Equipment/Bucket ID	Hotel Main Electrical Room Gear HSB1 Bucket HB-1

Fault	Slight temperature delta at fuse clips
Defect Rating	I

Recommendations	There is a slight temperature delta between phases at the right side fuse clips. Inspect and clean the fuse clips and switch contacts.
-----------------	--

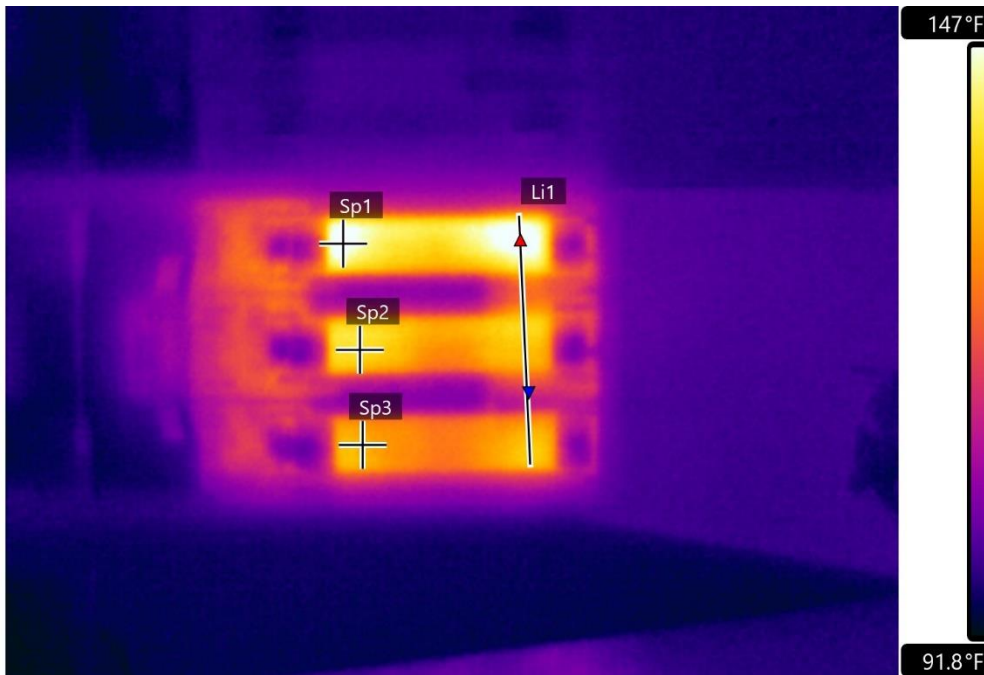
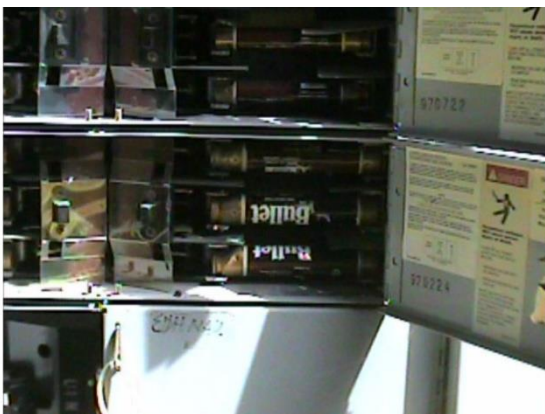
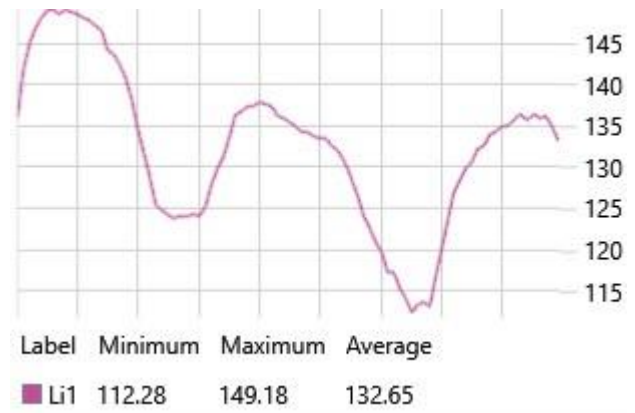
Component	Fuse clips
Equipment/Bucket ID	Hotel Roof Distribution Board EHDBR Bucket AHU 1

Sp1	148.1 °F
Sp2	138.1 °F
Sp3	132.3 °F
Li1 Minimum	112.3 °F
Li1 Maximum	149.2 °F
Areas	-

Fault	Poor fuse clip connection
Defect Rating	I

Recommendations	Loaded circuit shows possible high resistive fuse connections for the A phase. Inspect and clean the fuse clips and fuses.
-----------------	--
