# QualiTest IR Radiometric Survey Report

## ICE Industries

Job Number	140286
Survey Date	7-31-19
Report Date	7-31-19

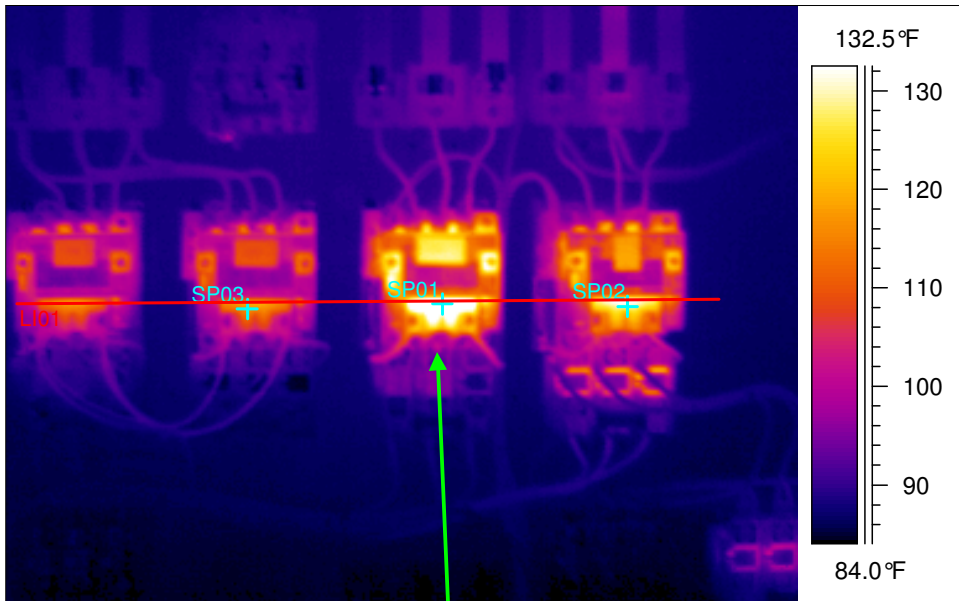
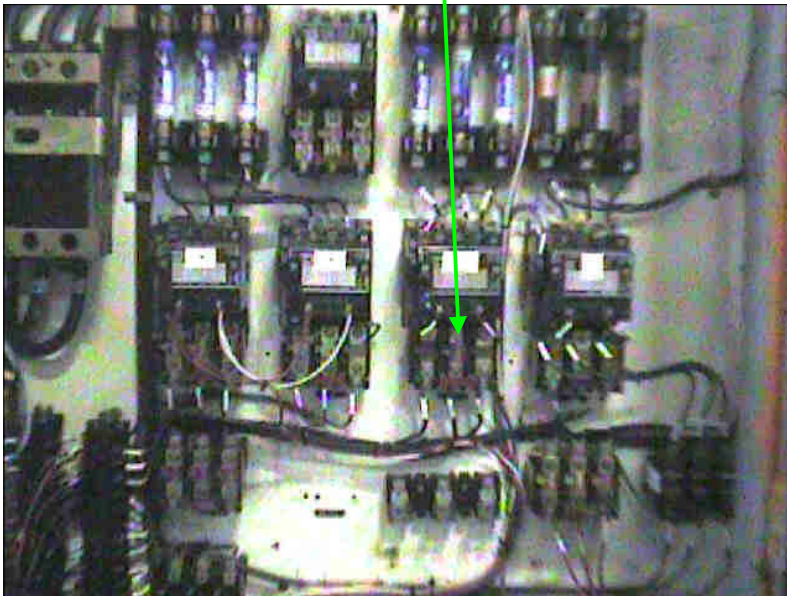
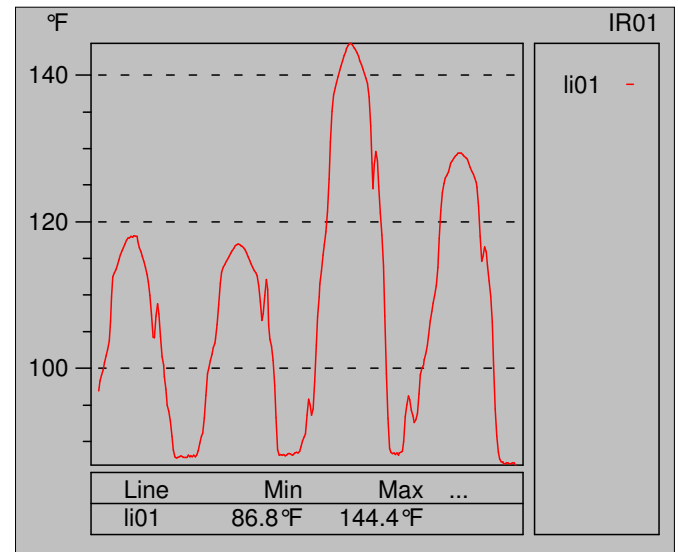
Component	Equipment/Bucket ID	Plant/Area	Date
Starter Coil	left Panel	Versen Press	7-31-19

Label	Value
IR : max	147.5°F
IR : min	83.7°F
SP01	147.5°F
SP02	130.3°F
SP03	117.0°F
LI01 : max	144.4°F
LI01 : min	86.8°F

<b>Fault</b>	Hot Coil
<b>Defect Rating</b>	Class I

Replace the starter coil as time allows.

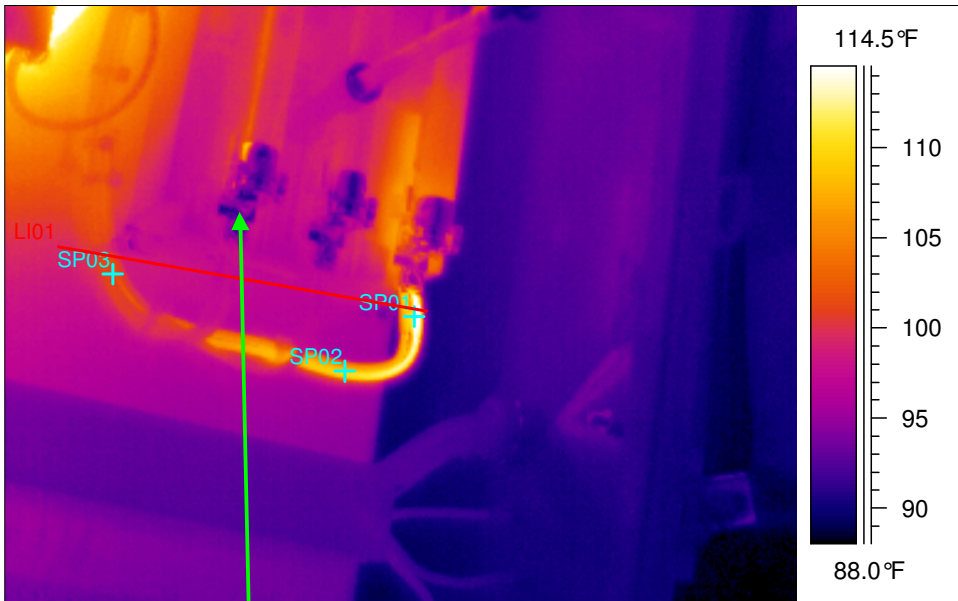
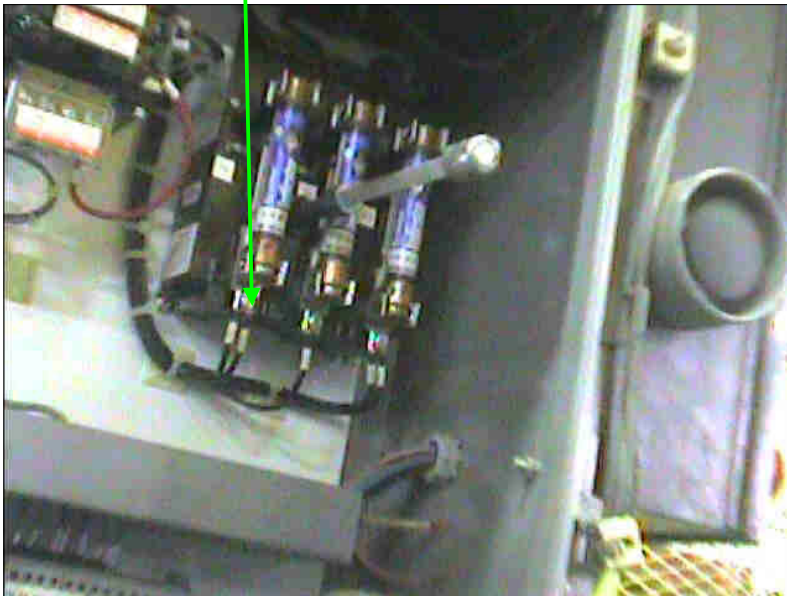
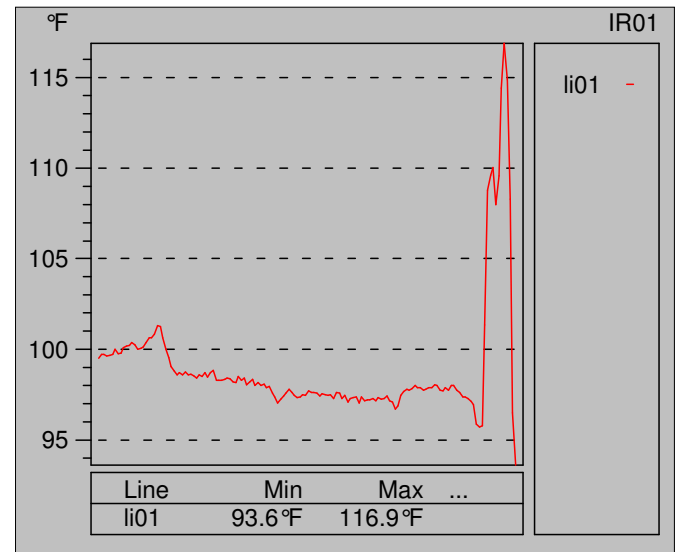
Component	Equipment/Bucket ID	Plant/Area	Date
Main Switch terminal	Volvo Heim Press	Back Building	7-31-19

Label	Value
IR : max	121.9°F
IR : min	87.2°F
SP01	116.5°F
SP02	110.0°F
SP03	101.3°F
LI01 : max	116.9°F
LI01 : min	93.6°F

<b>Fault</b>	Poor connection
<b>Defect Rating</b>	Class I

Localized heating at load side of "C" phase on main switch.  
Inspect the wire termination as well as the fuse clip. Repair or replace.

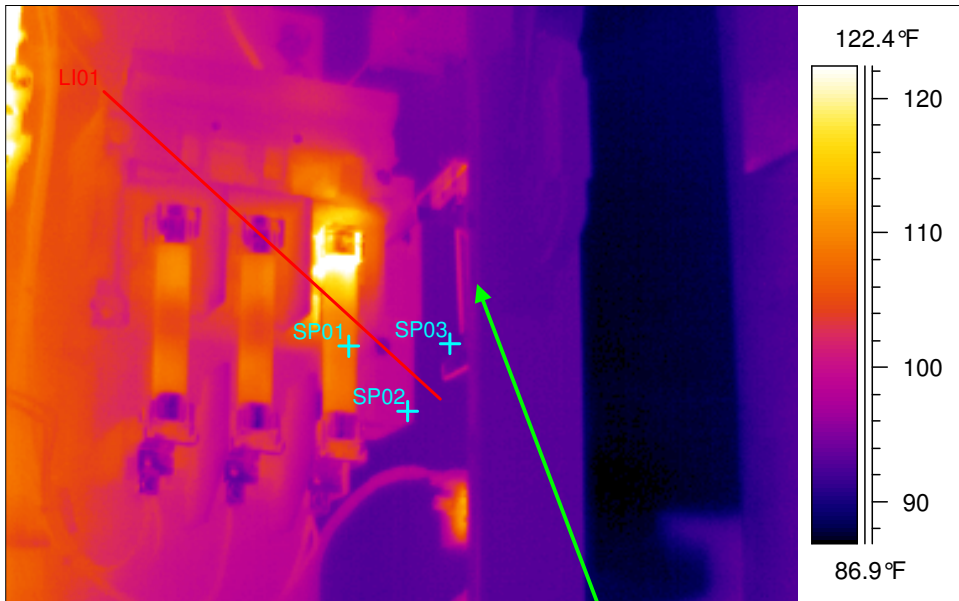
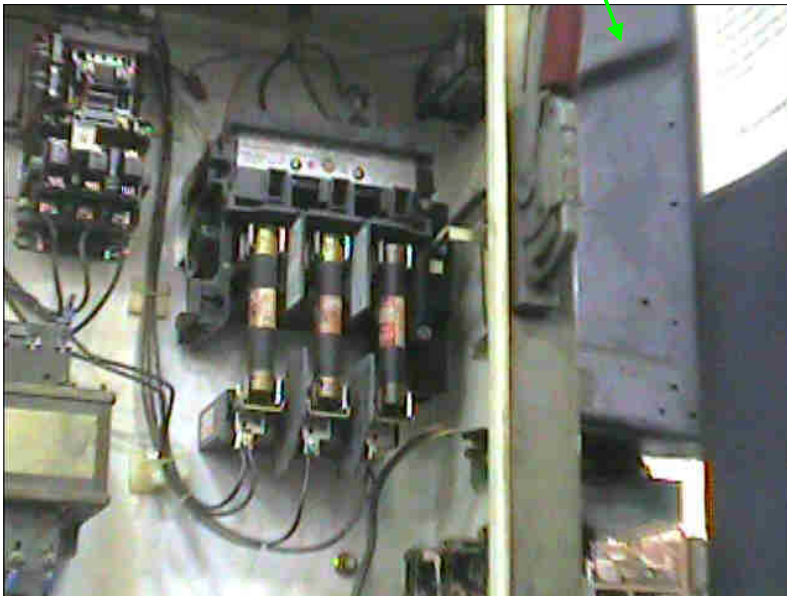
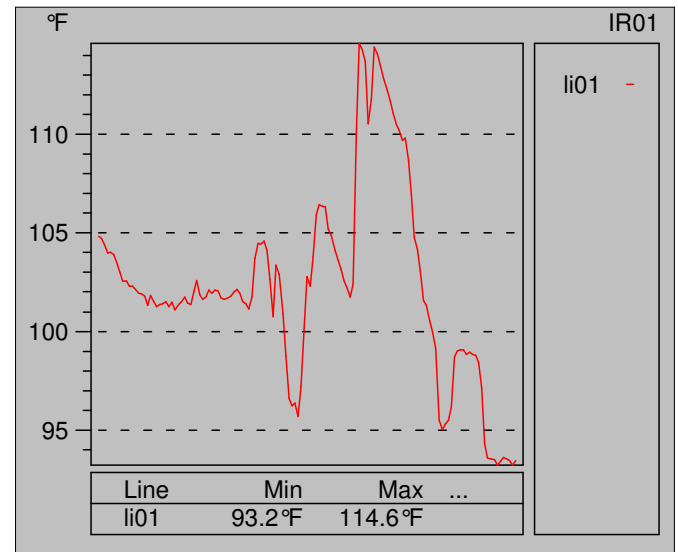
Component	Equipment/Bucket ID	Plant/Area	Date
Main switch "C" phase	Head Press 2	Back Building	7-31-19

Label	Value
IR : max	137.2°F
IR : min	86.6°F
SP01	108.3°F
SP02	98.5°F
SP03	93.4°F
LI01 : max	114.6°F
LI01 : min	93.2°F

<b>Fault</b>	Poor connection at switch
<b>Defect Rating</b>	Class I

Excessive heat found "C" phase line side fuse clip or possibly internal switch connection.  
Clean and inspect, repair or replace.

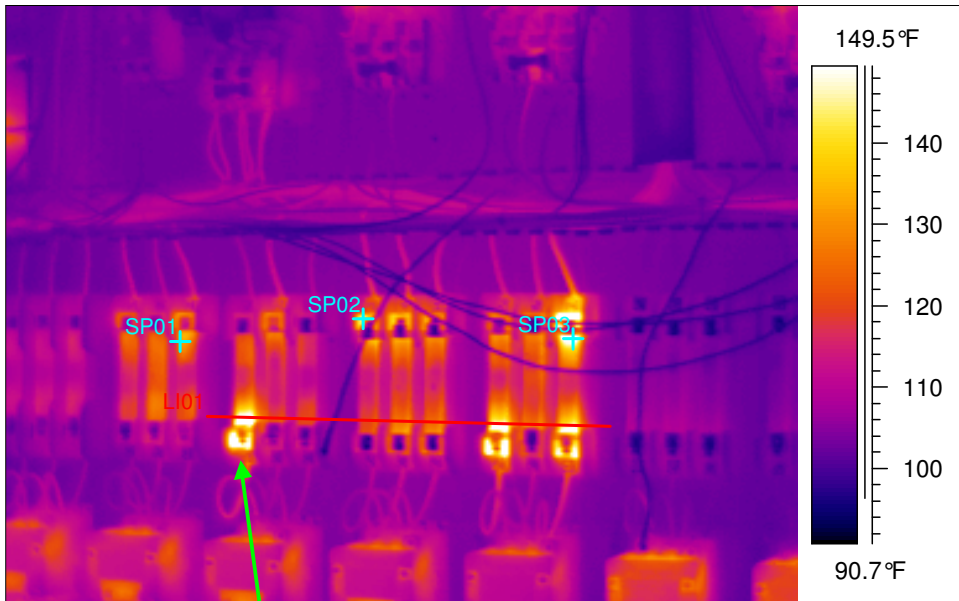
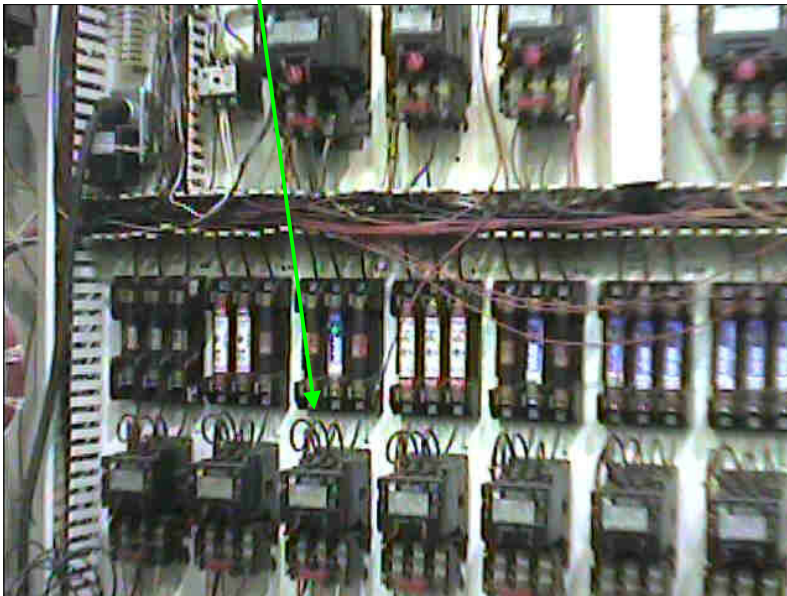
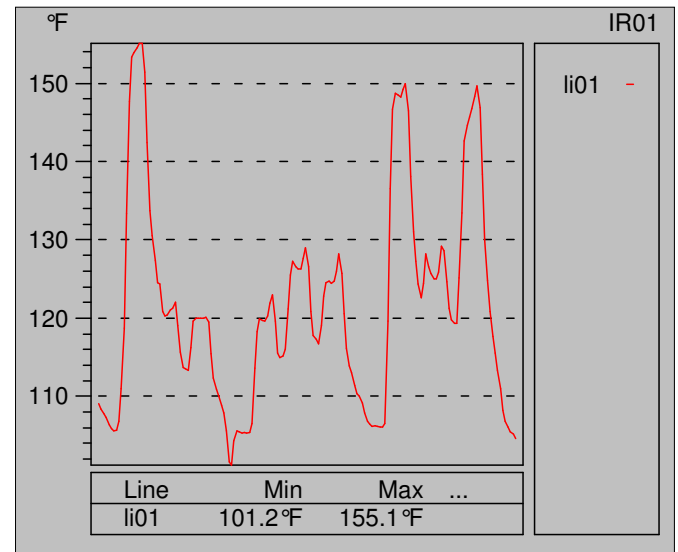
Component	Equipment/Bucket ID	Plant/Area	Date
Left Panel	Paint Line	Back Building	7-31-19

Label	Value
IR : max	177.0°F
IR : min	95.5°F
SP01	130.7°F
SP02	138.0°F
SP03	157.7°F
LI01 : max	155.1°F
LI01 : min	101.2°F

<b>Fault</b>	Poor connections
<b>Defect Rating</b>	Class II

Bottom Left Fuse Blocks have multiple poor connections at the fuse clips and wire terminations. 2nd from left to the 5th have notable issues. Clean and inspect, repair or replace.

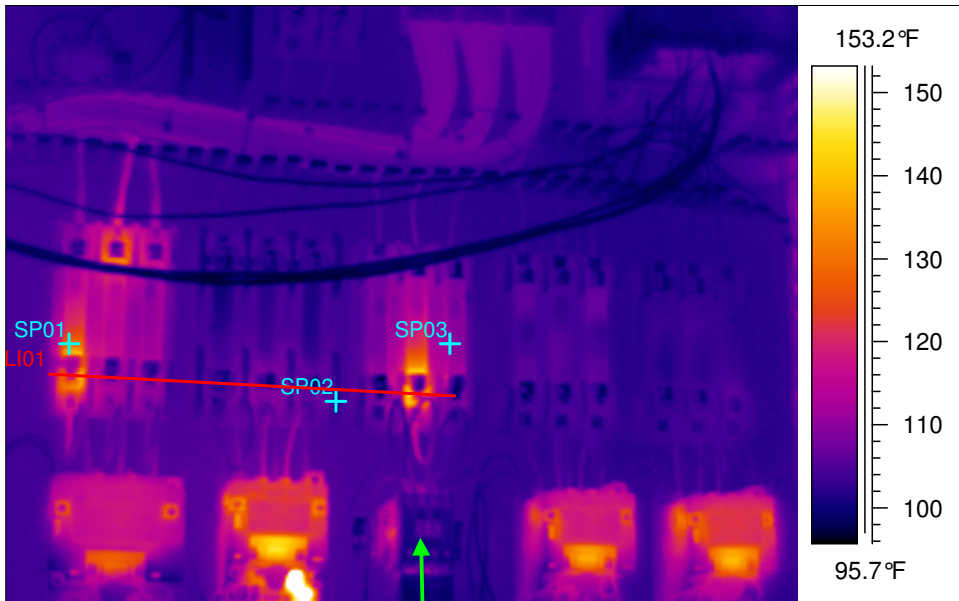
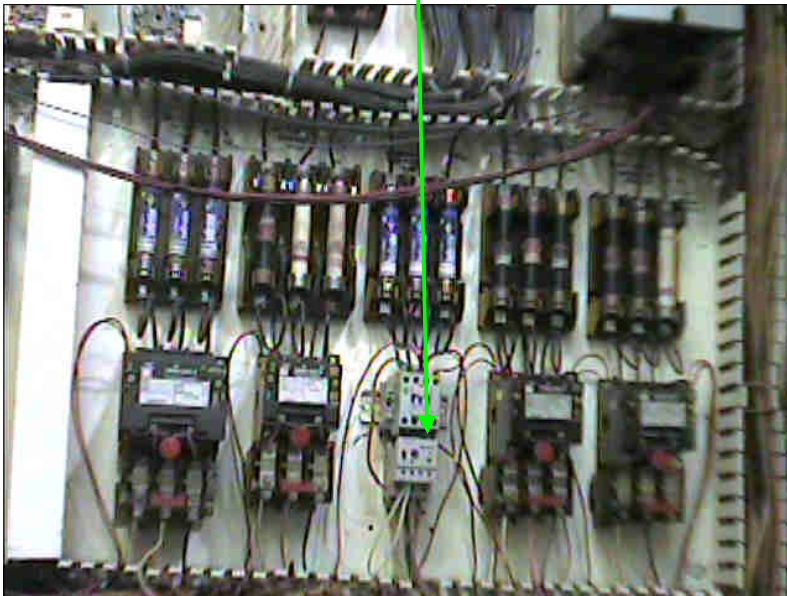
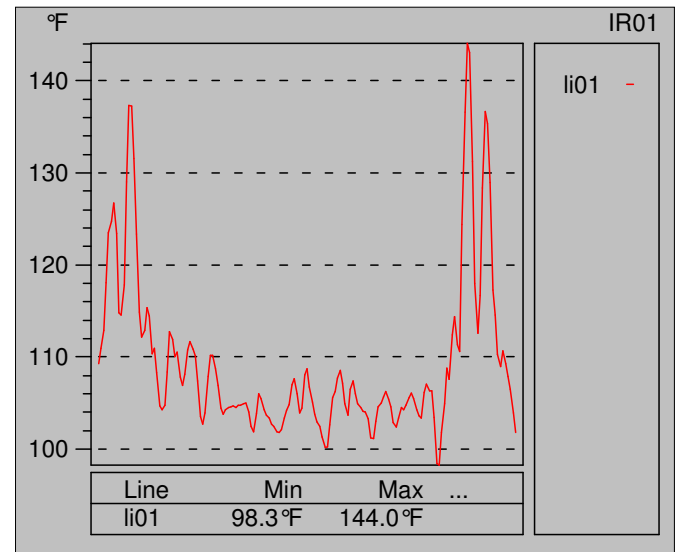
Component	Equipment/Bucket ID	Plant/Area	Date
Right Middle Fuse Blocks	Paint Line	Back Building	7-31-19

Label	Value
IR : max	>320.4°F
IR : min	96.7°F
SP01	129.1°F
SP02	102.7°F
SP03	110.3°F
LI01 : max	144.0°F
LI01 : min	98.3°F

<b>Fault</b>	Poor Connections at fuse blocks
<b>Defect Rating</b>	Class I

Paint Panel right middle fuse blocks.  
Inspect the 1st and 3rd fuse blocks. Clean and inspect. Repair or Replace.
