I.F.F Visual Inspection Electrical

The following items was found during the
infrared scan

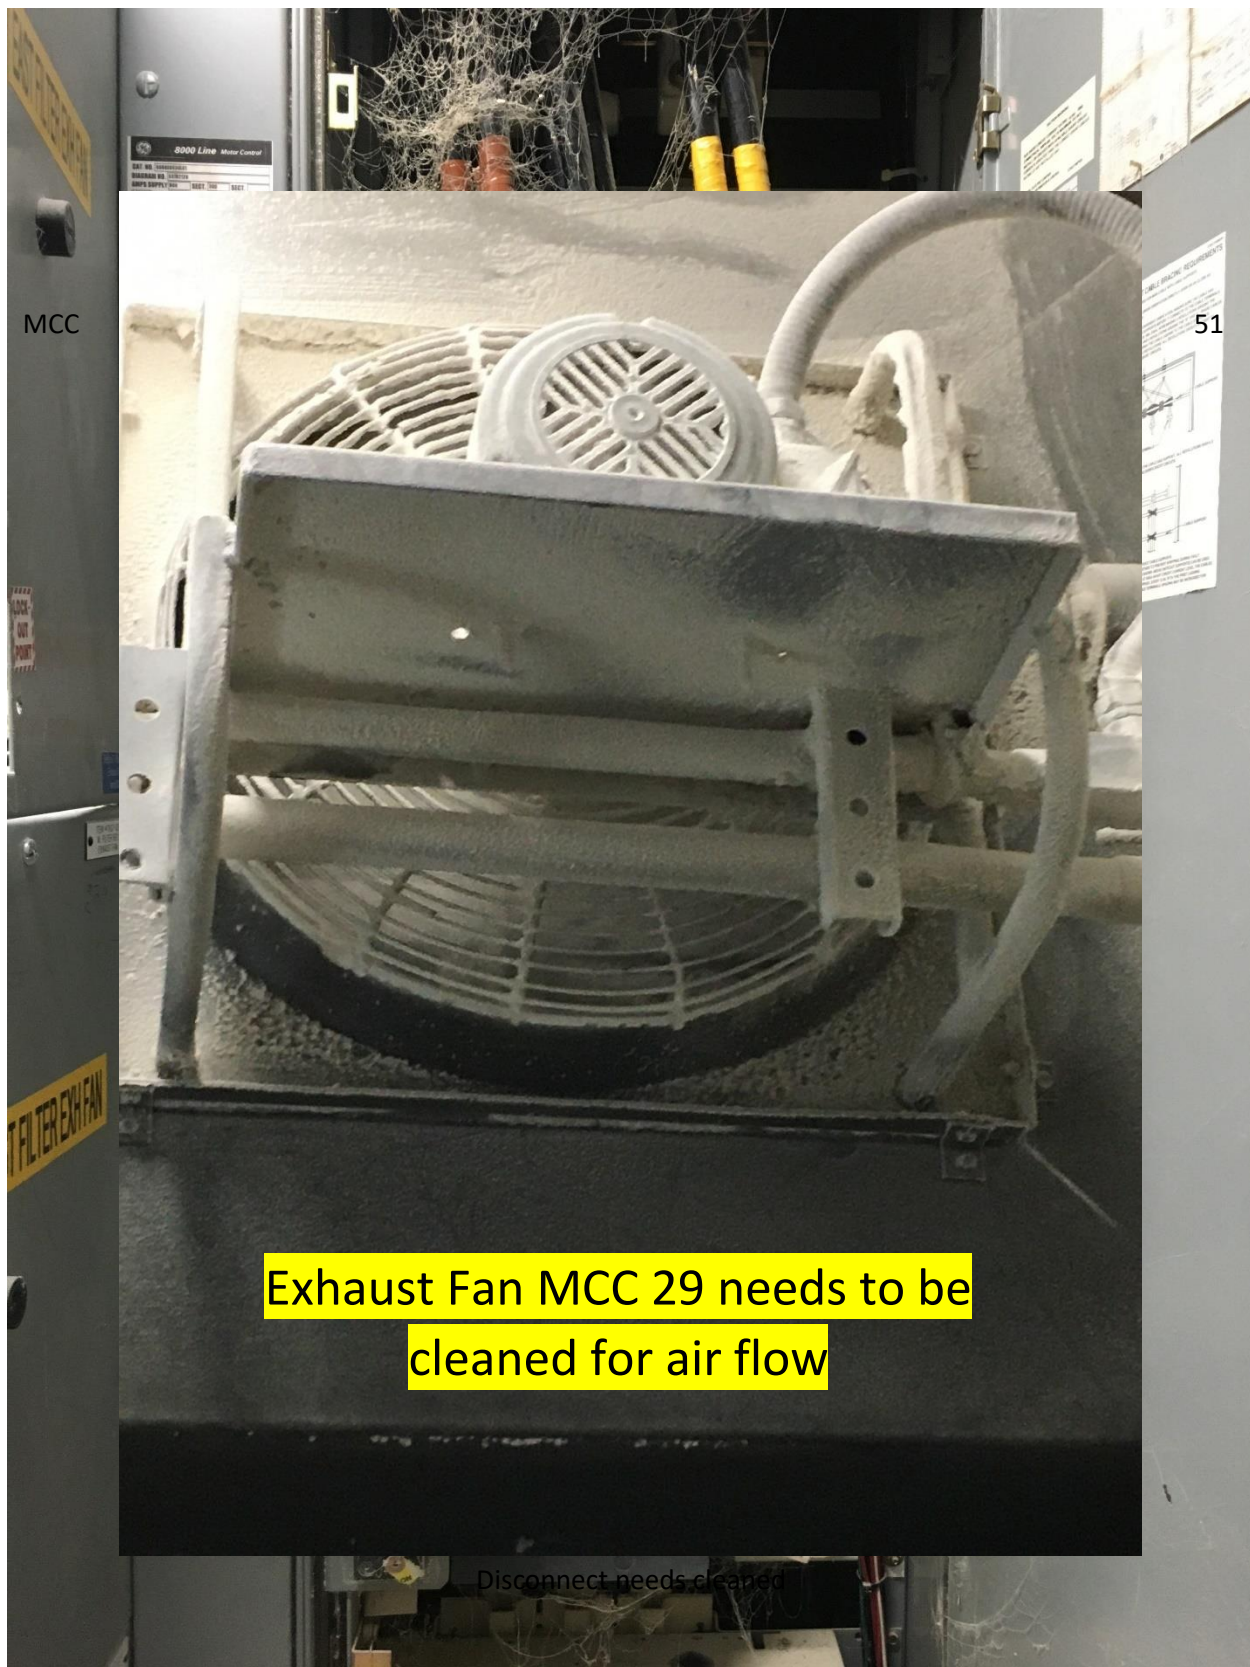
Exhaust Fan MCC 29 needs to be
cleaned for air flow

Disconnect needs cleaned

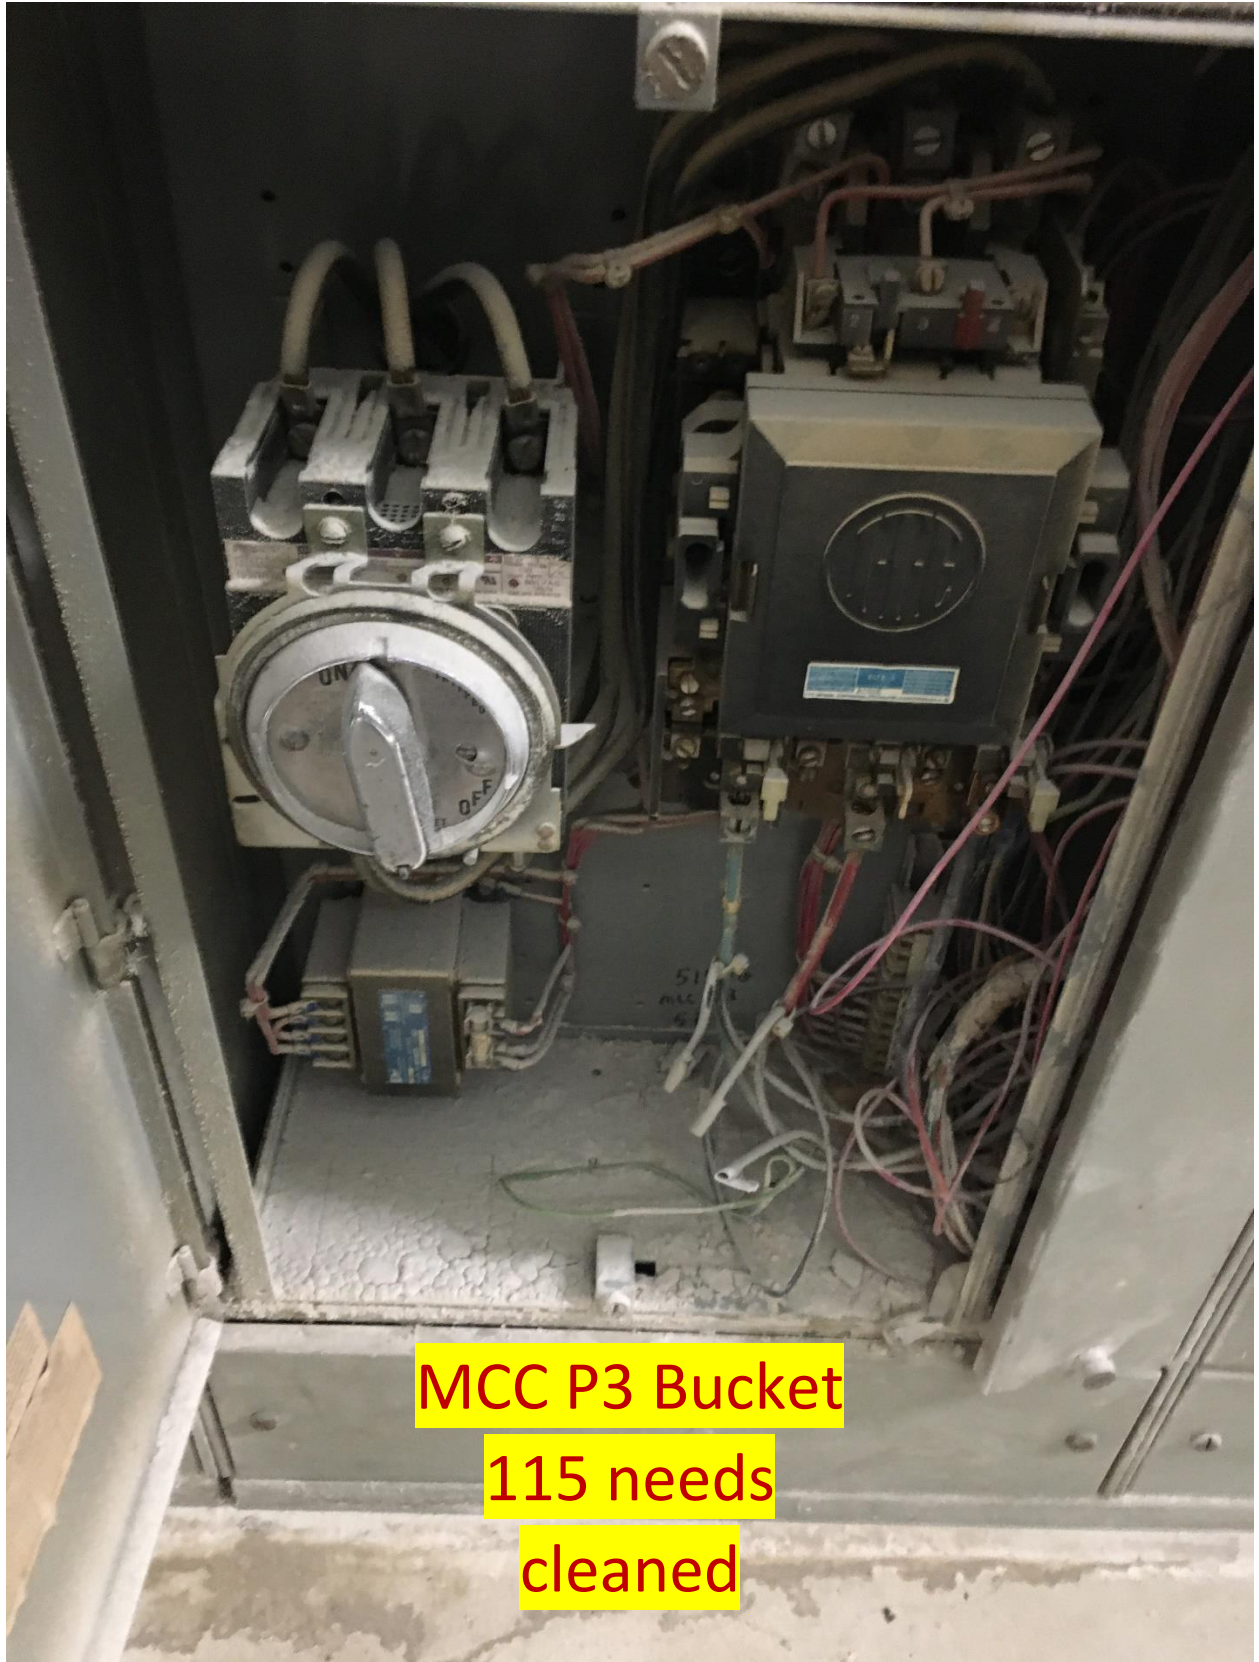
MCC P3 Bucket

115 needs
cleaned

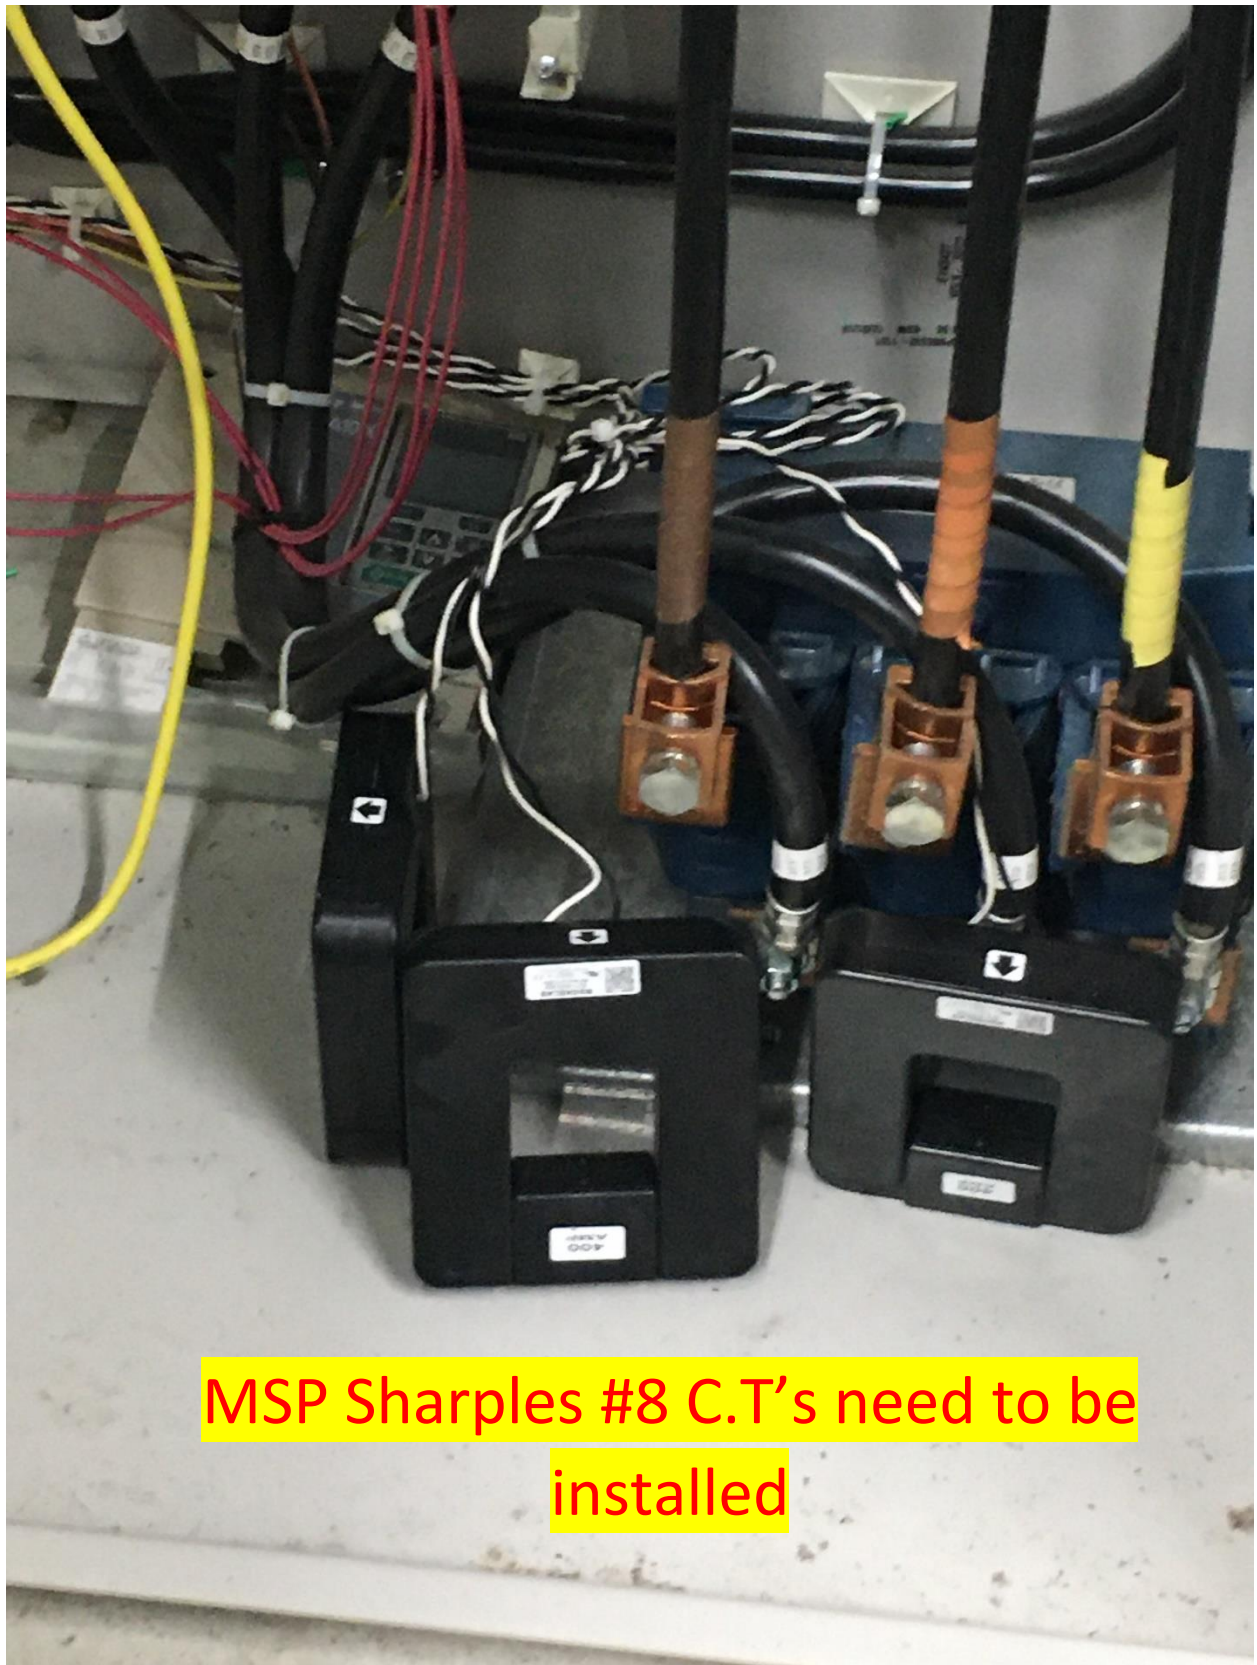
MSP Sharples #8 C.T's need to be
installed

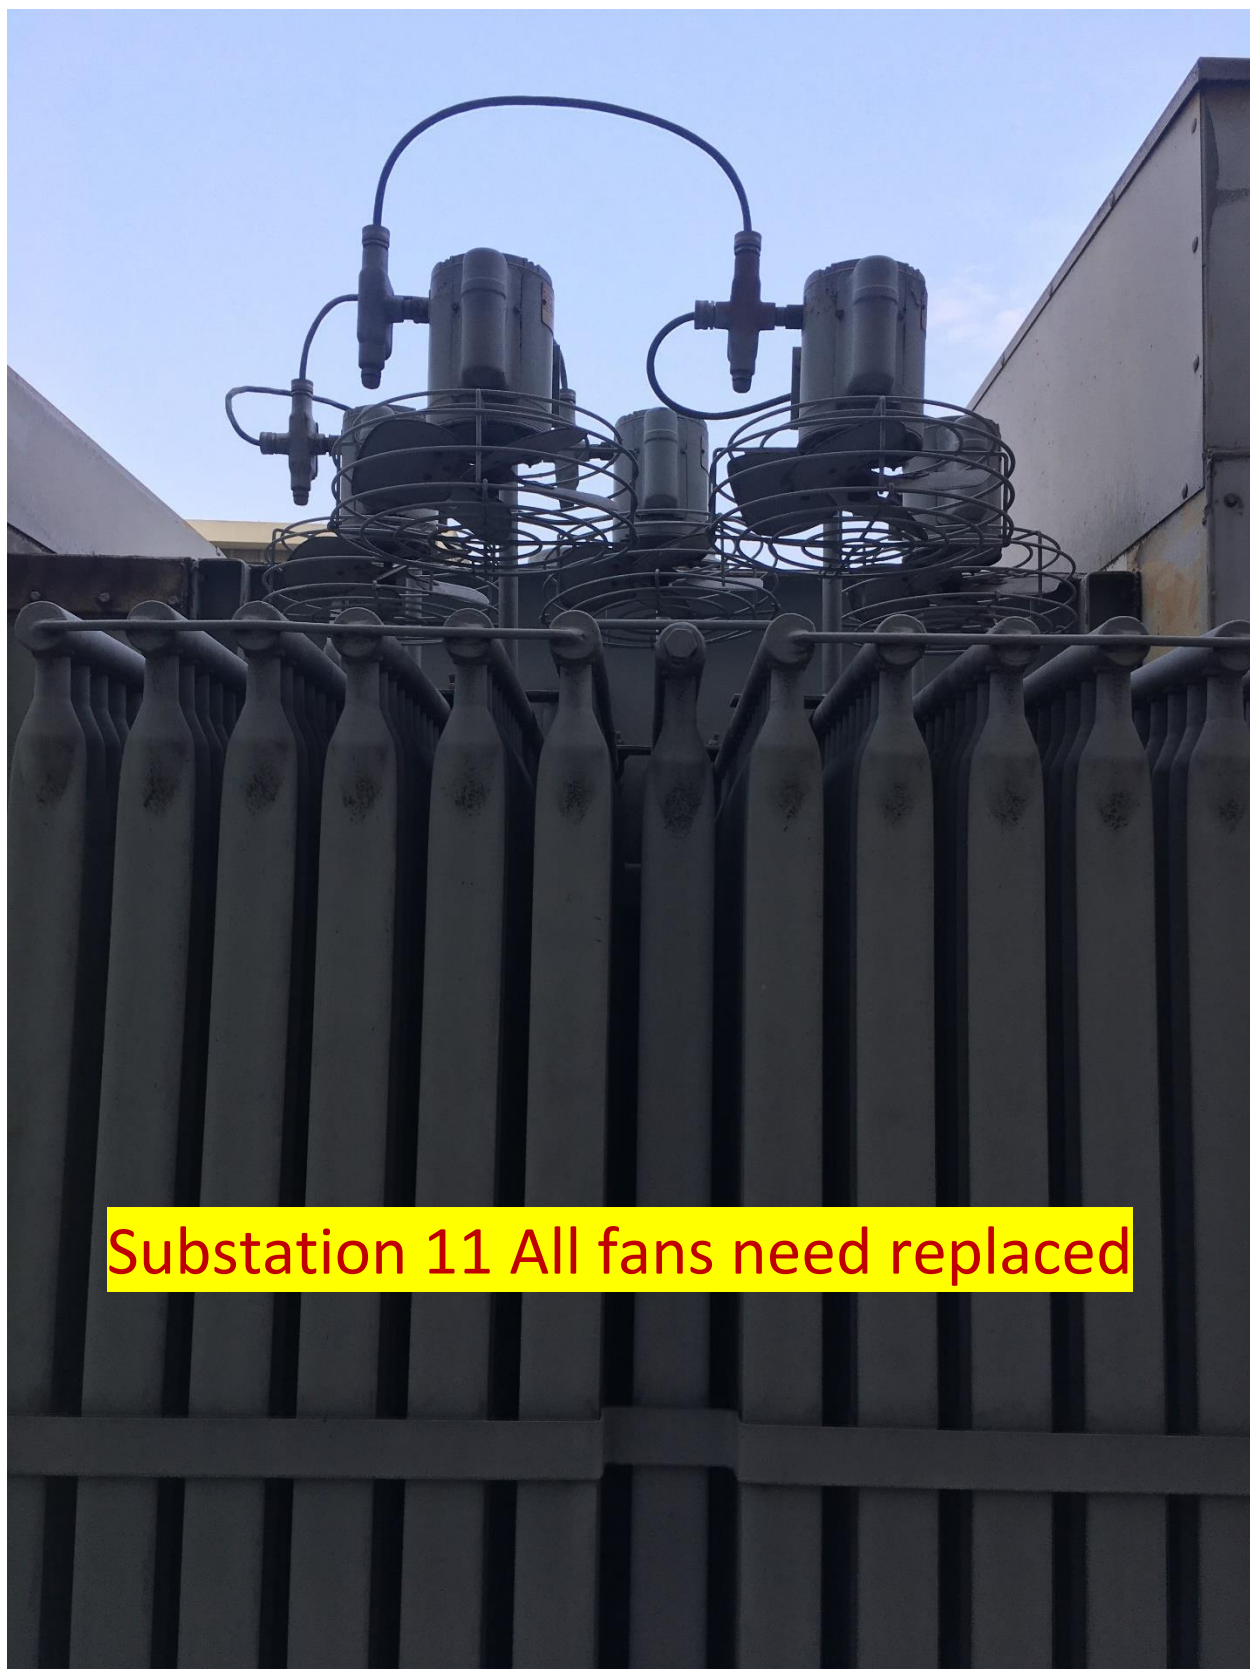
Substation 11 All fans need replaced

Substation 11 needs 8 fans
