Infrared Thermography Report

JULY 2020

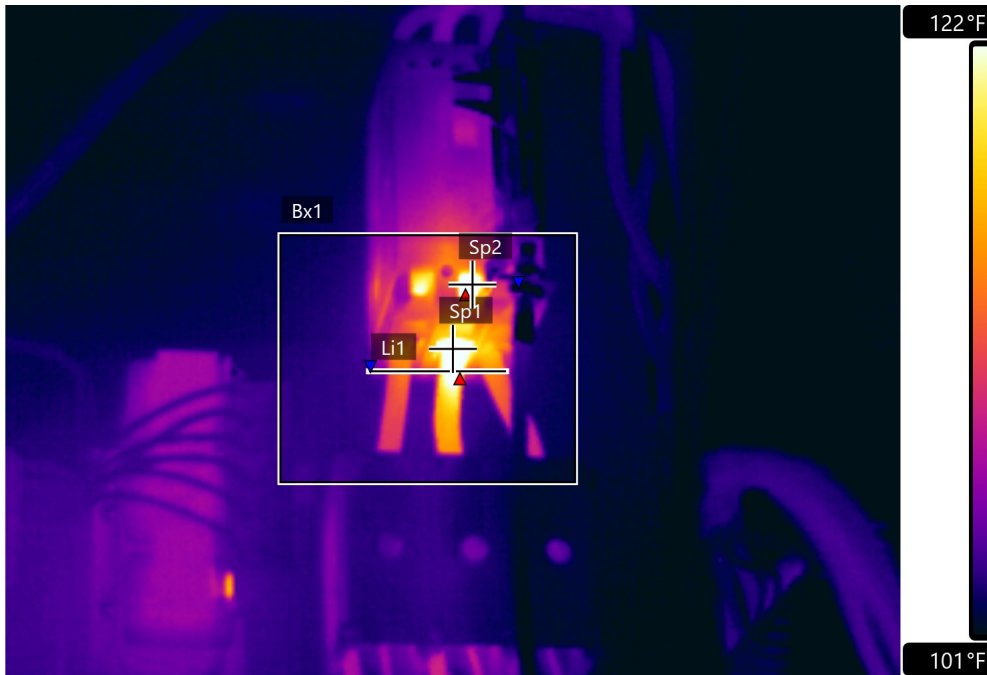
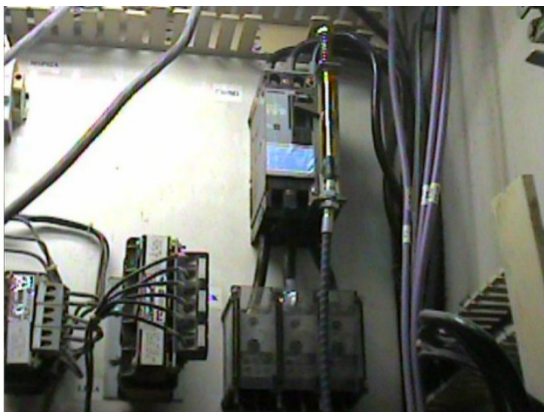
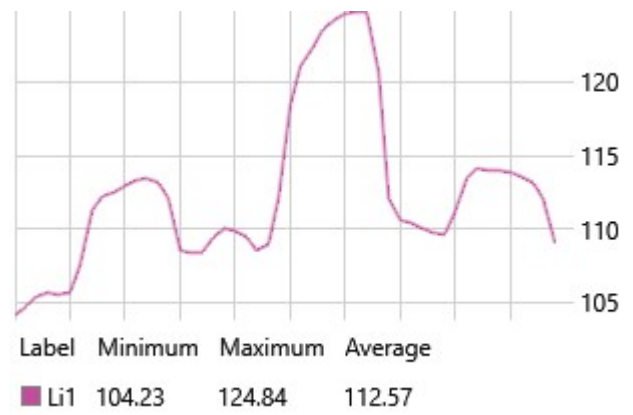
Component	Main Breaker
Equipment/Bucket ID	VFD Cascade Kiln Jack

Sp1	130.0 °F
Sp2	133.4 °F
Li1 Minimum	104.2 °F
Li1 Maximum	124.8 °F
Bx1 Minimum	96.9 °F
Bx1 Maximum	142.8 °F

Fault	Faulty Breaker/Connection
Defect Rating	CLASS I

Recommendations	There still appears to be an issue even after repairs were made to connections. This breaker is LIKELY the issue here. It is recommended to replace the breaker as soon as time allows.
-----------------	--

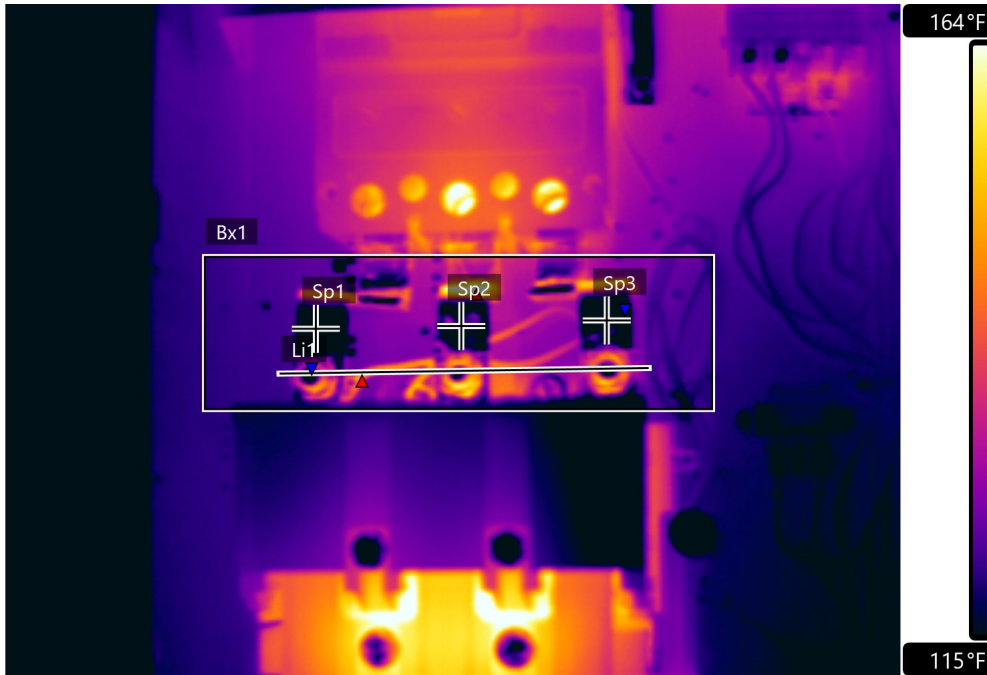
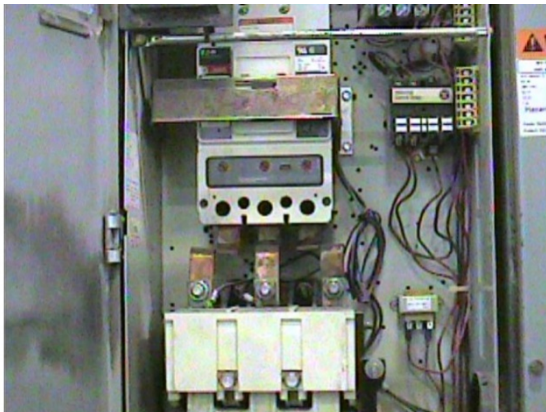
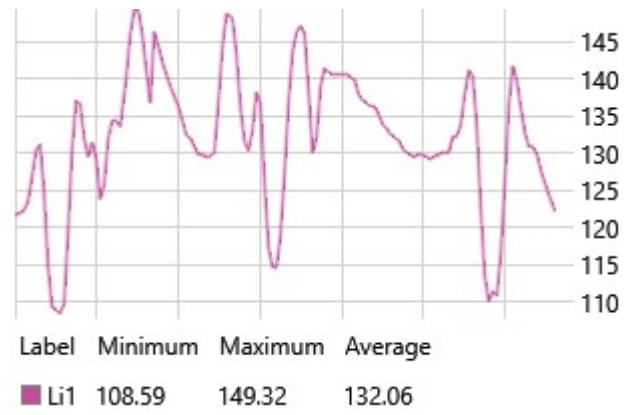
Component	
Equipment/Bucket ID	Vacuum Pump #1

Sp1	101.7 °F
Sp2	118.9 °F
Sp3	101.5 °F
Li1 Minimum	108.6 °F
Li1 Maximum	149.3 °F
Bx1 Minimum	97.7 °F
Bx1 Maximum	167.1 °F

Fault	None
Defect Rating	N/A

Recommendations
This is a recheck after repair. Issue appears to have been resolved. No further actions needed.

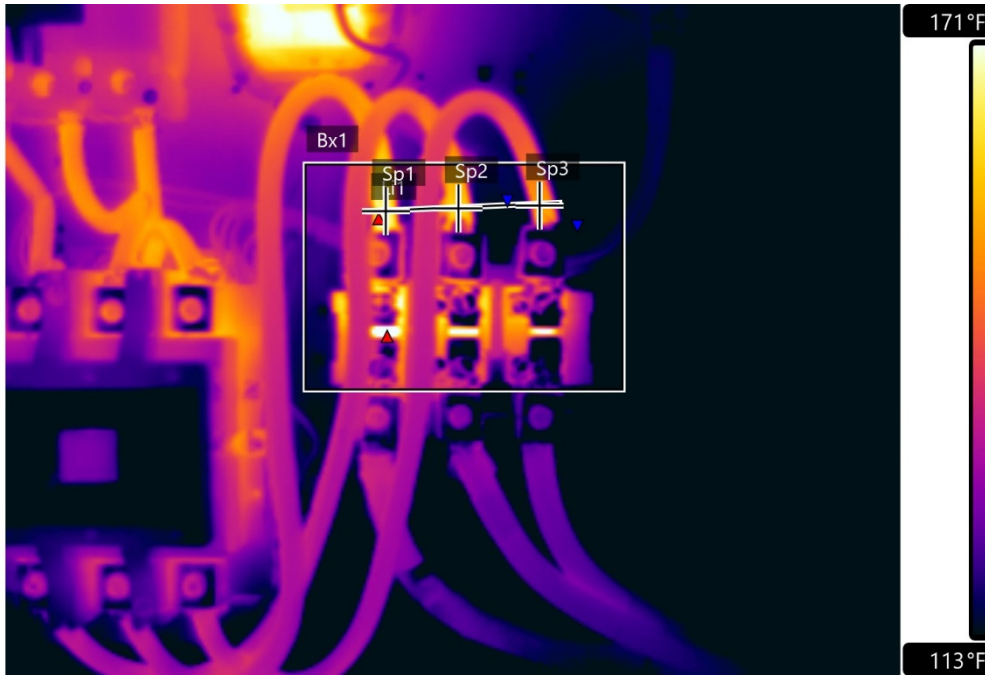
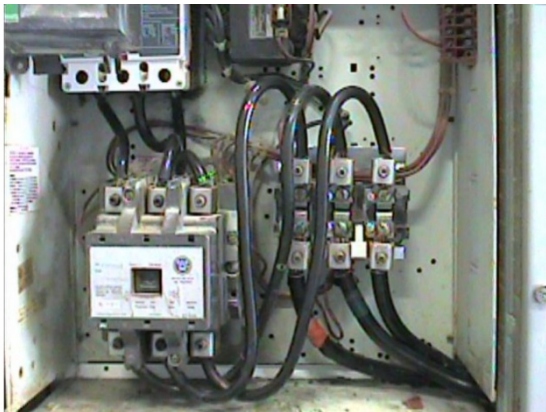
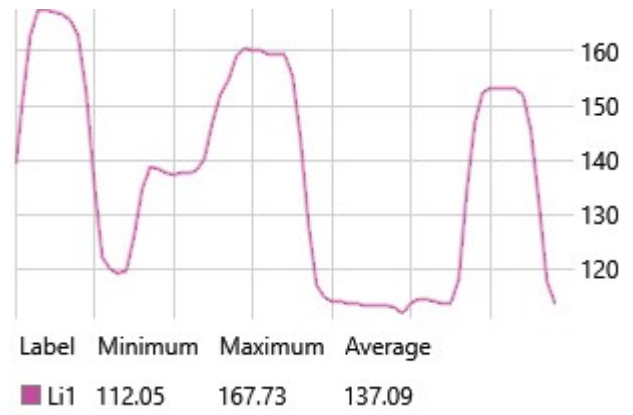
Component	
Equipment/Bucket ID	Whitewater Loop Pump #1

Sp1	166.9 °F
Sp2	159.4 °F
Sp3	153.5 °F
Li1 Minimum	112.0 °F
Li1 Maximum	167.7 °F
Bx1 Minimum	97.7 °F
Bx1 Maximum	204.4 °F

Fault	None
Defect Rating	N/A

Recommendations	This is a recheck after repair. Issue appears to have been resolved. No further actions needed.
-----------------	---

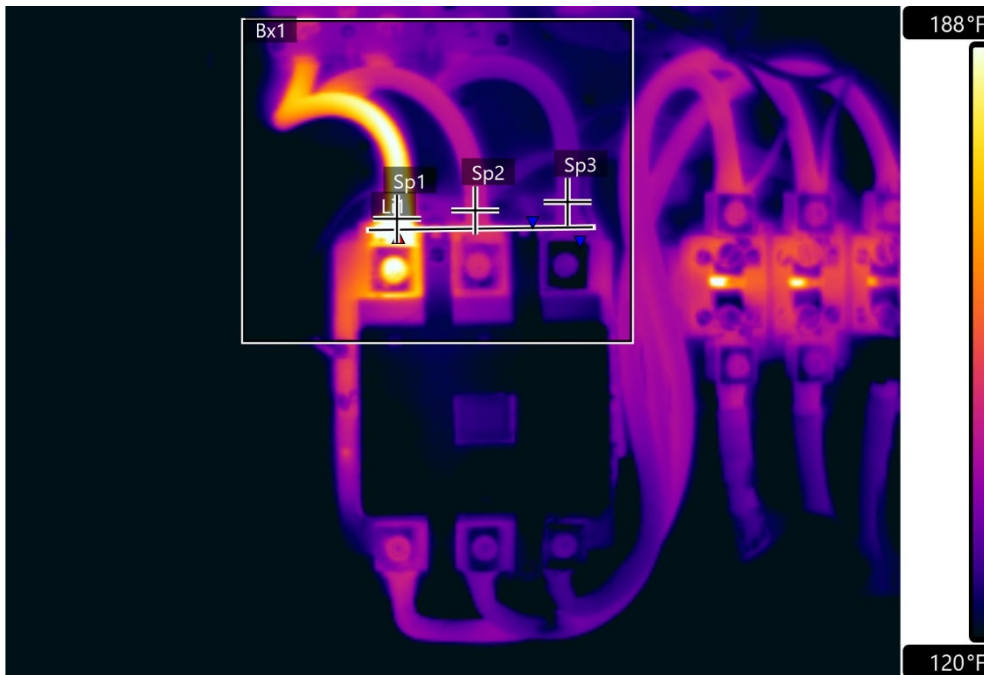
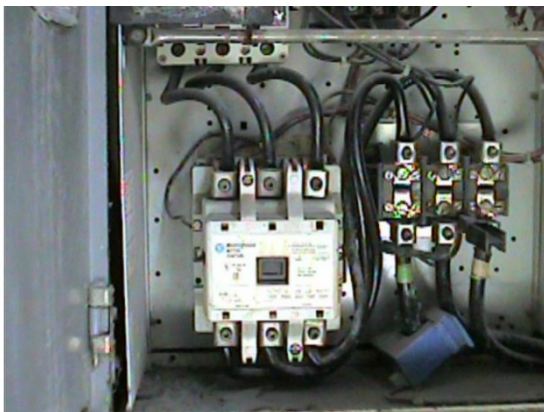
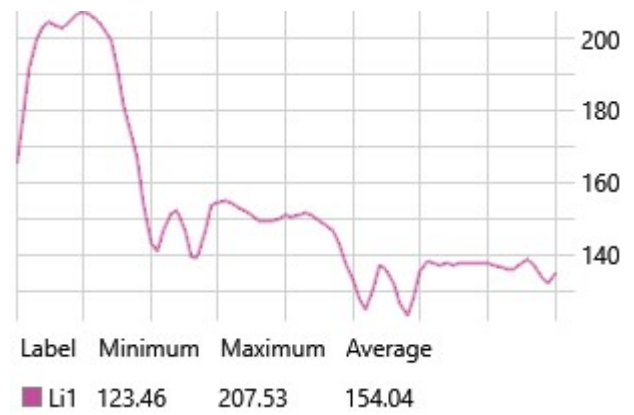
Component	A Phase Connection
Equipment/Bucket ID	MCC-4C1/ North Well Water Pump

Sp1	200.2 °F
Sp2	146.4 °F
Sp3	134.7 °F
Li1 Minimum	123.5 °F
Li1 Maximum	207.5 °F
Bx1 Minimum	112.1 °F
Bx1 Maximum	207.5 °F

Fault	Loose/Dirty Connection
Defect Rating	CLASS III

Recommendations	A phase connection appears to be faulty. Inspect, clean, and tighten connection ASAP . Wire will likely need to be replaced.
-----------------	---
