# QualiTest IR Radiometric Survey Report

June 2019

Job Number	140088
Survey Date	6/28/19
Report Date	7/9/19

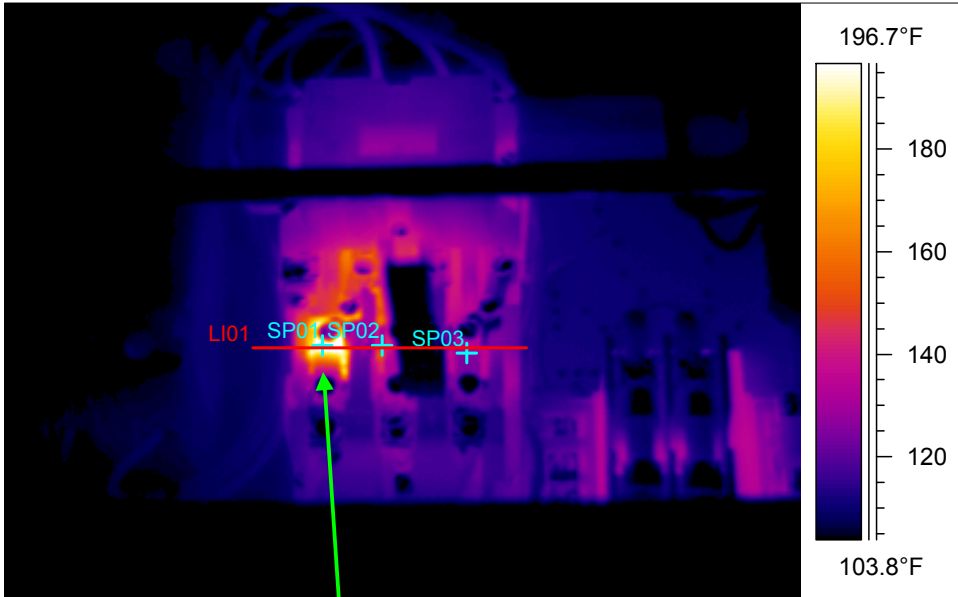
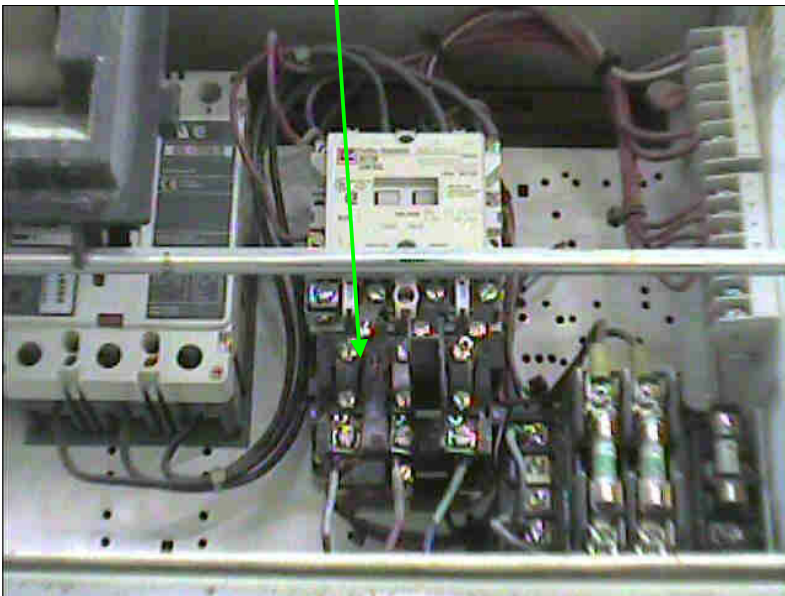
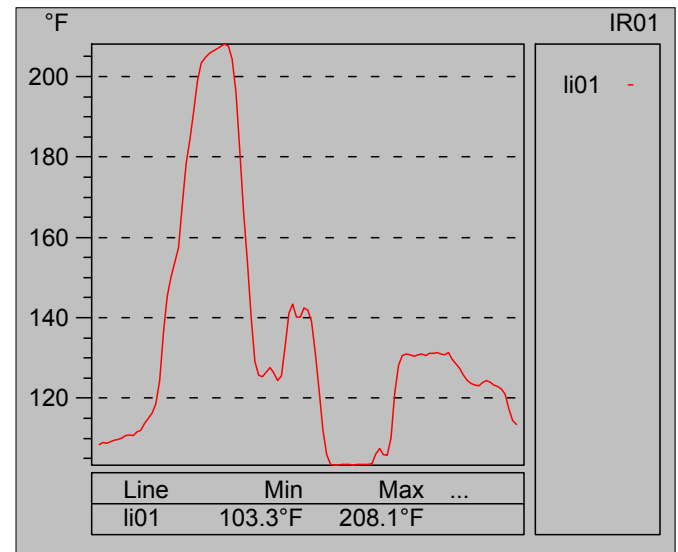
Component	Equipment/Bucket ID	Plant/Area	Date
Heater/Contactor	MCC-FG2/M5333 IR Comb. Fan	Reclaim	7/1/19

Label	Value
IR : max	212.7°F
IR : min	91.1°F
SP01	210.9°F
SP02	136.0°F
SP03	128.3°F
LI01 : max	208.1°F
LI01 : min	103.3°F

<b>Fault</b>	Faulty Heater/Contactor issue
<b>Defect Rating</b>	<b>CLASS II</b>

Heater still shows an issue after checking/tightening connections. Heater needs to be replaced. If issue still shows after replacing heater, then there may be an internal contact issue in the contactor.

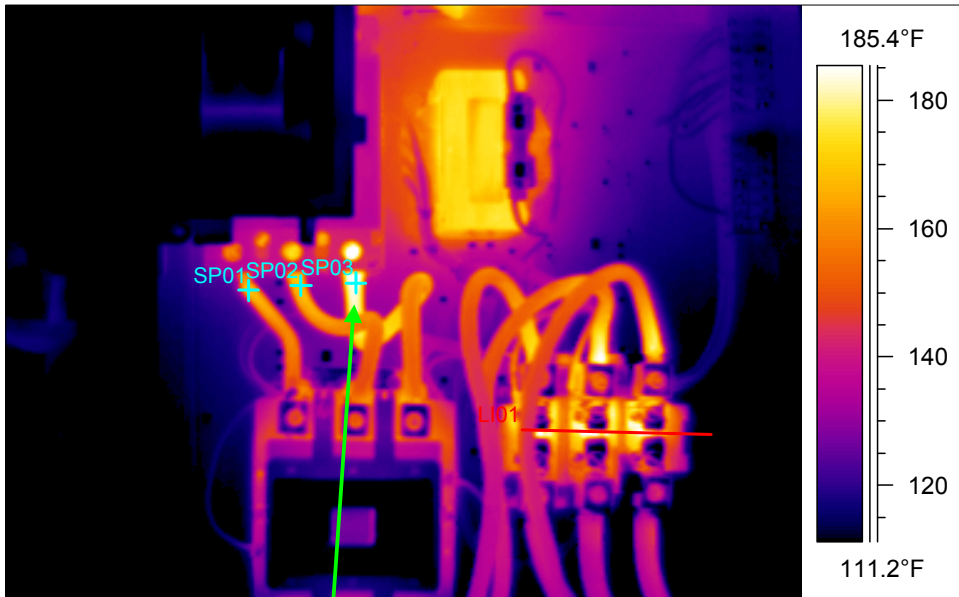
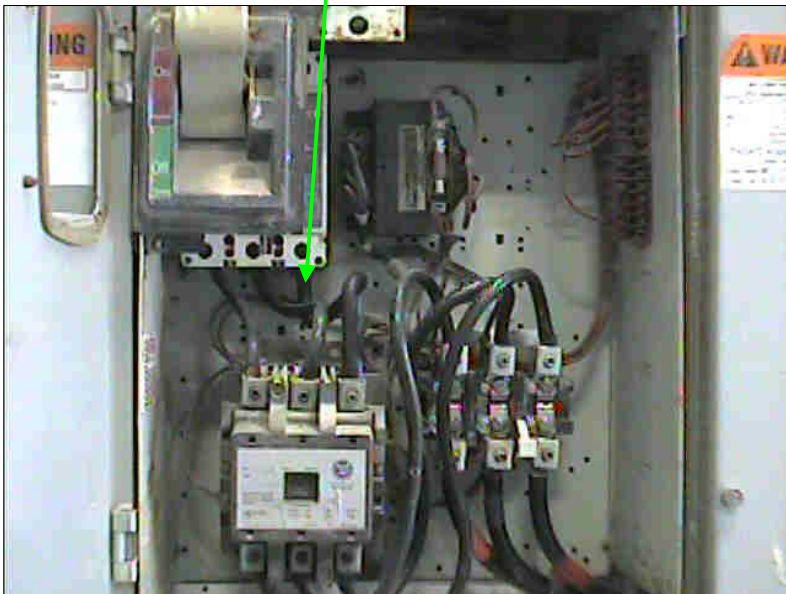
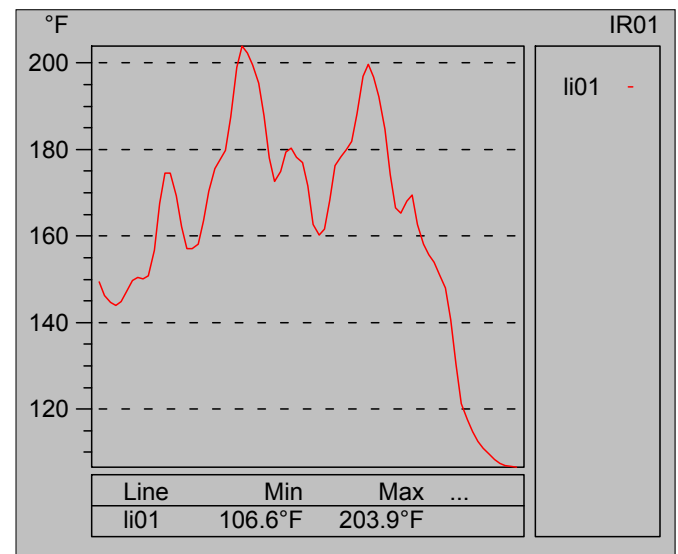
Component	Equipment/Bucket ID	Plant/Area	Date
N/A	MCC-2C2/#1 White Water Loop Pump	Reclaim	7/1/19

Label	Value
IR : max	203.9°F
IR : min	89.8°F
SP01	168.8°F
SP02	168.8°F
SP03	186.0°F
LI01 : max	203.9°F
LI01 : min	106.6°F

<b>Fault</b>	None
<b>Defect Rating</b>	None

This IR image is a recheck. Other than possible high load, this looks ok after repairs.

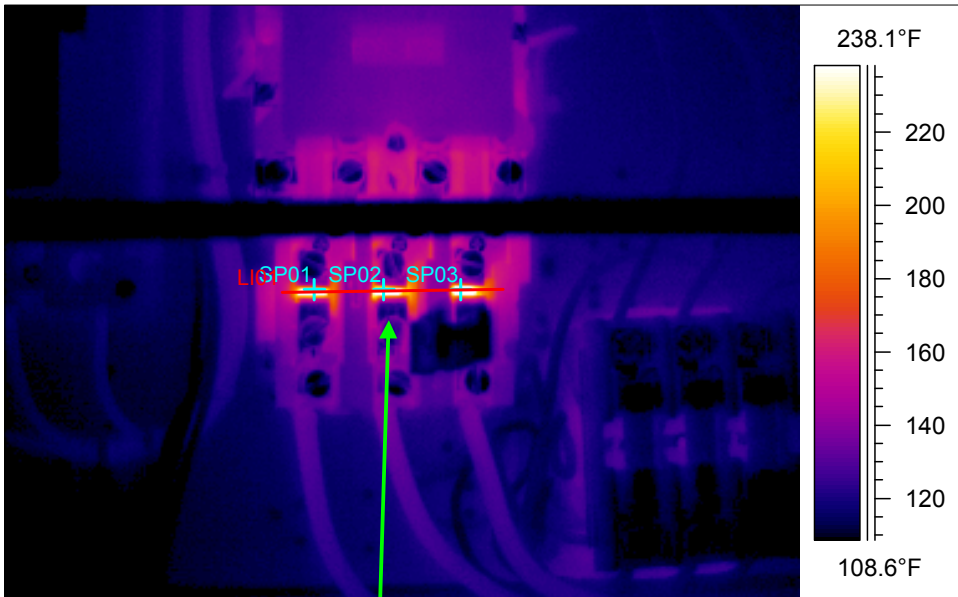
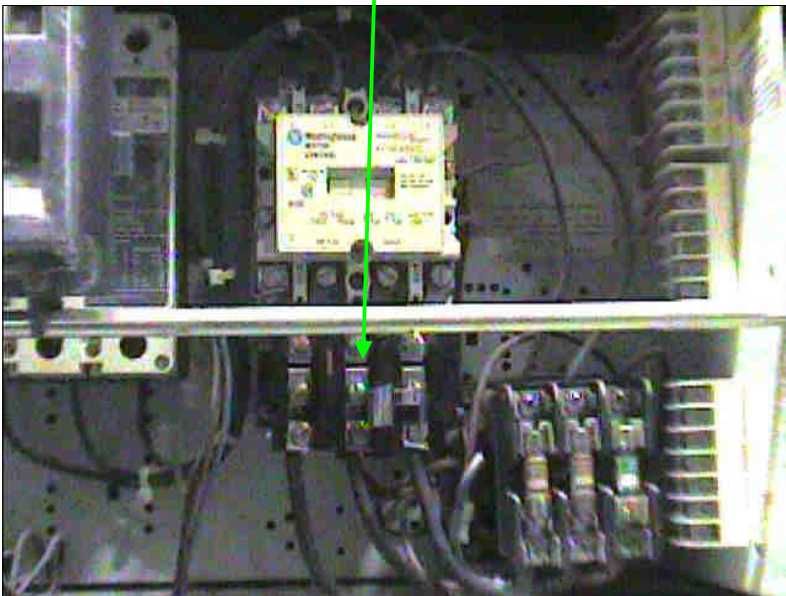
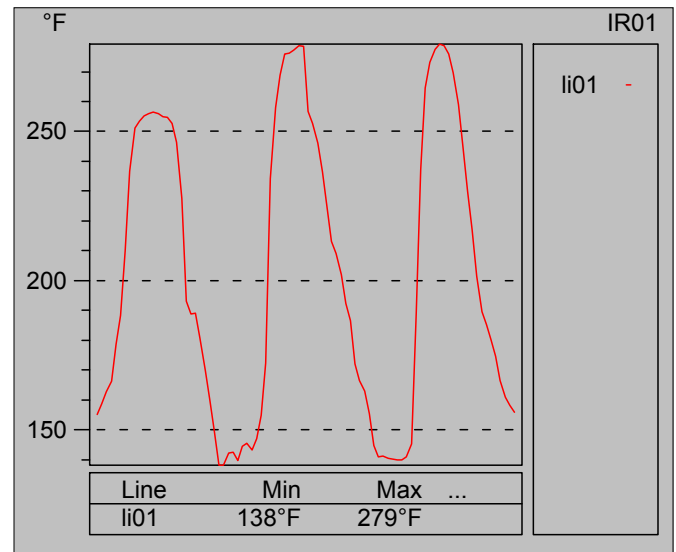
Component	Equipment/Bucket ID	Plant/Area	Date
Heaters	MCC7D1/M5247 Wet Zone Burner Room N Exh. Fan	Board Line	7/1/19

Label	Value
IR : max	289°F
IR : min	95°F
SP01	239°F
SP02	261°F
SP03	277°F
LI01 : max	279°F
LI01 : min	138°F

<b>Fault</b>	Possible Heater Issue
<b>Defect Rating</b>	<b>CLASS II</b>

All three heaters appear to be very hot. This may be due to issue with the heaters. It is recommended to replace heaters and recheck.

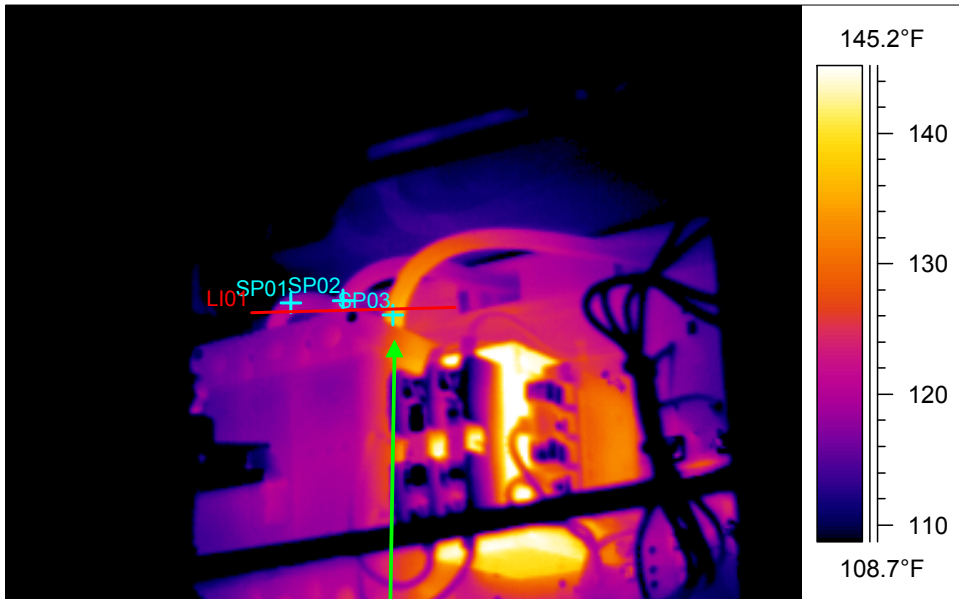
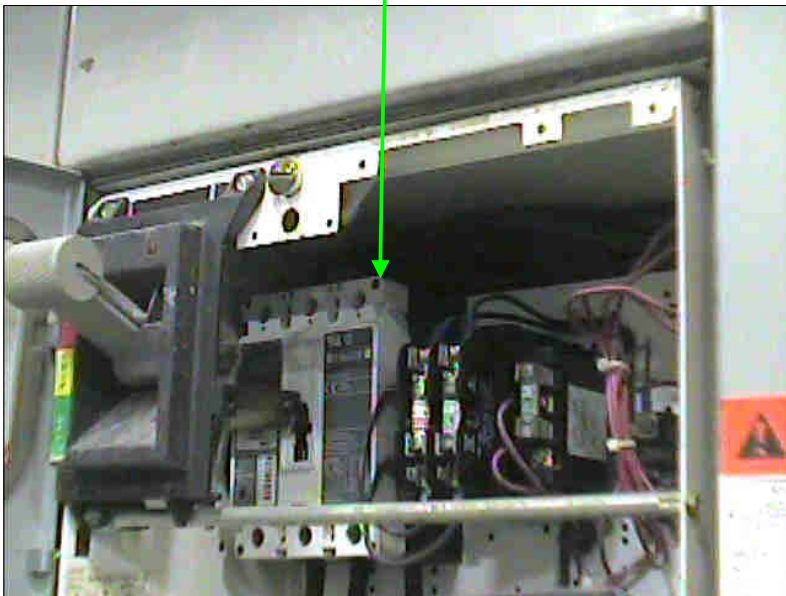
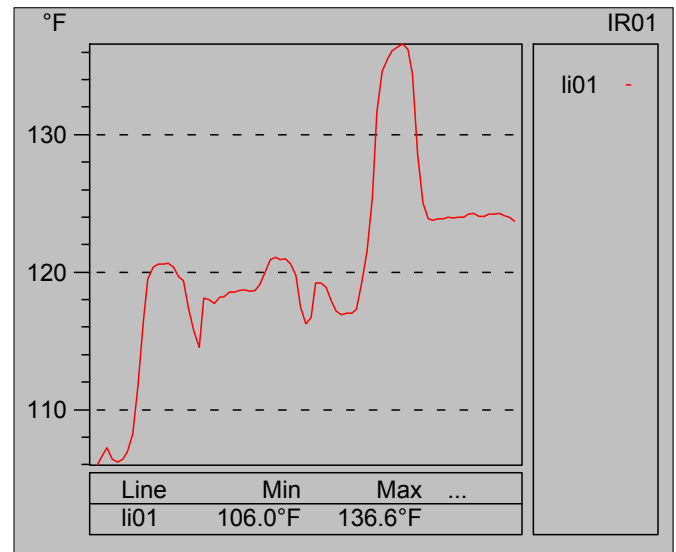
Component	Equipment/Bucket ID	Plant/Area	Date
N/A	MCC-1CB2 Hydropupler Dump Chest Agitator	Reclaim	7-9-18

Label	Value
IR : max	148.5°F
IR : min	87.8°F
SP01	119.2°F
SP02	121.5°F
SP03	136.2°F
LI01 : max	136.6°F
LI01 : min	106.0°F

<b>Fault</b>	None
<b>Defect Rating</b>	None

Recheck shows that issue has been resolved. No further action is needed.
