Infrared Thermography Report

USG

June 2022

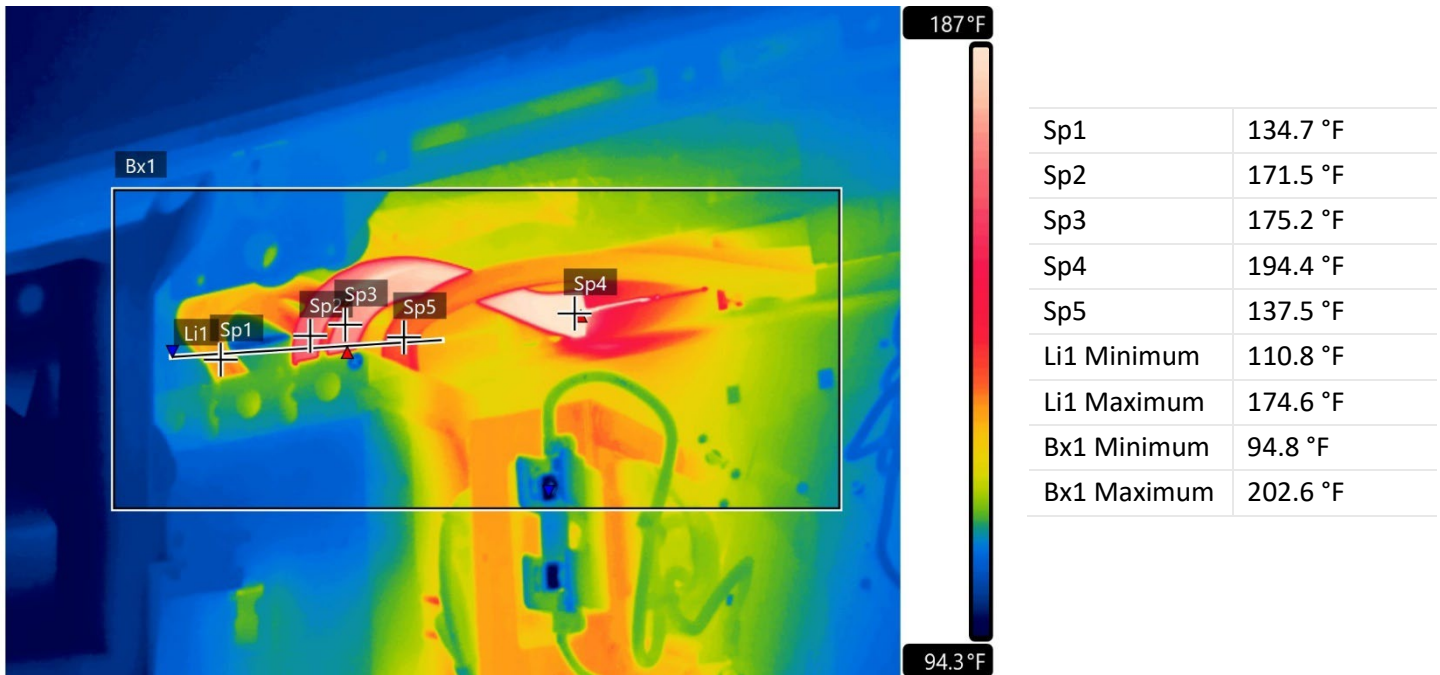
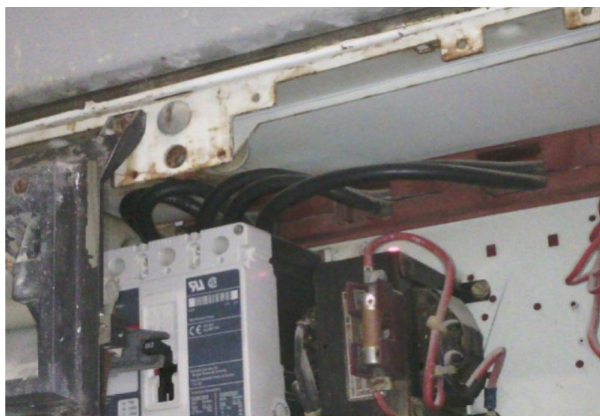
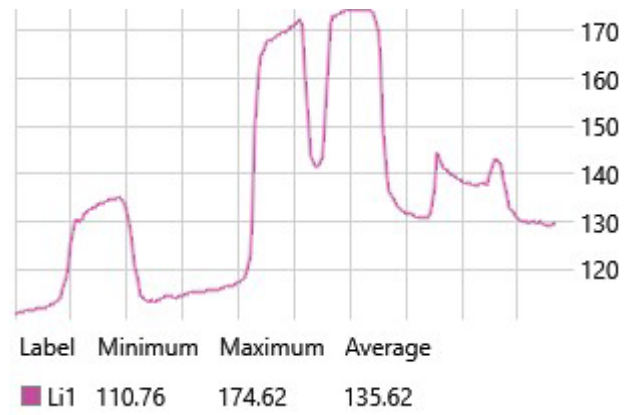
Component	Incoming Power Leads
Equipment/Bucket ID	Whiter Water Loop Pump

Fault	Possible connection issue or lead issue
Defect Rating	CLASS II

Recommendations
IR image shows a strange issue here. Notice that B phase leads are around 25 degrees hotter as the leads go into the cabinet. These are incoming power leads. Unfortunately, we could not see where the origin of the heat is. We believe that there may be a connection issue up the lead or some other issue. It is highly recommended to inspect the B phase lead and connections on the incoming power side.

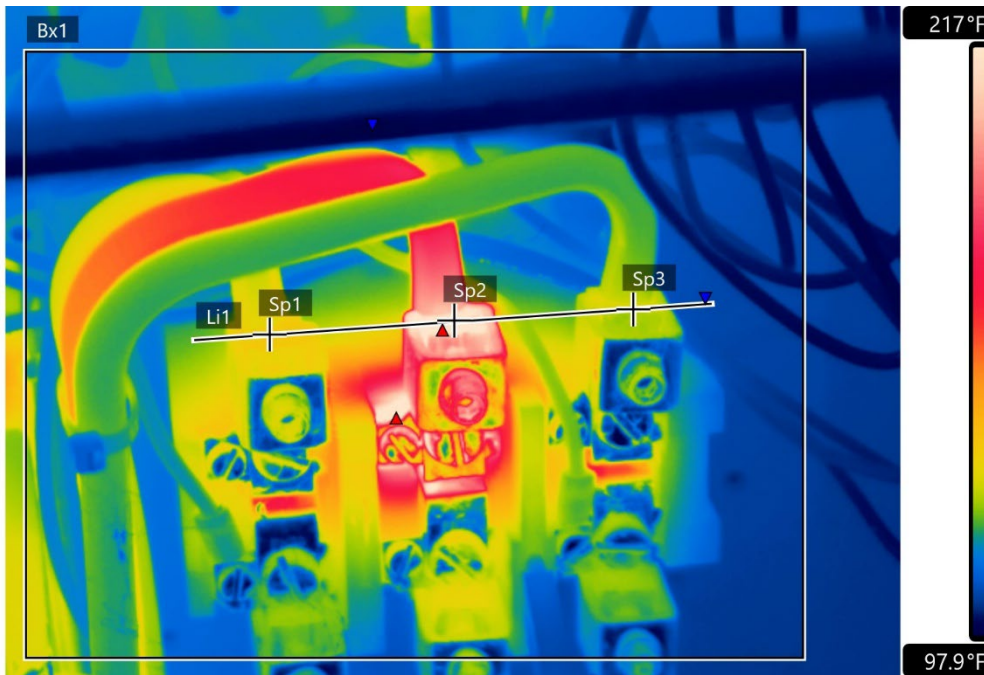
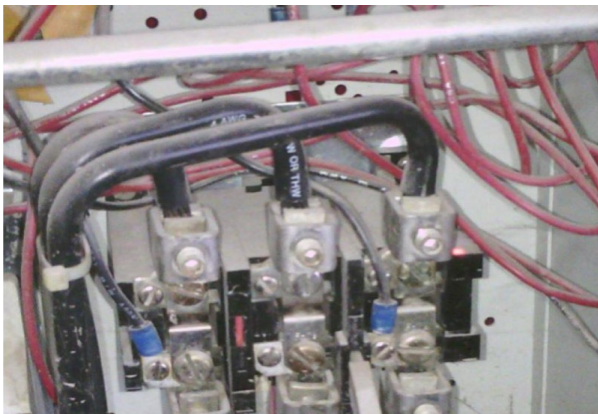
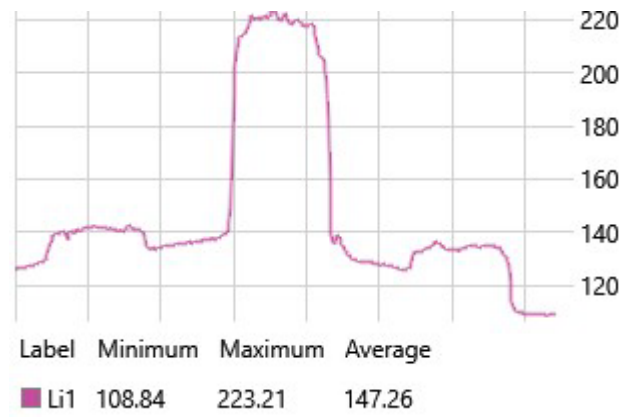
Component	B phase connection
Equipment/Bucket ID	M1443 Seal water collector tank pump/MCC-7B2

Sp1	142.3 °F
Sp2	221.3 °F
Sp3	134.6 °F
Li1 Minimum	108.8 °F
Li1 Maximum	223.2 °F
Bx1 Minimum	96.2 °F
Bx1 Maximum	230.5 °F

Fault	Faulty connection
Defect Rating	CLASS III

Recommendations	IR shows some high heat on B phase connection. Ensure connection is clean and tight. Repair ASAP.
-----------------	---

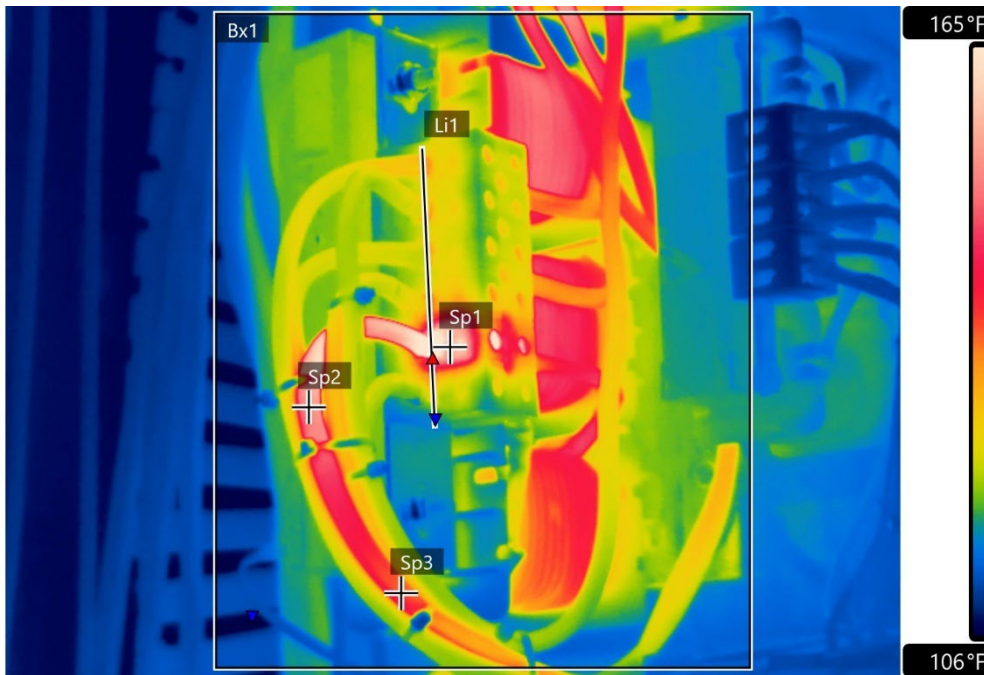
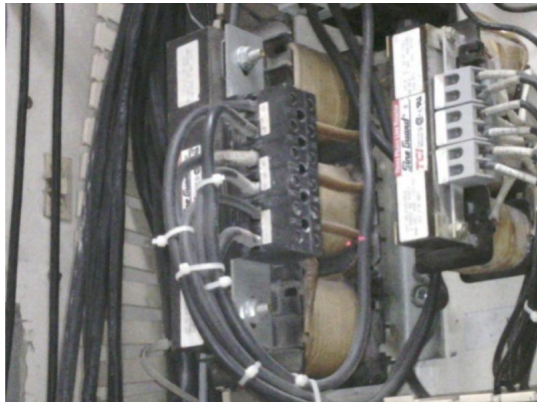
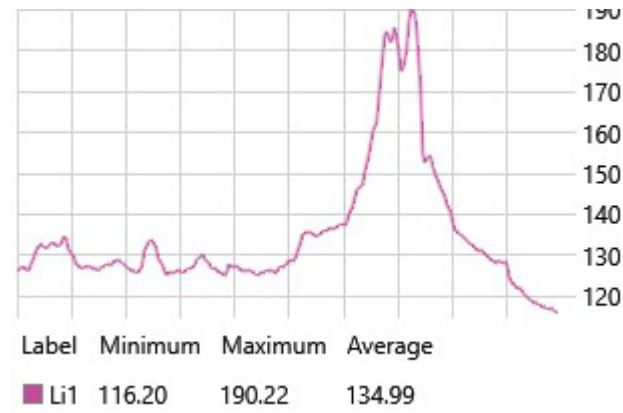
Component	Lead connection
Equipment/Bucket ID	VFD-Forming Main Power

Sp1	155.3 °F
Sp2	154.1 °F
Sp3	138.7 °F
Li1 Minimum	116.2 °F
Li1 Maximum	190.2 °F
Bx1 Minimum	105.5 °F
Bx1 Maximum	190.2 °F

Fault	Faulty Connection
Defect Rating	CLASS II

Recommendations	IR image shows some type of connection issue at second from bottom lead. Inspect connection as soon as practical.
-----------------	---

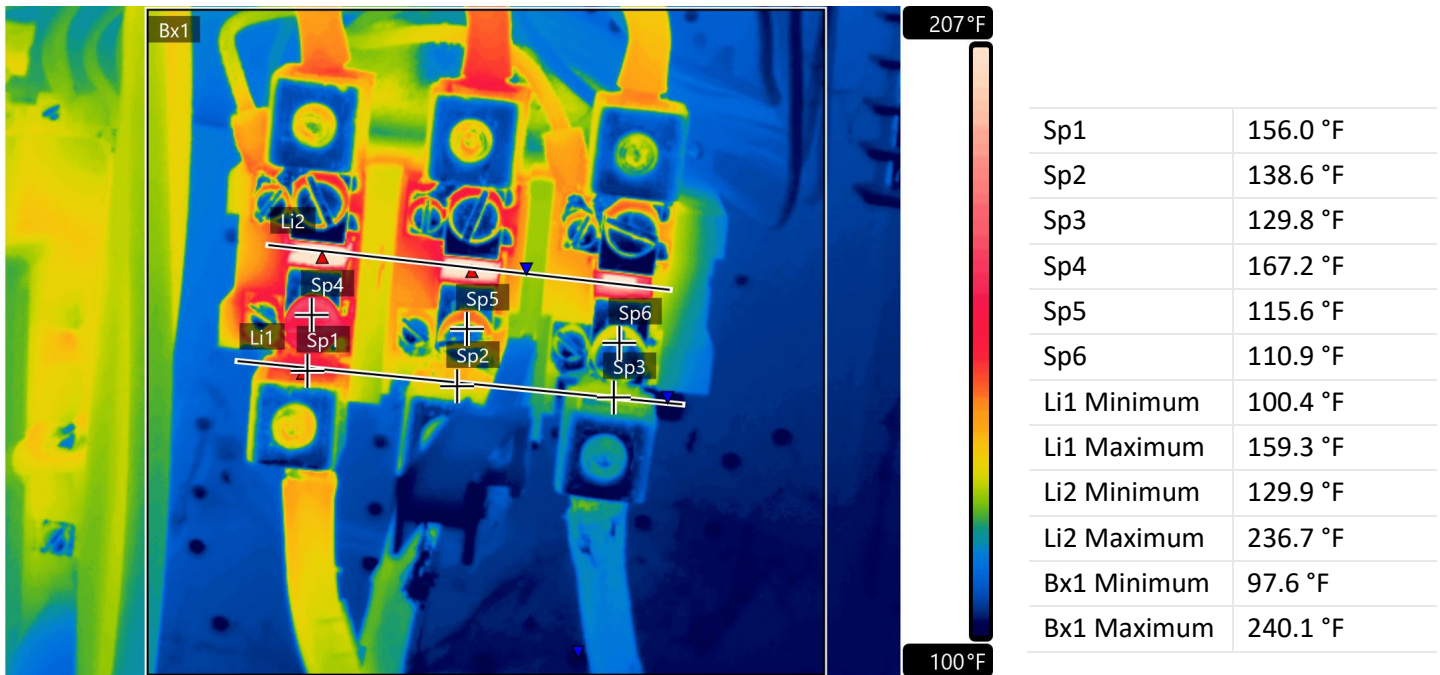
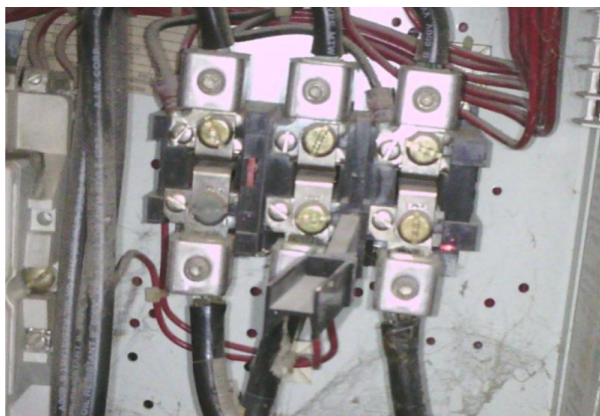
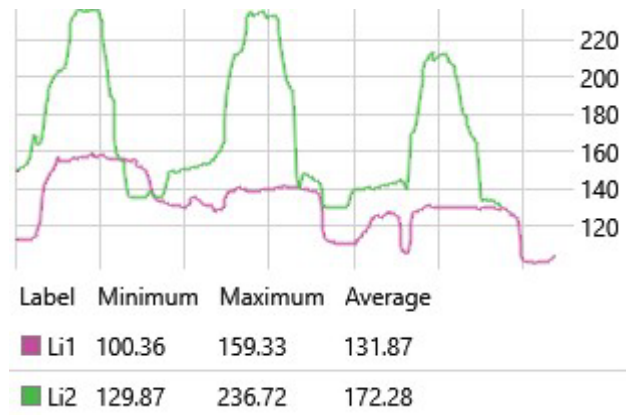
Component	A phase connection
Equipment/Bucket ID	#3 machine whitewater pump M1377/MCC-7C1

Fault	Connection issue
Defect Rating	CLASS I

Recommendations	<p>A phase likely has a connection issue. Notice in the IR image that the A phase Heater screw head is discolored. This may be influencing the emissivity of the screw which is showing a higher temp in IR image. However, there may also be a connection issue here. Inspect A phase heater connections and main lead connection as time allows.</p>
-----------------	--

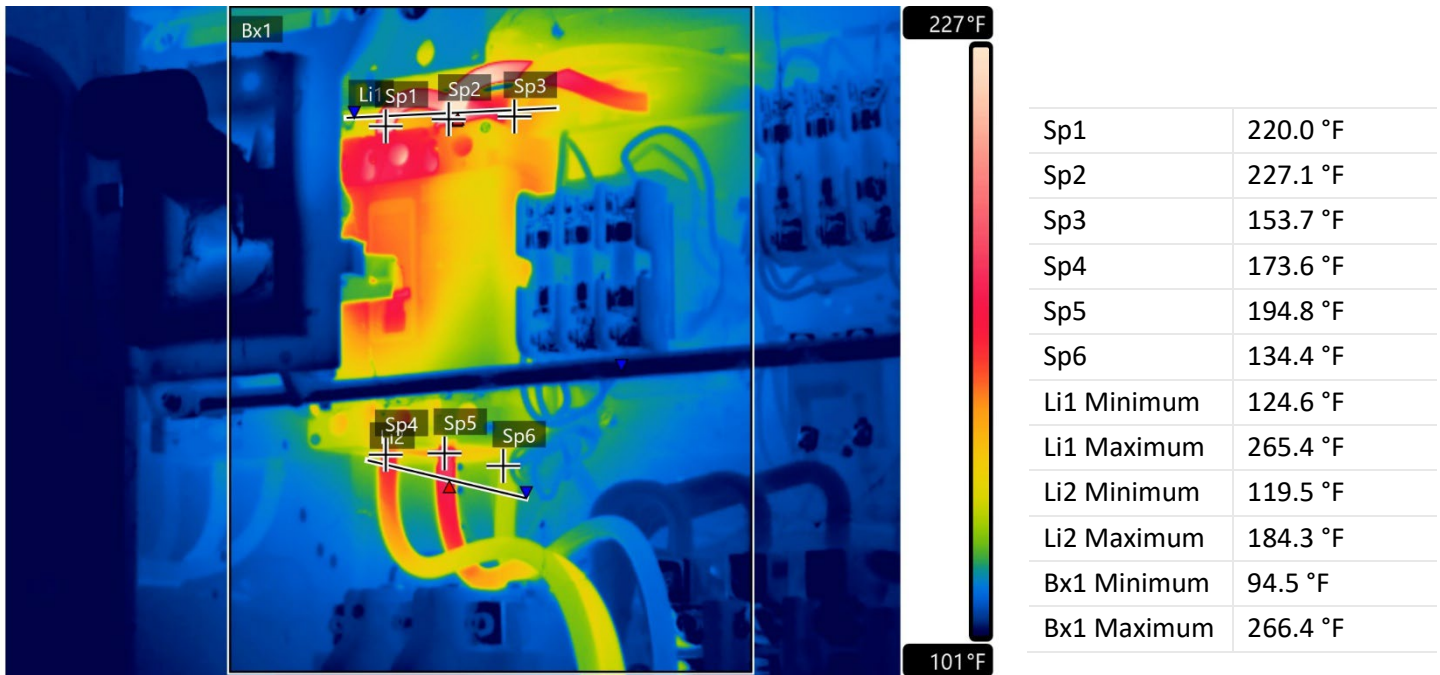
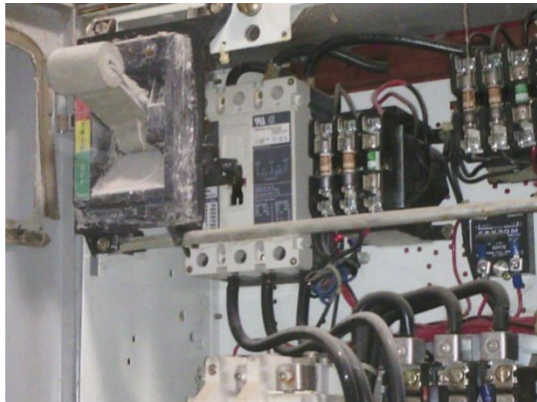
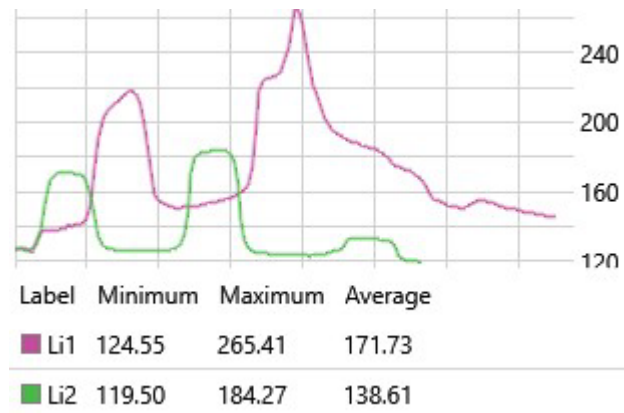
Component	Leads/Connections
Equipment/Bucket ID	VFD-MCP2/MCC-7C1

Fault	Corroded leads/Faulty connections
Defect Rating	CLASS III

Recommendations
B phase lead connections appear to be the issue here. There is visible corrosion/oxidizing on the leads. Replace leads as needed and ensure a clean tight connection on all lead connections ASAP.

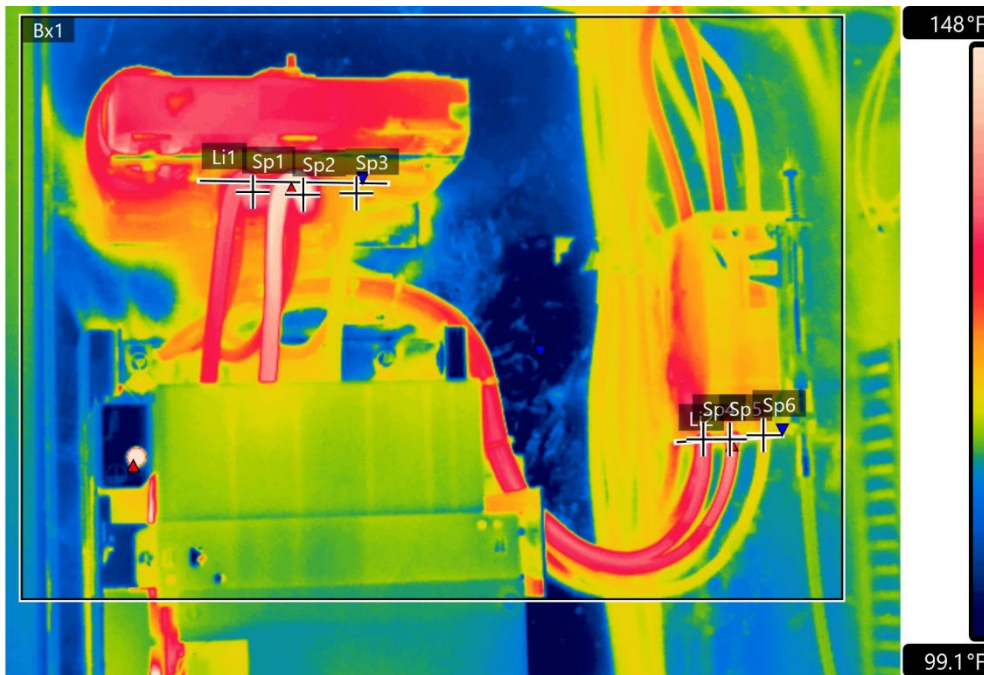
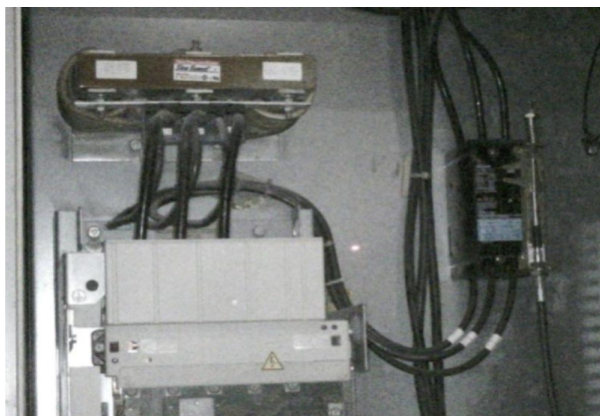
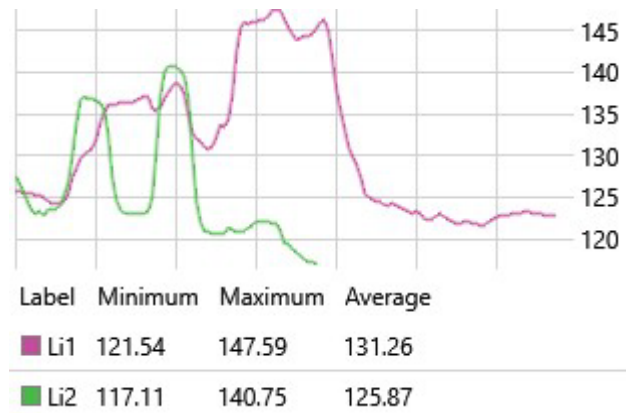
Component	Lead connections
Equipment/Bucket ID	VFD-MCP1 Machine chest pump 3B

Sp1	140.0 °F
Sp2	146.5 °F
Sp3	121.4 °F
Sp4	136.7 °F
Sp5	140.6 °F
Sp6	122.0 °F
Li1 Minimum	121.5 °F
Li1 Maximum	147.6 °F
Li2 Minimum	117.1 °F
Li2 Maximum	140.7 °F
Bx1 Minimum	97.5 °F
Bx1 Maximum	156.6 °F

Fault	Possible connection issue/Load imbalance
Defect Rating	CLASS I

Recommendations
IR image shows a possible load imbalance and or connection issues. Inspect load on each phase and ensure all connections are clean and tight.
