Motion Amplification Study, KTG Memphis, TN

1: Executive Summary

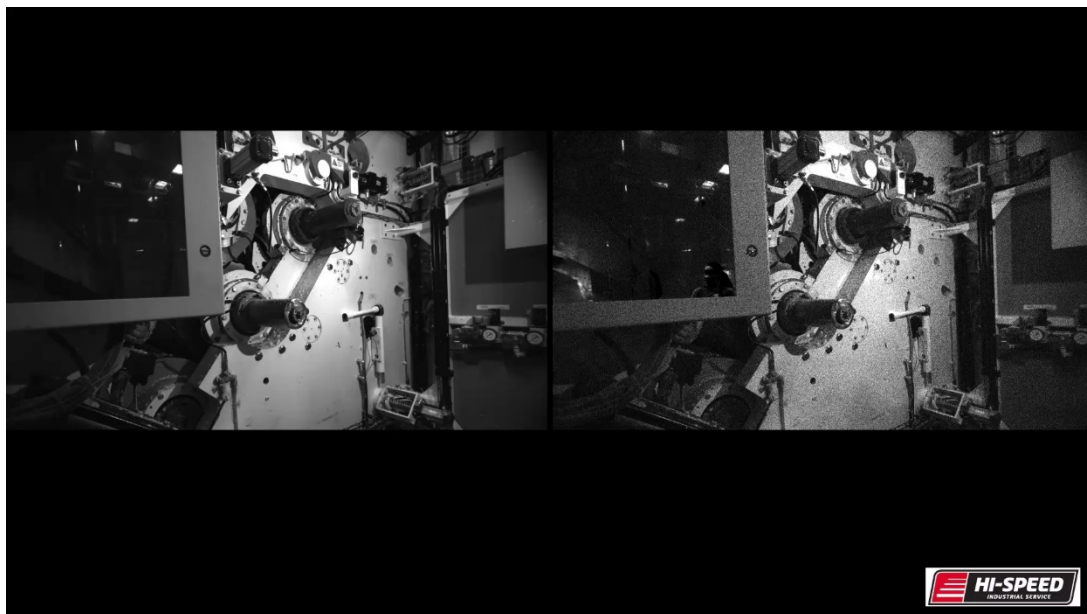
Figure 1: Motion Amplification, North side doctor chamber unloading

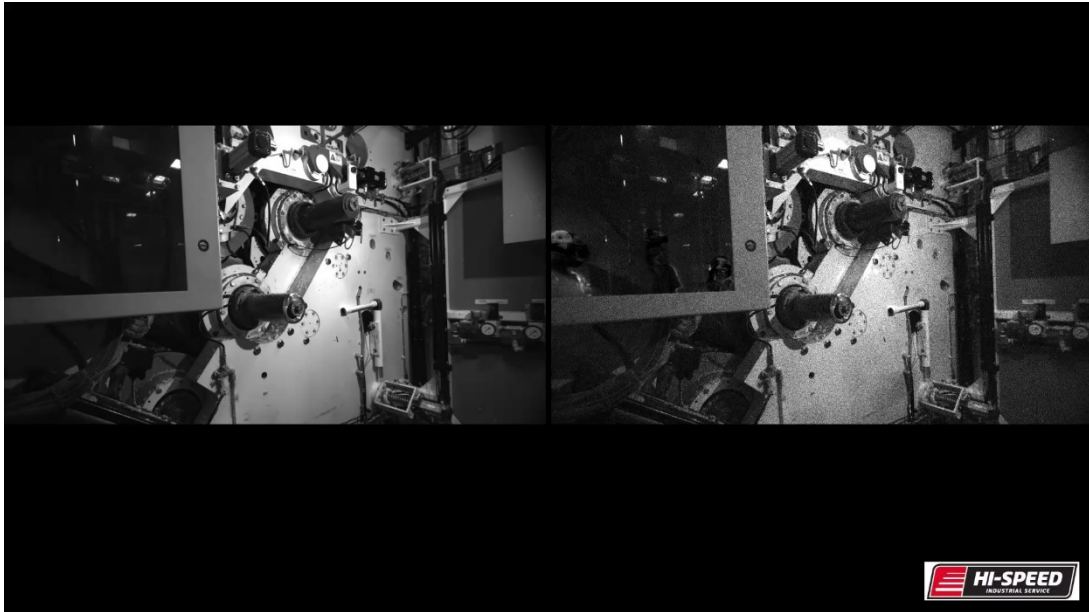
Figure 2: Motion Amplification, North side doctor chamber loading

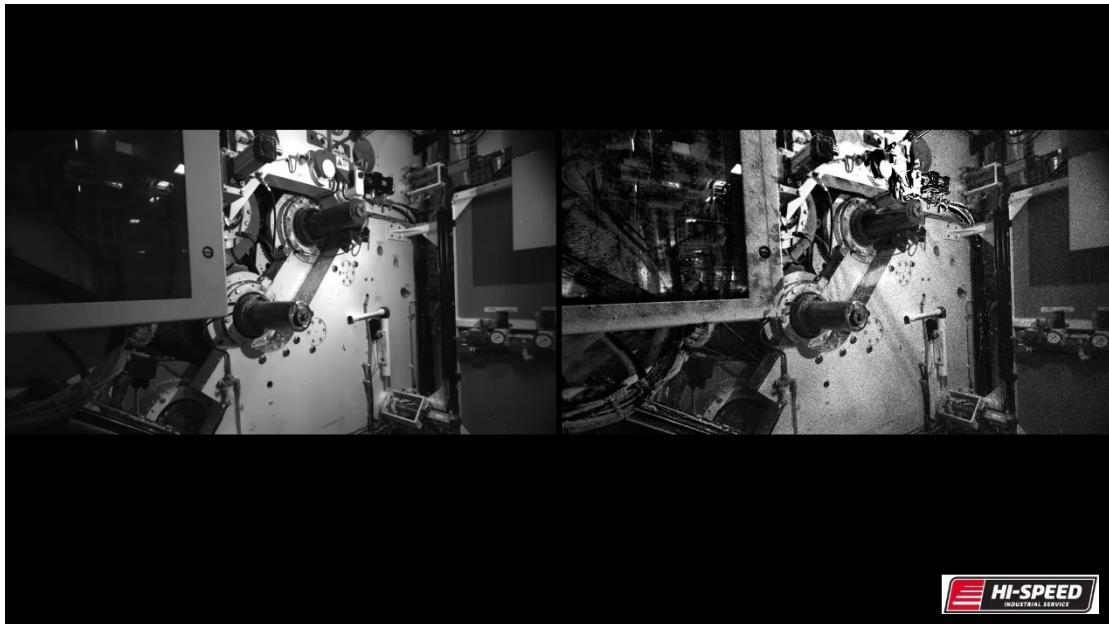
Figure 3: Motion Amplification, North Side clamshell unloading

In conclusion, there appears to be little to no movement in the emboss section in question. Motion was amplified up to 50 x and showed no evidence of excessive movement. The videos of the clamshell loading and unloading may show some movement; however, there appears to be an anomaly present that shows excessive movement of the entire right side of shot. This is likely not accurate data.

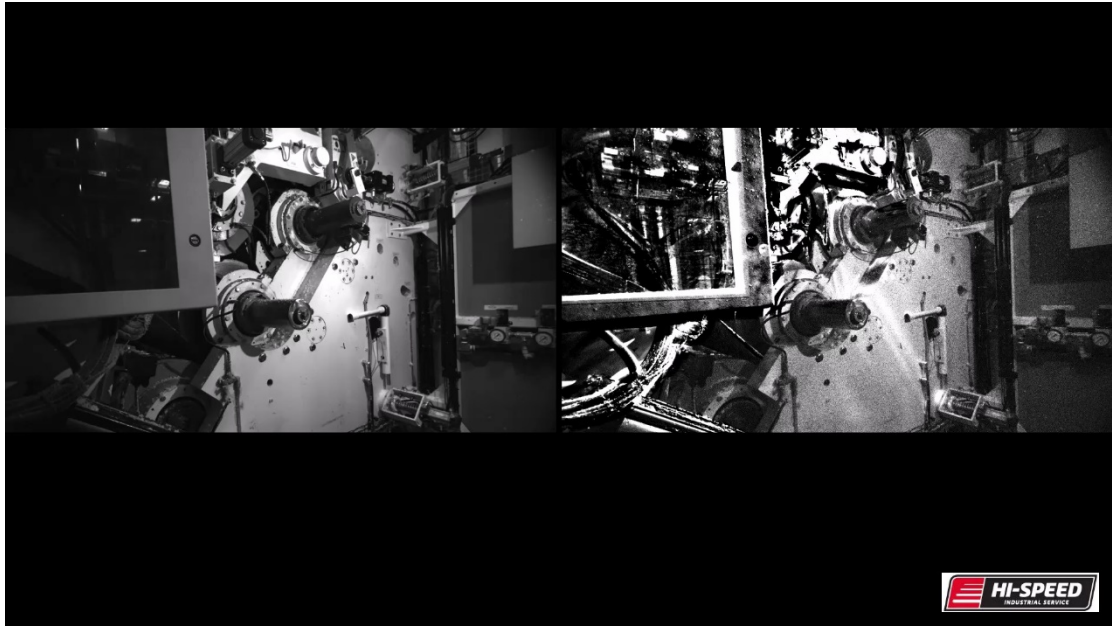
Figure 4: North Side Clamshell Loading

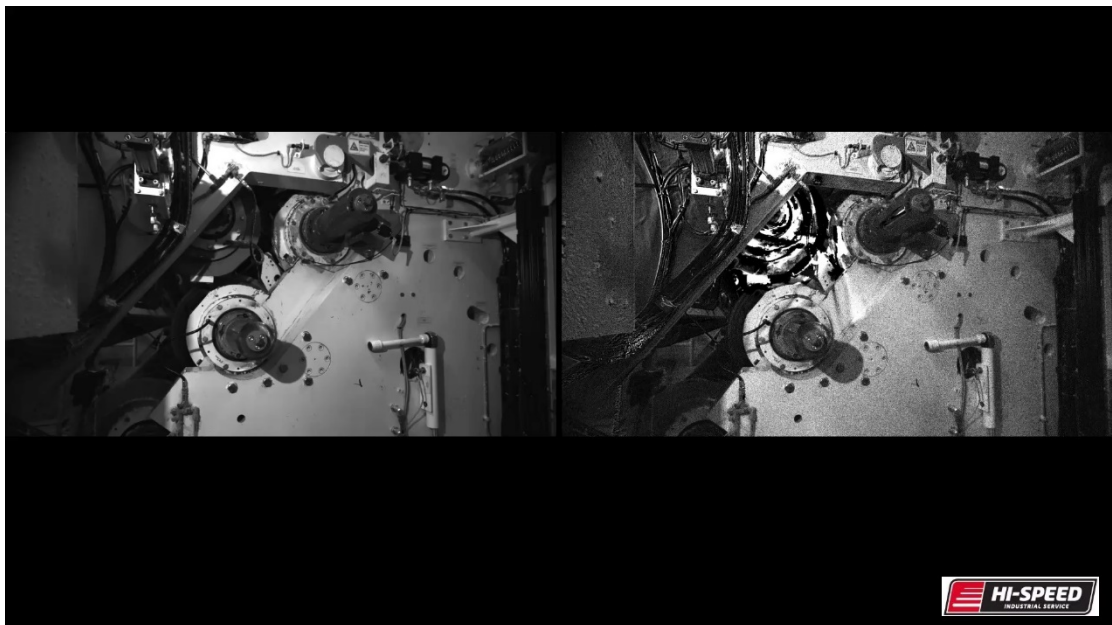
Figure 5: Marrying Roll Loading

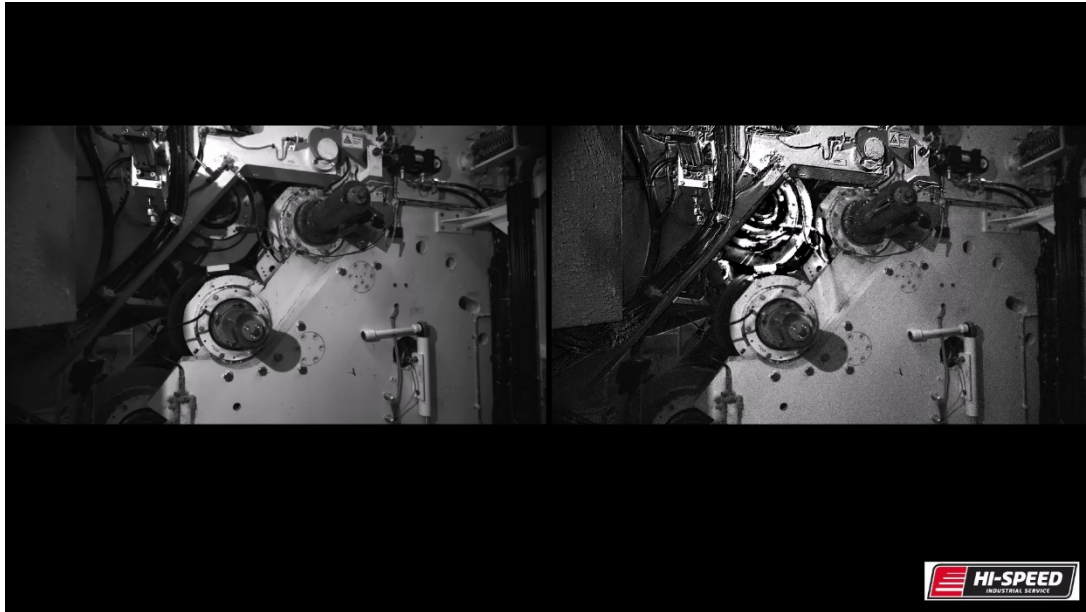
Figure 6: Motion Amplification, Marrying Roll Unloading

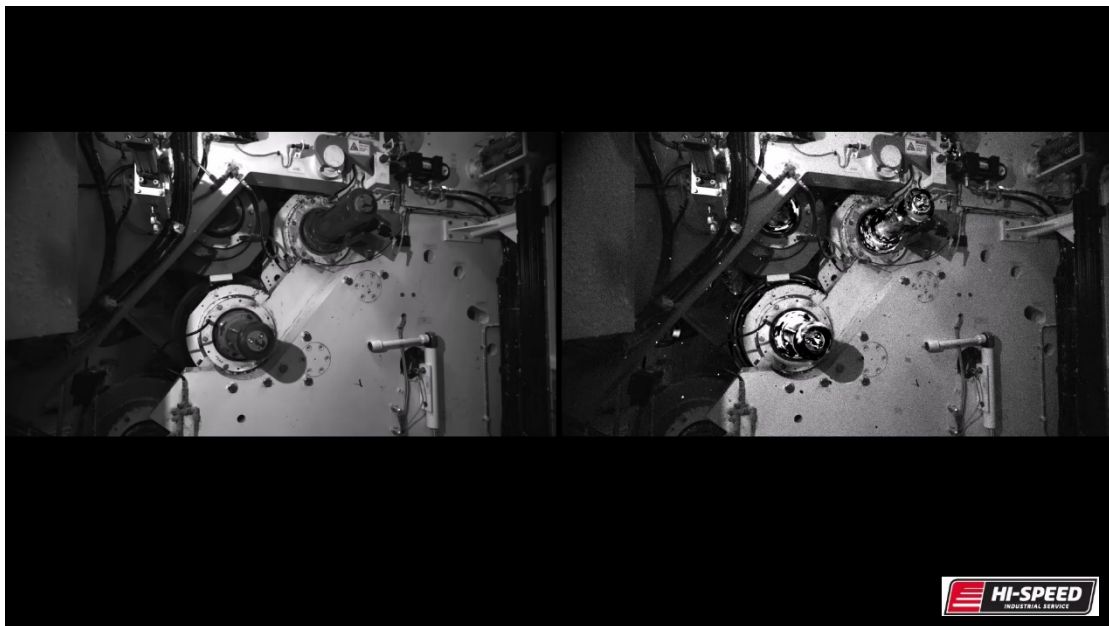
Figure 7: Motion Amplification, Operating at 200 mpm

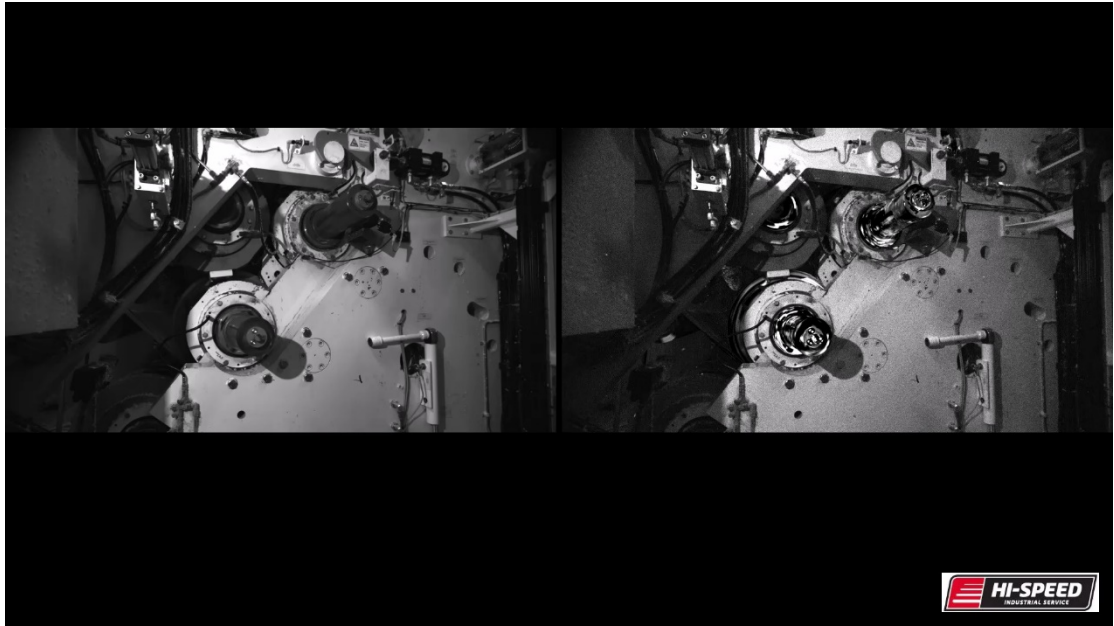
Figure 8: Motion Amplification, Operating at 400 mpm

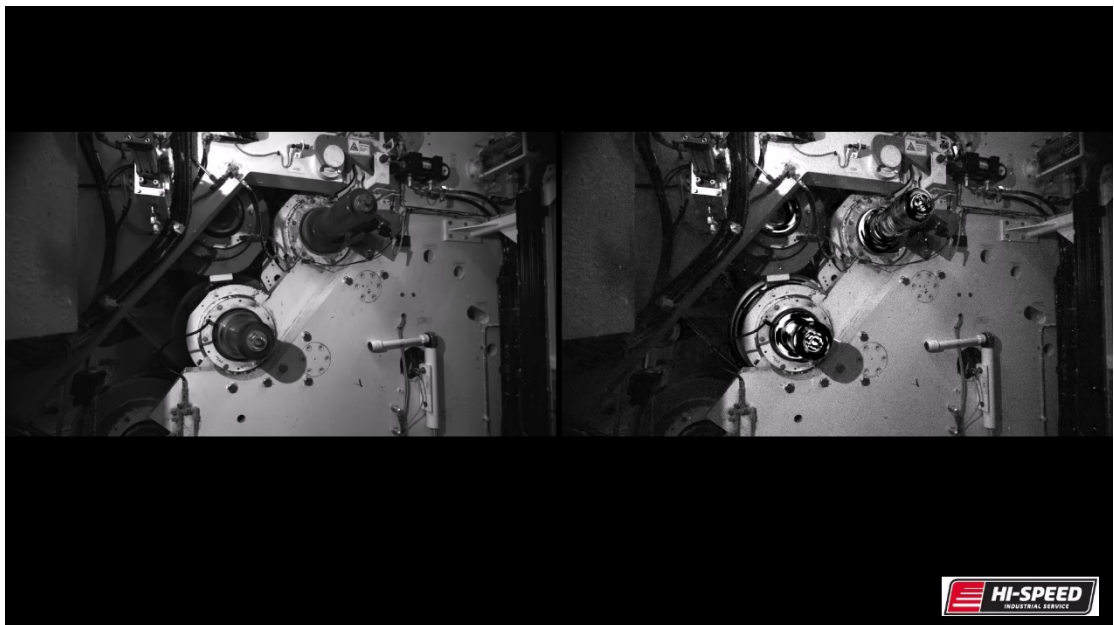
Figure 9: Motion Amplification, Operating at 610 mpm

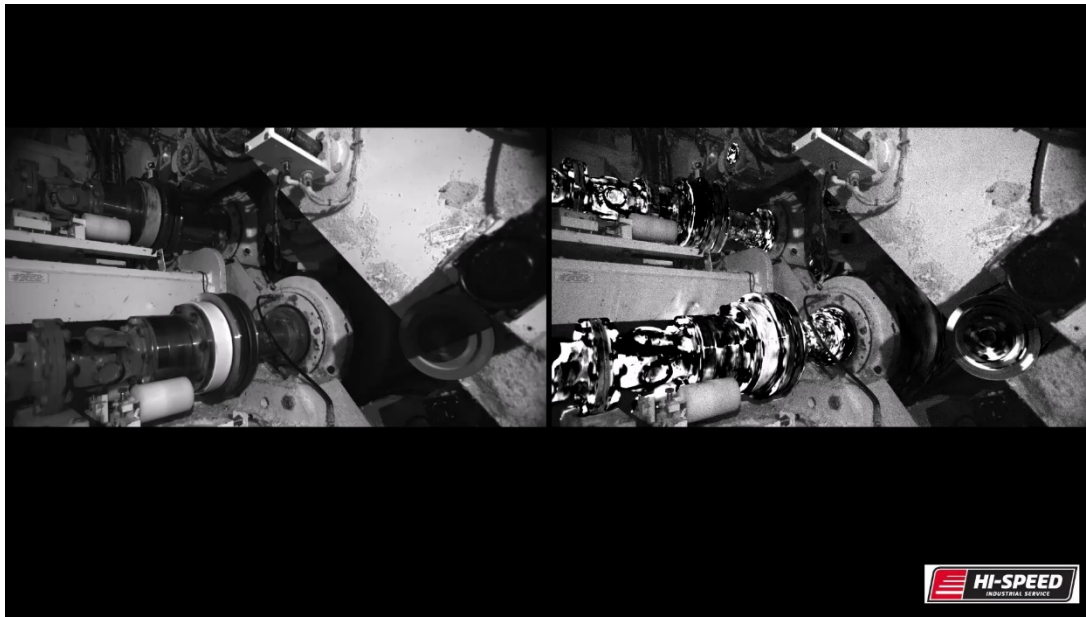
Figure 10, Motion Amplification, Operating at 200 mpm

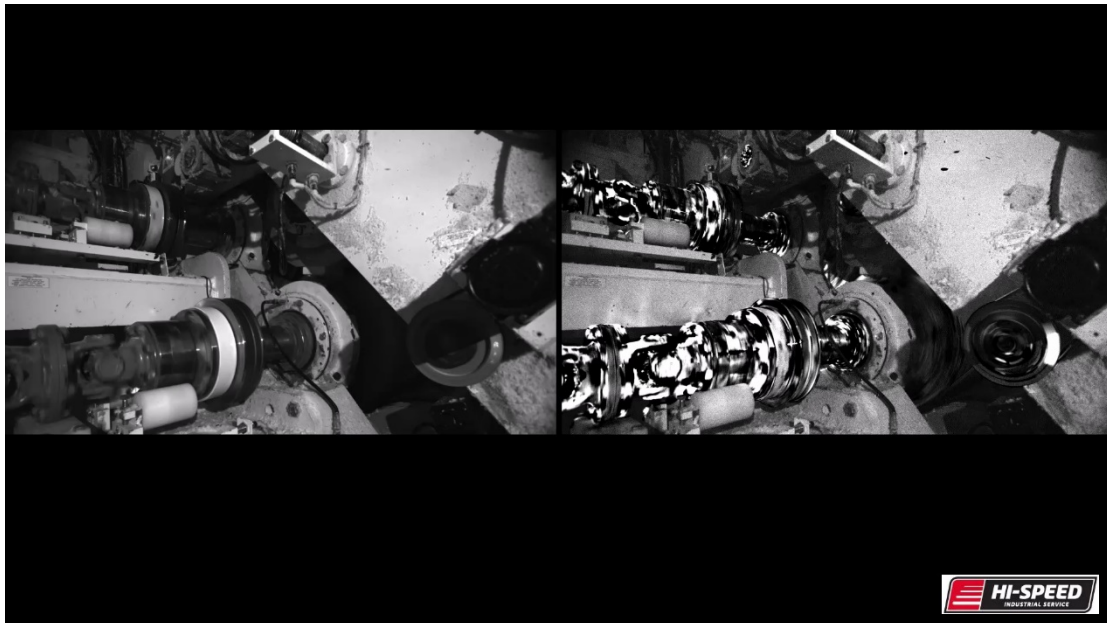
Figure 11, Motion Amplification, Operating at 400 mpm

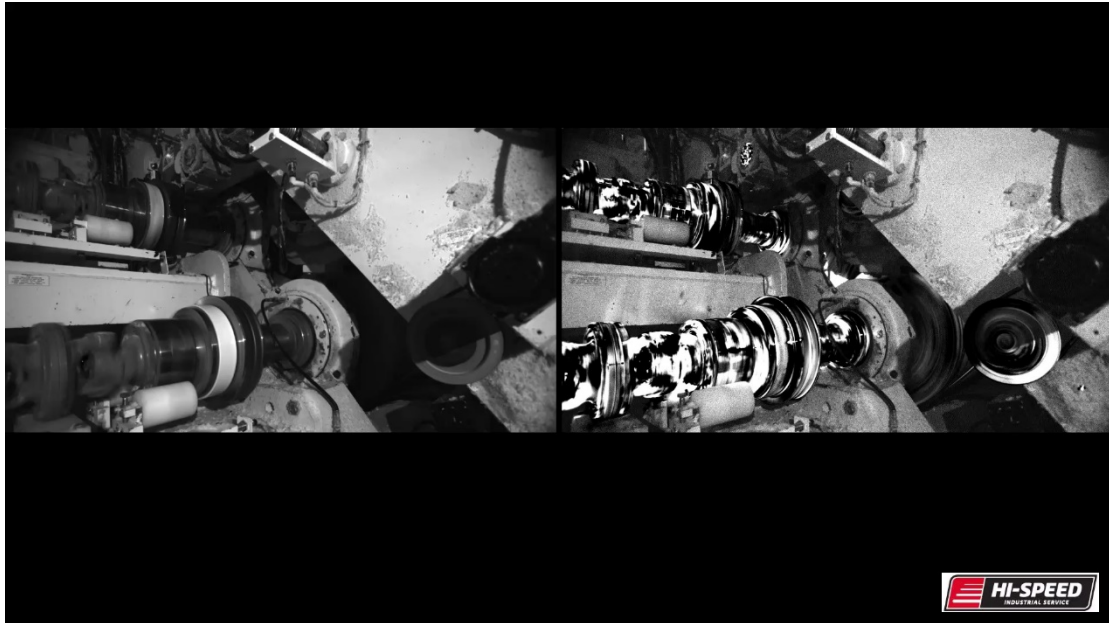
Figure 12, Motion Amplification, Operating at 610 mpm

There does appear to be some movement of the clamshell section on the south side video, especially with the winder operating at 610 mpm. This may be a slight resonance; however, we do not believe this would cause the issues in question. Apparently before we arrived to collect video data, mechanics had checked fasteners on the unit and found loose fasteners. They tightened all fasteners before we were able to perform any collections. It is possible that this could have been causing some of the issue; however, we are not certain of this.

Given the evidence of no excessive movements being shown in motion amplification video, we do not recommend adding stiffeners/bracing to the structure. Please do not hesitate to contact us for any questions or comments. We thank you for allowing Hi-Speed Industrial Service to provide our Motion Amplification services to KTG USA Memphis.

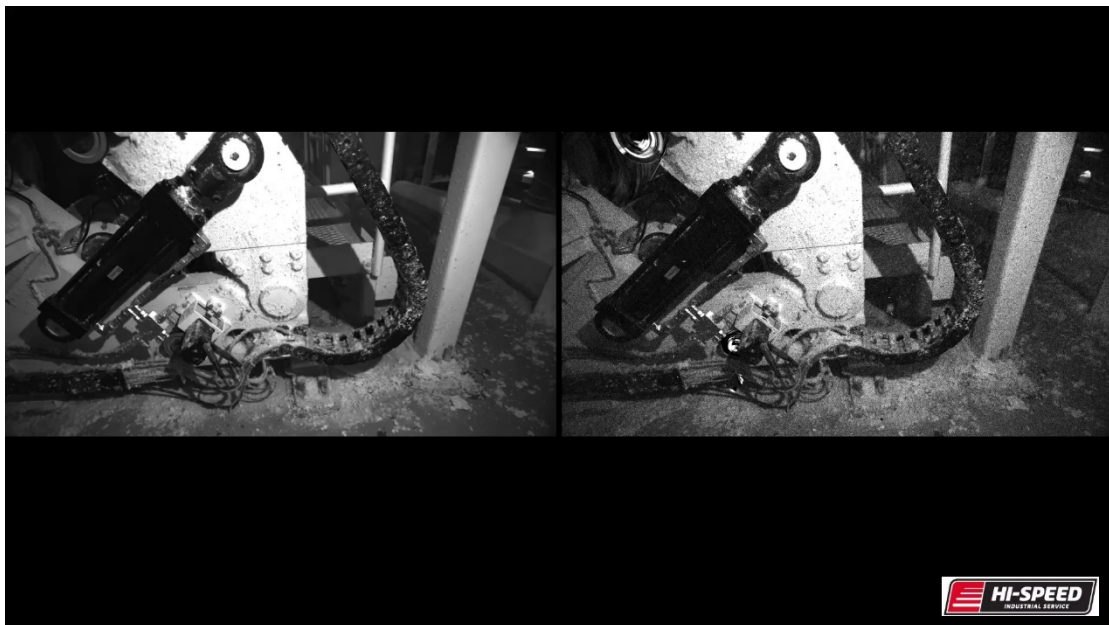
Figure 13, Motion Amplification, South Side Pivot Point
