Infrared Thermography Report

USG May 2020

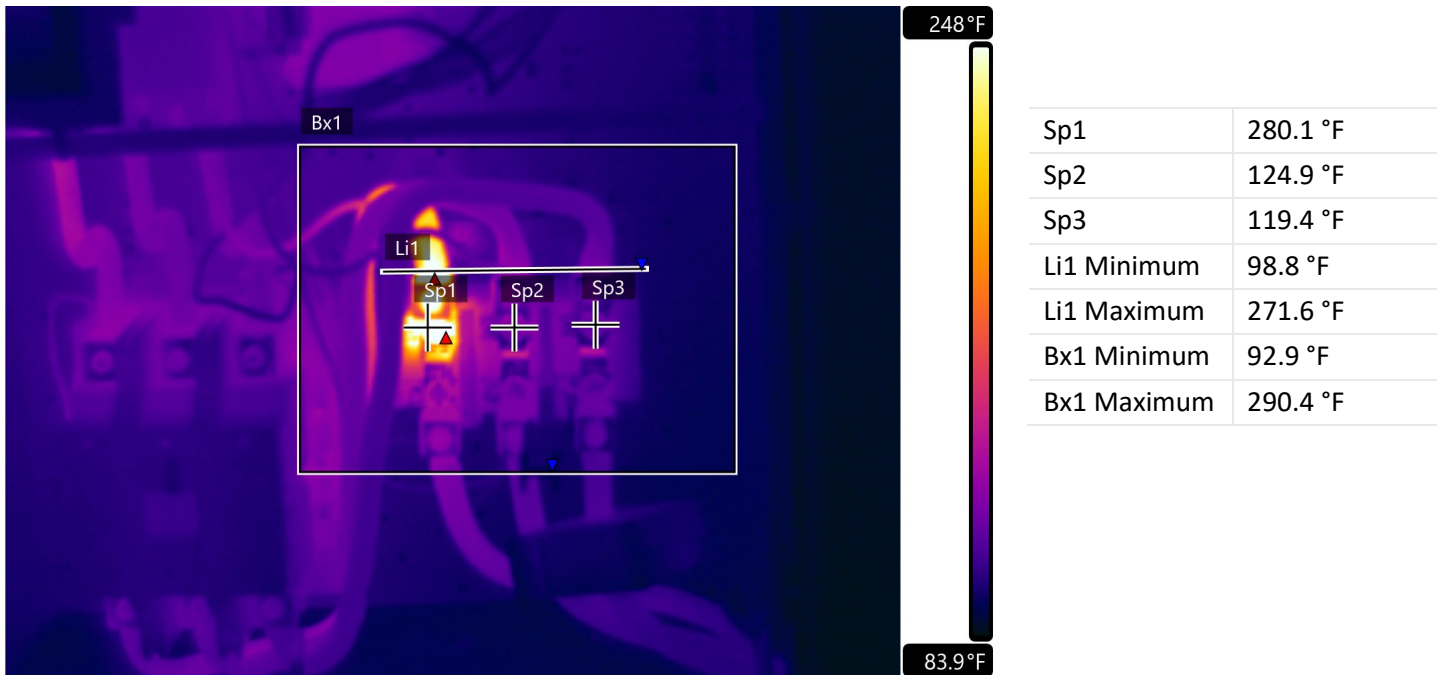
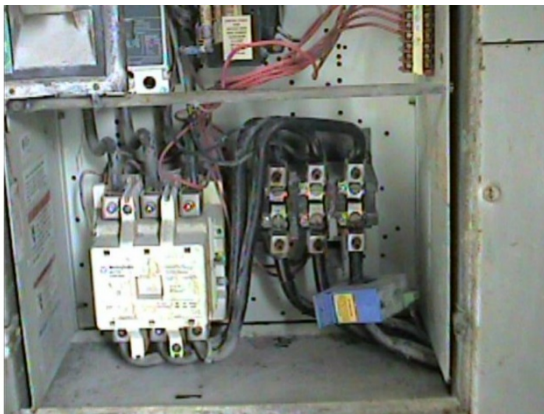
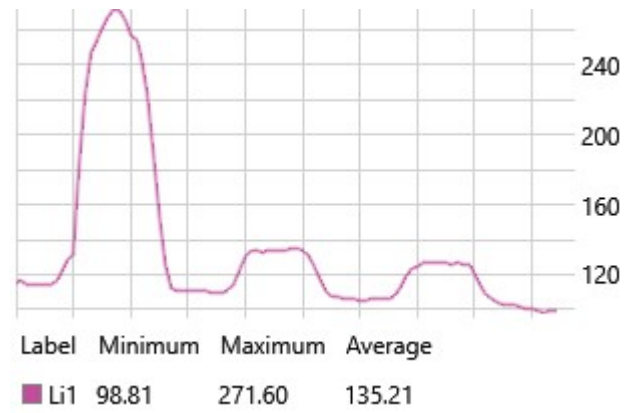
Component	A Phase Connections
Equipment/Bucket ID	MCC 4C1 South Well Water Pump

Fault	Loose/Faulty Connections
Defect Rating	CLASS III

Recommendations	Extremely high temp can be seen on the A Phase connection on the terminal block. Inspect replace/repair components as needed ASAP.
-----------------	--

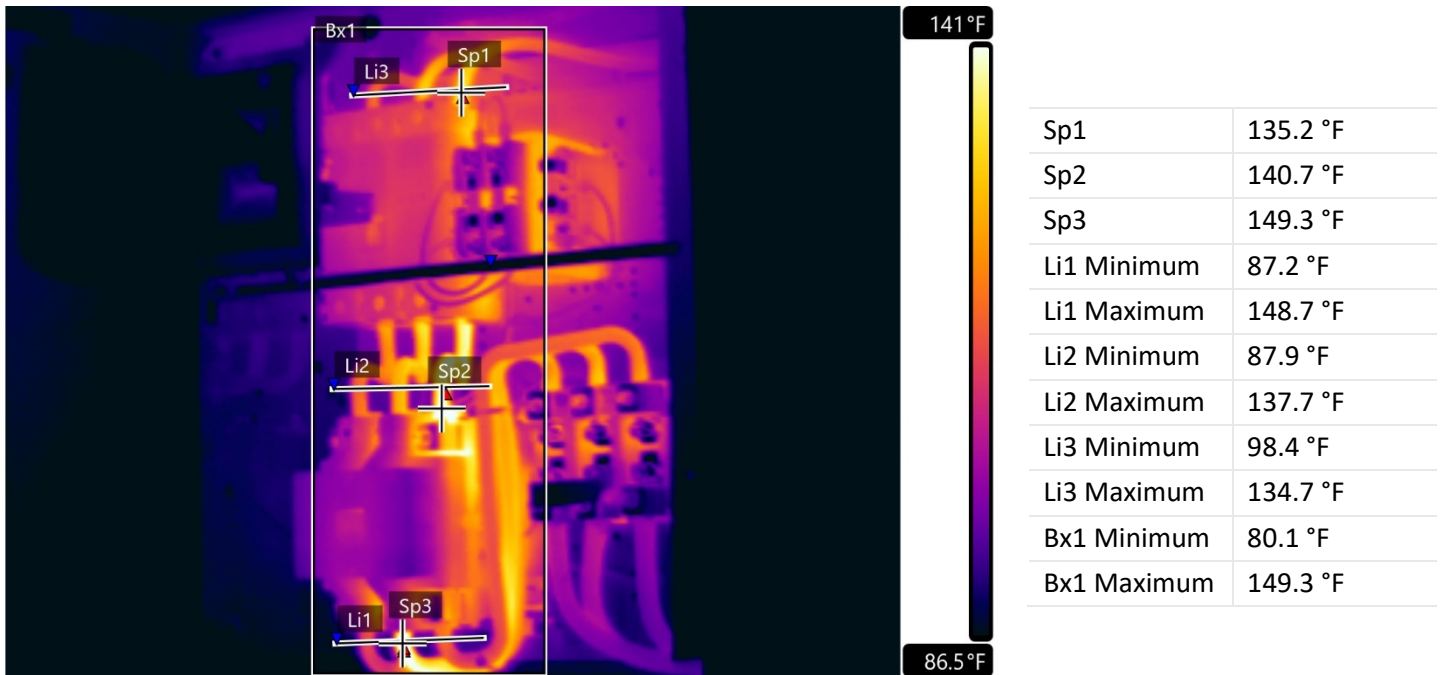
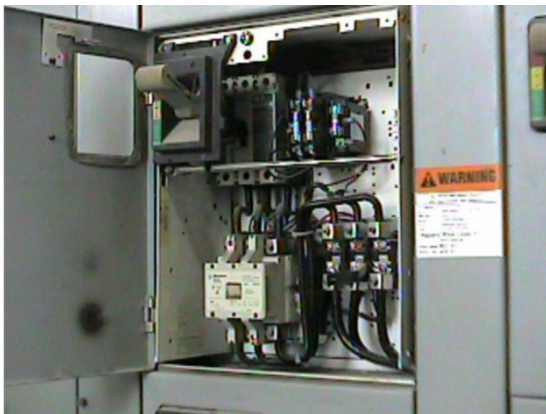
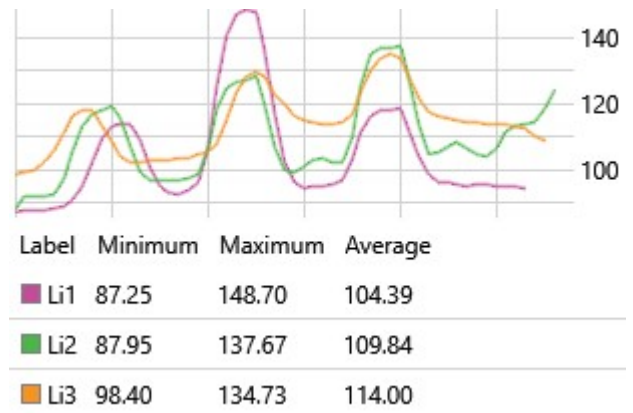
Component	Lead Connections
Equipment/Bucket ID	MCC 2C1/M5080 #2 Effluent Pit Pump

Fault	Connection issues
Defect Rating	CLASS I

Recommendations	There appears to be 3 issues in this panel. All look to be connection issues. Clean and tighten connections as needed.
-----------------	--

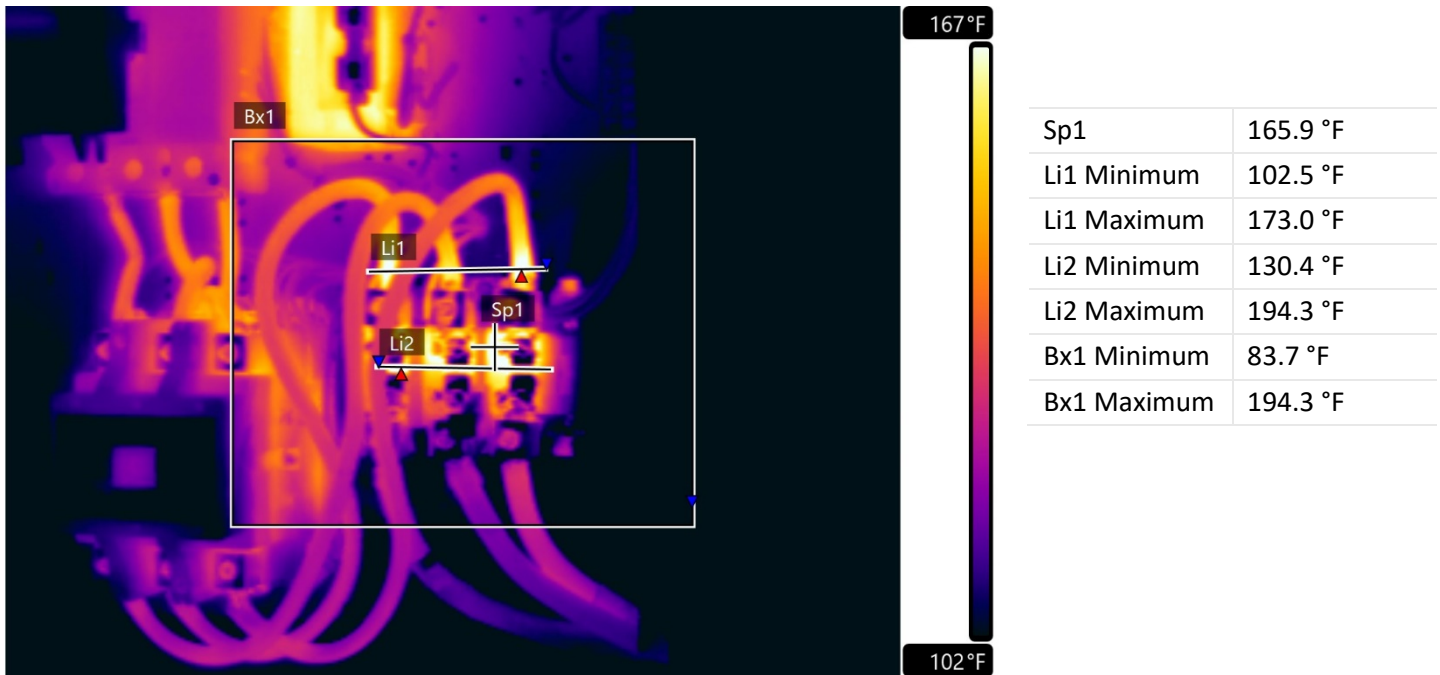
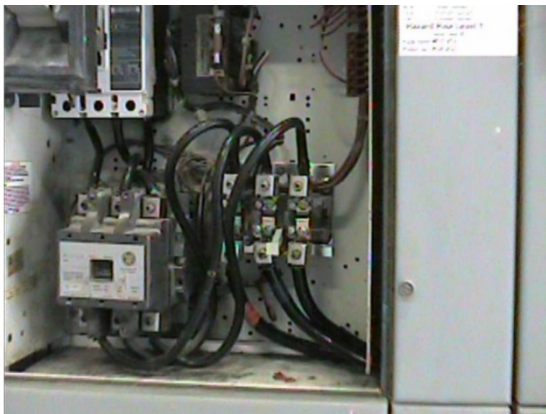
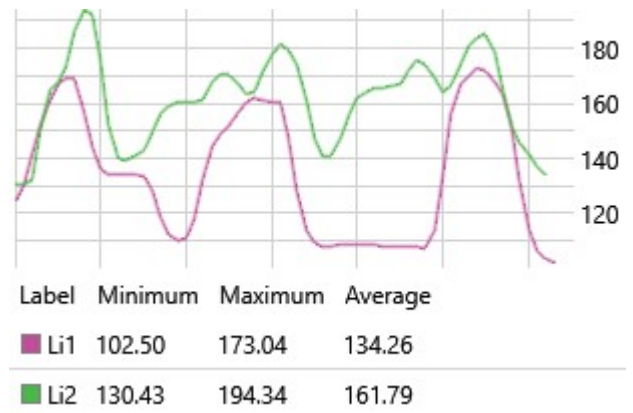
Component	Terminal Connections
Equipment/Bucket ID	MCC 2C2/White Water Loop Pump

Fault	Connection/Heater Issues
Defect Rating	CLASS II

Recommendations
This panel has had issues in the past with this terminal block and with the heaters. There appears to be similar issues taking place once again. Inspect, clean and tighten connections as needed. Terminal block may need to be replaced.

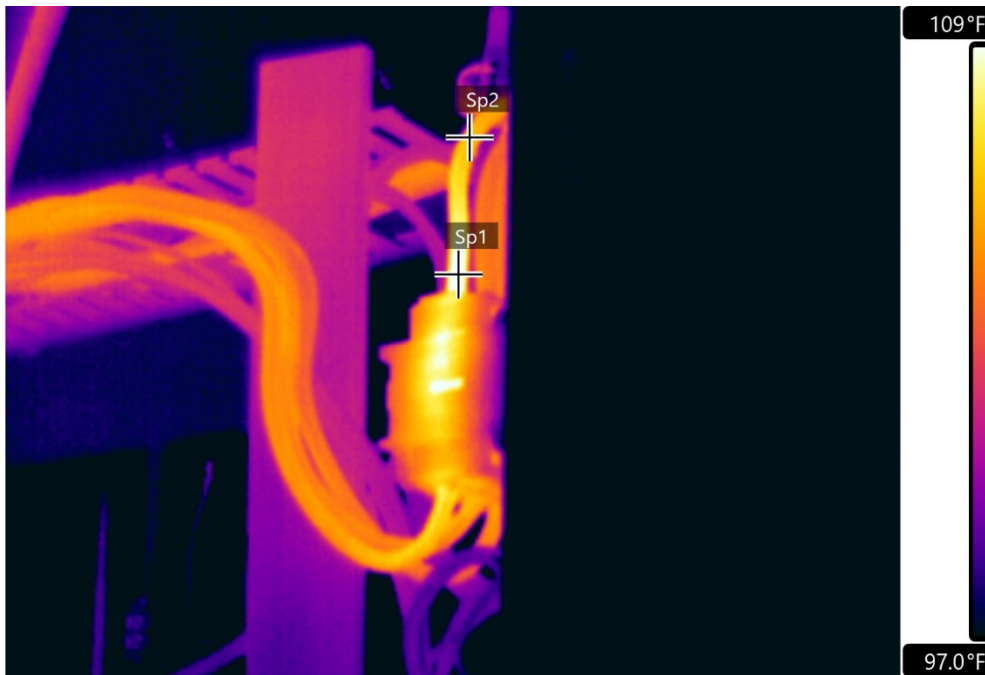
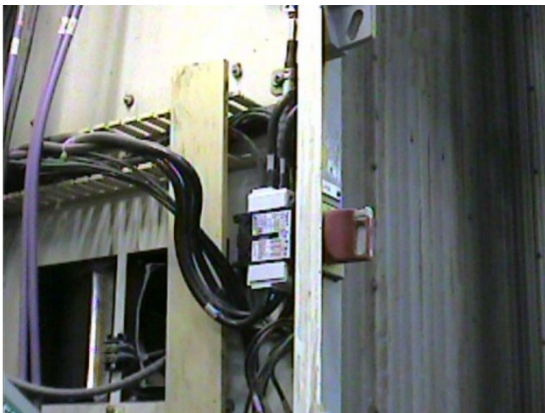
Component	Breaker/Connections
Equipment/Bucket ID	Kiln Jack VFD Panel

Sp1	109.9 °F
Sp2	106.3 °F
Lines	-
Areas	-

Fault	None
Defect Rating	None

Recommendations	This is a recheck after repairs. No further actions are needed at this time.
-----------------	--

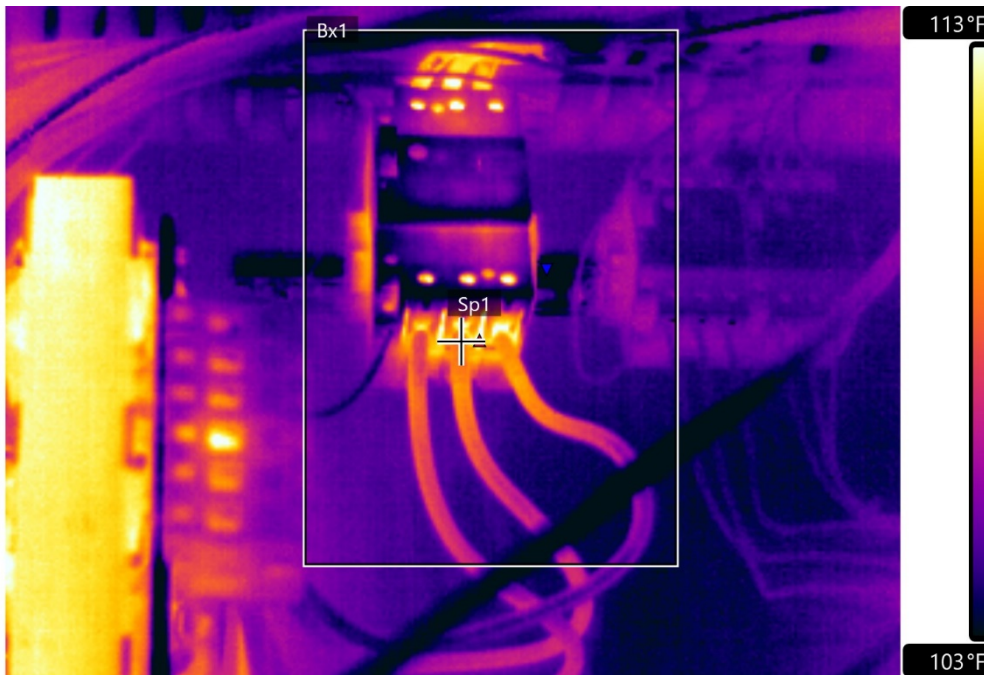
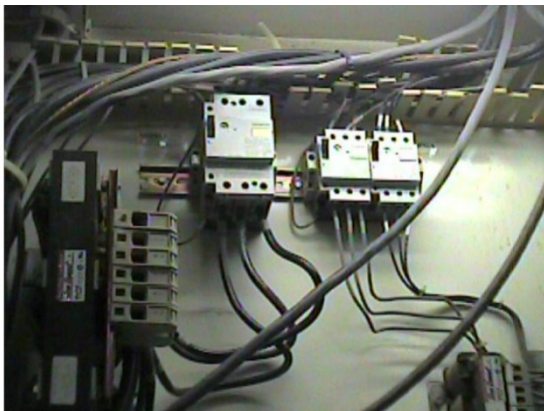
Component	N/A
Equipment/Bucket ID	Kiln Jack VFD Panel

Sp1	109.6 °F
Lines	-
Bx1 Minimum	99.1 °F
Bx1 Maximum	117.2 °F

Fault	None
Defect Rating	None

Recommendations	This is a recheck after repairs. No further actions are needed at this time.
-----------------	--

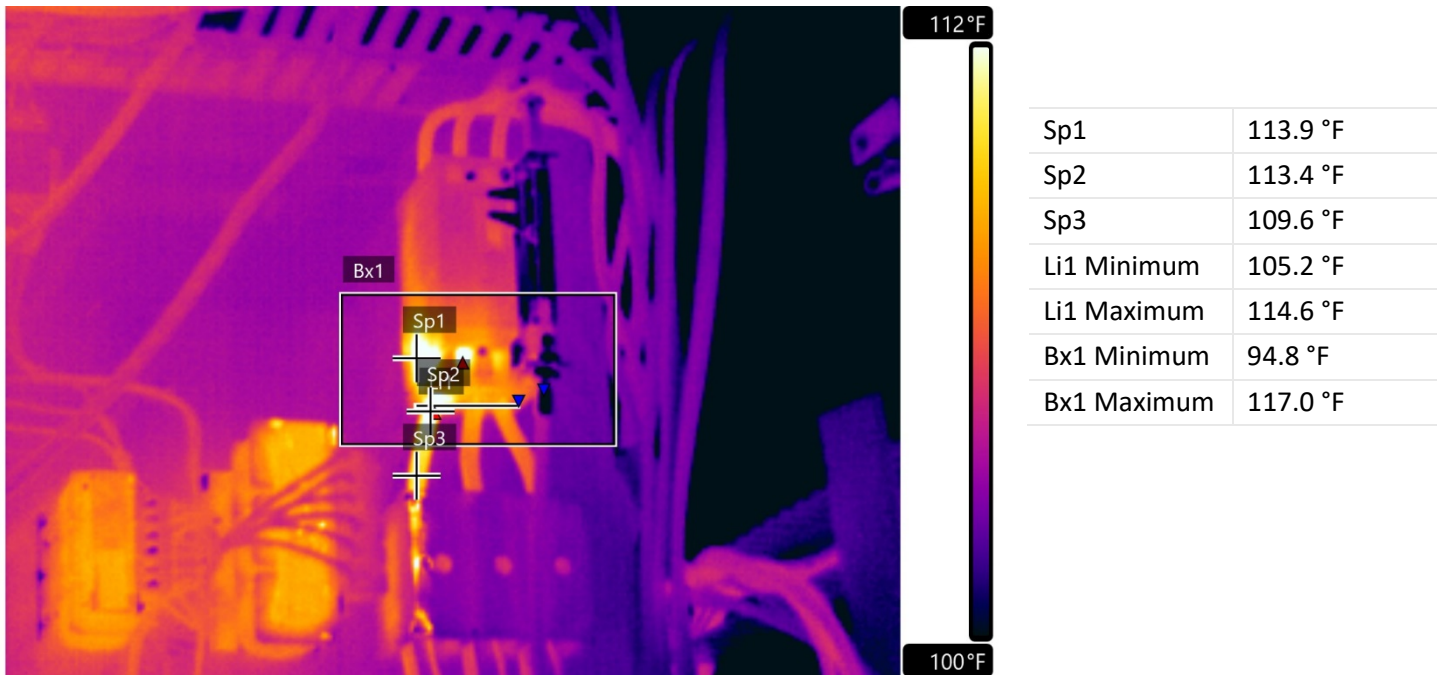
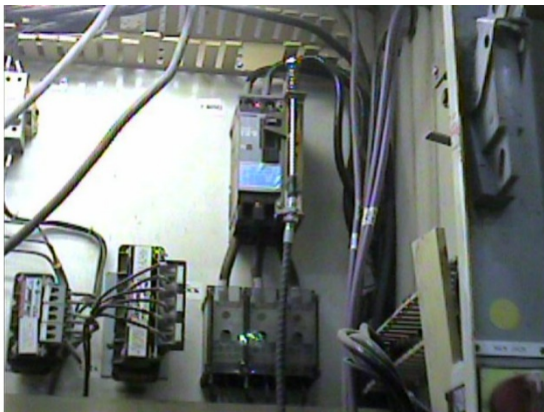
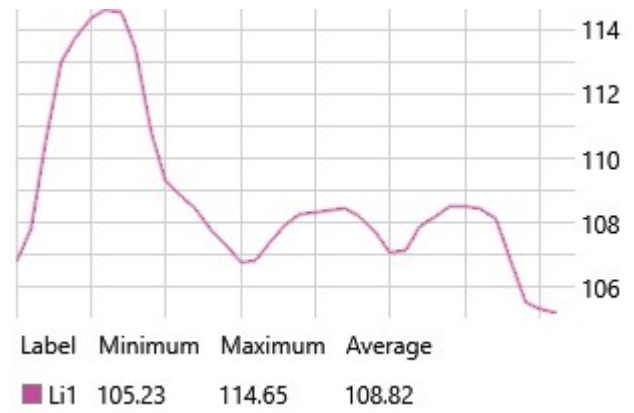
Component	A Phase Connection
Equipment/Bucket ID	Kiln Jack VFD Panel

Fault	Connection issue
Defect Rating	CLASS I

Recommendations	A phase appears to have a connection issue at the bottom side of breaker. Inspect and repair as needed.
-----------------	---
