# QualiTest IR Radiometric Survey Report

Job Number	140984
Survey Date	10/25/19
Report Date	10/31/19

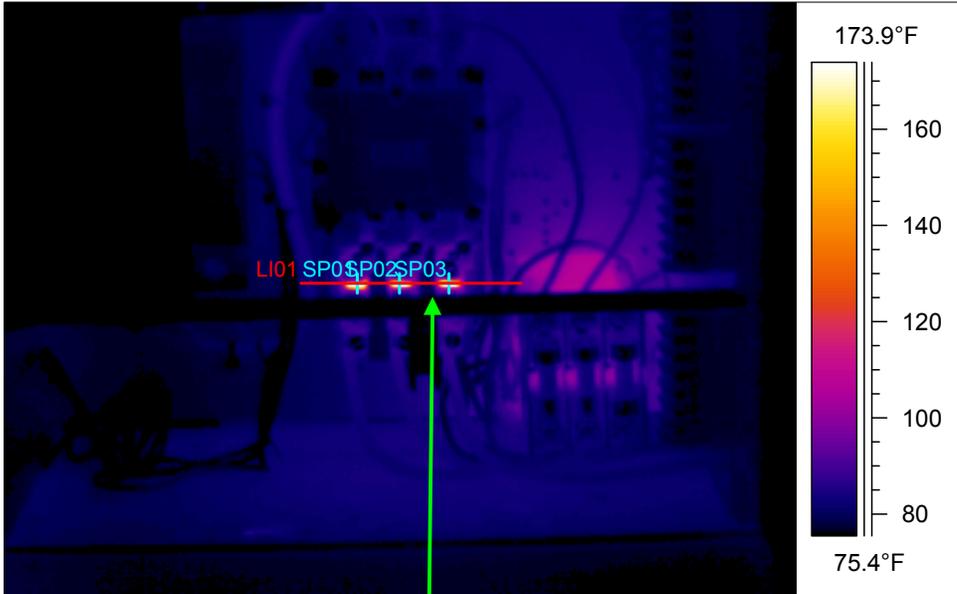
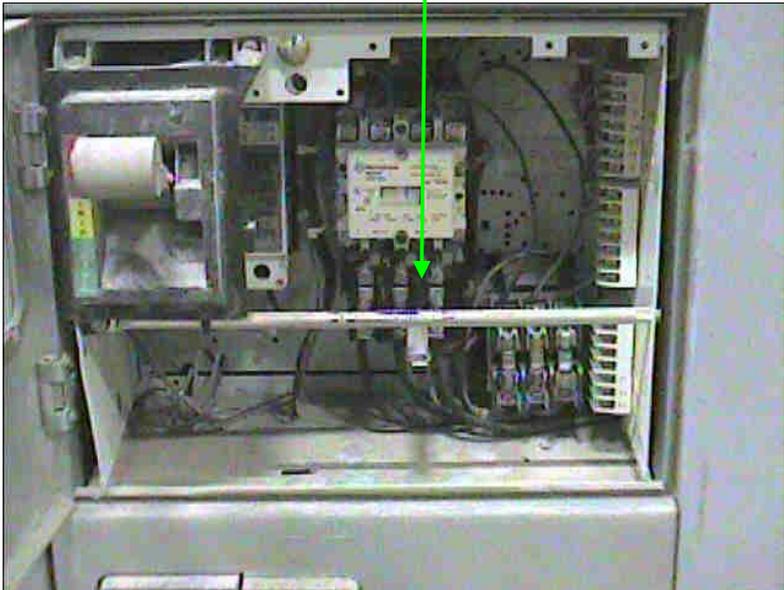
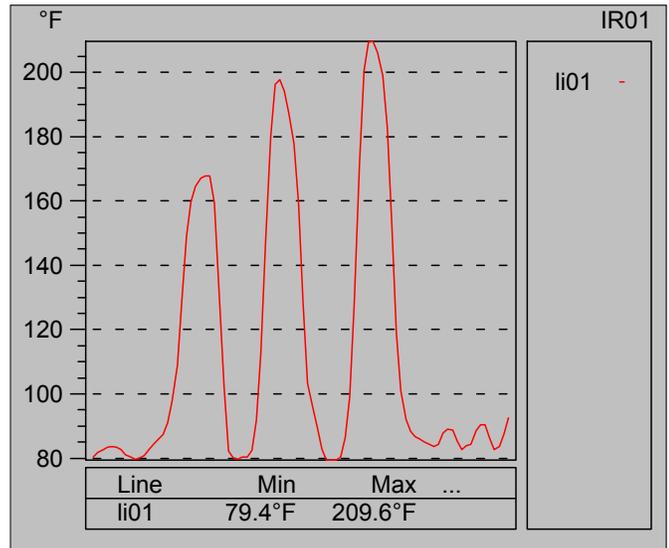
Component	Equipment/Bucket ID	Plant/Area	Date
Heaters	5247 Wet Zone Burner Room Exh Fan N	Board Line 3/MCC-7D1	10/25/19

Label	Value
IR : max	209.6°F
IR : min	67.2°F
SP01	167.1°F
SP02	197.7°F
SP03	209.6°F
LI01 : max	209.6°F
LI01 : min	79.4°F

<b>Fault</b>	Heater
<b>Defect Rating</b>	<b>CLASS I</b>

This is a recheck from an ongoing issue with the thermal heaters. Heaters have been replaced and continue to show high temperature at between 160-210 degree F. Ensure that the heaters are properly sized. If heaters are sized right then this may be normal for this type of heater.

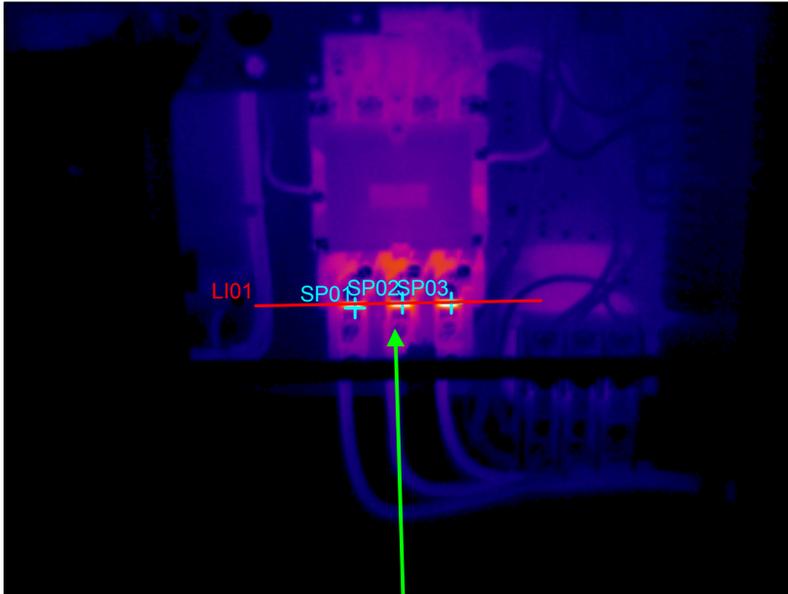
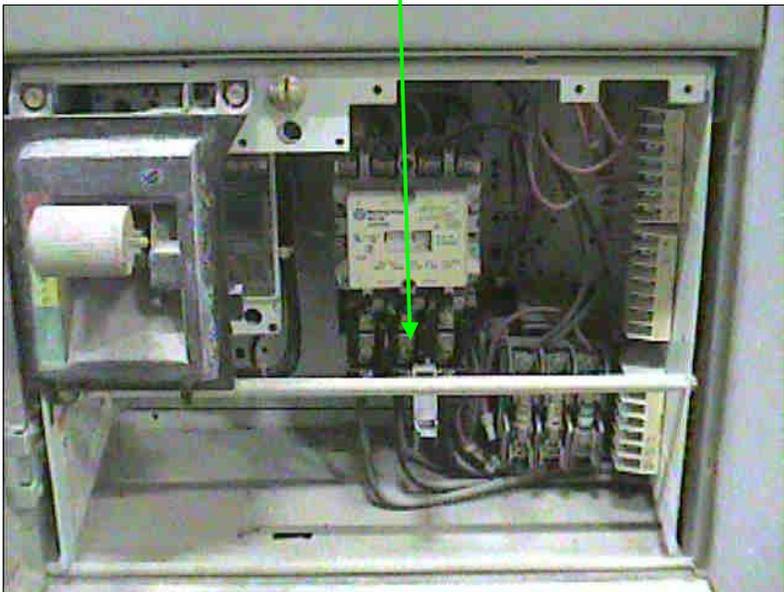
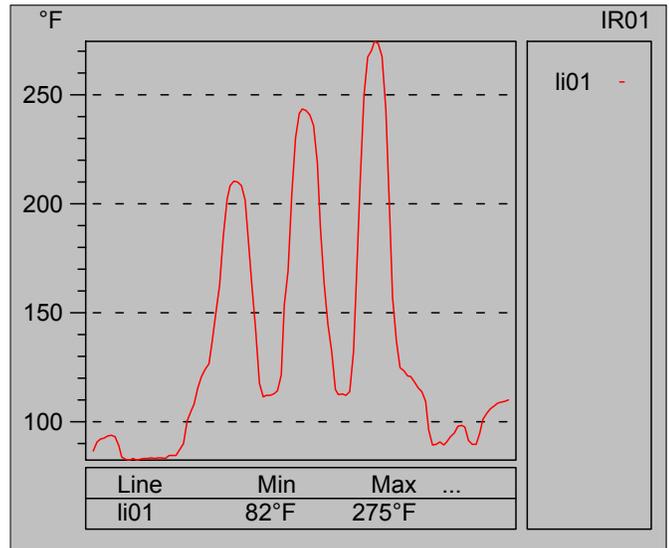
Component	Equipment/Bucket ID	Plant/Area	Date
Heater	M5254 Wet Zone Burner Room Exh Fan S	Board Line 3/MCC-7D1	10/25/19

Label	Value
IR : max	275°F
IR : min	66°F
SP01	170°F
SP02	243°F
SP03	274°F
LI01 : max	275°F
LI01 : min	82°F

<b>Fault</b>	Heater
<b>Defect Rating</b>	<b>CLASS I</b>

South unit is showing some higher temps than the North unit. This still may be normal for this type of heater. For now, ensure heaters are properly sized.

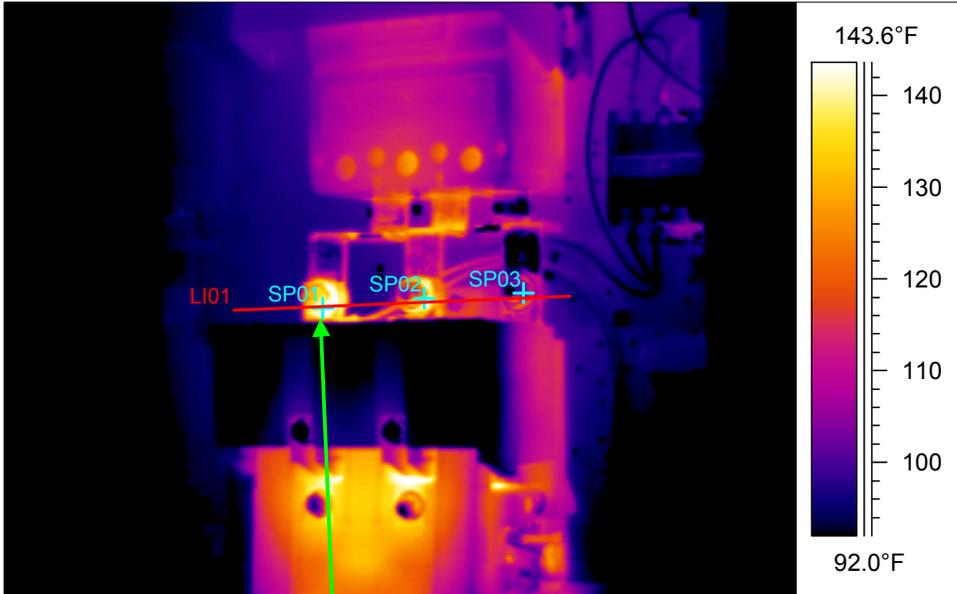
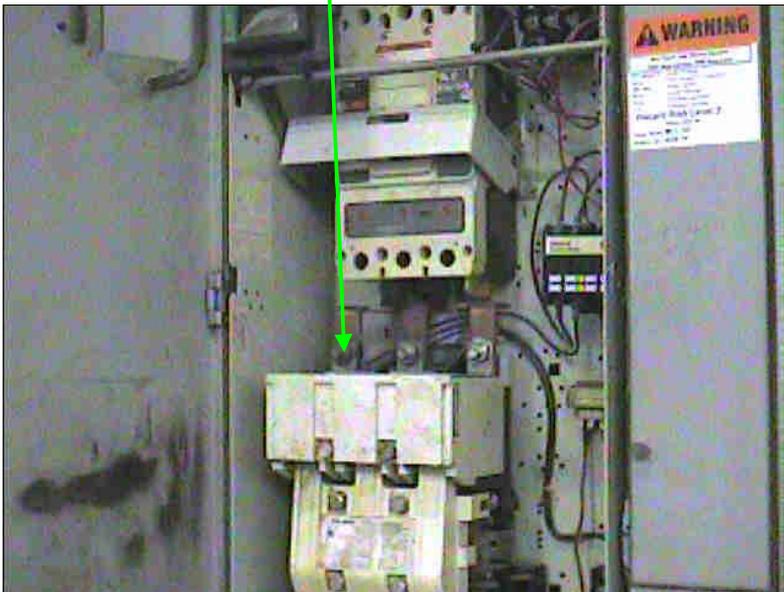
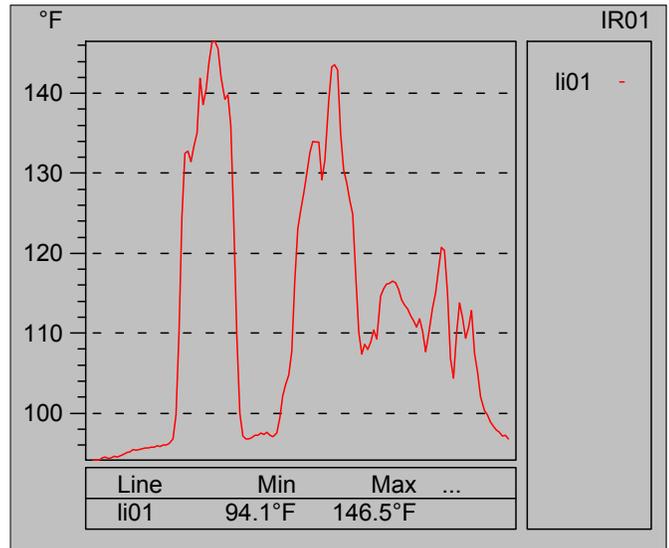
Component	Equipment/Bucket ID	Plant/Area	Date
Bolted connection	#2 Vacuum Pump	Vacuum Pump 2	10/25/19

Label	Value
IR : max	150.0°F
IR : min	73.0°F
SP01	137.6°F
SP02	131.9°F
SP03	102.1°F
LI01 : max	146.5°F
LI01 : min	94.1°F

<b>Fault</b>	None
<b>Defect Rating</b>	None

This is a recheck after repairs. Looks like the A phase bolted connection has a dulled finish on the nut as compared to phase 2 and 3. This will make the IR appear to have a higher delta T due to a difference in emissivity. All looks good. No further actions needed at this time.

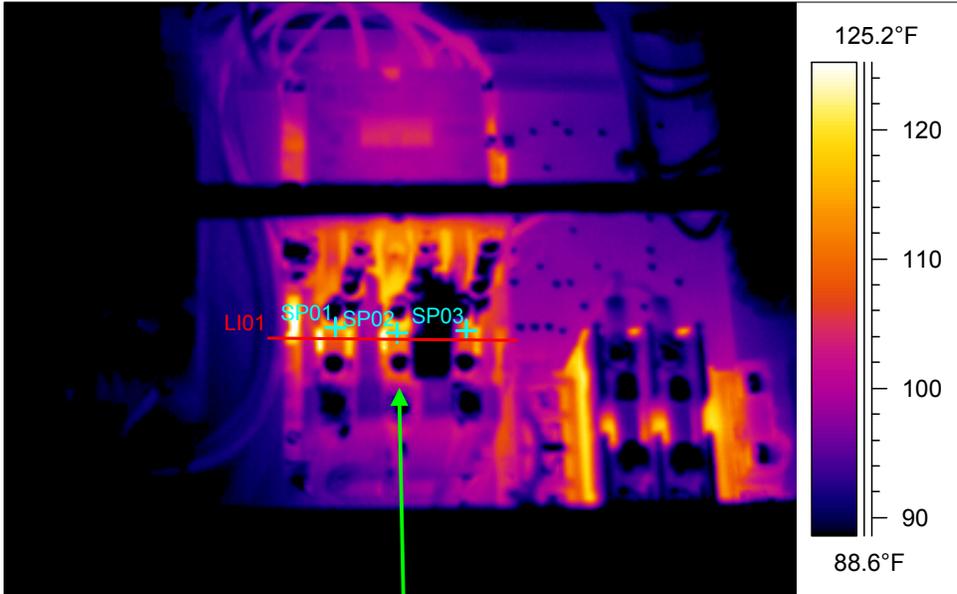
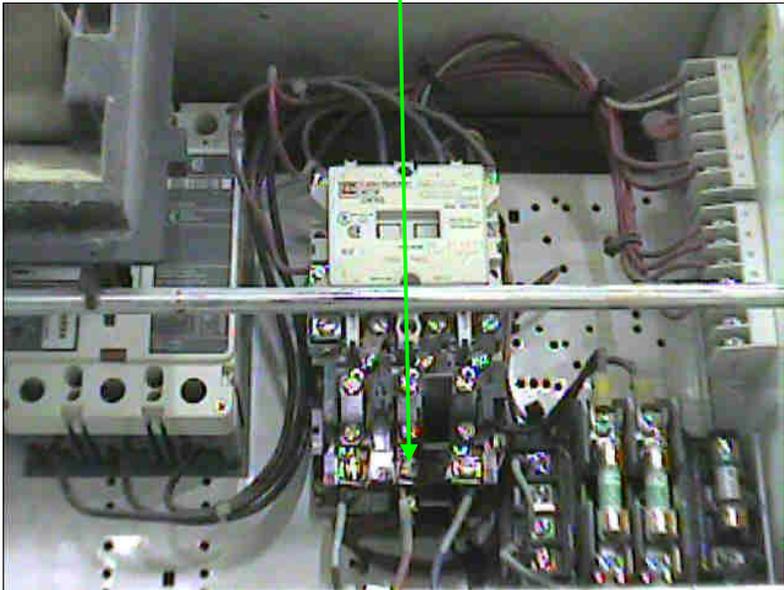
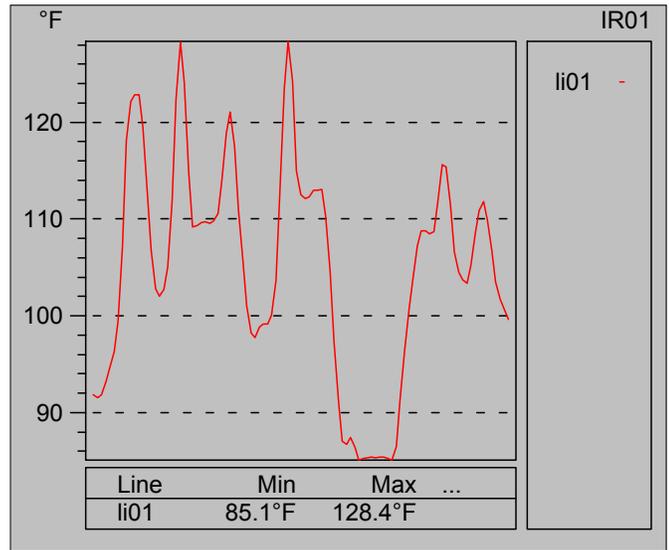
Component	Equipment/Bucket ID	Plant/Area	Date
Heaters	M5333 IR Comb Fan	MCC-FG2	10/25/19

Label	Value
IR : max	130.2°F
IR : min	70.9°F
SP01	116.3°F
SP02	114.8°F
SP03	112.5°F
LI01 : max	128.4°F
LI01 : min	85.1°F

<b>Fault</b>	None
<b>Defect Rating</b>	None

This is a recheck after repairs. All looks good. No further actions are needed.

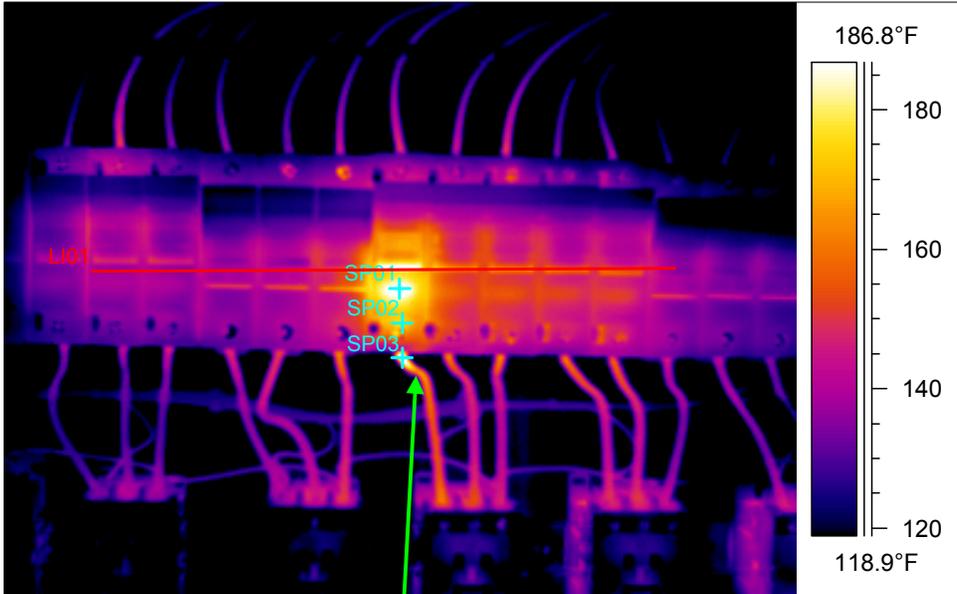
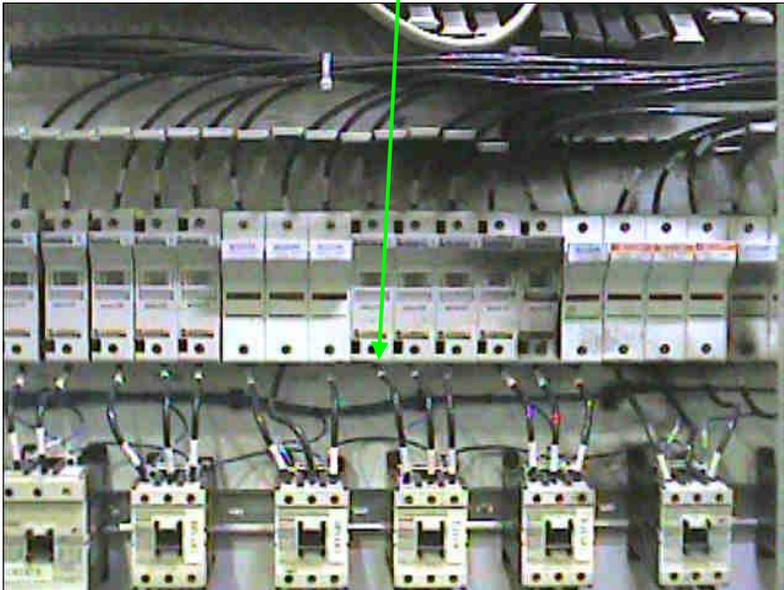
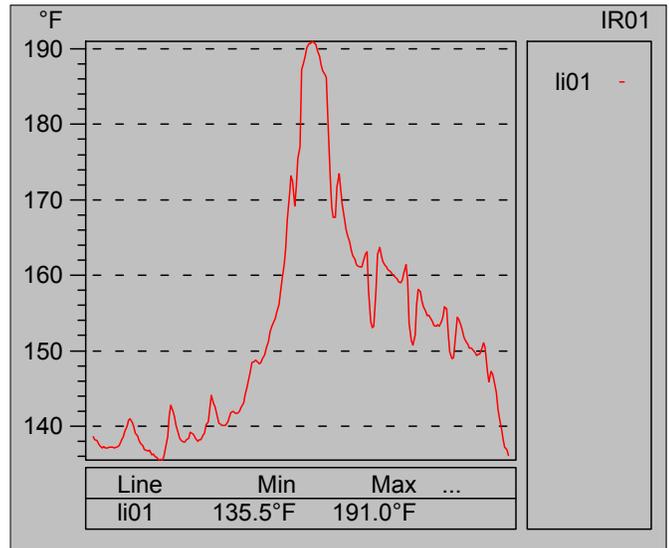
Component	Equipment/Bucket ID	Plant/Area	Date
Lead connection	VFD12XXFG 1st Pass Paint Heater Panel	Fiberglass	10/25/19

Label	Value
IR : max	202.5°F
IR : min	93.7°F
SP01	189.6°F
SP02	175.6°F
SP03	202.5°F
LI01 : max	191.0°F
LI01 : min	135.5°F

<b>Fault</b>	Possible loose connection
<b>Defect Rating</b>	<b>CLASS II</b>

Component with the X marked on it has the issue. Check bottom lead connection SOON.

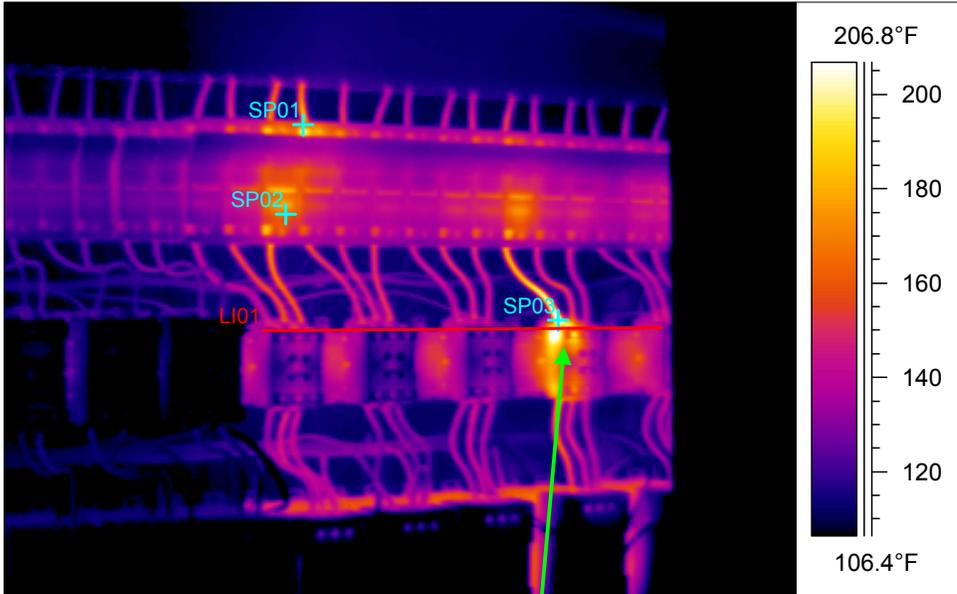
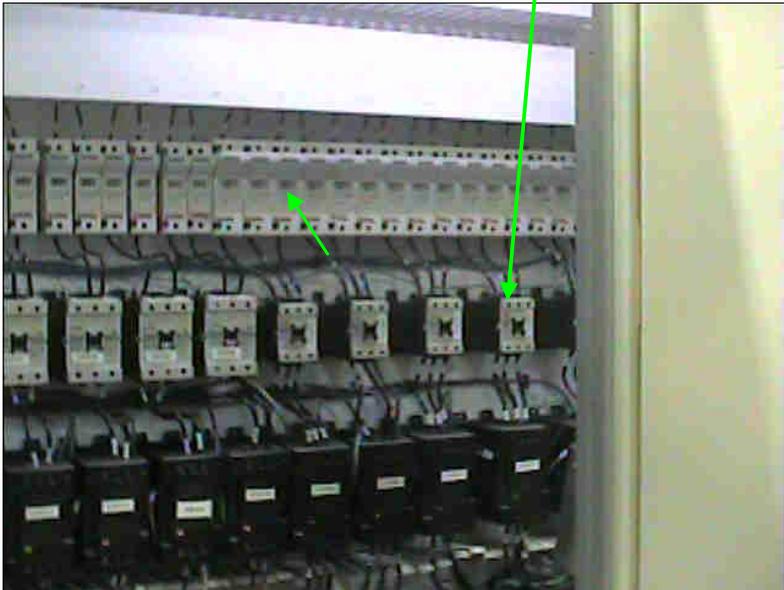
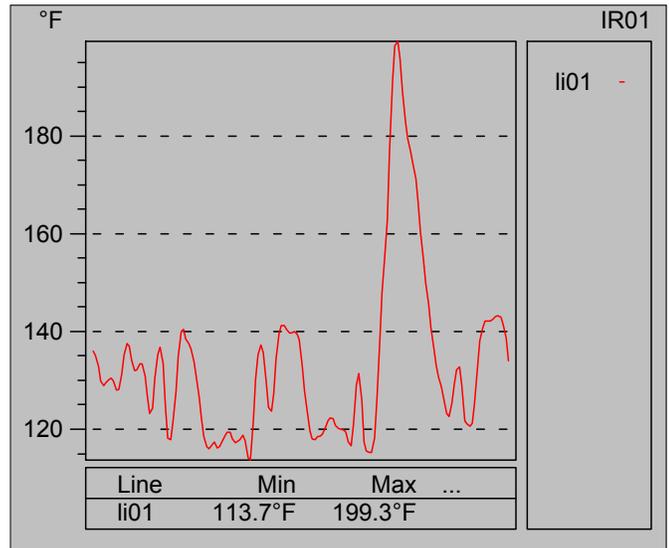
Component	Equipment/Bucket ID	Plant/Area	Date
CR3012	2nd Pass Paint Heater Panel	Fiberglass	10/25/19

Label	Value
IR : max	235.0°F
IR : min	85.6°F
SP01	165.4°F
SP02	166.4°F
SP03	235.0°F
LI01 : max	199.3°F
LI01 : min	113.7°F

<b>Fault</b>	Possible loose connections
<b>Defect Rating</b>	<b>CLASS II</b>

IR image shows connection issue on CR3012. Possible other issue can be seen on component with small arrow. Check connections SOON.

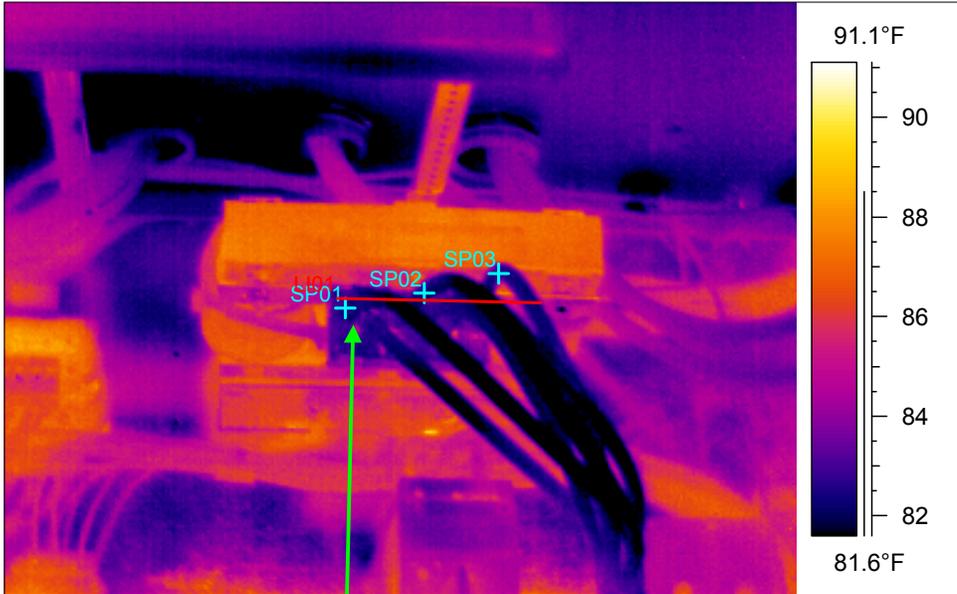
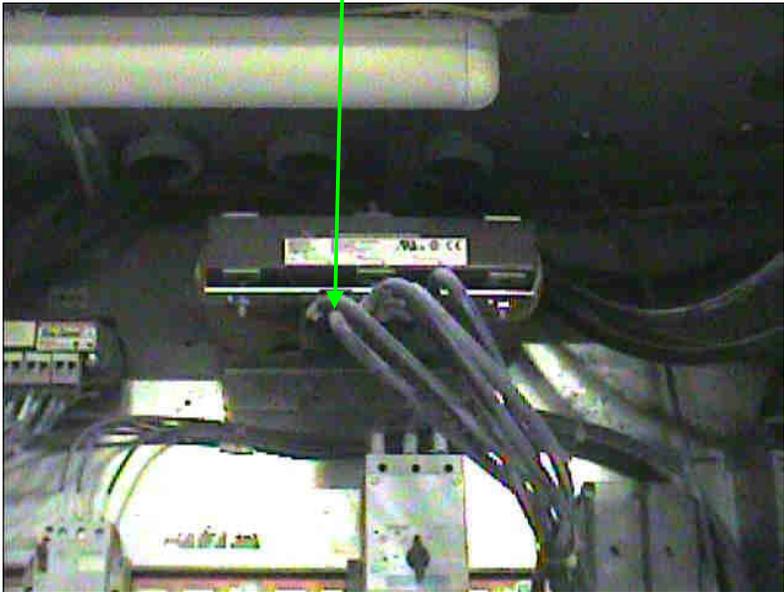
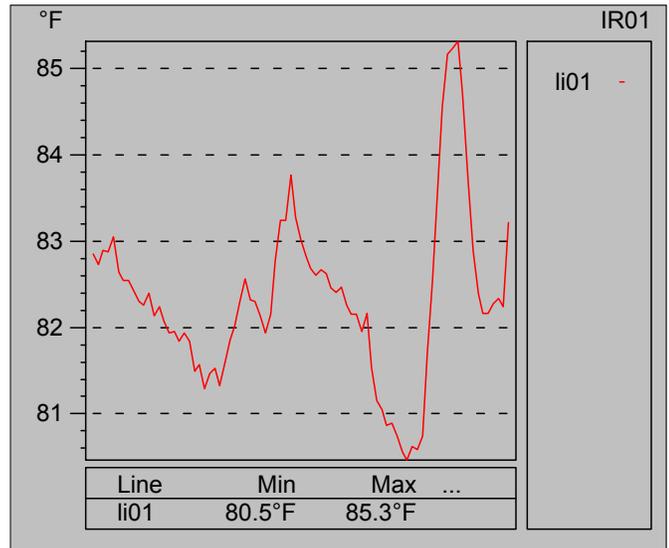
Component	Equipment/Bucket ID	Plant/Area	Date
NA	VFD-PP3 Press Drive System	Finishing	10/25/19

Label	Value
IR : max	89.8°F
IR : min	78.9°F
SP01	82.4°F
SP02	82.0°F
SP03	82.7°F
LI01 : max	85.3°F
LI01 : min	80.5°F

<b>Fault</b>	None
<b>Defect Rating</b>	None

Recheck after repairs. All appears to be good. No further actions are needed.
