Fiberglass
2ND Pass Paint Heater Panel
Panel # VFDIIXX
Fuse with X marked on it

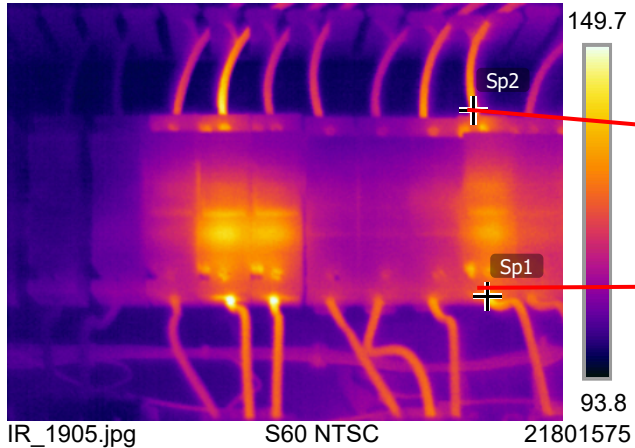
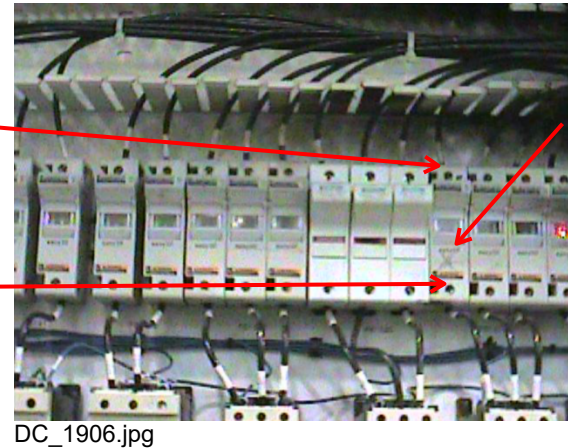
Sp1	143.2 °F
Sp2	139.5 °F

Infrared data indicates a high resistance connection on the load side and line side of phase A. The data also shows that the load side of the fuse is overheating. Replace the fuse and clean the fuse holder with sandpaper. Check the wire for damage. Replace if necessary, and repair as necessary. Tighten to proper torque.

It's the fuse right of CR1500 with X marked on it.
