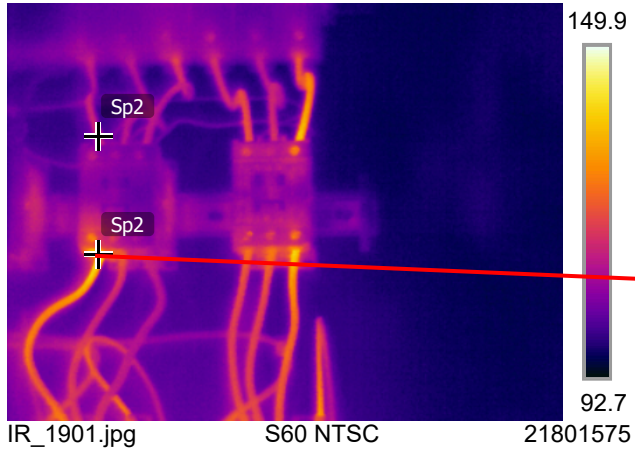
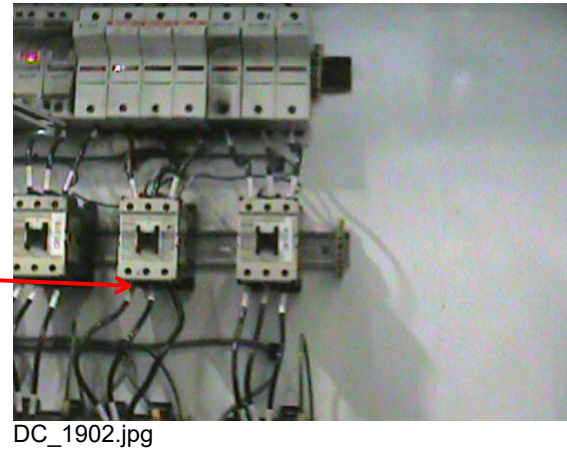
### Measurements

| Sp2 | 147.4 °F |
| Sp2 | 118.1 °F |

Infrared data indicate a high resistance connection on the load side of phase A. Check the wire for damage. Replace if necessary, and repair as necessary tighten to proper torque.
