Client	A.E.C.I. Dell	Survey Date	7-30-19
Location	Dell, AR	Report Date	7-30-19
Machine	BFWP 2B	QMS No.	140203
Component	Nelson Drive and Pump	Analyst	DWS

Client	A.E.C.I. Dell	Survey Date	7-30-19
Location	Dell, AR	Report Date	7-30-19
Machine	Unit 2 LP Recirculator Pump	QMS No.	140203
Component	Motor/alignment	Analyst	DWS

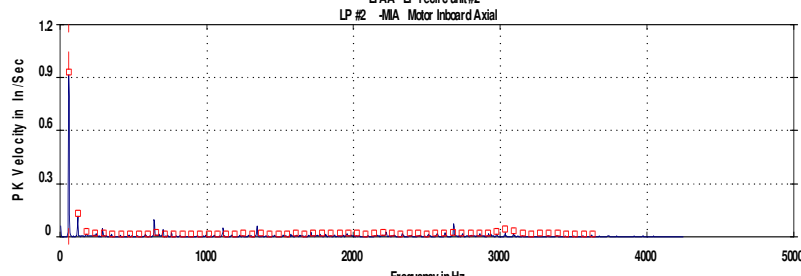
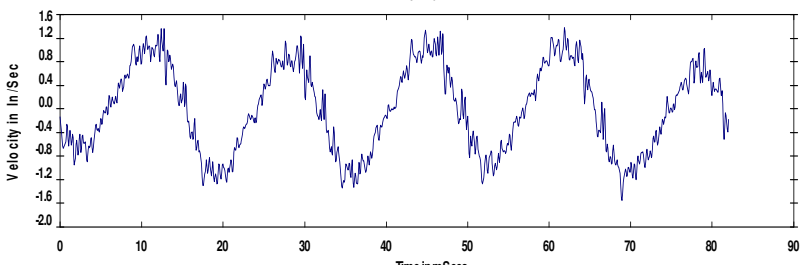
Vibration Data	Analysis
<p>LFAA - LP recirc unit#2 LP #2 -MA Motor Inboard Axial</p>

<p>Route Waveform 24-Jul-19 10:00:38 PK = 1.02 PK(+-) = 1.37/1.55 CRESTF=2.14</p> <p>Freq: 58.44 Ord: .984 Spec: .917</p>	<p>High 1x RPM vibration with modulation.</p>

Discussion / Repair recommendations	Trend Data
<p>High vibration above 1"/sec velocity peak in the axial most likely indicates excessive shaft misalignment and could lead to eventual motor failure, possibly within a short time frame. Bearing Fluting still is apparent, but is not the main concern here. Rated a Class IV Defect.</p>

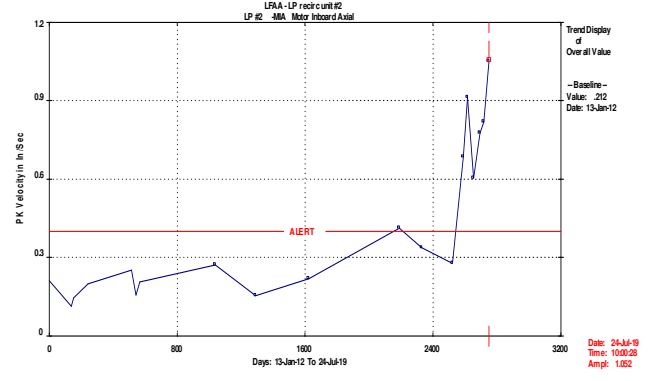
<p>Trend Display Overall Value - Baseline - Value: .212 Date: 13-Jan-12</p> <p>Date: 24-Jul-19 Time: 10:00:28 Ampl: 1.052</p>
