Client	ARKEMA	Survey Date	8-9-19
Location	Memphis, TN	Report Date	8-9-19
Machine	Middle Mixed Bed Water Pump	QMS No.	140287
Component	Pump	Analyst	DWS

Vibration Data	Analysis
<p>H202 - MMX BED WATER PUMP 191-07 191-07 -71 Chilled H2O Pump Horizontal</p>

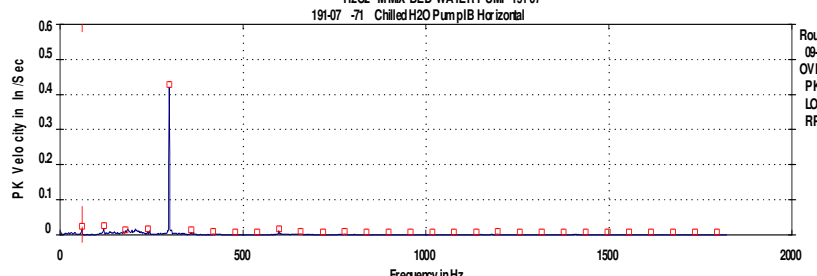
<p>Route Spectrum 08-Aug-19 15:03:14 OVERALL= .4332 V-DG PK = .4316 LOAD = 100.0 RPM = 3593. (59.88 Hz)</p>

Discussion / Repair recommendations	Trend Data
<p>The unit appears to have a strong vane pass vibration. We assume there are 5 vanes on the impeller. We recommend ensuring the pump is being operated at near the best operating point and that the pump internals are not worn. Inspect in the near future. Rated a Class II Defect.</p>

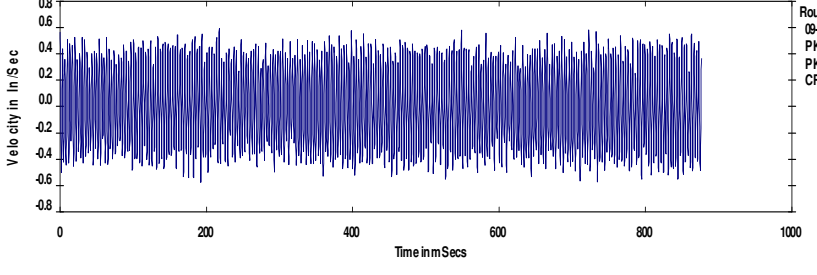
<p>Route Waveform 08-Aug-19 15:03:14 PK = .4284 PK(+-) = .5931/.5731 CRESTF= 1.96</p> <p>Freq: 59.84 Ord: .999 Spec: .01900</p>	<p>5X RPM vibration dominates the pump velocity data.</p>

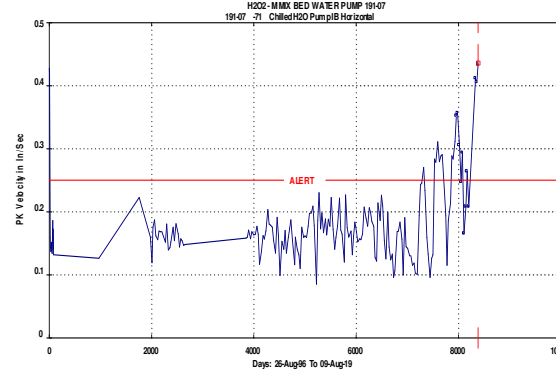
<p>Trend Display d Overall Value --Baseline-- Value: .428 Date: 26-Aug-18</p> <p>Alert</p> <p>Date: 09-Aug-19 Time: 15:02:46 Ampl: .433</p>
