Client	Penn A Kem	Survey Date	9-12/18-19
Location	53	Report Date	9-19-19
Machine	R53-301 Agitator	QMS No.	140477
Component	Motor/coupling	Analyst	DWS

Vibration Data	Analysis
<p>NEW - AGITATOR GBX CHEMNEER 15HP R53-301 -11 MOTOR OUTBOARD HORIZ</p>

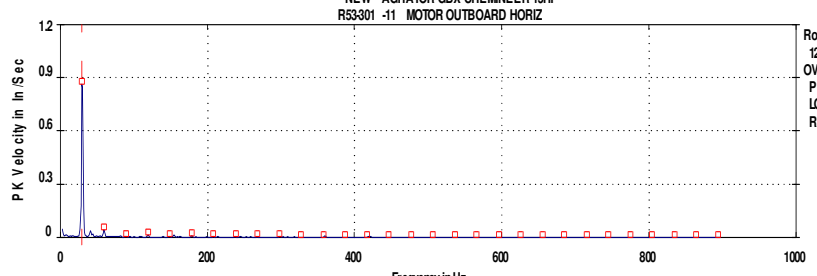
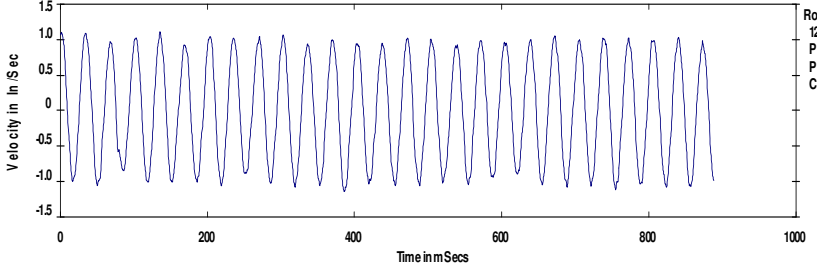
<p>Route Waveform 12-Sep-19 13:36:21 PK = 1.02 PK(μ)=1.12/1.14 CRESTF=1.59</p> <p>Freq: 29.80 Ord: 1.000 Spec: 1.006</p>	<p>Dominant shaft speed vibration in motor data at over 1"/sec velocity peak. Secondary vibration at 2x.</p>

Discussion / Repair recommendations	Data
<p>The high amplitude vibration data could indicate an issue in or adjacent to the motor. Ensure all fasteners are tight. Inspect the motor cooling fan and the shaft coupling for wear or damage. Have the shaft alignment checked and adjusted if necessary. Vibrations over 1"/sec velocity peak require attention. <b>Rated a Class III Defect.</b></p>

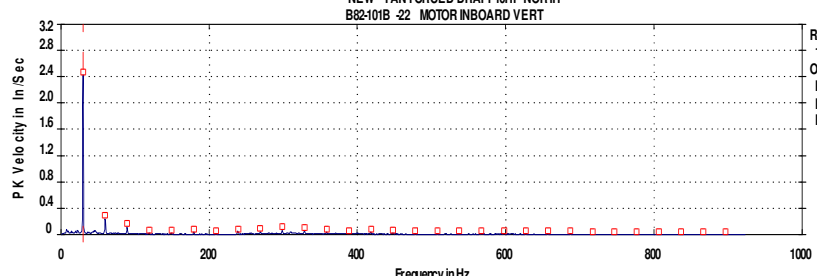
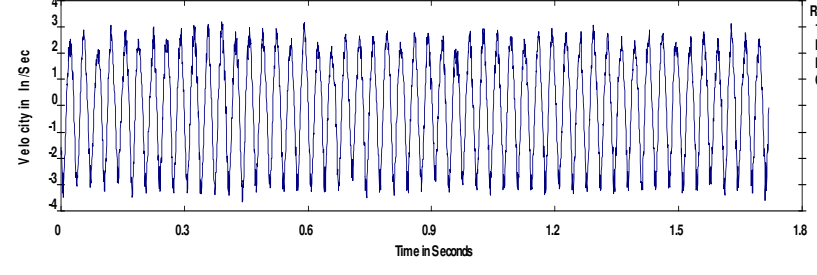
Vibration Data	Analysis
<p>NEW - FAN FORCED DRAFT 10HP NORTH B82-101B -22 MOTOR INBOARD VERT</p>

<p>Route Waveform 12-Sep-19 12:53:41 PK = 2.69 PK(4/3) = 3.19/3.65 CRESTF= 1.92</p> <p>Freq: 29.88 Ord: 1.000 Spec: 2.590</p>	<p>Dominant shaft speed vibration in the motor at over 3"/sec peak velocity.</p>

Discussion / Repair recommendations	Data
<p>This unit should be shut down and inspected as soon as possible. The likelihood of secondary damage is extremely conceivable if allowed to run. Unit area should be barricaded until repairs are completed. Vibrations are over 3"/sec velocity peak in the time waveform of the motor inboard vertical and dominated by the shaft fundamental. We suspect imbalance and other factors such as loose fasteners, looseness in the bearing fits and possible structural defects. <b>Rated a Class IV Defect.</b></p>

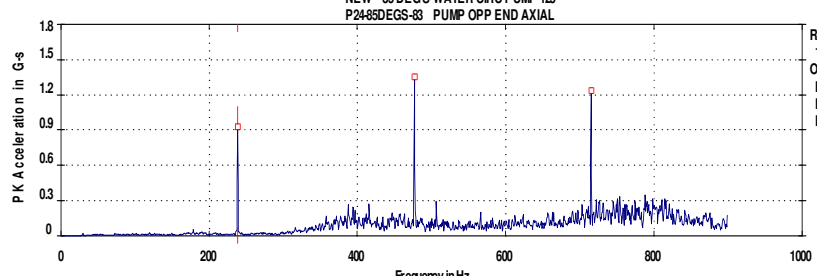
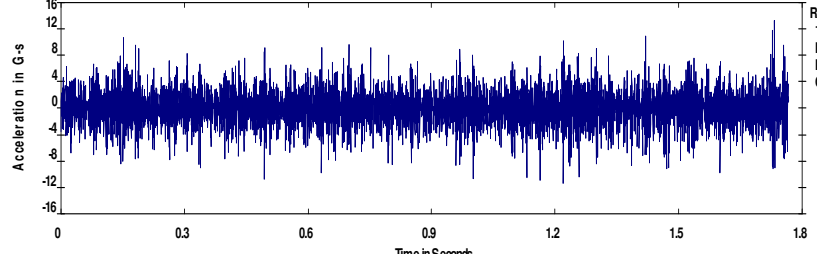
Vibration Data	Analysis
<p>NEW -85 DEGS WATER CIRC PUMP 125 P24-85DEGS-83 PUMP OPP END AXIAL</p>

<p>Route Waveform 12-Sep-19 10:52:55 PK = 4.15 PK(+) = 13.24/11.42 CREST= 4.51</p> <p>Freq: 238.57 Ordr: 8.000 Spec: .901</p>	<p>8x RPM vibration peak and 2 harmonics show suspected vane pass.</p>

Discussion / Repair recommendations	Data
<p>Vibration data consists of: vane pass and harmonics, slightly elevated noise floor and impacting in the time waveform. We suspect the pump is worn and not running in the optimal area of the performance curve. Have the flow and pressure's checked as time allows. We will watch for changes. <b>Rated a Class II Defect.</b></p>

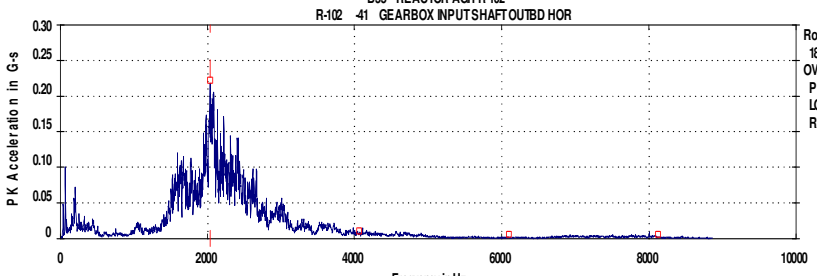
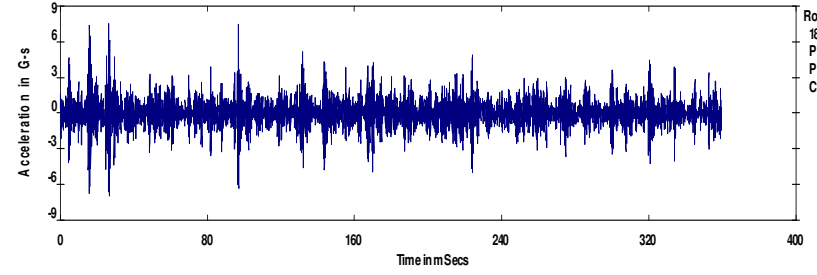
Vibration Data	Analysis
<p>B55 - REACTOR AGTR-102 R-102 -41 GEARBOX INPUT SHAFT OUTBD HOR</p>

<p>Route Waveform 18-Sep-19 10:04:58 PK = 1.75 PK(μ)= 7.567.00 CRESTF= 6.12</p> <p>Freq: 2032.9 Ord: 69.30 Spec: .218</p>	<p>Noise hump in the acceleration spectrum and impacting in the time domain.</p>

Discussion / Repair recommendations	Trend Data
<p>The unit gearbox could be in distress. We recommend a visual inspection and Oil analysis to confirm. This is the first survey so we will only rate this <b>Class II at this time.</b></p>

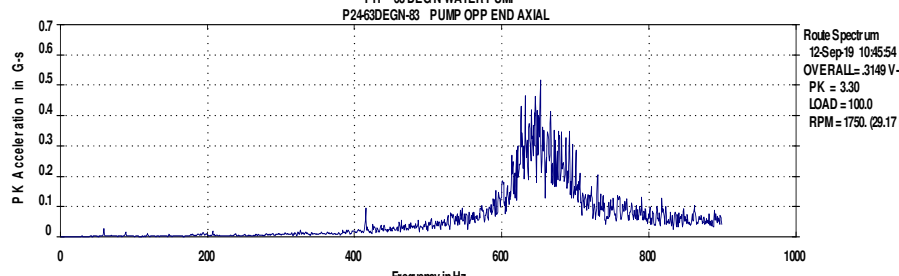
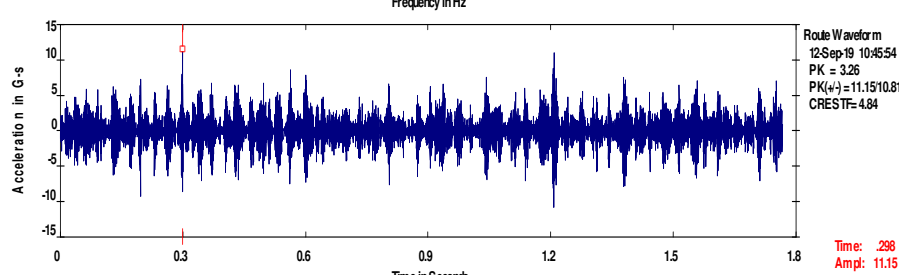
Vibration Data	Analysis
<p>PH -63 DEGN WATER PUMP P2463DEGN-83 PUMP OPP END AXIAL</p>

<p>Elevated noise floor and impacting in the acceleration time waveform.</p>

Discussion / Repair recommendations	Trend Data
<p>Random impacting in the data is usually a good indicator of the presence of bearing defects. The addition of a large noise hump could help to support the analysis or sometimes it could indicate cavitation in the pump or both. We suspect the bearings are in some distress with possible cavitation. Inspect the outboard pump bearing and check process parameters. <b>Rated a Class III Defect.</b></p>
