Client	Blues City Brewery	Survey Date	9-3-19
Location	Memphis, TN	Report Date	9-3-19
Machine	Boiler 3 Fan Motor	QMS No.	140748
Component	Bearings	Analyst	DWS

Client	Blues City Brewery	Survey Date	9-3-19
Location	Memphis, TN	Report Date	9-3-19
Machine	Ammonia Compressor 3	QMS No.	140748
Component	Bearings/Bars	Analyst	DWS

Client	Blues City Brewery	Survey Date	9-3-19
Location	Memphis, TN	Report Date	9-3-19
Machine	Sugar Tank 4 Pump	QMS No.	140748
Component	Coupling/Alignment	Analyst	DWS

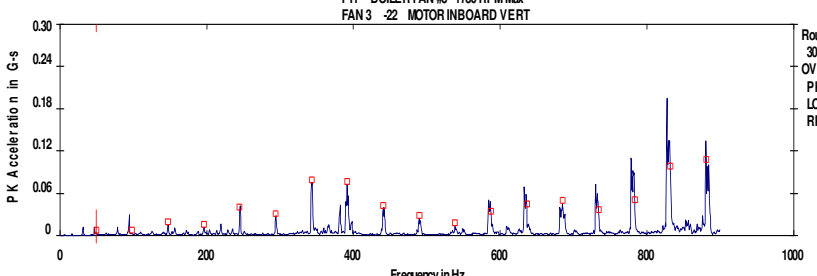
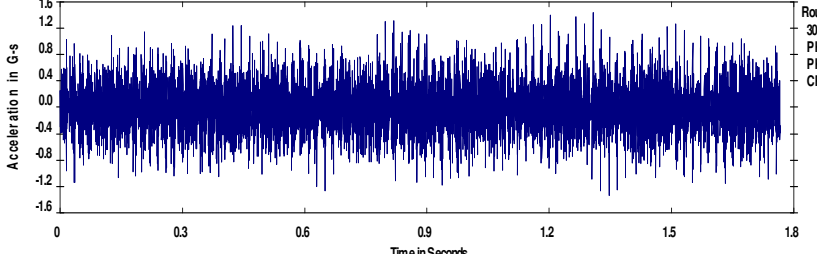
Vibration Data	Analysis
<p>PH - BOILER FAN #3 - 1780 RPM Max FAN 3 -22 MOTOR INBOARD VERT</p>

<p>Route Spectrum 30-Sep-19 10:15:50 OVERALL= .0739 V-DG PK = .5774 LOAD = 100.0 RPM = 939. (15.65 Hz)</p>

<p>Route Waveform 30-Sep-19 10:15:50 PK = .6179 PK(u)=1.44/1.34 CRESTF=3.30</p> <p>Freq: 48.94 Ord: 3.127 Spec: .00406</p>	<p>Non synchronous peaks marked in the spectrum. Impacting in the time domain.</p>

Discussion / Repair recommendations	Trend Data
<p>Possible bearing defect frequencies in the motor; which look to be from fluting. Increase in the acceleration trend. Expect to change out the bearings in the future. <b>Rated a Class II Defect.</b></p>

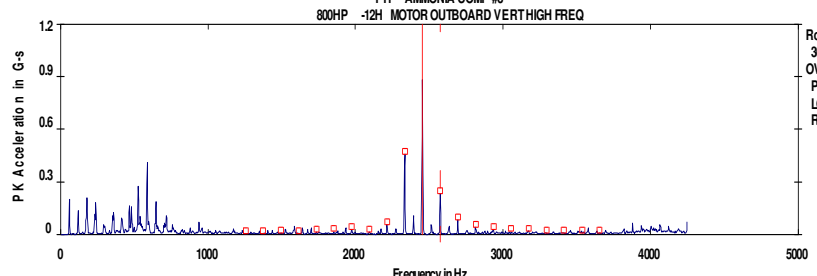
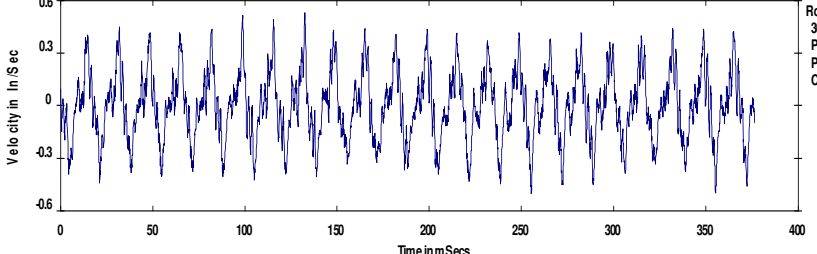
Vibration Data	Analysis
<p>PH - AMMONIA COMP #3 800HP -12H MOTOR OUTBOARD VERTHIGH FREQ</p>

<p>Route Spectrum 30-Sep-19 10:41:31 OVERALL= 2827 V-DG PK = 1.43 LOAD = 100.0 RPM = 3591. (59.85 Hz)</p>

<p>Route Waveform 30-Sep-19 10:41:31 PK = .2755 PK(+) = 5290/5035 CREST= 2.72</p> <p>Freq: 2574.4 Ord: 43.01 Spec: .232 Dirq: 119.99</p>	<p>Synchronous peak with 2x line frequency sidebands, and multiple shaft speed harmonics in the acceleration spectrum of the motor outboard bearing.</p>

Discussion / Repair recommendations	Trend Data
<p>The motor is still be suffering from two issues. Plot data shows high frequency vibration peaks with 2 times line frequency sidebands. This is called a rotor bar issue. Some of the bars have weak or cracked connections. As time progresses the vibrations usually tend to rise; ultimately, the bars will become loose and start to cause vibrations at shaft speed then with side bands. This motor also seems to have looseness, or excessive clearance in or around the bearings. Check the bearing clearances if possible for now. <b>Rated a Class II Defect.</b></p>

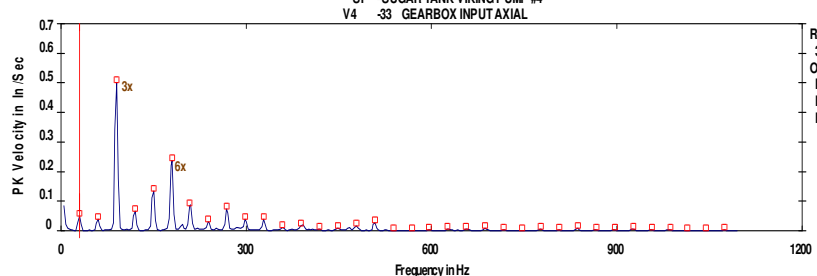
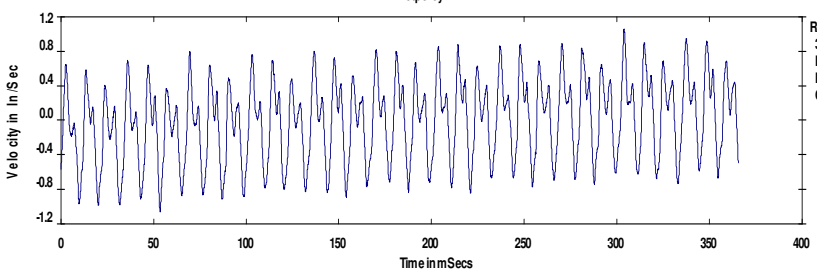
Vibration Data	Analysis
<p>SP - SUGAR TANK VIKING PUMP #4 V4 -33 GEARBOX INPUT AXIAL</p>

<p>Route Spectrum 30-Sep-19 11:28:17 OVERALL= .6338 V-DG PK = .6320 LOAD = 100.0 RPM = 1792 (29.87 Hz)</p>

<p>Route Waveform 30-Sep-19 11:28:17 PK = .6525 PK(+-) = 1.06/1.06 CRESTF= 2.30</p> <p>Freq: 29.87 Ord: 1.000 Spec: .05026 Dir: .207</p>	<p>A dominant 3x RPM vibration is a good indicator of a coupling issue, especially if it is equipped with a love joy type.</p>

Discussion / Repair recommendations	Trend Data
<p>The dominant 3x RPM vibration as well as the stepped time waveform are good indicators of a coupling and or alignment issue. The increase in vibrations require action. Inspect the unit soon. Replace worn or damaged components and re-align the shafts on the whole drivetrain. <b>Rated a Class III Defect.</b></p>
