Client	Arvin Sango	Survey Date	11-5-19
Location	Henderson, TN	Report Date	11-6-19
Machine	Dust Collector Fan	QMS No.	141108
Component	Fan	Analyst	DWS

Vibration Data	Analysis
<p>FANS - DUSTCOLLECTOR FAN DC FAN - FOH FAN OUTBOARD HORIZ</p>

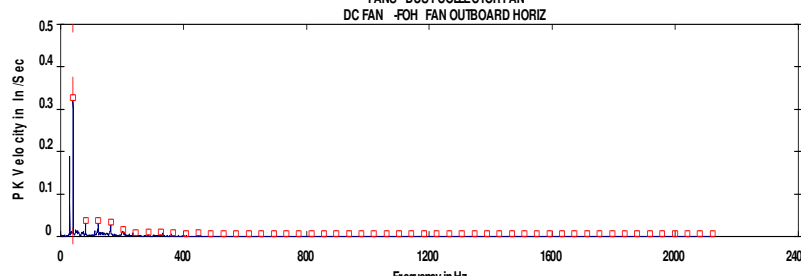
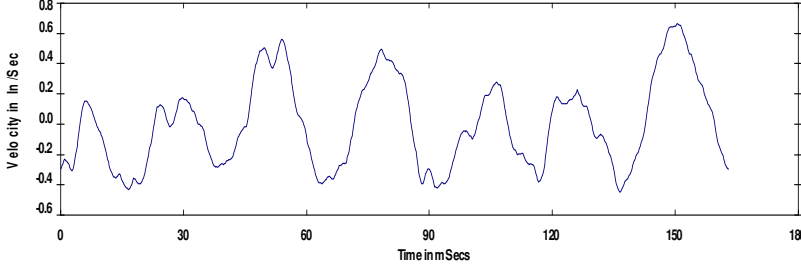
<p>Route Spectrum 05-Nov-19 09:24:27 OVERALL = .4278 V-DG PK = .4267 LOAD = 100.0 RPM = 1800. (30.00 Hz)</p>

<p>Route Waveform 05-Nov-19 09:24:27 PK = .4075 PK(+) = .6657/.4484 CREST = 2.31</p> <p>Freq: 40.51 Ord: 1.350 Spec: .322</p>	<p>1x fan and motor vibrations in the fan outboard bearing data. Overall is almost 1/2" per second.</p>

Discussion / Repair recommendations	Trend Data
<p>The vibration data shows an increase in fan shaft vibrations at fan and motor speed. We suspect one or more of the following issues: Build up on the fan wheel plus: sheaves out of alignment, worn sheaves, worn belts, eccentric shaft or sheave, loose fasteners, and possible frame cracks. Clean and inspect the fan wheel and all associated parts. Call for a trim if needed. Rated A Class II Defect.</p>

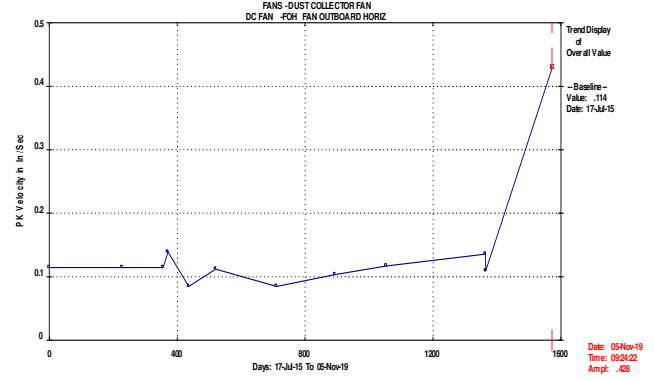
<p>Trend Display Overall Value Baseline Value: .114 Date: 17-Jul-15</p> <p>Date: 05-Nov-19 Time: 09:24:22 Ampl: .428</p>
