Client	Penn-A-Kem	Survey Date	1-8-2020
Location	Memphis, TN	Report Date	1-13-2020
Machine	P24-63DEGN 63 Degree North Pump	QMS No.	141533
Component	Pump Unit	Analyst	DWS

Vibration Data	Analysis
<p>NEW - 63 DEGN WATER PUMP P24-63DEGN-11 MOTOR OUTBOARD HORIZ</p>

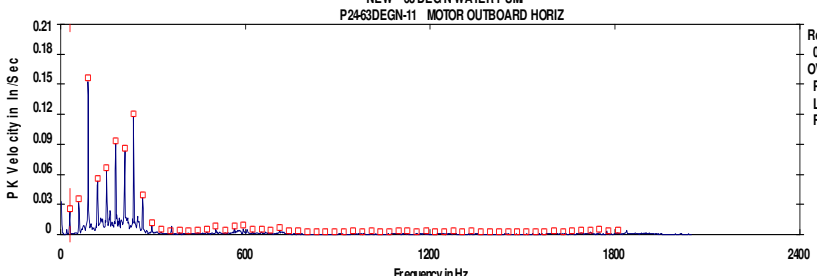
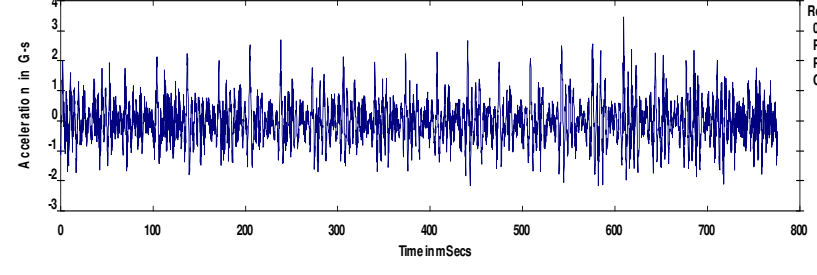
Defect Rating for this machine	Class III
Defect Rating System	
Class I: Defect is present, but effect on reliability is not clear; no immediate action is required. Continue normal monitoring.	Class III: Defect (s) present that may cause failure in short term (less than 2 mos.). Should be addressed as soon as practical, with a high maintenance priority. Increase monitoring frequency.
Class II: Defect (s) present that may cause problem in long term (2-6 mos.). Repair during normal maintenance scheduling. Continue to monitor.	Class IV: Defect (s) present that makes continued reliability unpredictable, and possibility of secondary damage is high. Repairs should be made ASAP. An unscheduled shutdown should be considered for repairs.

<p>Route Spectrum 08-Jan-20 10:43:08 OVERALL= 2937 V-DG PK = 2927 LOAD = 100.0 RPM = 1779. (29.65 Hz)</p>

<p>Route Waveform 08-Jan-20 10:43:08 PK = .9763 PK(+) = 3.46215 CRESTF= 5.01</p> <p>Freq: 29.65 Ord: 1.000 Spec: .02326</p>	<p>The trends are generally higher for the unit. Multiple defect frequency vibration types are present.</p>

Discussion / Repair recommendations	Trend Data
<p>Both the motor and pump still have issues. The motor bearings show multiple harmonics of shaft speed indicating mechanical looseness. Random impacting in the pump data is usually a good indicator of the presence of bearing defects also. The rear pump seal is gone and spraying the bearing hard. We recommend replacing the motor and pump in the near future. Renew the coupling if needed as well. Rated a Class III Defect.</p>

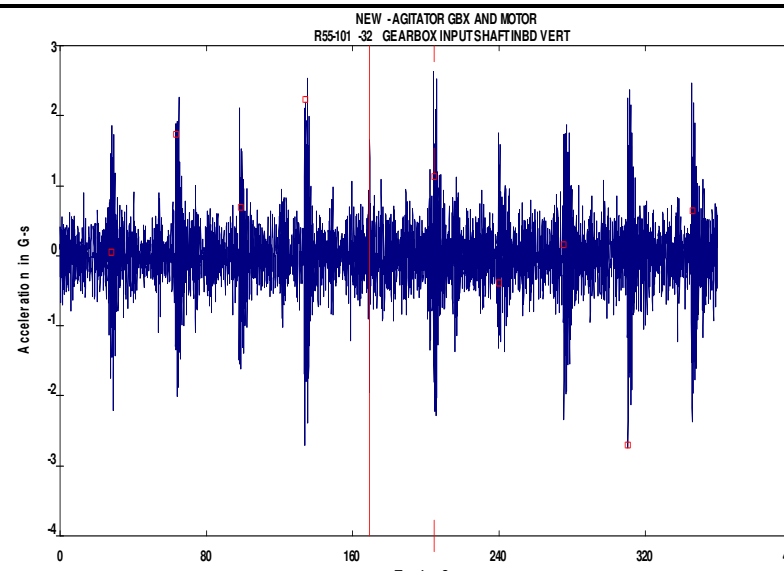
Vibration Data	Analysis
<p>NEW - AGITATOR GBX AND MOTOR R55-101 -32 GEARBOX INPUT SHAFT INBD VERT</p>

Defect Rating for this machine	Class II
Defect Rating System	
Class I: Defect is present, but effect on reliability is not clear; no immediate action is required. Continue normal monitoring.	Class III: Defect (s) present that may cause failure in short term (less than 2 mos.). Should be addressed as soon as practical, with a high maintenance priority. Increase monitoring frequency.
Class II: Defect (s) present that may cause problem in long term (2-6 mos.). Repair during normal maintenance scheduling. Continue to monitor.	Class IV: Defect (s) present that makes continued reliability unpredictable, and possibility of secondary damage is high. Repairs should be made ASAP. An unscheduled shutdown should be considered for repairs.

<p>Route Waveform 08-Jan-20 13:16:35</p> <p>PK = .6338 LOAD = 100.0 RPM = 1760. (29.33 Hz)</p> <p>PK(+) = 2.63 PK(-) = 2.74 CRESTF = 6.12</p> <p>Time: 204.62 Ampl: 1.089 Dlim: 35.30 Freq: 28.33</p>	<p>Waterfall shows elevated noise floor in the gearbox input data. Time domain shows impacting at shaft speed.</p>

Discussion / Repair recommendations	Trend Data
<p>The unit gearbox or input coupling could still be in distress. We recommend an inspection of the drivetrain and oil analysis of the gearbox oil to confirm. Impacting can be seen in the time domain. The gearbox seemed to be generating audible noises too; which also concerns us. Inspect as soon as practical. Rated a Class II Defect.</p>

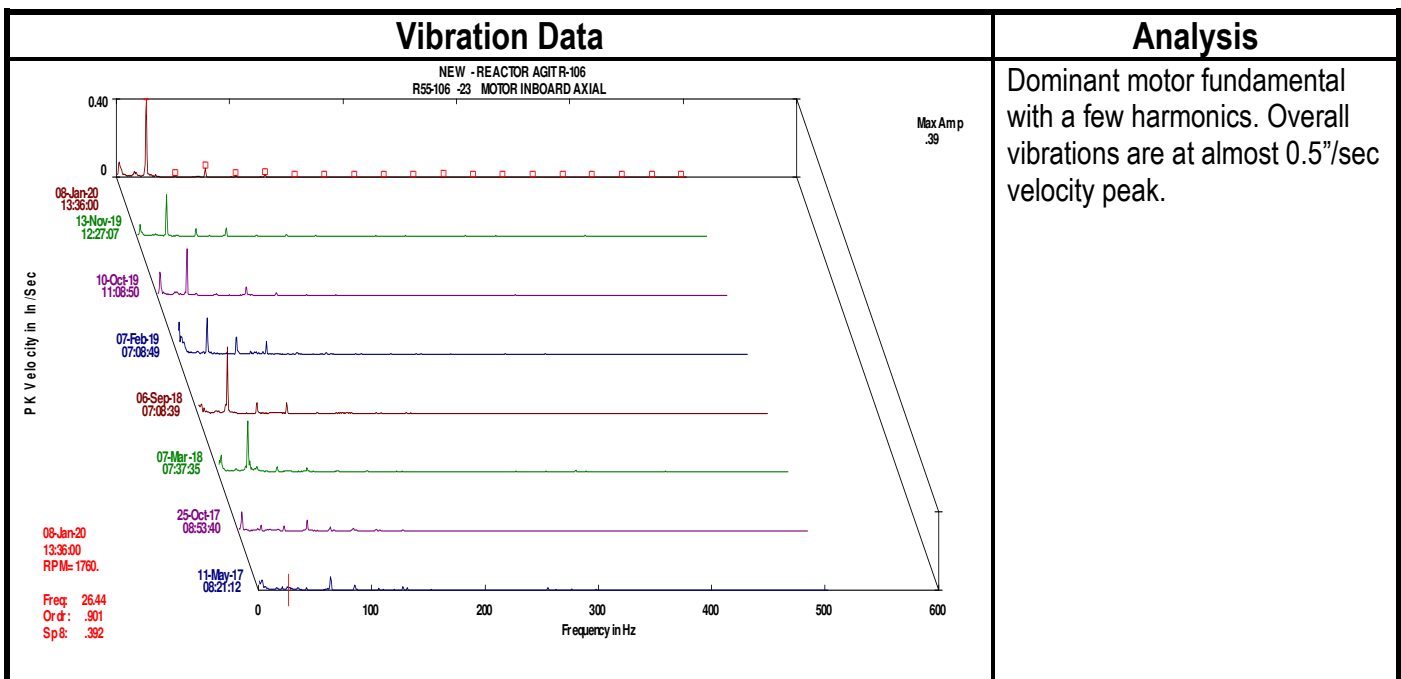
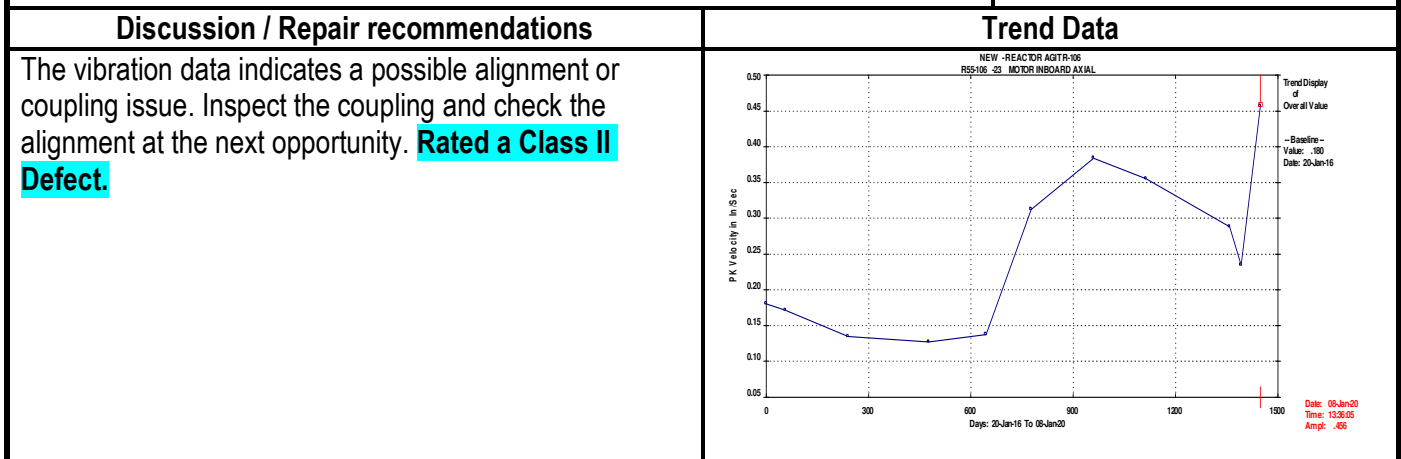
Defect Rating for this machine	Class II
Defect Rating System	
Class I: Defect is present, but effect on reliability is not clear; no immediate action is required. Continue normal monitoring.	Class III: Defect (s) present that may cause failure in short term (less than 2 mos.). Should be addressed as soon as practical, with a high maintenance priority. Increase monitoring frequency.
Class II: Defect (s) present that may cause problem in long term (2-6 mos.). Repair during normal maintenance scheduling. Continue to monitor.	Class IV: Defect (s) present that makes continued reliability unpredictable, and possibility of secondary damage is high. Repairs should be made ASAP. An unscheduled shutdown should be considered for repairs.

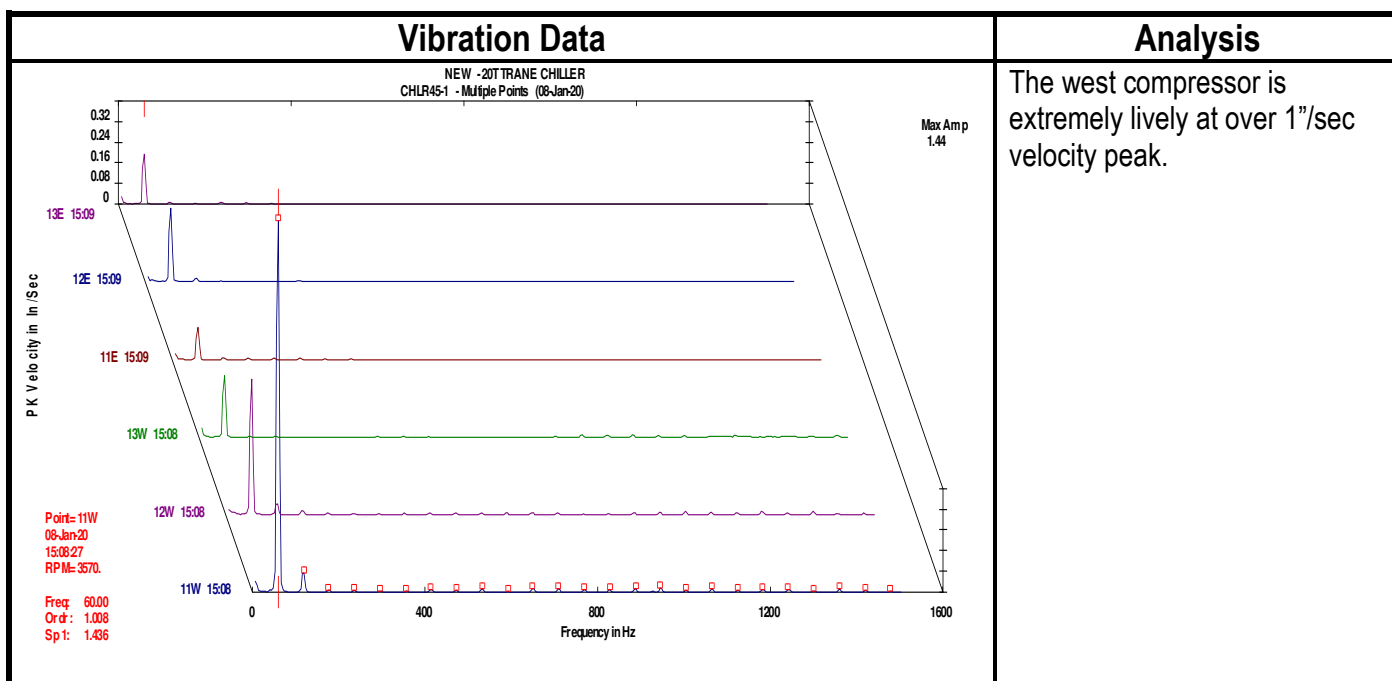
Defect Rating for this machine	Class II
Defect Rating System	
Class I: Defect is present, but effect on reliability is not clear; no immediate action is required. Continue normal monitoring.	Class III: Defect (s) present that may cause failure in short term (less than 2 mos.). Should be addressed as soon as practical, with a high maintenance priority. Increase monitoring frequency.
Class II: Defect (s) present that may cause problem in long term (2-6 mos.). Repair during normal maintenance scheduling. Continue to monitor.	Class IV: Defect (s) present that makes continued reliability unpredictable, and possibility of secondary damage is high. Repairs should be made ASAP. An unscheduled shutdown should be considered for repairs.

Discussion / Repair recommendations	Vibration Data
<p>The top measurements are shown in the waterfall data, the West compressor is vibrating near 1.5"/sec velocity peak at 60 Hz shaft speed. Vibrations at these levels in the West unit will likely cause a reduced lifespan. Have the unit checked for compliance with the manufactures specification. Rated a Class II Defect for now.</p>
