Client	Penn-A-Kem	Survey Date	5-26-2020
Location	Memphis, TN	Report Date	5-27-2020
Machine	R80-30 Agitator gearbox	QMS No.	142527
Component		Analyst	DWS

Client	Penn-A-Kem	Survey Date	5-26-2020
Location	Memphis, TN	Report Date	5-27-2020
Machine	P24 85 Degree Pump North	QMS No.	142527
Component		Analyst	DWS

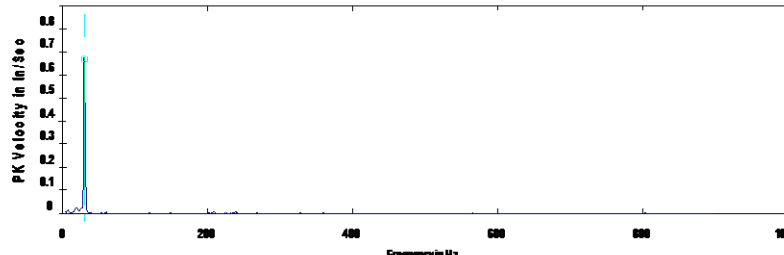
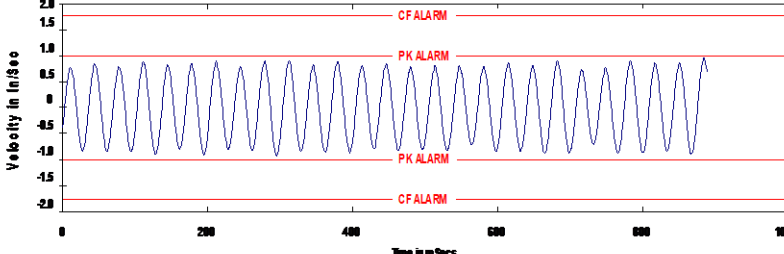
Vibration Data	Analysis
<p>NEW - AGITATOR GEARBOX CHEMIEER R80-30 - 42 MOTOR OUBOARD VERT</p>

<p>Route Spectrum 26-May-20 15:02:26 OVERALL= .7905 V-DG PK = .7894 LOAD = 100.0 RPM = 1788, (29.81 Hz)</p>

<p>Route Waveform 26-May-20 15:02:26 PK = .8294 PK(+) = .9823/.9368 CRE STF= 1.64</p> <p>CF ALARM PK ALARM PK ALARM CF ALARM</p> <p>Freq: 29.81 Ordr: 1.000 Spec: .785 Dirq: .00000</p>	<p>The back end of the motor shows a large shaft speed vibration.</p>

Discussion / Repair recommendations	Trend Data
<p>The motor shaft speed vibration is very high at nearly 1"/sec velocity peak in the time domain. Inspect the unit ASAP to determine the cause. We believe there could be damage to the fan, loose fasteners, broken feet or structure, or a coupling issue. Rate a Class III Defect.</p>

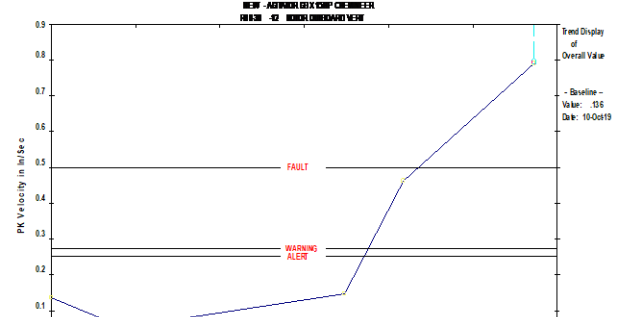
<p>Trend Display of Overall Value</p> <p>Baseline Value: .65 Date: 10-Oct-19</p> <p>FAULT WARNING ALERT</p> <p>Days: 10-Oct-19 to 26-May-20</p> <p>Date: 26-May-20 Time: 15:02:25 Ampl: .791</p>

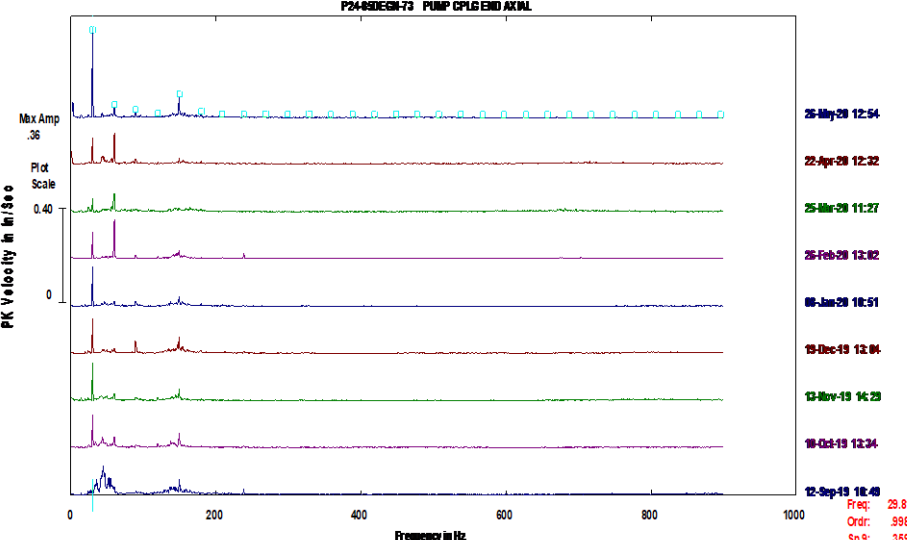
Vibration Data	Analysis
<p>NEW - 85 DEGREE WATER CIRC PUMP 125 P24-85DEGR-73 PUMP CPLE END AXIAL</p>

<p>25-May-20 12:54 22-Apr-20 12:32 25-Mar-20 11:27 26-Feb-20 12:02 09-Jan-20 10:51 19-Dec-19 12:04 12-Nov-19 14:29 18-Oct-19 12:34 12-Sep-19 10:40</p> <p>Max Amp: 0.36 Plot Scale: 0.40 PK Velocity in in/sec Frequency in Hz</p> <p>Freq: 29.81 Ordr: 998 Sp 9: 359</p>	<p>Large increase in the shaft fundamental vibration.</p>

Discussion / Repair recommendations	Trend Data
<p>Vibration data shows an increase at shaft speed and vane pass (5x) for the inboard pump bearing. Water is now leaking from the seal also. Inspect for defects as time allows. Rated a Class II Defect.</p>

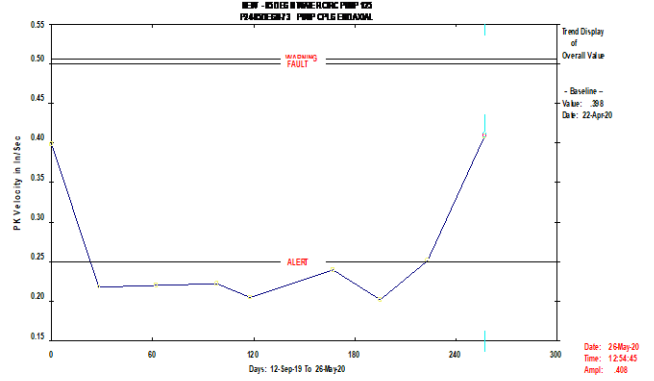
<p>NEW - 85 DEGREE WATER CIRC PUMP 125 P24-85DEGR-73 PUMP CPLE END AXIAL</p> <p>Trend Display of Overall Value</p> <p>Baseline - 0.30 Date: 22-Apr-20</p> <p>Alert</p> <p>Days: 12-Sep-19 To 26-May-20</p> <p>Date: 24-May-20 Time: 12:54:45 Ampl: 408</p>
