Client	ADM Flour Milling	Survey Date	6-3-2020
Location	Jackson, TN	Report Date	6-4-2020
Machine	Bailer 1 Fan (Near fan unit)	QMS No.	142569
Component	Fan	Analyst	DEWS

Vibration Data	Analysis
<p>FANS - BALEMASTER 1 FRONT FAN B1MFRONT_FAN_FAN INBOARD HORIZ.</p>

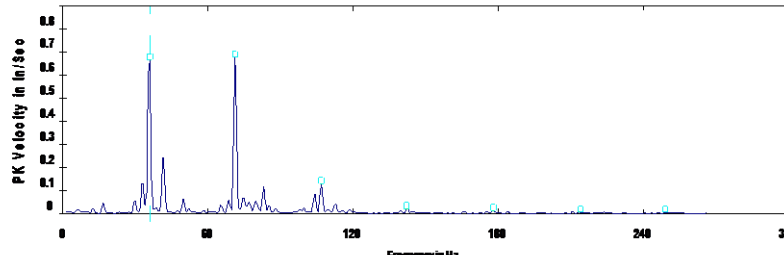
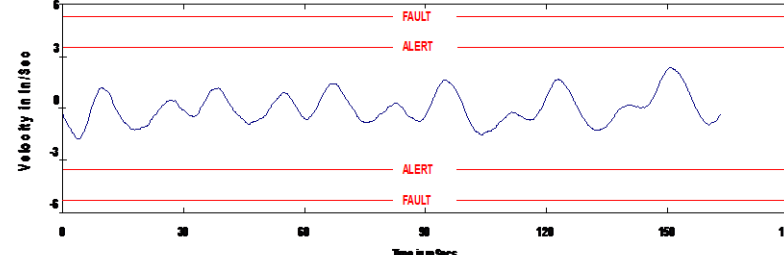
<p>Route Spectrum 03-Jun-20 14:01:19 OVERALL= 1.11 V-DG PK = 1.11 LOAD = 100.0 RPM = 1800, (30.00 Hz)</p>

<p>Route Waveform 03-Jun-20 14:01:19 PK = 1.25 PK(4) = 2.36/1.77 CRE STF= 2.66</p> <p>Freq: 35.86 Ordr: 1.195 Spec: .668</p>	Harmonic peaks dominate the spectrum.

Discussion / Repair recommendations	Trend Data
Vibration data indicates an issue with the fan shaft and components. Check for shaft run out, misalignment and sheave/belt wear. Check the structure for cracks. <b>Rated a Class III Defect.</b>

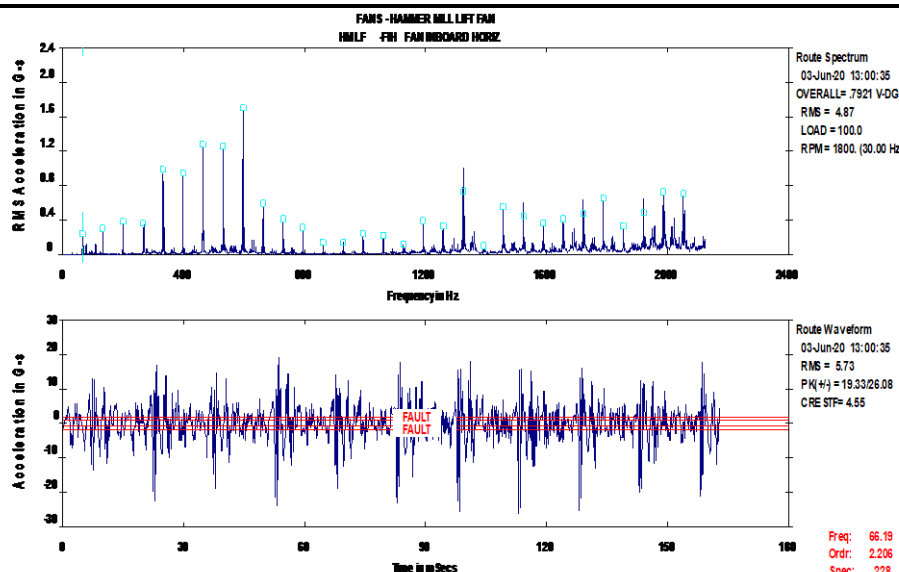
Vibration Data	Analysis
<p>FANS - HAMMER MILL LIFT FAN HMLF - FM FAN IMBOARD HORIZ</p>

<p>Harmonics of 66 Hz dominate the spectrum and time waveform.</p>

Discussion / Repair recommendations	Trend Data
<p>Data for the sheave end fan bearing suggests mechanical looseness. There are also other possibilities. The bearings will most likely need to be changed. The motor bearing are also showing signs of distress. Inspect the full drive train for defects and wear. Check the sheave alignment too. Acceleration is almost 5 g's RMS.</p> <p><b>Rated a Class III Defect.</b></p>

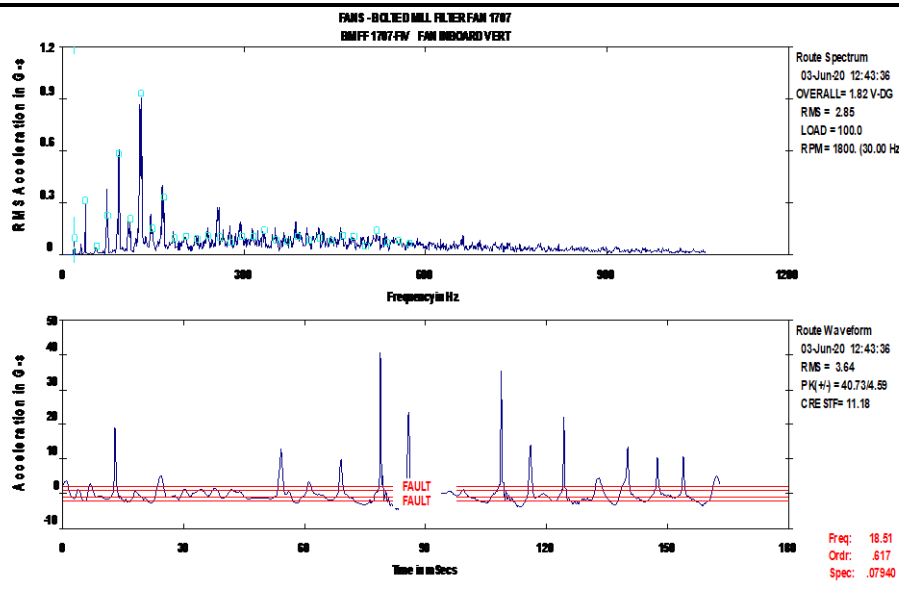
Vibration Data	Analysis
<p>FANS - BOLTED MILL FILTER FAN 1707 BMFF-1707-FW FAN INBOARD VERT</p>

<p>Large acceleration peaks in the acceleration spectrum and asymmetrical peaks in the acceleration time waveform.</p>
Discussion / Repair recommendations	Trend Data
<p>Strong harmonics in the spectrum and impacting in the time domain of the inboard fan bearing indicate severe component distress. Inspect the bearings and all associated components as soon as possible to avoid secondary damage. <b>Rated a Class IV Defect.</b></p>

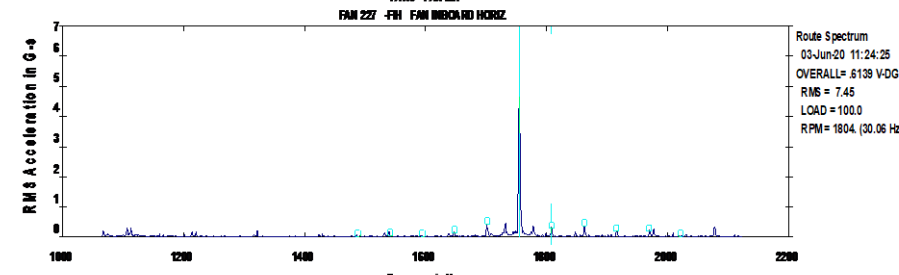
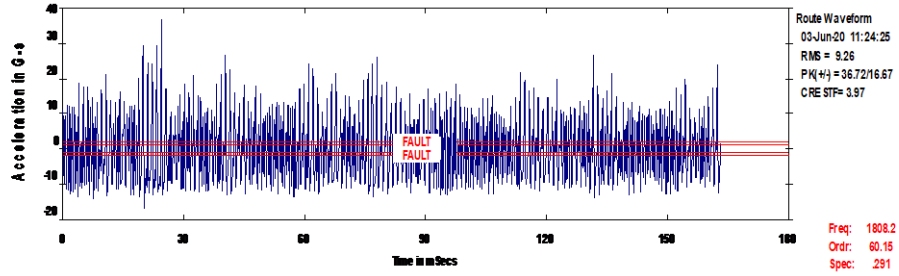
Vibration Data	Analysis
<p>FANS - FAN 227 FAN 227 - FBI FAN BEARING HORIZ</p>

<p>Route Spectrum 03-Jun-20 11:24:25 OVERALL= .6139 V-DG RMS = 7.45 LOAD = 100.0 RPM = 1804. (30.06 Hz)</p>

<p>Route Waveform 03-Jun-20 11:24:25 RMS = 9.26 PK(4)= 36.72/16.67 CRE STF= 3.97</p> <p>FAULT FAULT</p> <p>Freq: 1808.2 Ordr: 60.15 Spec: .291 Dirq: 53.48</p>	<p>Large vibration peak with sidebands. Asymmetrical vibration peaks in the time domain.</p>
Discussion / Repair recommendations	Trend Data
<p>Data indicates the bearings are in poor shape. Replace the bearings and any other components worn during repairs. <b>Rated a Class IV Defect.</b></p>

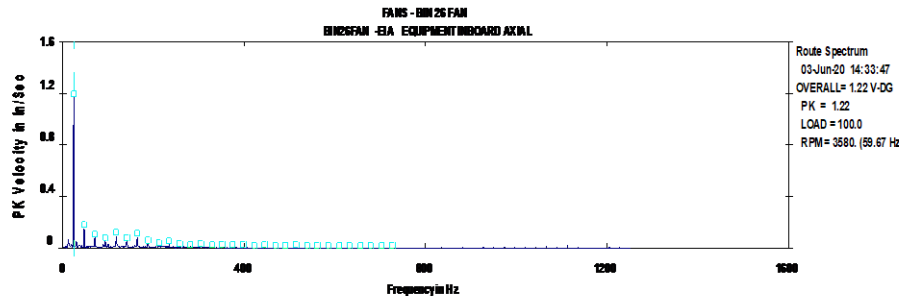
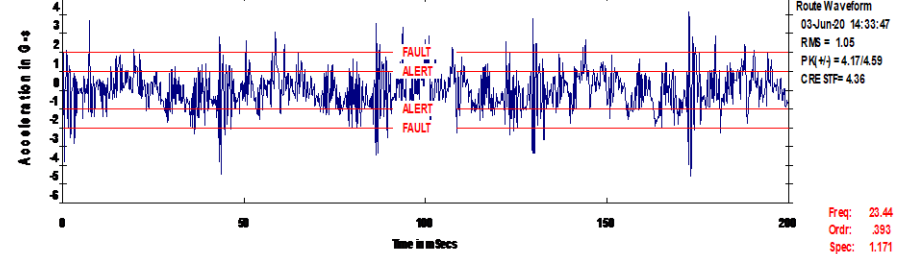
Vibration Data	Analysis
<p>FANS - BIN 26 FAN BIN26FAN -EIA EQUIPMENT MBOARD AXIAL</p>

<p>Large 1x fan rpm vibration for the fan axial.</p>
Discussion / Repair recommendations	Trend Data
<p>High axial vibration data indicated an issue with fan shaft, but we found a large through crack in the bearing support leg. There could some wear in the bearings though too. Fix the crack now and monitor the bearing as time allows. <b>Rated a Class IV Defect.</b></p>

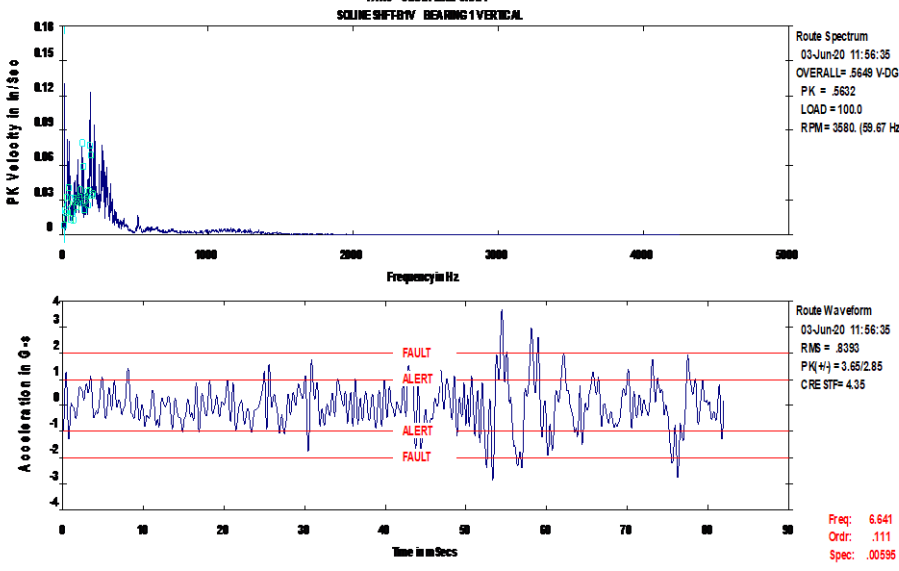
Vibration Data	Analysis
<p>FANS - SOUTH LINE SHAFT SOUTH LINE SHAFT BEARING 1 VERTICAL</p>

<p>Route Spectrum 03-Jun-20 11:56:35 OVERALL= 5649 V-DG PK = .5632 LOAD = 100.0 RPM = 3580, (59.67 Hz)</p> <p>Route Waveform 03-Jun-20 11:56:35 RMS = .8393 PK (4) = 3.65/2.85 CRE STF= 4.35</p> <p>Freq: 6.641 Ordr: .111 Spec: .00595</p>	Random noise in the first bearing.
Discussion / Repair recommendations	Trend Data
<p>The first bearing, next to the motor appears to be in distress due to the randomness of the vibrations seen in the data. The motor sheaves and belts could also be an issue, but we believe the bearing is trashed. Inspect the bearing being prepared to replace the internals. Make sure the housings are not too worn for continued use.</p> <p><b>Rated a Class III Defect.</b></p>
