MILLINGTON, TN

Subject: New Roof Fan

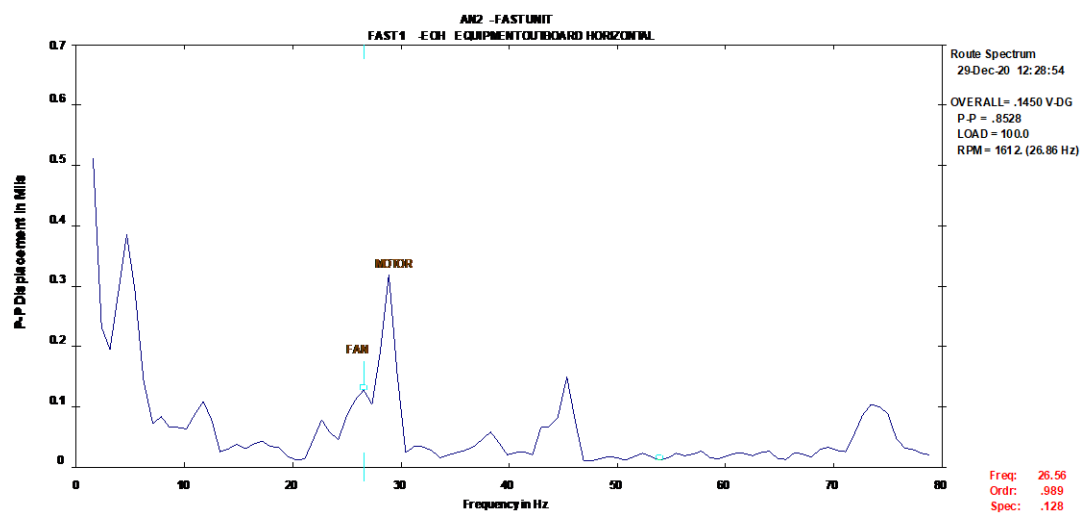
The new roof fan vibration analysis performed on December 29th indicated the fan balance was at or below the specification for type and speed, about 1 mil p-p. Supporting data follows.
