Client	Lucite	Survey Date	2-1-21
Location	Memphis, TN	Report Date	2-3-21
Machine	SAR 03 turbine compressor main blower	QMS No.	133393
Component		Analyst	DWS

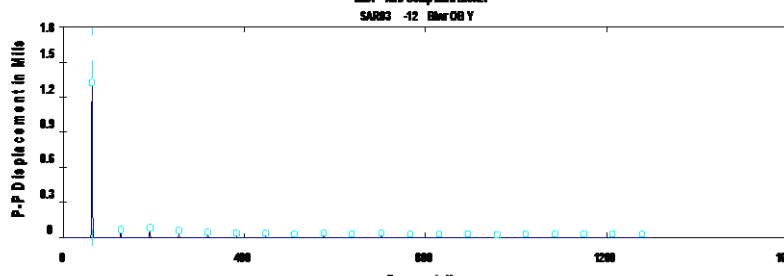
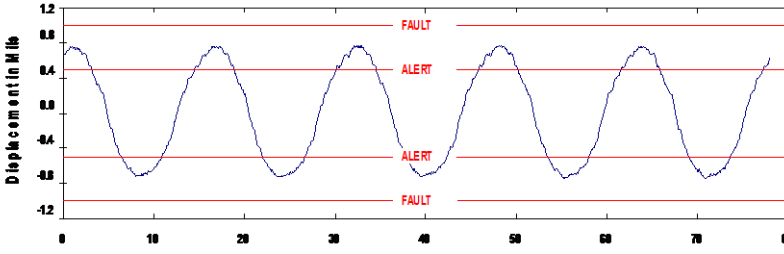
Vibration Data	Analysis
<p>MM - Turb Comp Main Blower SAR03 -12 Blw DB Y</p>

<p>Route Spectrum 02Feb21 08:09:22 OVERALL= 1.52 D-OG P.P = 1.51 LOAD = 100.0 RPM = 3828 (63.80 Hz)</p>

<p>Route Waveform 02Feb21 08:09:22 P.P = 1.51 PK(H) = .7728/7503 CRE STF= 1.44</p> <p>Freq: 64.19 Ordr: 1.006 Spec: 1.304</p>	<p>Point 12 proximity probe vibration continues to slowly climb in amplitude.</p>

Discussion / Repair recommendations	Trend Data
<p>Proximity probe 12 data shows a shaft speed vibration. The vibration amplitude continues to slowly increase in amplitude. The impeller is scheduled to be cleaned at this time so we will compare the readings next survey.</p> <p><b>Rated a Class II Defect.</b></p>

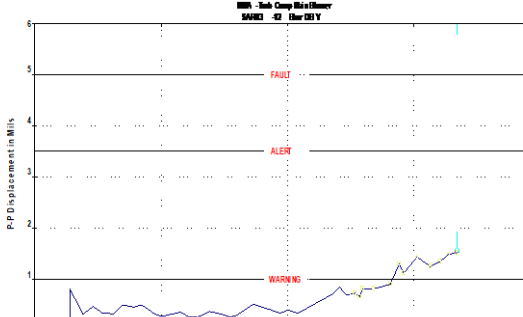
<p>Trend Display of Overall Value Baseline Value: .221 Date: 07-Jun-17</p> <p>Date: 02-Feb-21 Time: 08:09:22 Ampl: 1.517</p>

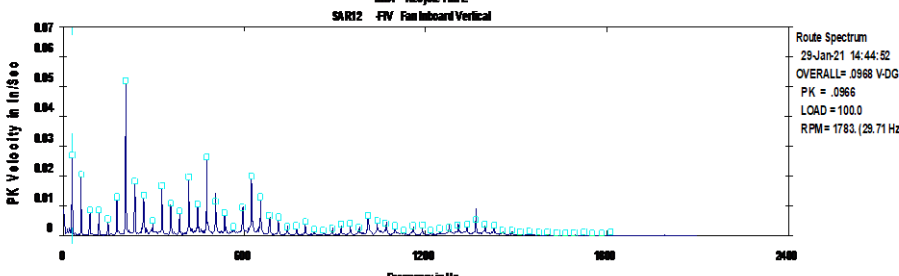
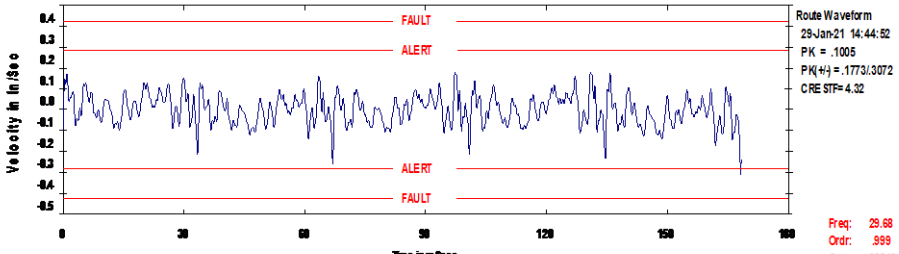
Vibration Data	Analysis
<p>MMA - Recycle Fan E SAR12 FV Fan Inboard Vertical</p>

<p>Route Spectrum 29-Jan-21 14:44:52 OVERALL= .0968 V-DG PK = .0966 LOAD = 100.0 RPM = 1783. (29.71 Hz)</p>

<p>Route Waveform 29-Jan-21 14:44:52 PK = .1005 PK(4x) = .1773/3072 CRE STF= 4.32</p> <p>Freq: 29.68 Ordr: 989 Spec: .02846</p>	Drop in vibrations after bearing adjustment.

Discussion / Repair recommendations	Trend Data
<p>The fan shaft was serviced a few months ago. Fan vibrations increased after that maintenance. The bearing caps were adjusted which subsequently dropped the vibration. Harmonics are still present and are indicative of excessive clearances (looseness) or structure/fastener issue. We will watch for changes. <b>Rated a Class II Defect.</b></p>

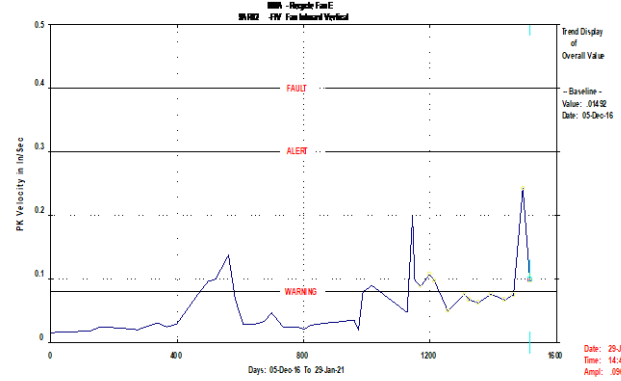
<p>Trend Display of Overall Value - Baseline - Value: .0432 Date: 05-Dec-16</p> <p>Date: 29-Jan-21 Time: 14:44:43 Ampl: .09684</p>

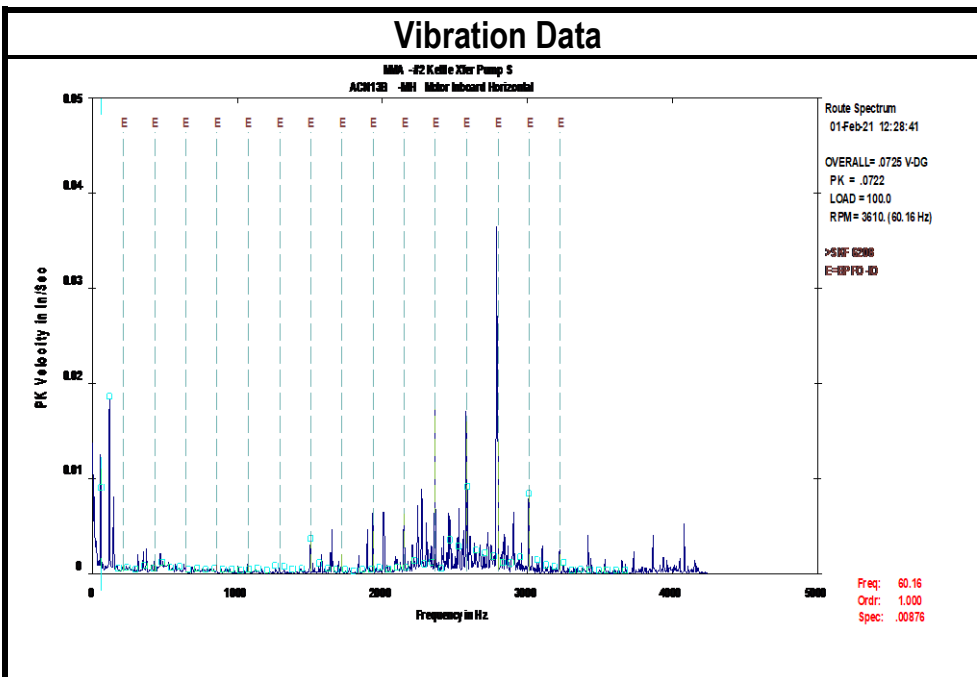
Outer race defect and harmonics are marked.

Discussion / Repair recommendations	Trend Data
Motor bearing data shows outer race defects in the inboard bearing. The vibrations have not changed much recently. We will watch this carefully going forward; however, it might be prudent to change this unit out as time allows. <b>Rated a Class II Defect.</b>
