Client	PENNAKEM	Survey Date	3-8-2021
Location	Memphis, TN	Report Date	3-12-2021
Machine	B82-101A 10HP FD FAN SOUTH (WEST)	QMS No.	144781
Component	Unit	Analyst	DWS

Defect Rating for this machine	CLASS II
Defect Rating System	
Class I: Defect is present, but effect on reliability is not clear; no immediate action is required. Continue normal monitoring.	Class III: Defect (s) present that may cause failure in short term (less than 2 mos.). Should be addressed as soon as practical, with a high maintenance priority. Increase monitoring frequency.
Class II: Defect (s) present that may cause problem in long term (2-6 mos.). Repair during normal maintenance scheduling. Continue to monitor.	Class IV: Defect (s) present that makes continued reliability unpredictable, and possibility of secondary damage is high. Repairs should be made ASAP. An unscheduled shutdown should be considered for repairs.

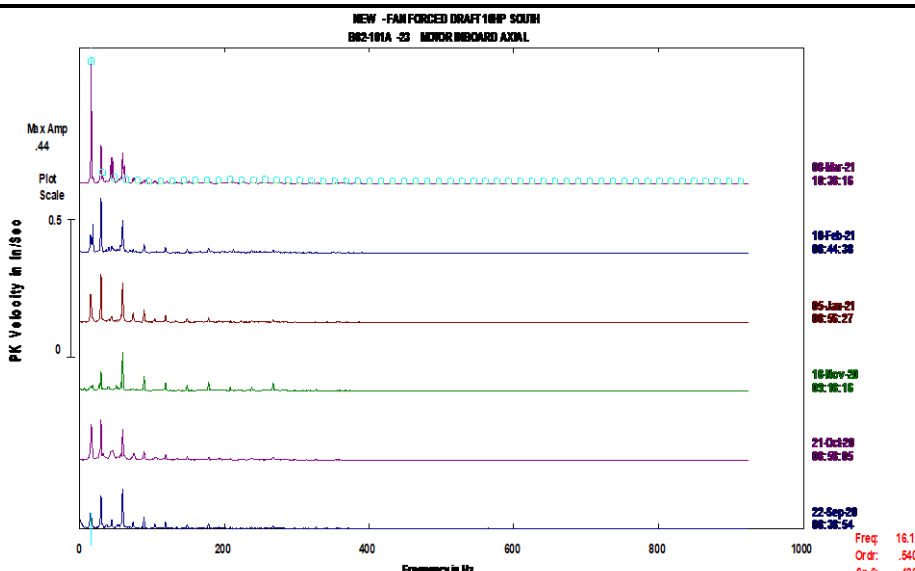
Vibration Data	Analysis
<p>NEW -FAN FORCED DRAFT 10HP SOUTH B82-101A -S3 MOTOR IMBOARD AXIAL</p>

<p>Max Amp .44 Plot Scale 0.5</p> <p>PK Velocity in in/sec</p> <p>Frequency in Hz</p> <p>09-Mar-21 18:38:16 18-Feb-21 08:44:38 05-Jan-21 08:58:27 18-Nov-20 03:18:16 21-Oct-20 08:58:05 22-Sep-20 08:38:54</p> <p>Freq: 16.19 Ordr: .540 Sp 6: .436</p>	<p>Large sub-synchronous vibration peak in motor axial.</p>

Discussion / Repair recommendations	Trend Data
<p>Motor axial has seen a large increase in a sub-synchronous non-fractional harmonic vibration which is either a resonant vibration or possibly a cracked shaft or loose fan hub, or another anomaly. Rated a Class II Defect.</p>
