MILLINGTON, TN

August 9, 2021

Most

Subject: Dust Collector vibration service

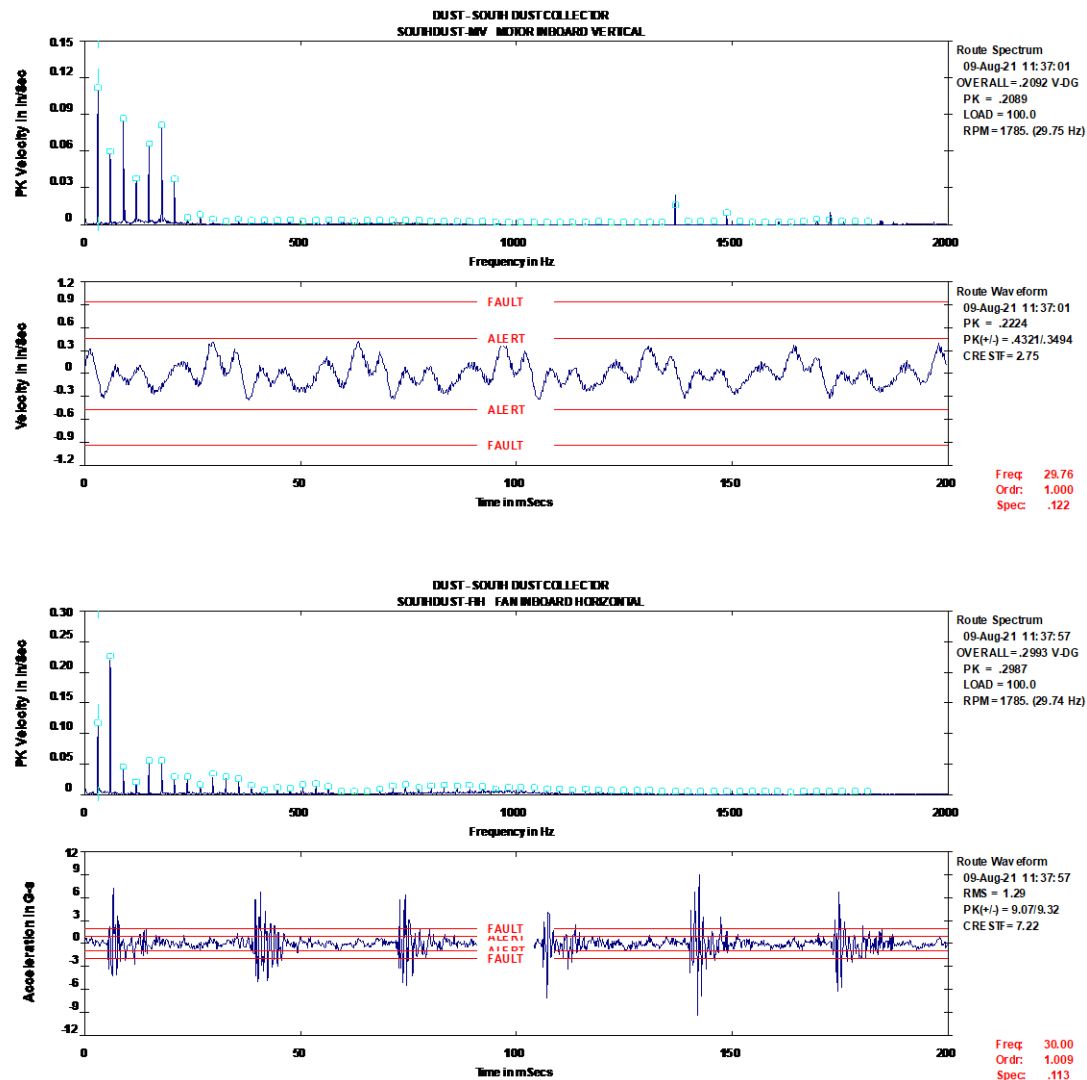
South Dust Collector Fan

The South motor and fan bearing data shows multiple shaft speed harmonic vibration peaks. The fan bearings also show a once per rev pulse. We suspect that both the motor and fan bearings have excessive shaft and/or housing fit looseness. Perform a lift check on both shafts to help confirm excessive clearance. Inspect for wear and recondition/replace worn components. Clean the fan wheel of build up as necessary. **Rated a Class II Defect.**

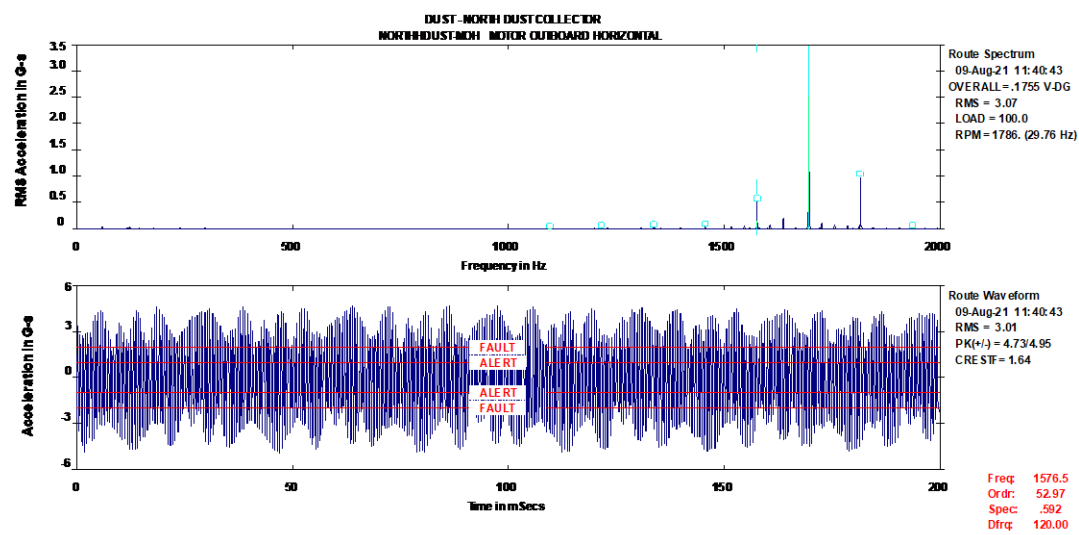
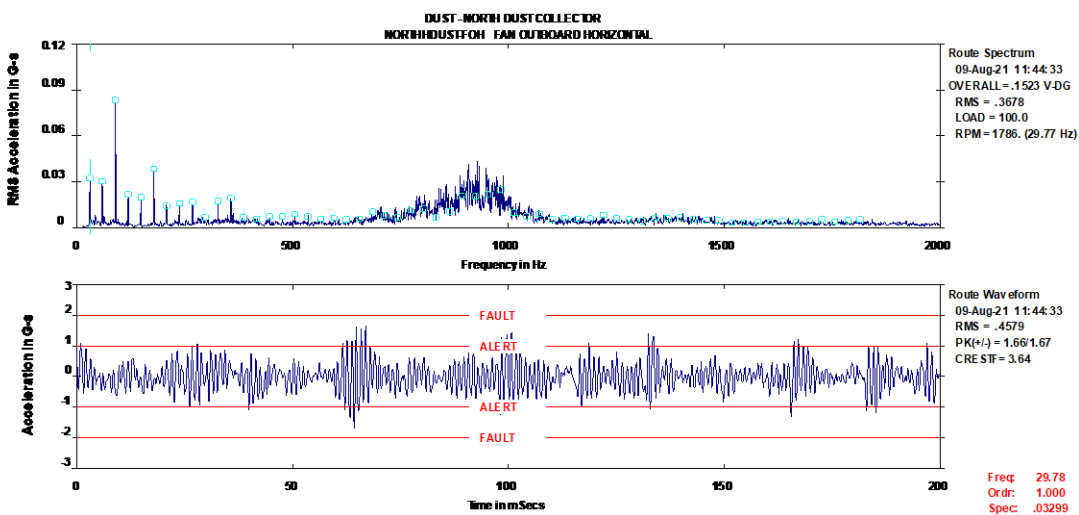
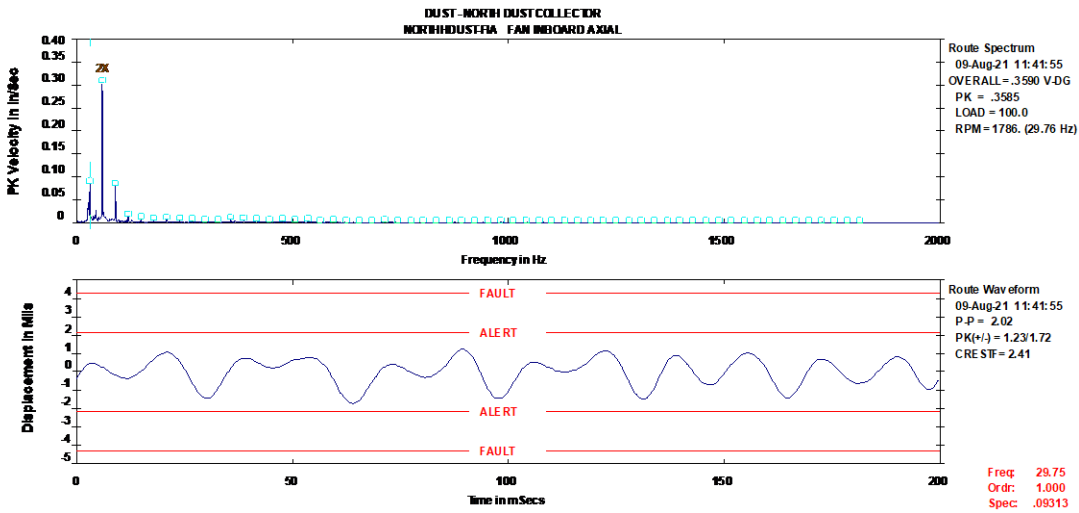
North Dust Collector Fan

The North fan looks to have some bearing wear and a few shaft speed harmonics. Inspect the bearings, purge the grease and re-lubricate as specified by manufacturer. Fan axial data shows a dominant 2x RPM vibration which usually indicates possible alignment/coupling issues. The motor data shows strong rotor bar related vibrations. Inspect the coupling and have the alignment checked. Check all motor electrical connections and have the motor electrically checked (PdMA). **Rated a Class II Defect**
