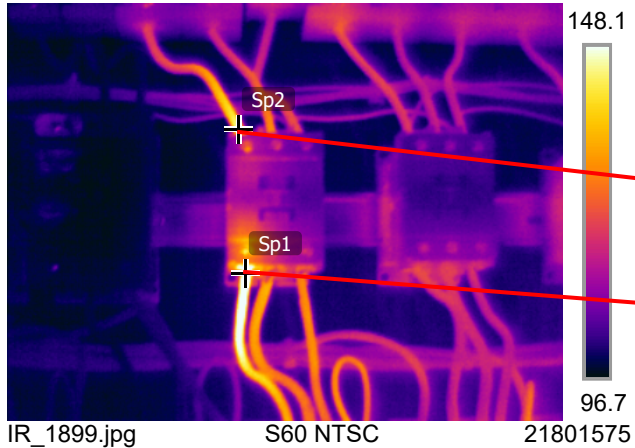
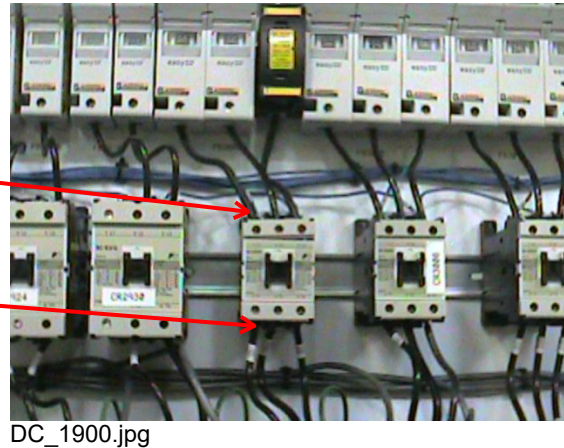
| Sp1 | 167.7 °F |
| Sp2 | 147.2 °F |

Infrared data indicate a high resistance connection on the line and load side of phase A . Check the contacts for damage. Replace if necessary and inspect the wire for damage, and repair as necessary tighten to proper torque.
