QualiTest IR Radiometric Survey Report

Thyssen Krupp

Job Number	139568
Survey Date	4-30-19
Report Date	5-13-19

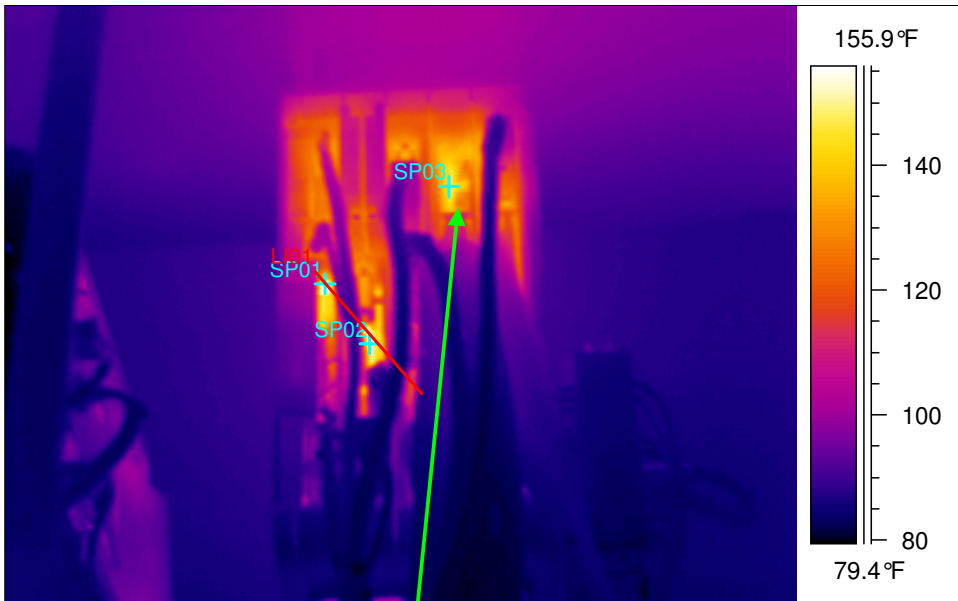
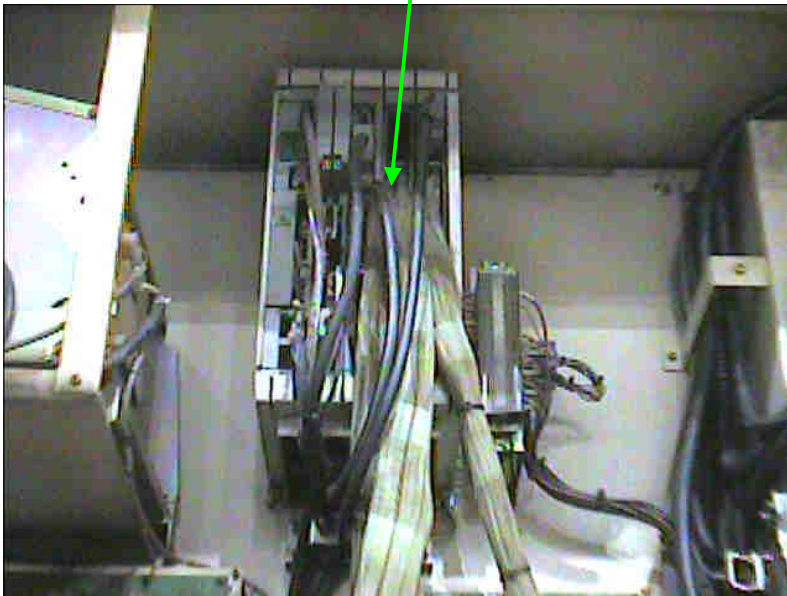
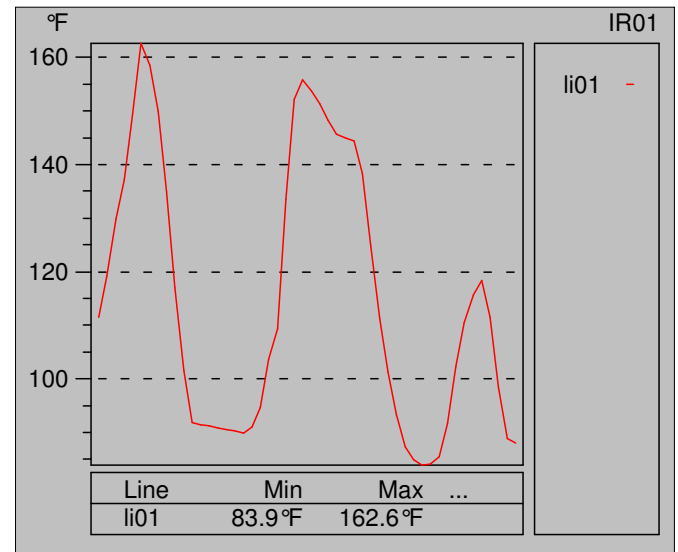
Component	Equipment/Bucket ID	Plant/Area	Date
Drive Unit	Machine 1332	Main	4-29-19

Label	Value
IR : max	162.6°F
IR : min	79.1°F
SP01	162.6°F
SP02	157.1°F
SP03	146.1°F
LI01 : max	162.6°F
LI01 : min	83.9°F

Fault	Possible poor contacts
Defect Rating	Class I

Inspect the unit for overheating and poor connections or contacts. Clean the contacts, replace the unit if necessary.

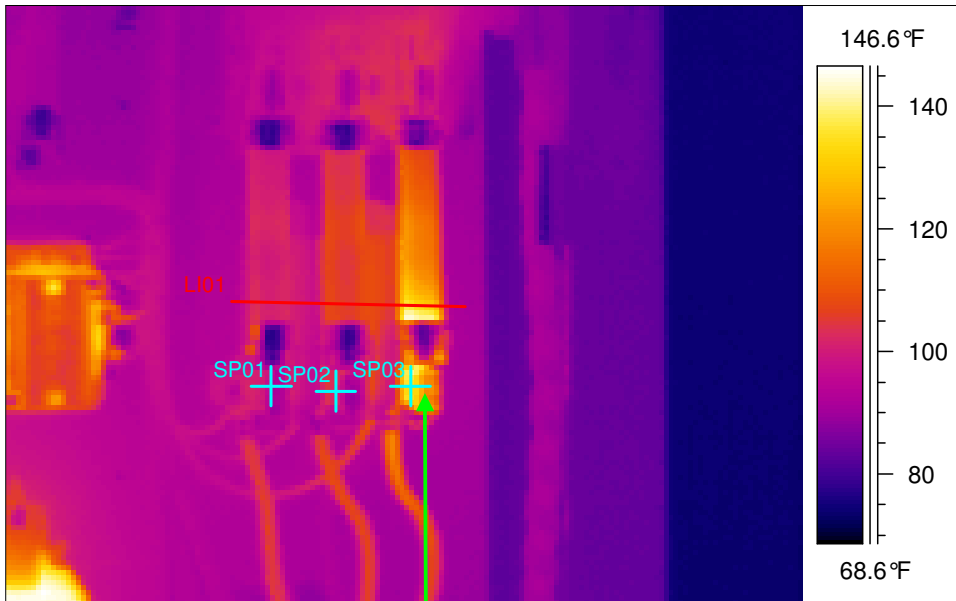
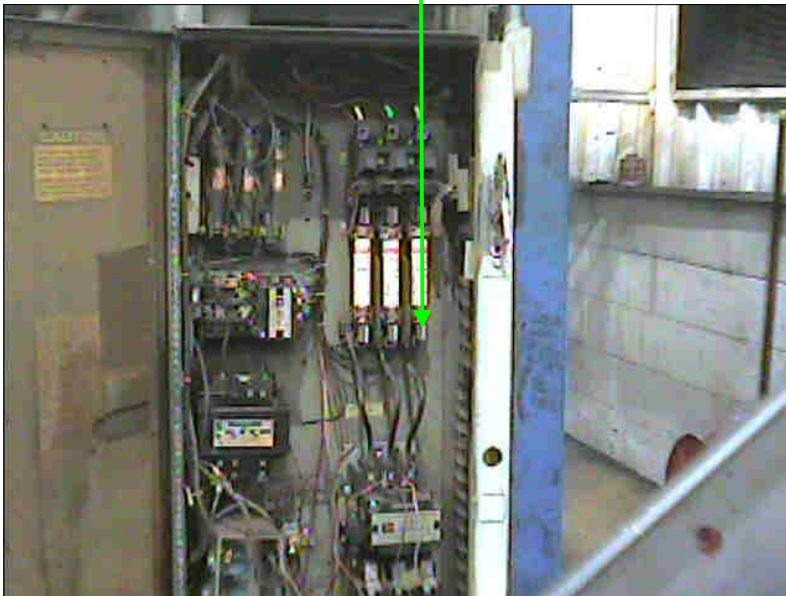
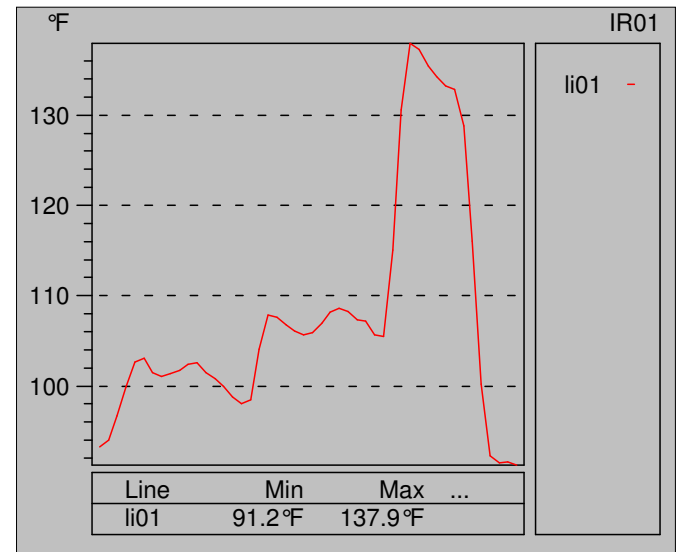
Component	Equipment/Bucket ID	Plant/Area	Date
Switch Fuse Block	Brake Press 2229	Main	4-29-19

Label	Value
IR : max	170.6°F
IR : min	68.2°F
SP01	91.4°F
SP02	100.7°F
SP03	133.6°F
LI01 : max	137.9°F
LI01 : min	91.2°F

Fault	Poor connection at fuse
Defect Rating	Class I

Localized hot spot suggests a poor connection at the bottom right fuse clip.
Inspect and repair or replace.

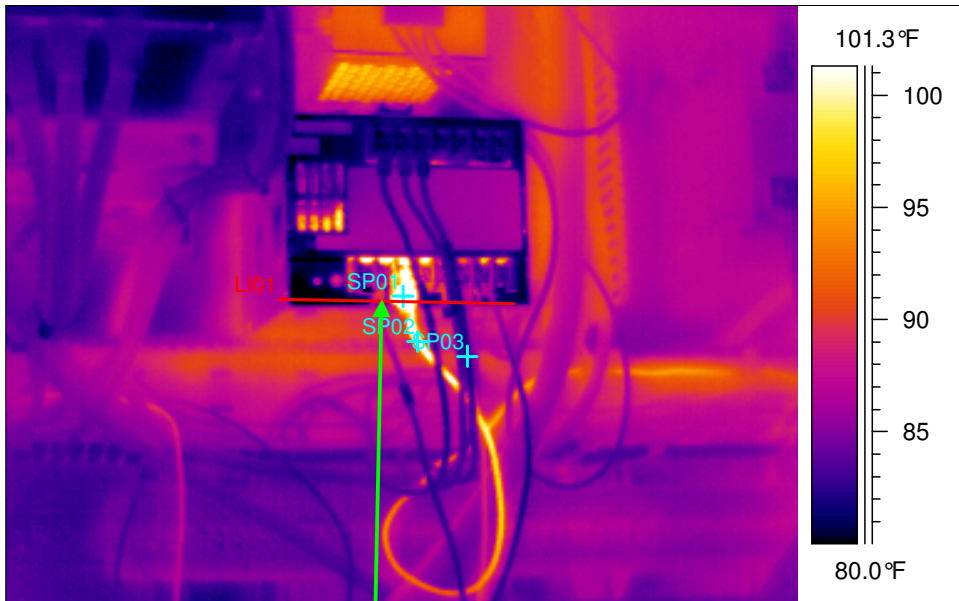
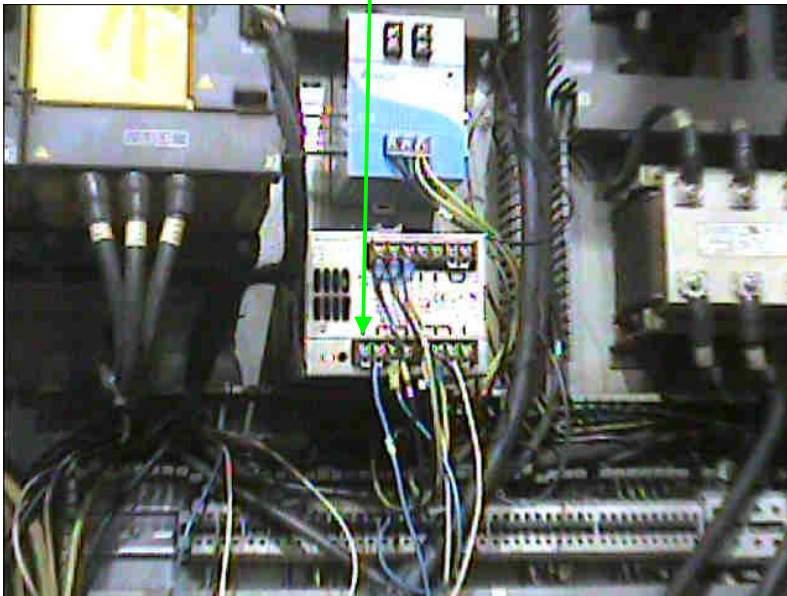
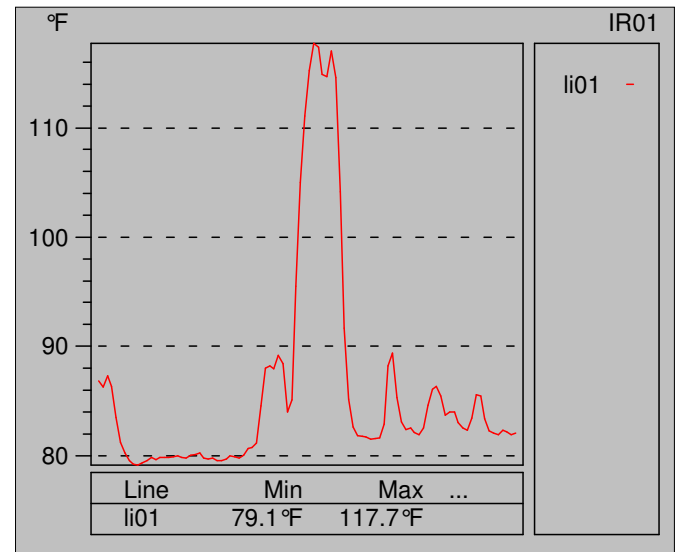
Component	Equipment/Bucket ID	Plant/Area	Date
Power Supply	Machine 1226	Main	4-29-19

Label	Value
IR : max	119.7°F
IR : min	79.1°F
SP01	118.1°F
SP02	108.5°F
SP03	81.8°F
LI01 : max	117.7°F
LI01 : min	79.1°F

Fault	Poor connection
Defect Rating	Class I

Localized hot spot indicates poor connection at wire terminal.
Inspect and tighten connection if possible. Replace as necessary.

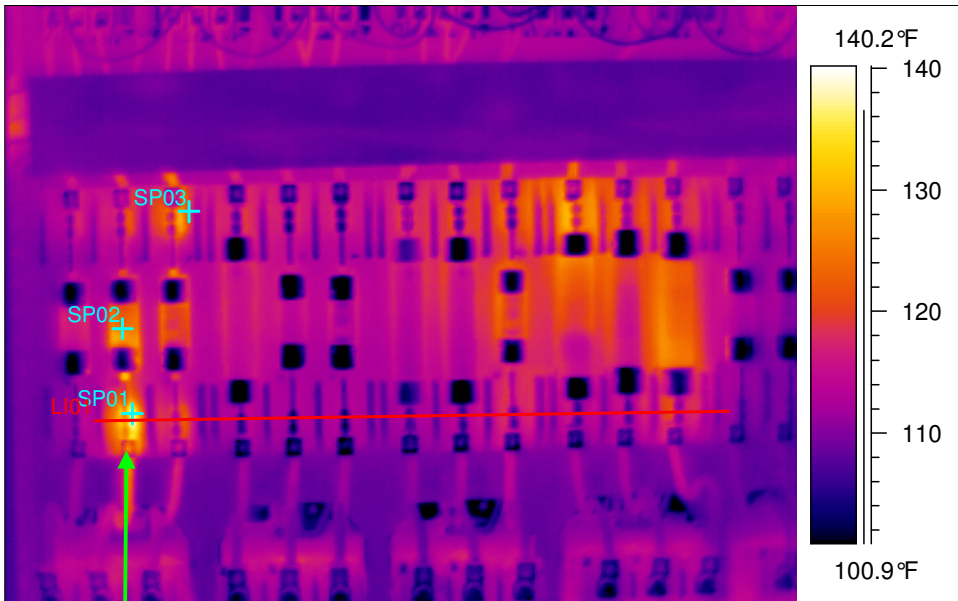
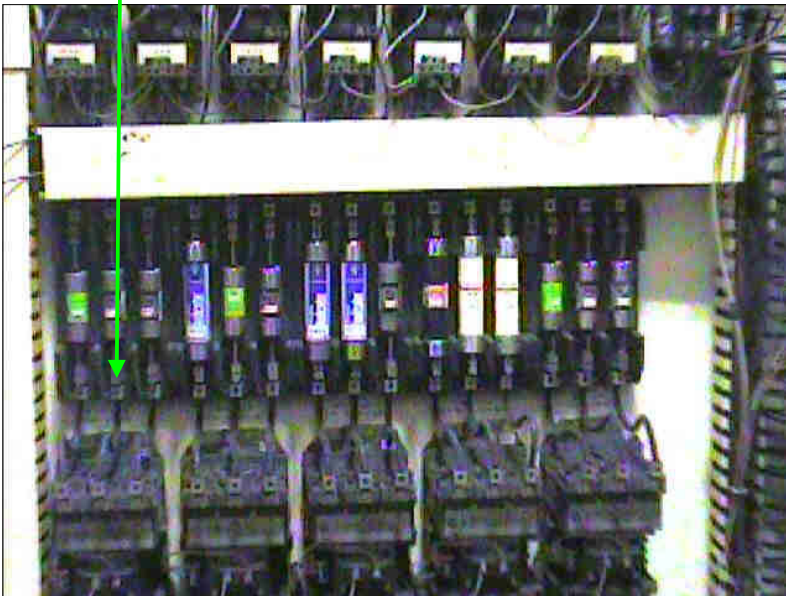
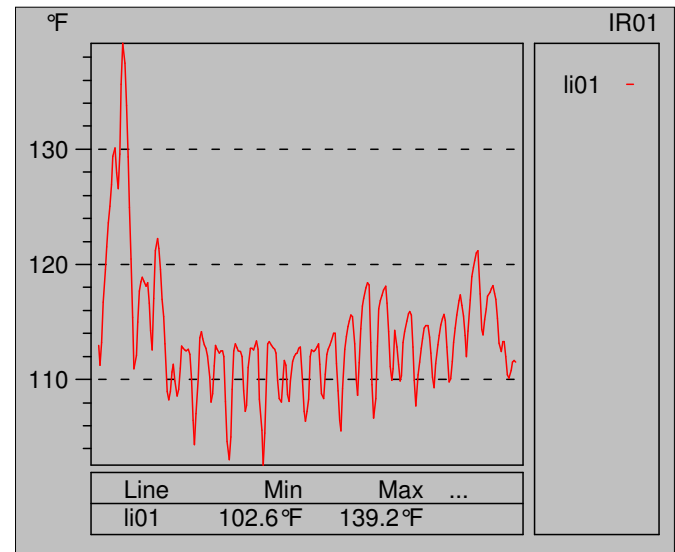
Component	Equipment/Bucket ID	Plant/Area	Date
fuse blocks	Bottom Right Panel	528 2200 Oven	4-29-19

Label	Value
IR : max	139.2°F
IR : min	92.6°F
SP01	137.4°F
SP02	124.7°F
SP03	120.3°F
LI01 : max	139.2°F
LI01 : min	102.6°F

Fault	Poor connection
Defect Rating	Class I

Localized hot spot indicates a poor connection at the left fuse block center phase lower lug and or fuse clip. Clean and inspect. Replace if necessary. 4th set of fuses and connections should be checked as well as the 3rd set. Note the amount of mismatched fuses.

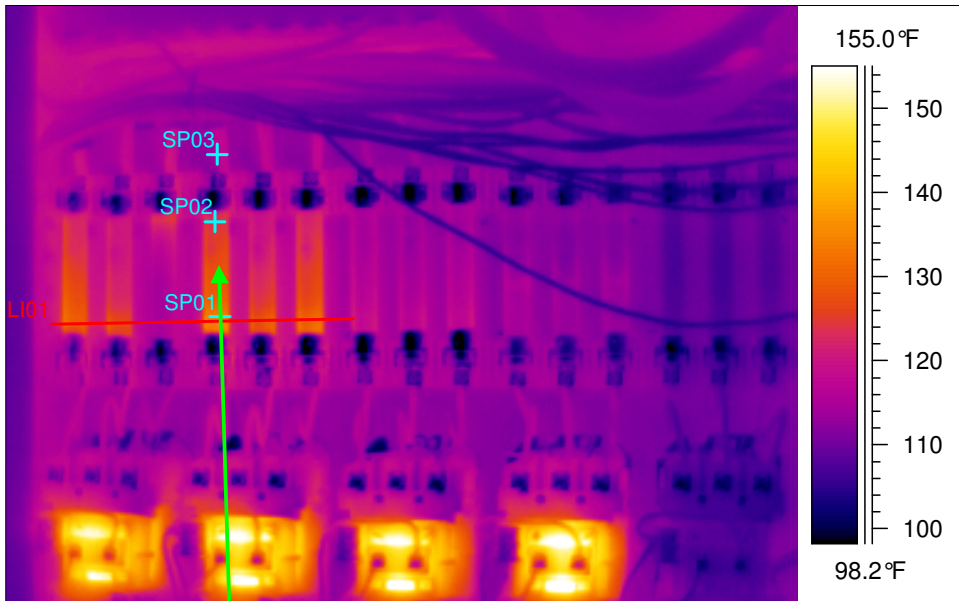
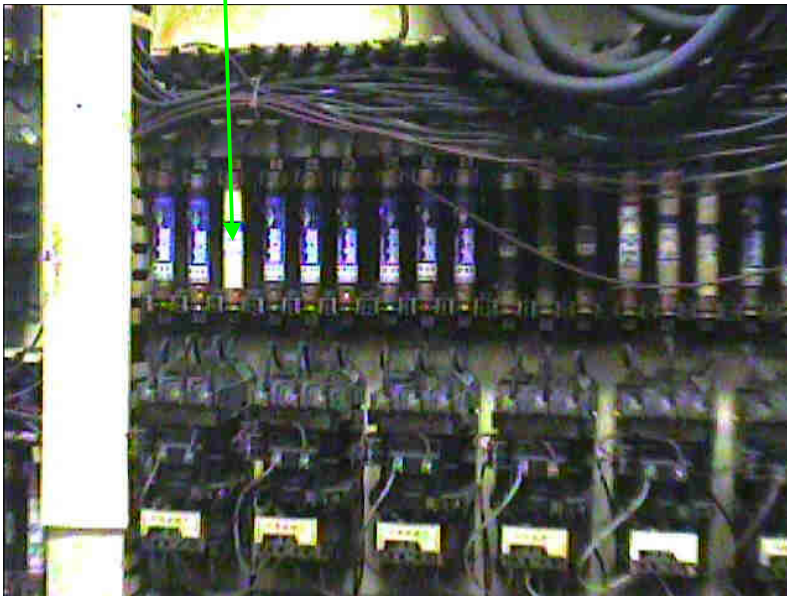
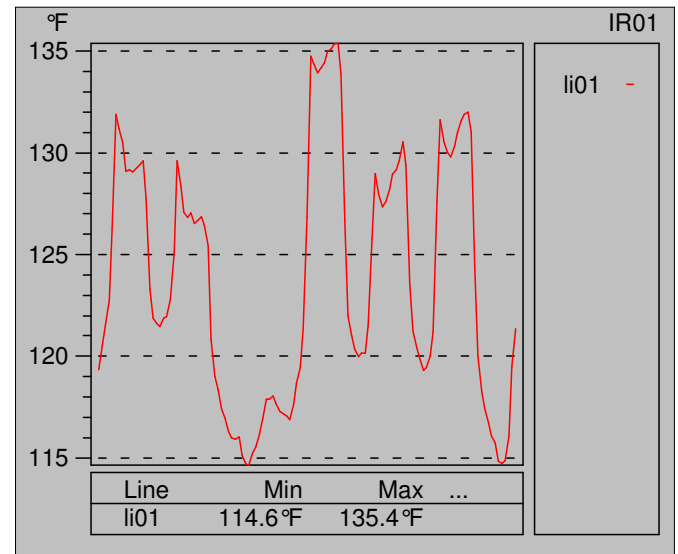
Component	Equipment/Bucket ID	Plant/Area	Date
Fuse Blocks	Top Right Panel	528 2200 Oven	4-29-19

Label	Value
IR : max	166.2°F
IR : min	93.1°F
SP01	134.3°F
SP02	123.7°F
SP03	117.6°F
LI01 : max	135.4°F
LI01 : min	114.6°F

Fault	Poor connection and or worn fuse
Defect Rating	Class I

The fuses in the first and second fuse blocks from the left have slightly elevated temperatures. Inspect and clean the fuse contacts and connections. Replace if necessary.

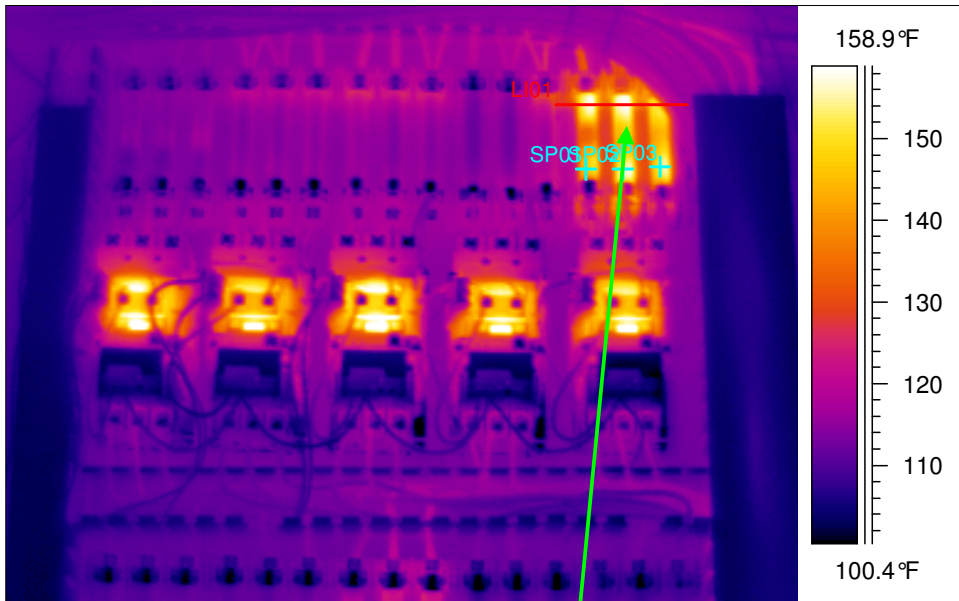
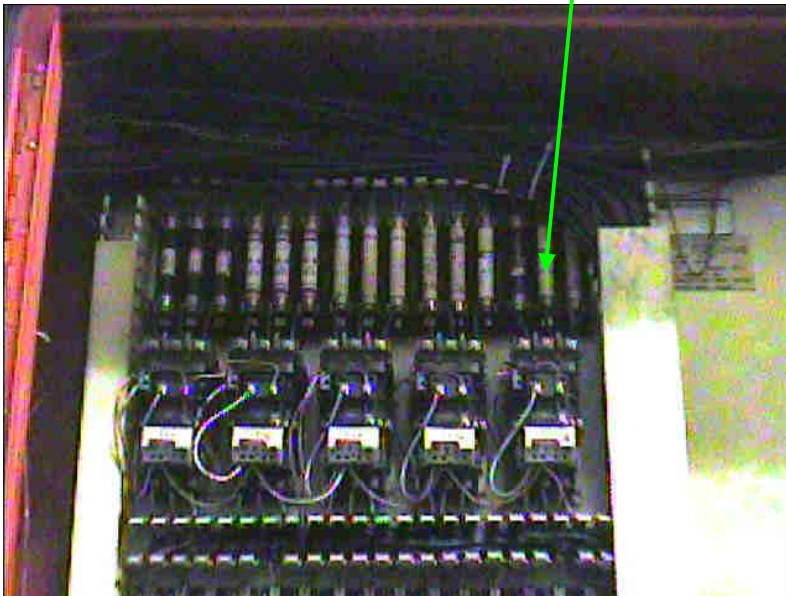
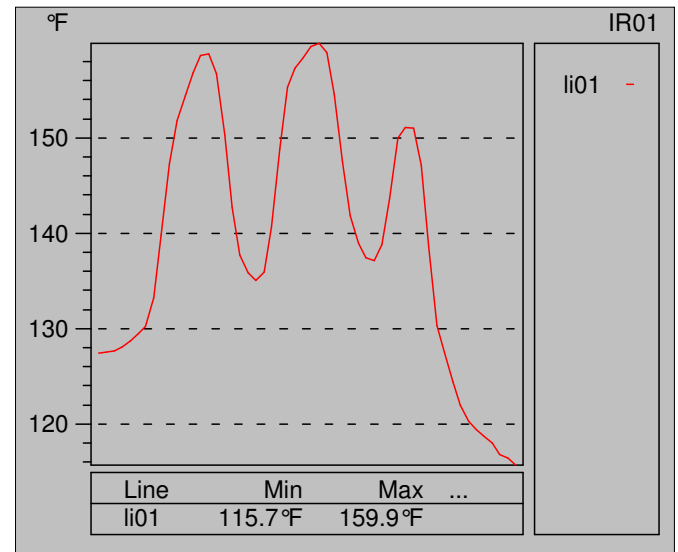
Component	Equipment/Bucket ID	Plant/Area	Date
Fuse Block	Top Center Panel	528 2200 Oven	4-29-19

Label	Value
IR : max	176.6°F
IR : min	95.5°F
SP01	146.3°F
SP02	155.0°F
SP03	152.7°F
LI01 : max	159.9°F
LI01 : min	115.7°F

Fault	Poor connections or high amp draw
Defect Rating	Class I

All 3 fuses have temperatures near 150 Degrees F. That could be an indication of high amp load or poor connections at the fuse clips and connections. Worn fuses could also show similar characteristics. Inspect and clean the fuse block components. Replace as necessary. Replace the fuses as precautionary. Perform an amp draw test before and after service to confirm repairs.

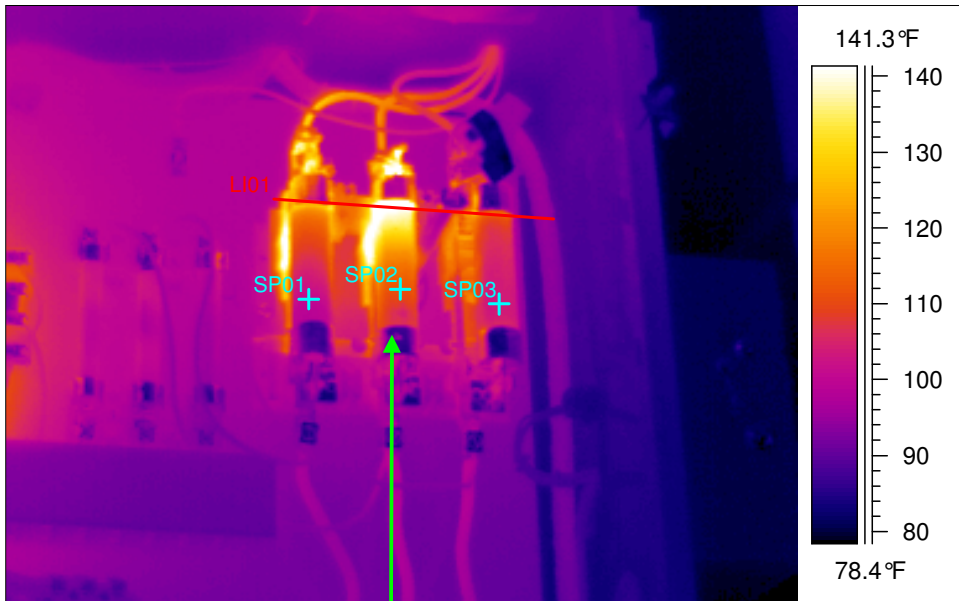
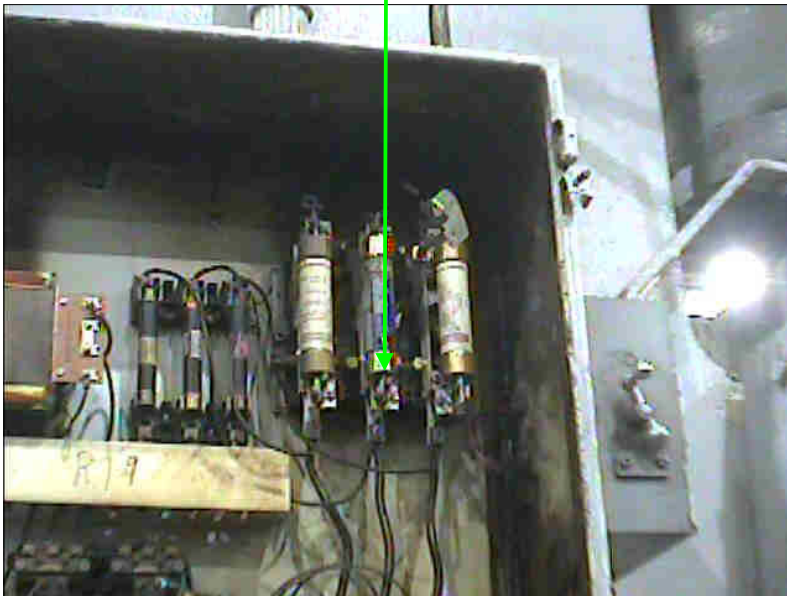
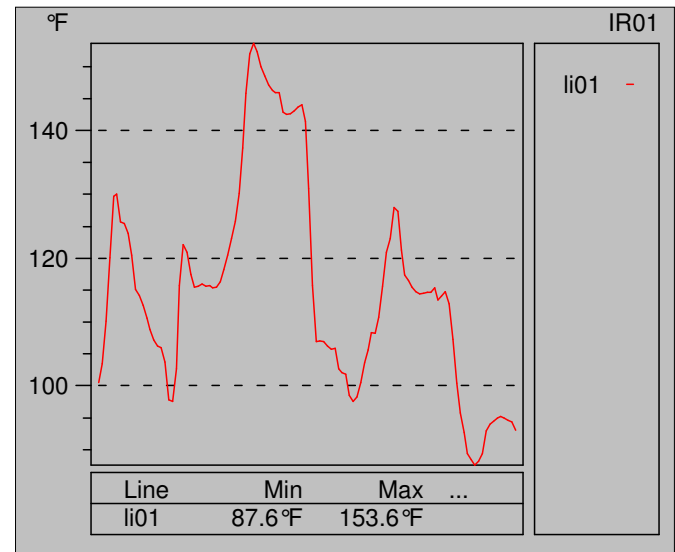
Component	Equipment/Bucket ID	Plant/Area	Date
Main Switch Fuse Block	2612 Shear	Main	4-29-19

Label	Value
IR : max	156.5°F
IR : min	77.0°F
SP01	101.0°F
SP02	112.5°F
SP03	103.9°F
LI01 : max	153.6°F
LI01 : min	87.6°F

Fault	Poor connction at fuse block
Defect Rating	Class I

Localized hot spots at the fuse clips and or connectors.
Clean and inspect the fuse block. Replace if necessary. Replact the fuses with 3 new ones.

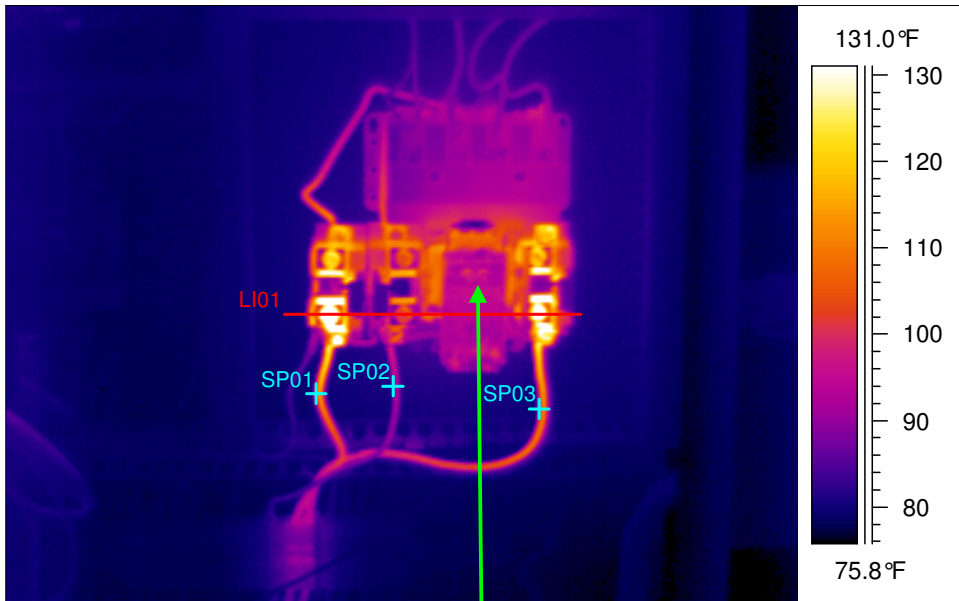
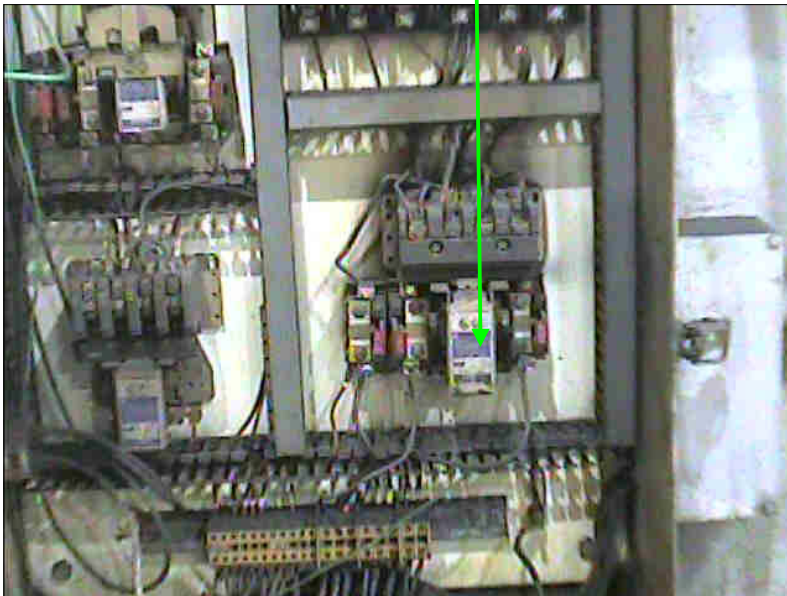
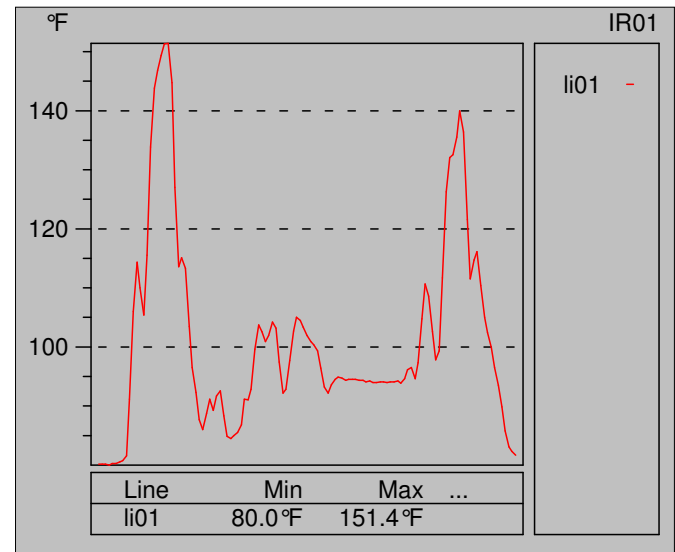
Component	Equipment/Bucket ID	Plant/Area	Date
Heater Connections	2609 Shear	Main	4-29-30

Label	Value
IR : max	154.4°F
IR : min	75.0°F
SP01	104.3°F
SP02	89.3°F
SP03	97.4°F
LI01 : max	151.4°F
LI01 : min	80.0°F

Fault	Poor connections at heater lugs.
Defect Rating	Class I

IR image suggests loose connections at the left and right heater output lugs. Clean, inspect and tighten the screws. Replace if necessary.

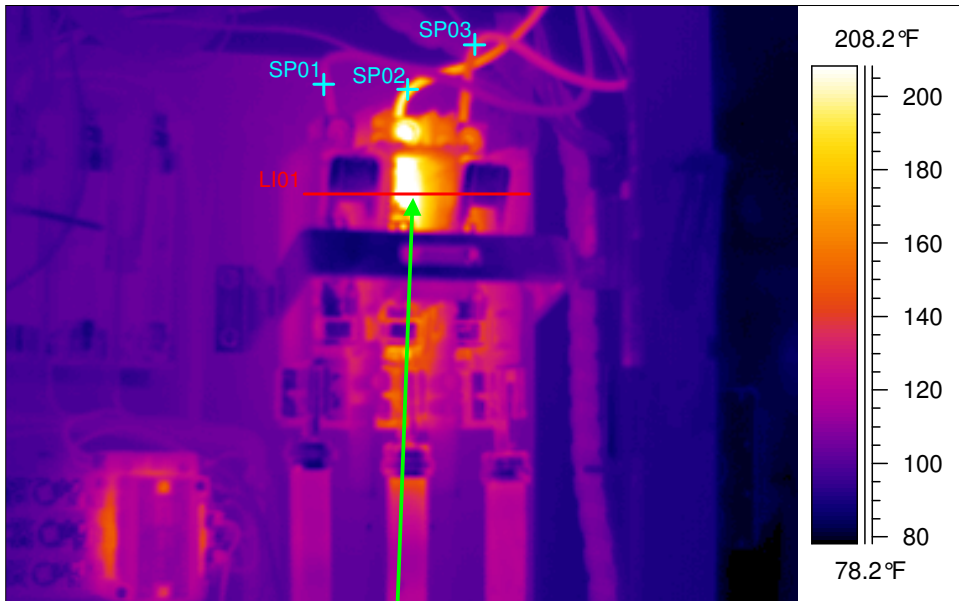
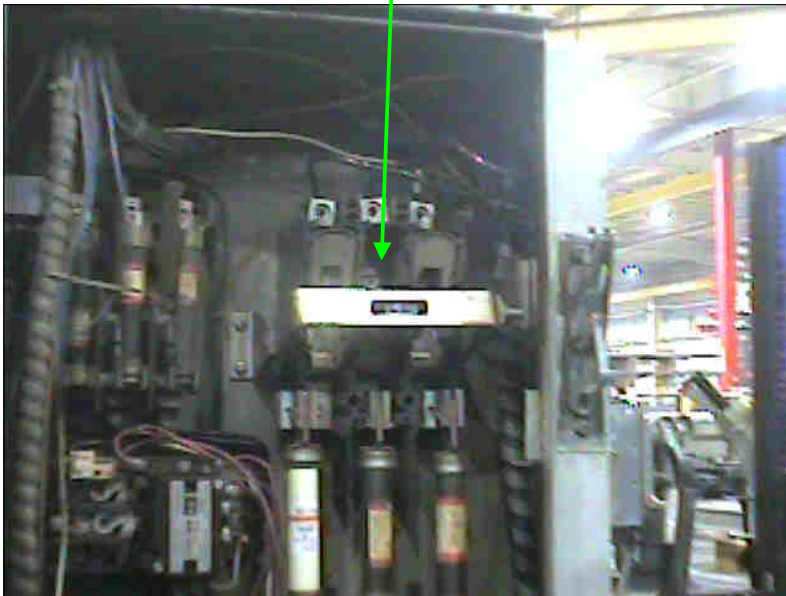
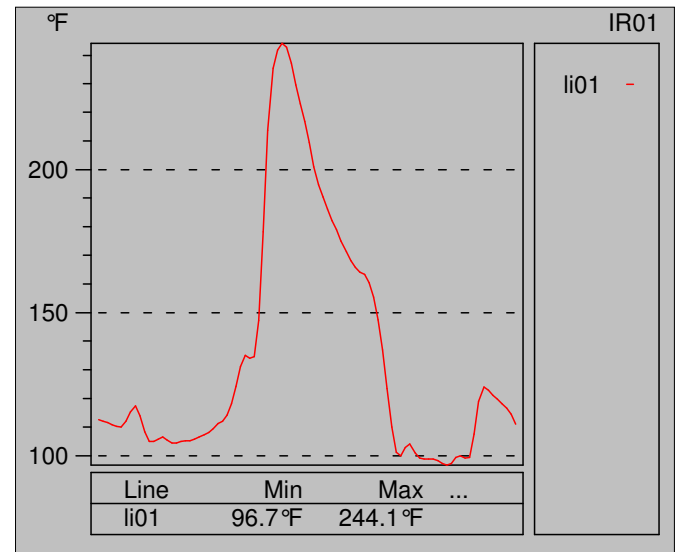
Component	Equipment/Bucket ID	Plant/Area	Date
Main Switch	2227 Brake	Main	4-29-19

Label	Value
IR : max	244.1°F
IR : min	77.7°F
SP01	115.8°F
SP02	194.0°F
SP03	138.1°F
LI01 : max	244.1°F
LI01 : min	96.7°F

Fault	Poor connection at switch contact.
Defect Rating	Class III

The center phase switch connection is extremely poor. Temperature delta is over 100 Degrees F between phases. Damage probably has occurred already so we recommend replacing the switch as soon as possible. Make sure all connections are tight before putting back into service.

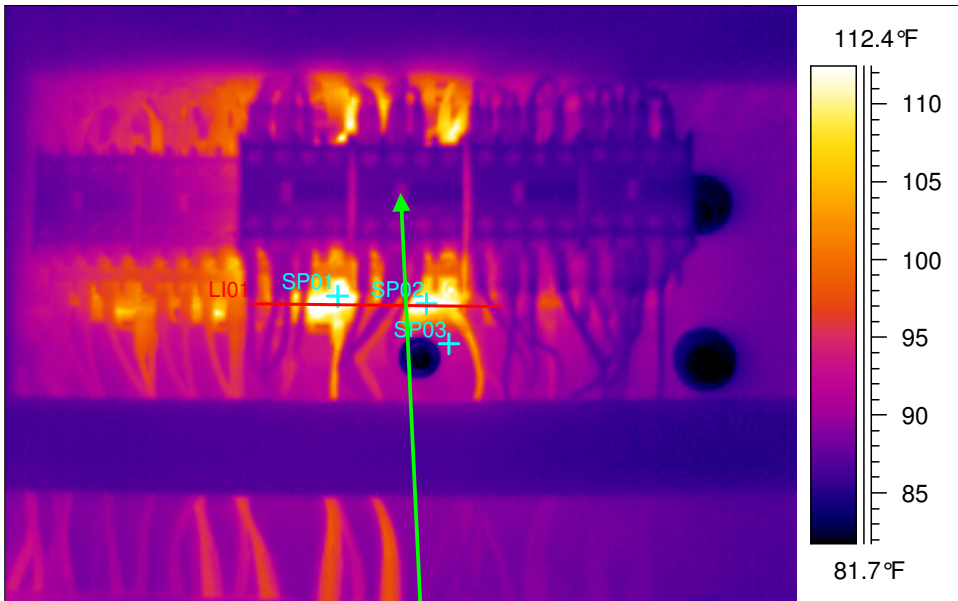
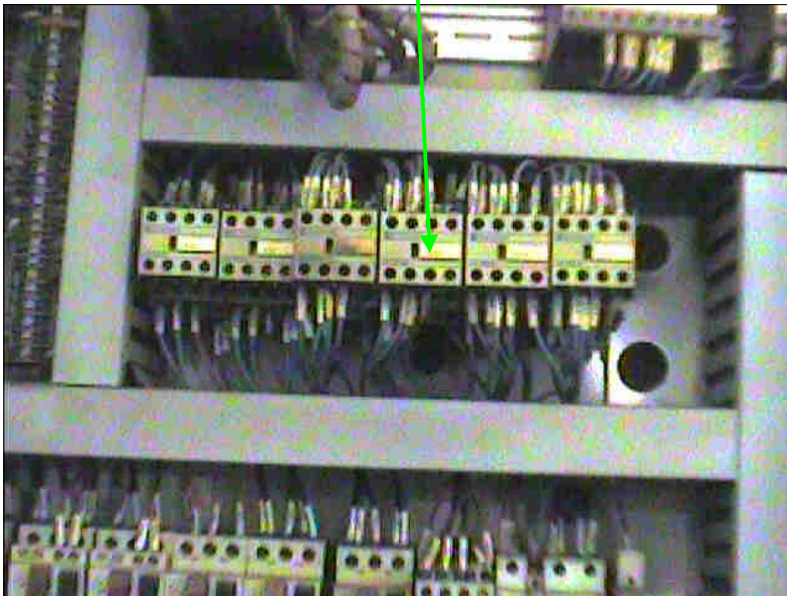
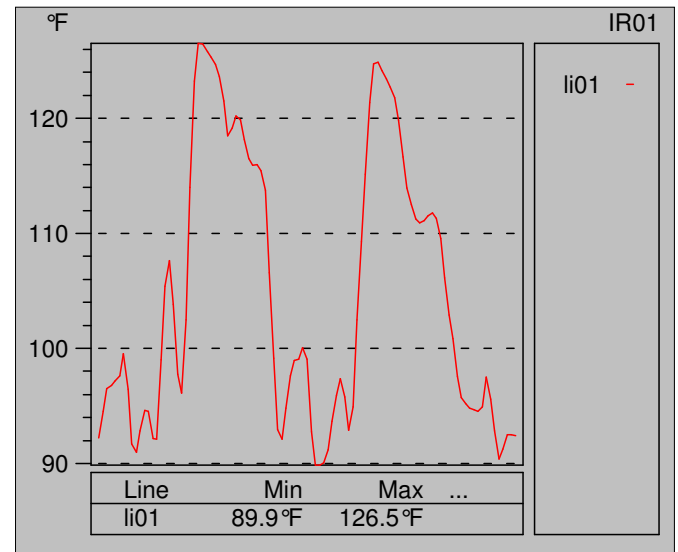
Component	Equipment/Bucket ID	Plant/Area	Date
Control Relays	1129 Left Panel	Tube	4-29-19

Label	Value
IR : max	126.5°F
IR : min	80.8°F
SP01	114.2°F
SP02	121.3°F
SP03	93.2°F
LI01 : max	126.5°F
LI01 : min	89.9°F

Fault	Relay Coils
Defect Rating	NON Rated

The temperature rise is not quite enough to warrant replacing the relays or coils.

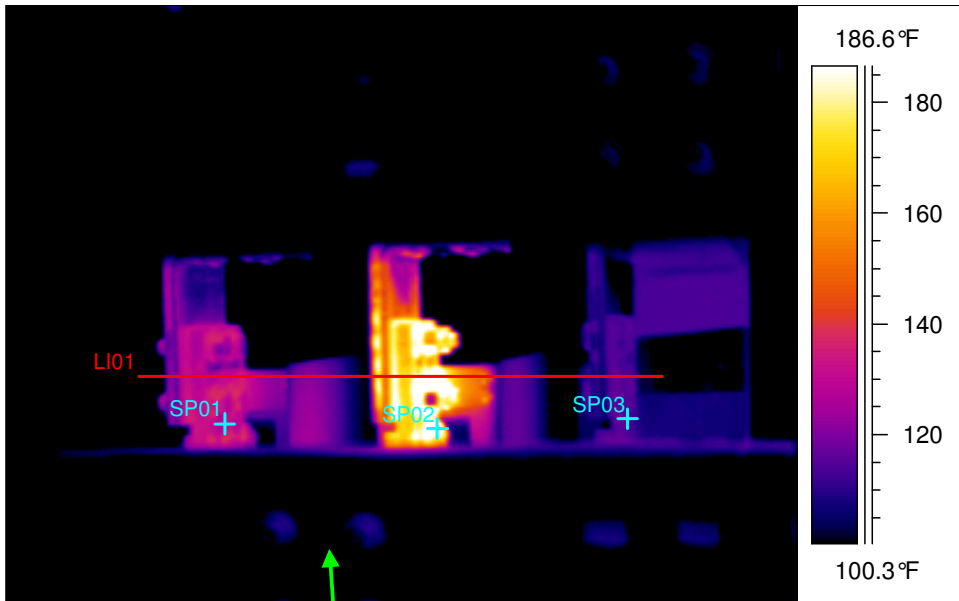
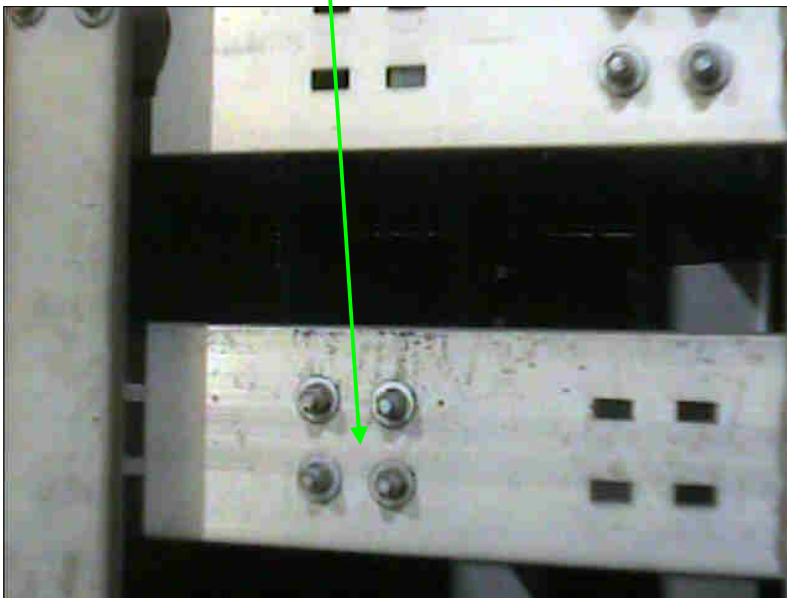
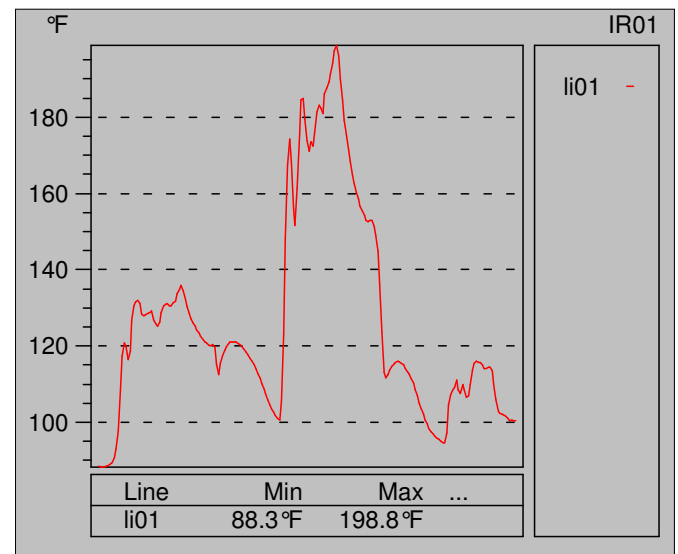
Component	Equipment/Bucket ID	Plant/Area	Date
Buss Connection	MCC Switch	533 DAP/DPL	4-30-19

Label	Value
IR : max	209.3°F
IR : min	85.3°F
SP01	131.5°F
SP02	209.3°F
SP03	113.3°F
LI01 : max	198.8°F
LI01 : min	88.3°F

Fault	Poor conection at buss bar.
Defect Rating	Class III

The vertical center buss bar connector is much hotter than adjacent bars. We suspect the connection fasteners are loose. Clean, inspect, re-torque and test to confirm repairs.

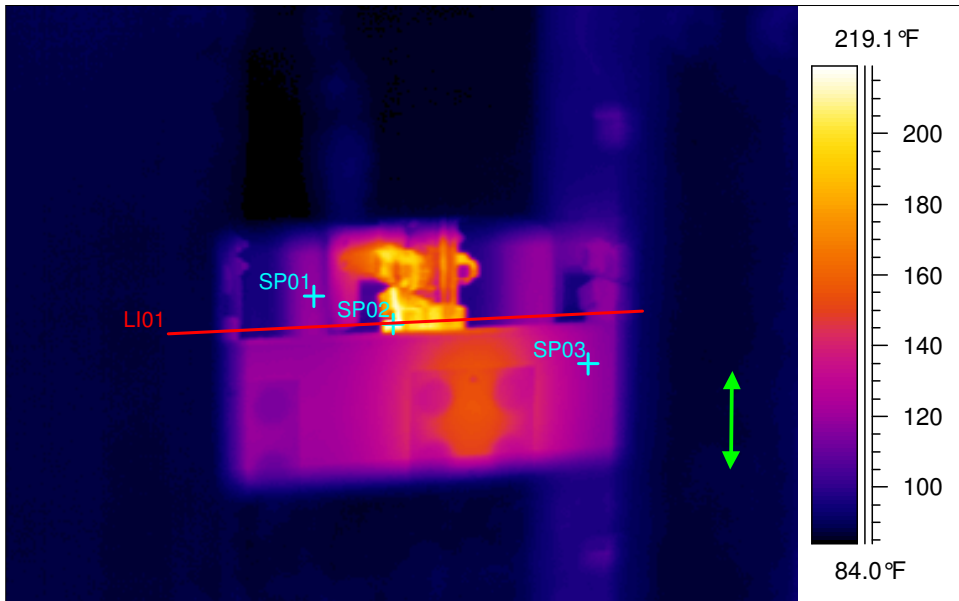
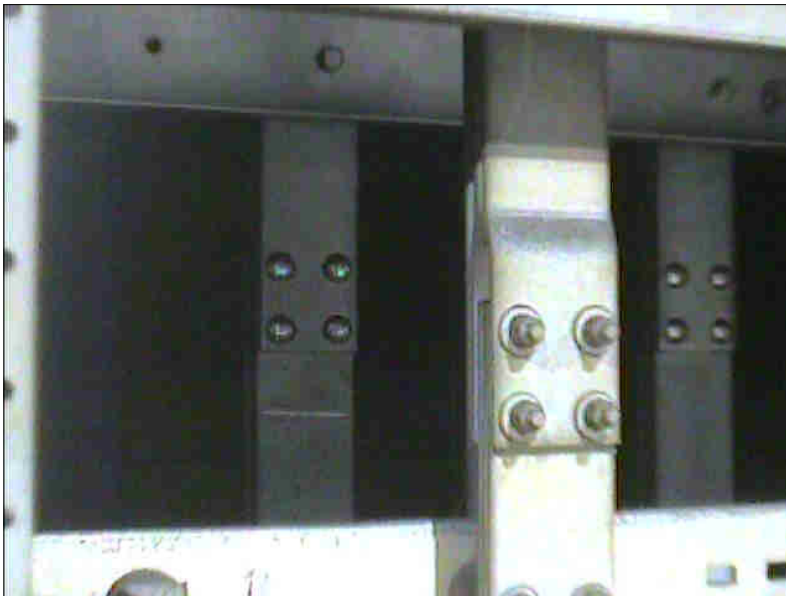
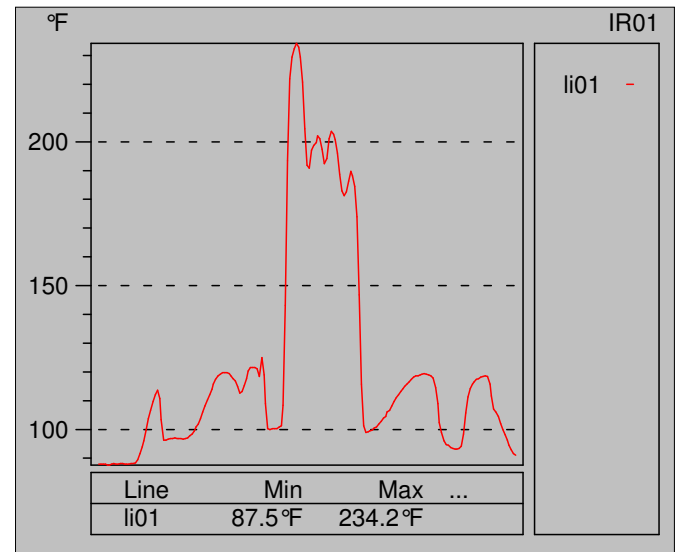
Component	Equipment/Bucket ID	Plant/Area	Date
Buss Connection	MCC Switch	533 DAP/DPL	4-30-19

Label	Value
IR : max	234.2°F
IR : min	83.8°F
SP01	118.5°F
SP02	234.2°F
SP03	121.2°F
LI01 : max	234.2°F
LI01 : min	87.5°F

Fault	Same poor conection at buss bar.
Defect Rating	Class III

The vertical center buss bar connector is much hotter than adjacent bars. We suspect the connection fasteners are loose. Clean, inspect, re-torque and test to confirm repairs ASAP. Check all buss bar fasteners.

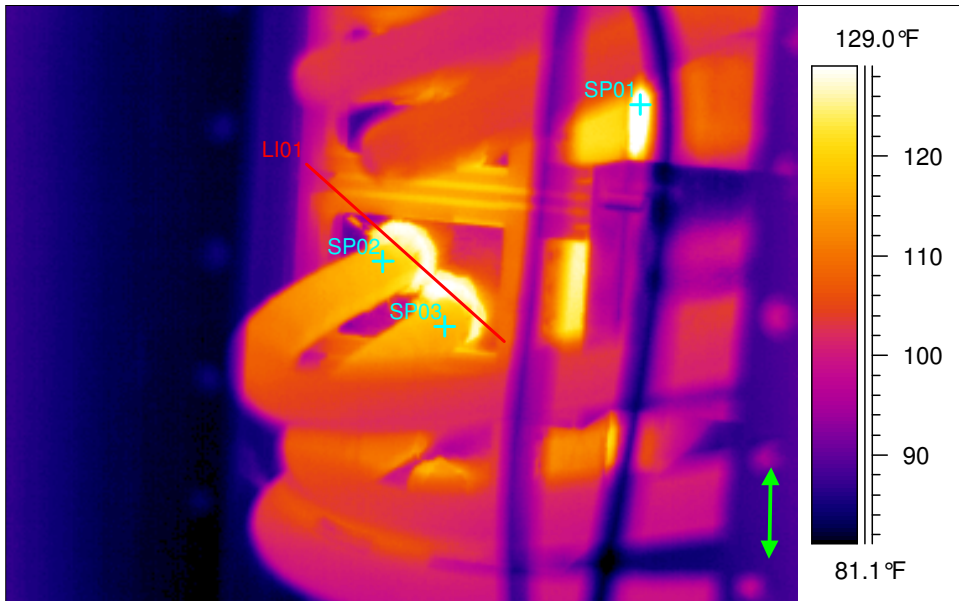
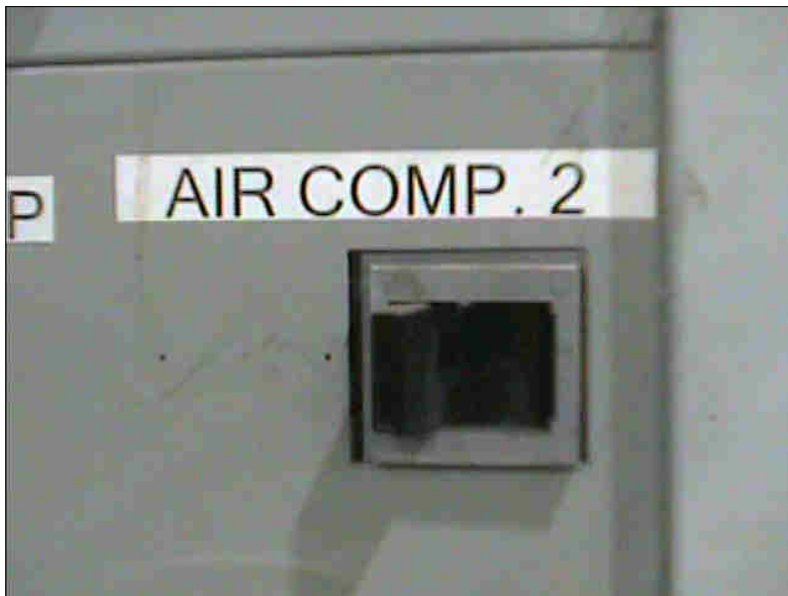
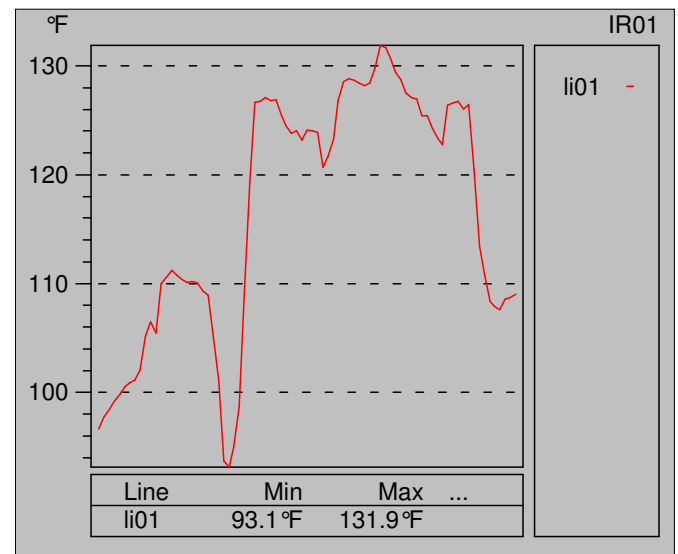
Component	Equipment/Bucket ID	Plant/Area	Date
Air Compressor 2 CB	South Wall MCC	PF Line	4-30-19

Label	Value
IR : max	147.2°F
IR : min	80.5°F
SP01	146.4°F
SP02	119.2°F
SP03	117.3°F
LI01 : max	131.9°F
LI01 : min	93.1°F

Fault	Worn switch or loose connections.
Defect Rating	Class II

The air compressor circuit breaker temperature is warm and appears to have a possible poor connection at the main buss, or the internals are worn. Clean and inspect and re-torque all fasteners ASAP. Re-check temperatures after repairs to confirm if replacement is warranted. Also perform amp draw test before and after repairs.

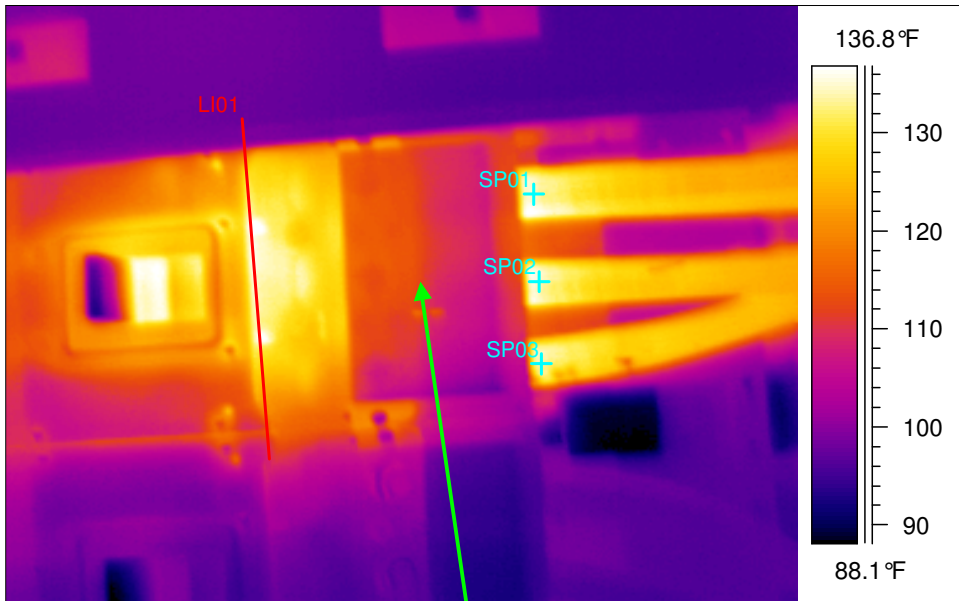
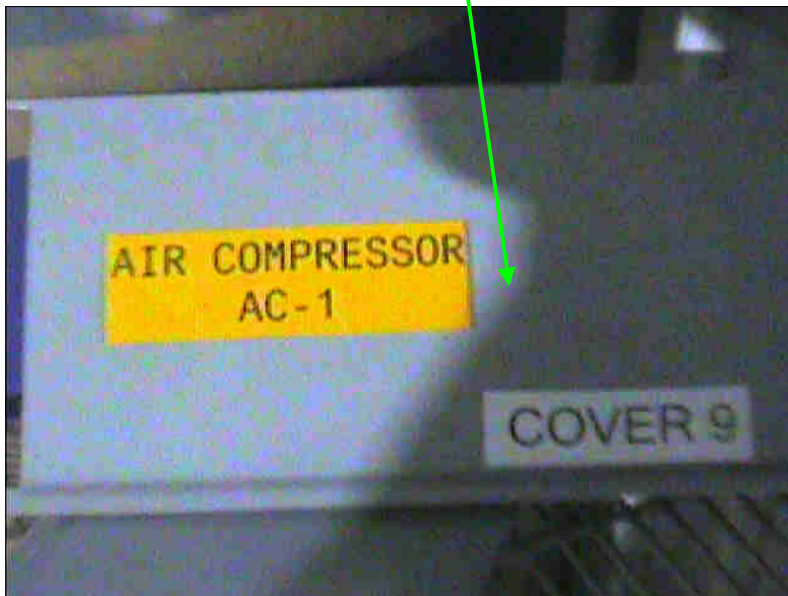
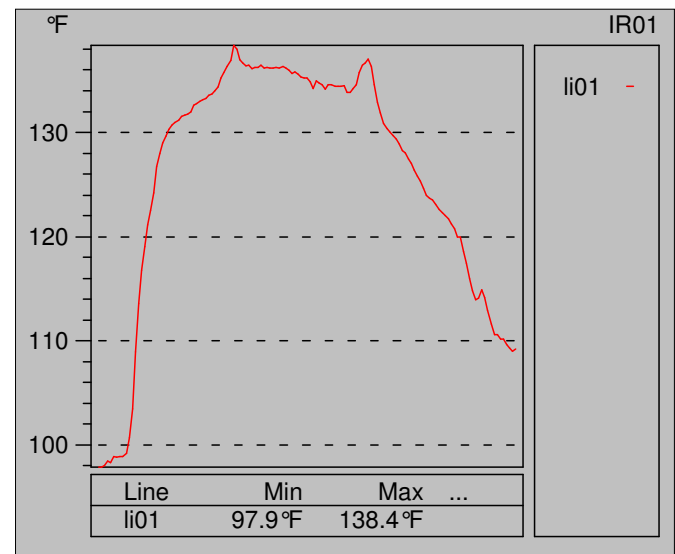
Component	Equipment/Bucket ID	Plant/Area	Date
Air Compressor 1 CB	2008 SALV 1 MDP	Salvano	4-30-19

Label	Value
IR : max	139.3°F
IR : min	87.8°F
SP01	134.8°F
SP02	135.0°F
SP03	133.6°F
LI01 : max	138.4°F
LI01 : min	97.9°F

Fault	Worn switch or loose connections.
Defect Rating	Class II

The air compressor circuit breaker temperature is warm and appears to have a possible poor connection at the main buss, or the internals are worn. Clean and inspect and re-torque all fasteners ASAP. Re-check temperatures after repairs to confirm if replacement is warranted. Also perform amp draw test before and after repairs.
