Infrared Thermography Report

Warren Oil April 2020

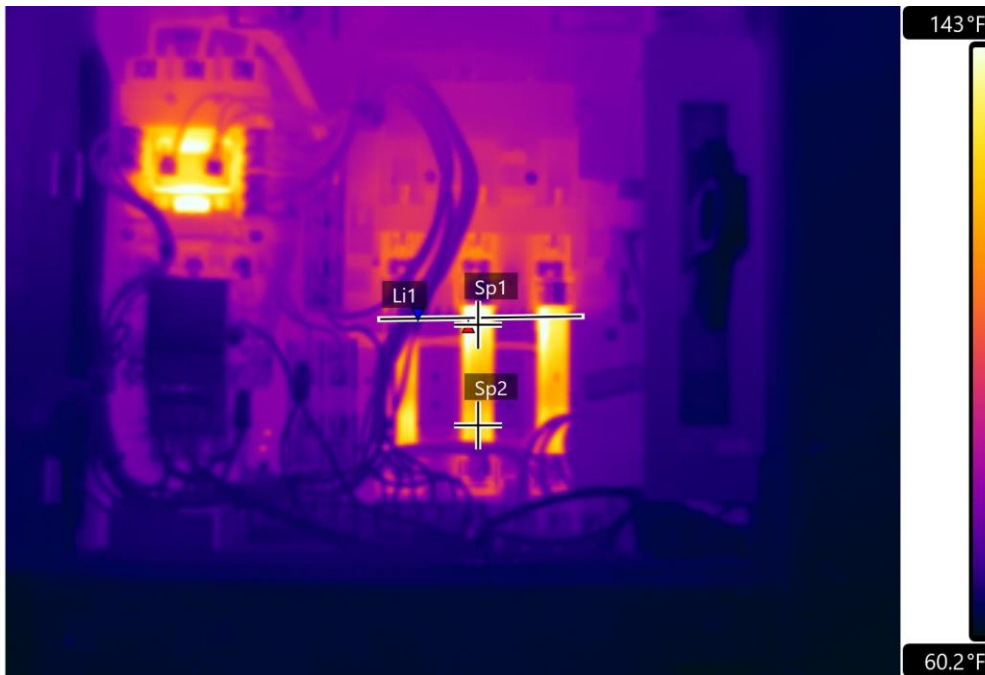
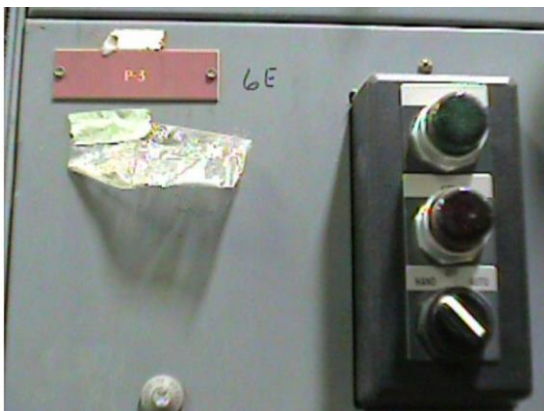
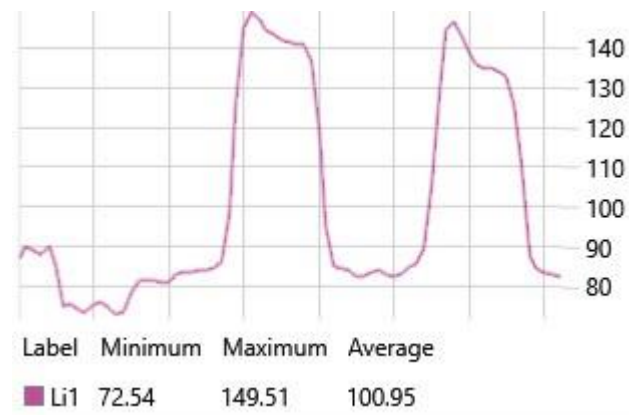
Component	Fuse
Equipment/Bucket ID	Blow Mold MCC Bucket P-3

Sp1	141.5 °F
Sp2	129.3 °F
Li1 Minimum	72.5 °F
Li1 Maximum	149.5 °F
Areas	-

Fault	Weak Fuse Clips
Defect Rating	Class I

Recommendations
Inspect the fuse block clips. Clean and repair or replace the block. Replace all fuses with like kind sized correctly.

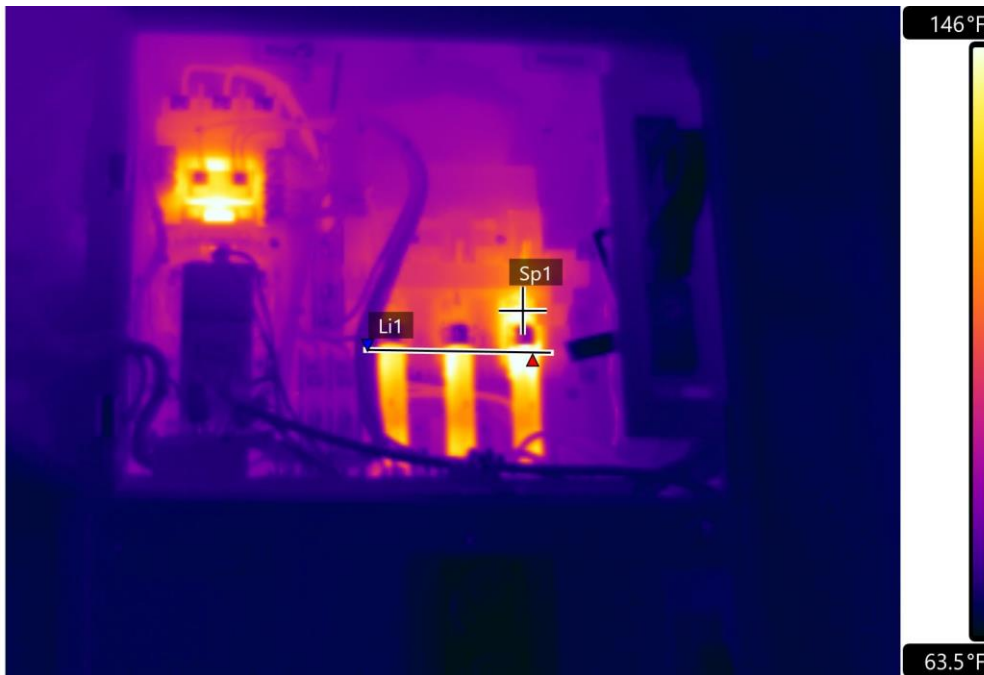
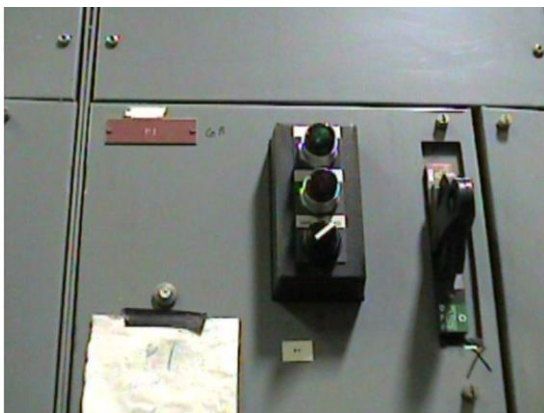
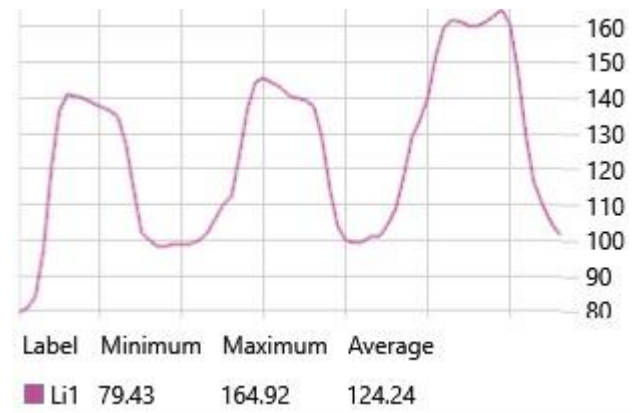
Component	Fuse/Fuse Block
Equipment/Bucket ID	Blow Mold MCC Bucket P-1

Sp1	144.8 °F
Li1 Minimum	79.4 °F
Li1 Maximum	164.9 °F
Areas	-

Fault	Weak fuse clip and or lug connection/switch knife blade
Defect Rating	Class II

Recommendations	The switch and fuse block assembly shows excessive heat at the C phase top near the switch blade. Inspect and repair the switch and fuse block or replace with new. Change all the fuses with like kind and sized correctly.
-----------------	--

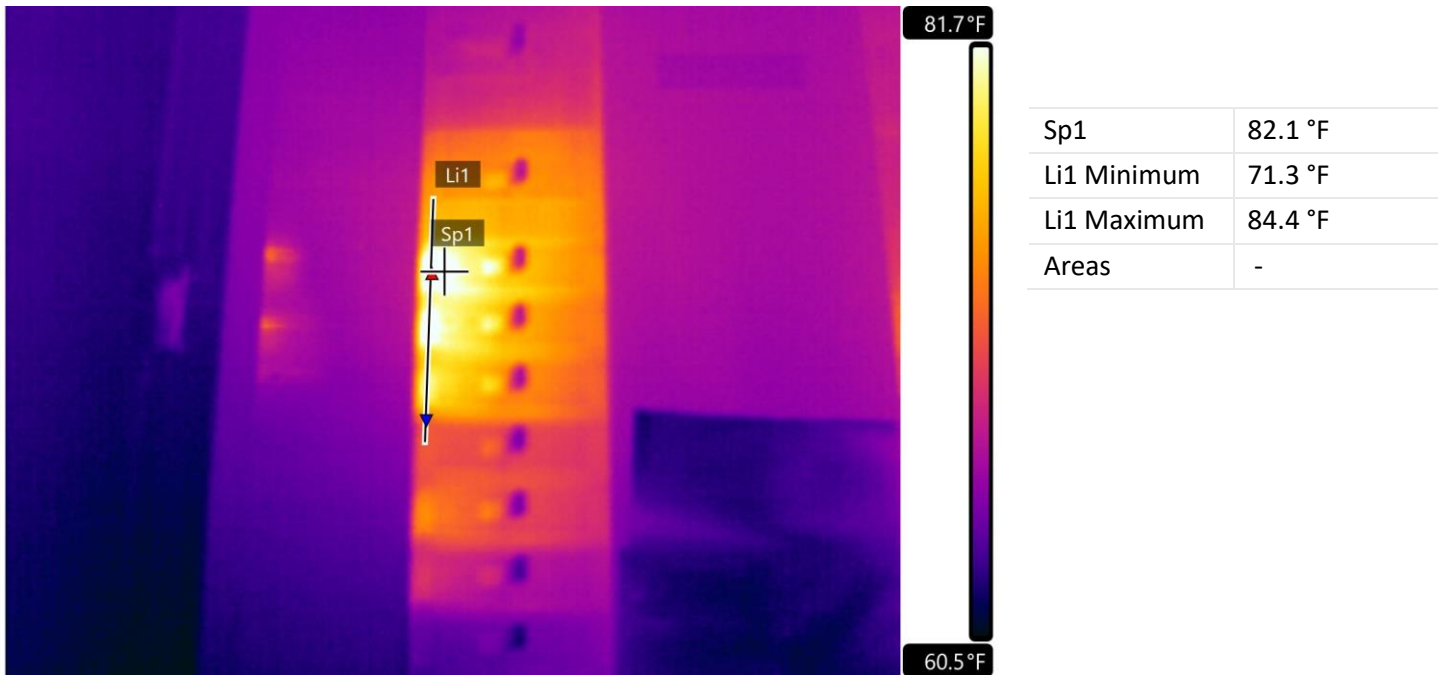
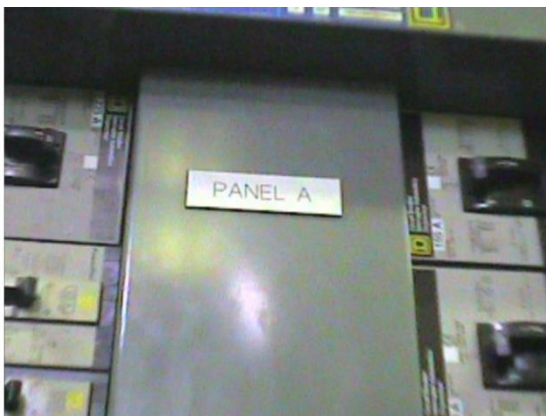
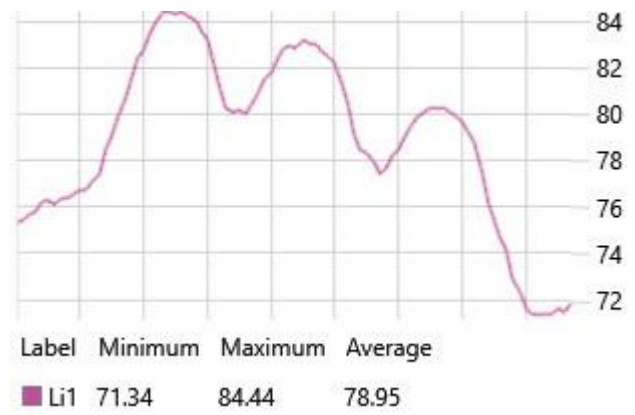
Component	Circuit Breakers
Equipment/Bucket ID	Pail Building Main Panel A

Fault	Loose connections
Defect Rating	Class I

Recommendations
Tighten all connections.
