Infrared Thermography Report

Warren Oil April 2020

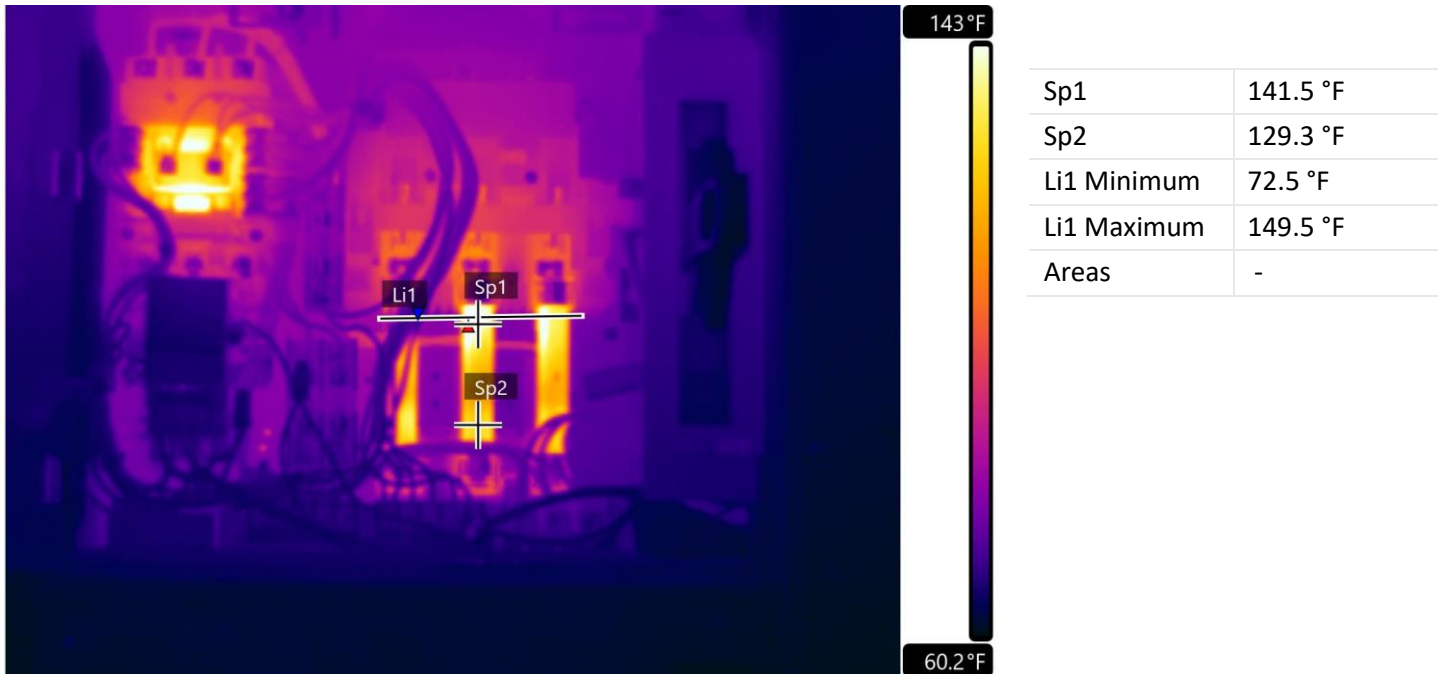
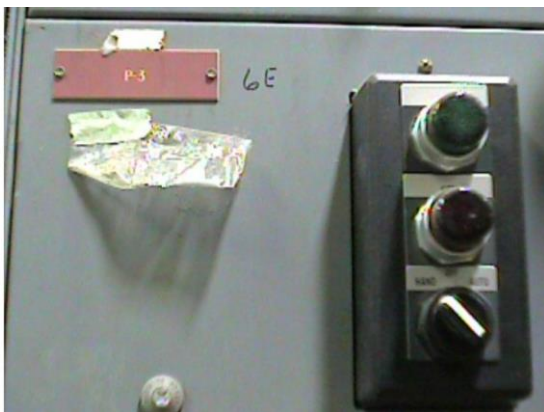
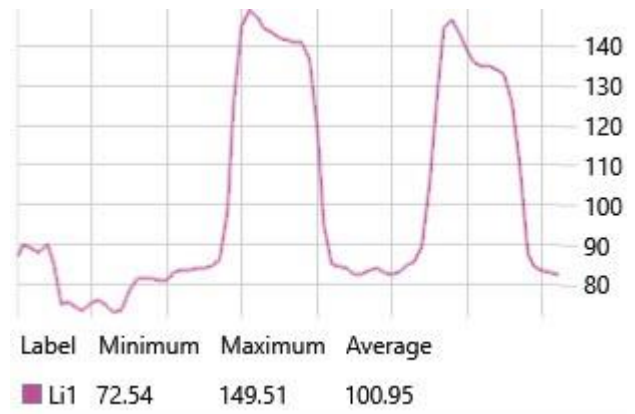
Component	Fuse
Equipment/Bucket ID	Blow Mold MCC Bucket P-3

Fault	Weak Fuse Clips
Defect Rating	Class I

Recommendations	Inspect the fuse block clips. Clean and repair or replace the block. Replace all fuses with like kind sized correctly.
-----------------	--

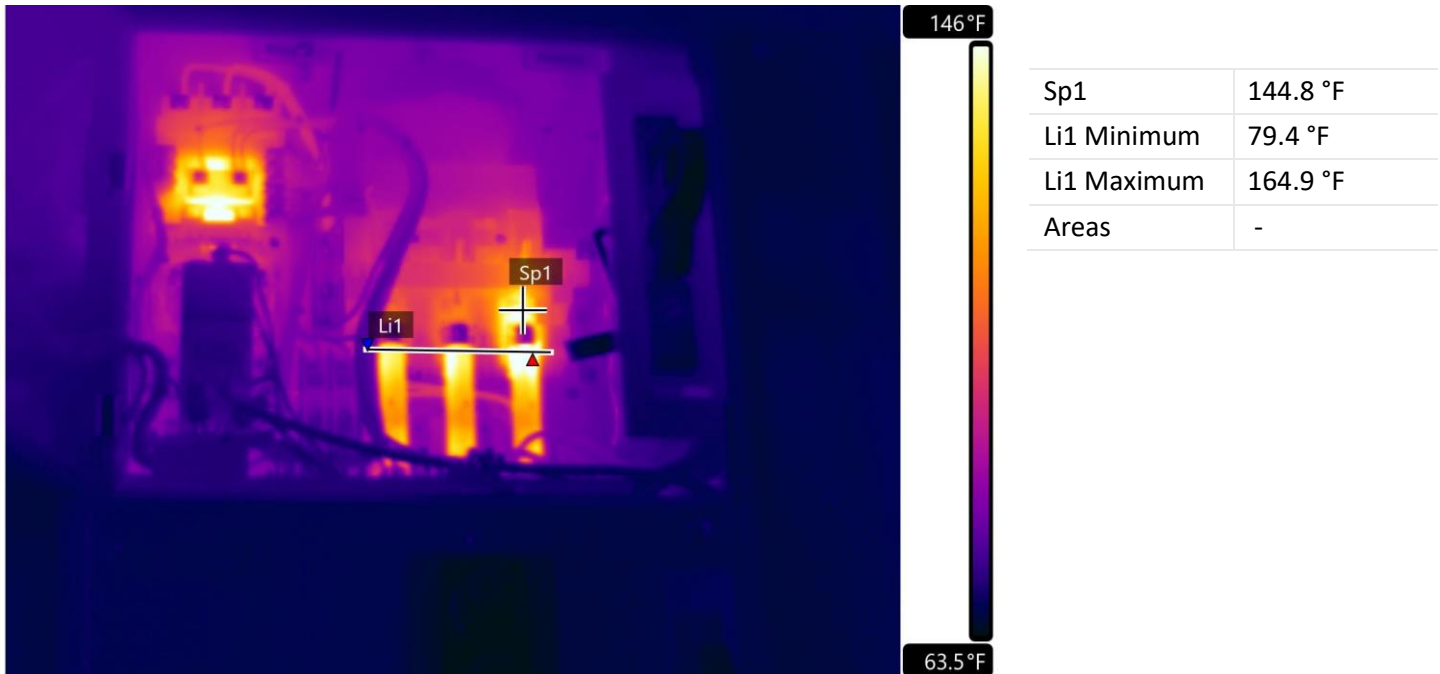
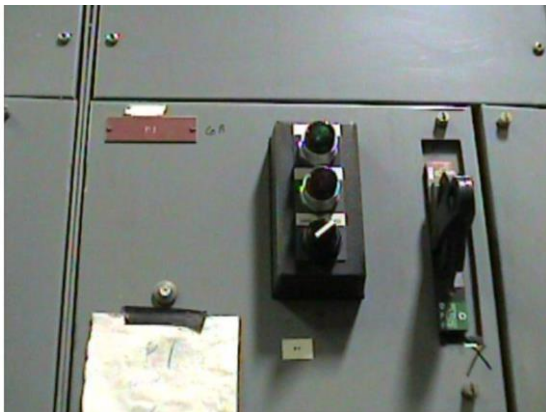
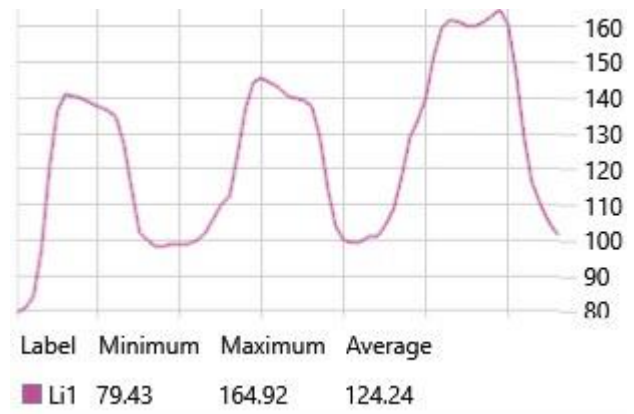
Component	Fuse/Fuse Block
Equipment/Bucket ID	Blow Mold MCC Bucket P-1

Fault	Weak fuse clip and or lug connection/switch knife blade
Defect Rating	Class II

Recommendations	The switch and fuse block assembly shows excessive heat at the C phase top near the switch blade. Inspect and repair the switch and fuse block or replace with new. Change all the fuses with like kind and sized correctly.
-----------------	--

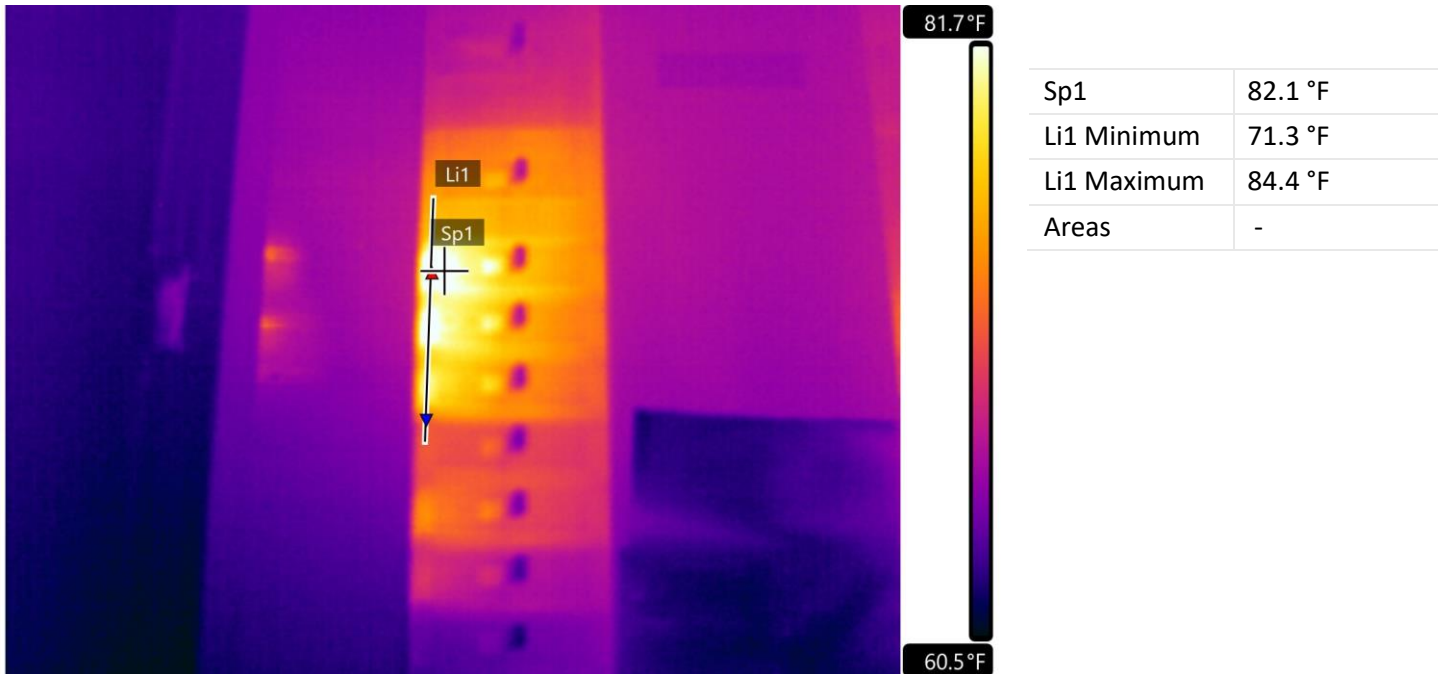
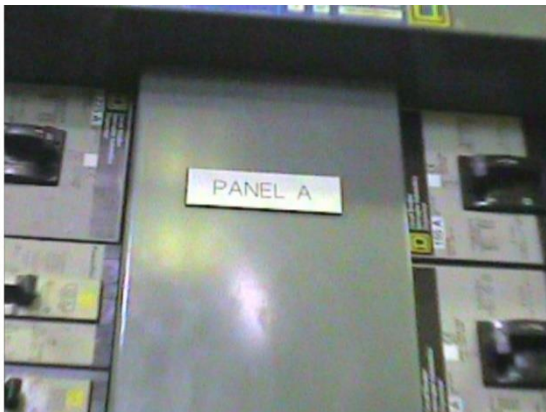
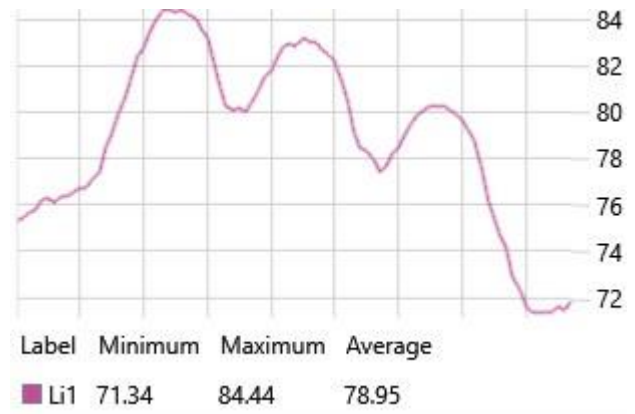
Component	Circuit Breakers
Equipment/Bucket ID	Pail Building Main Panel A

Fault	Loose connections
Defect Rating	Class I

Recommendations	Tighten all connections.
-----------------	--------------------------
