2022 Infrared Thermography Report

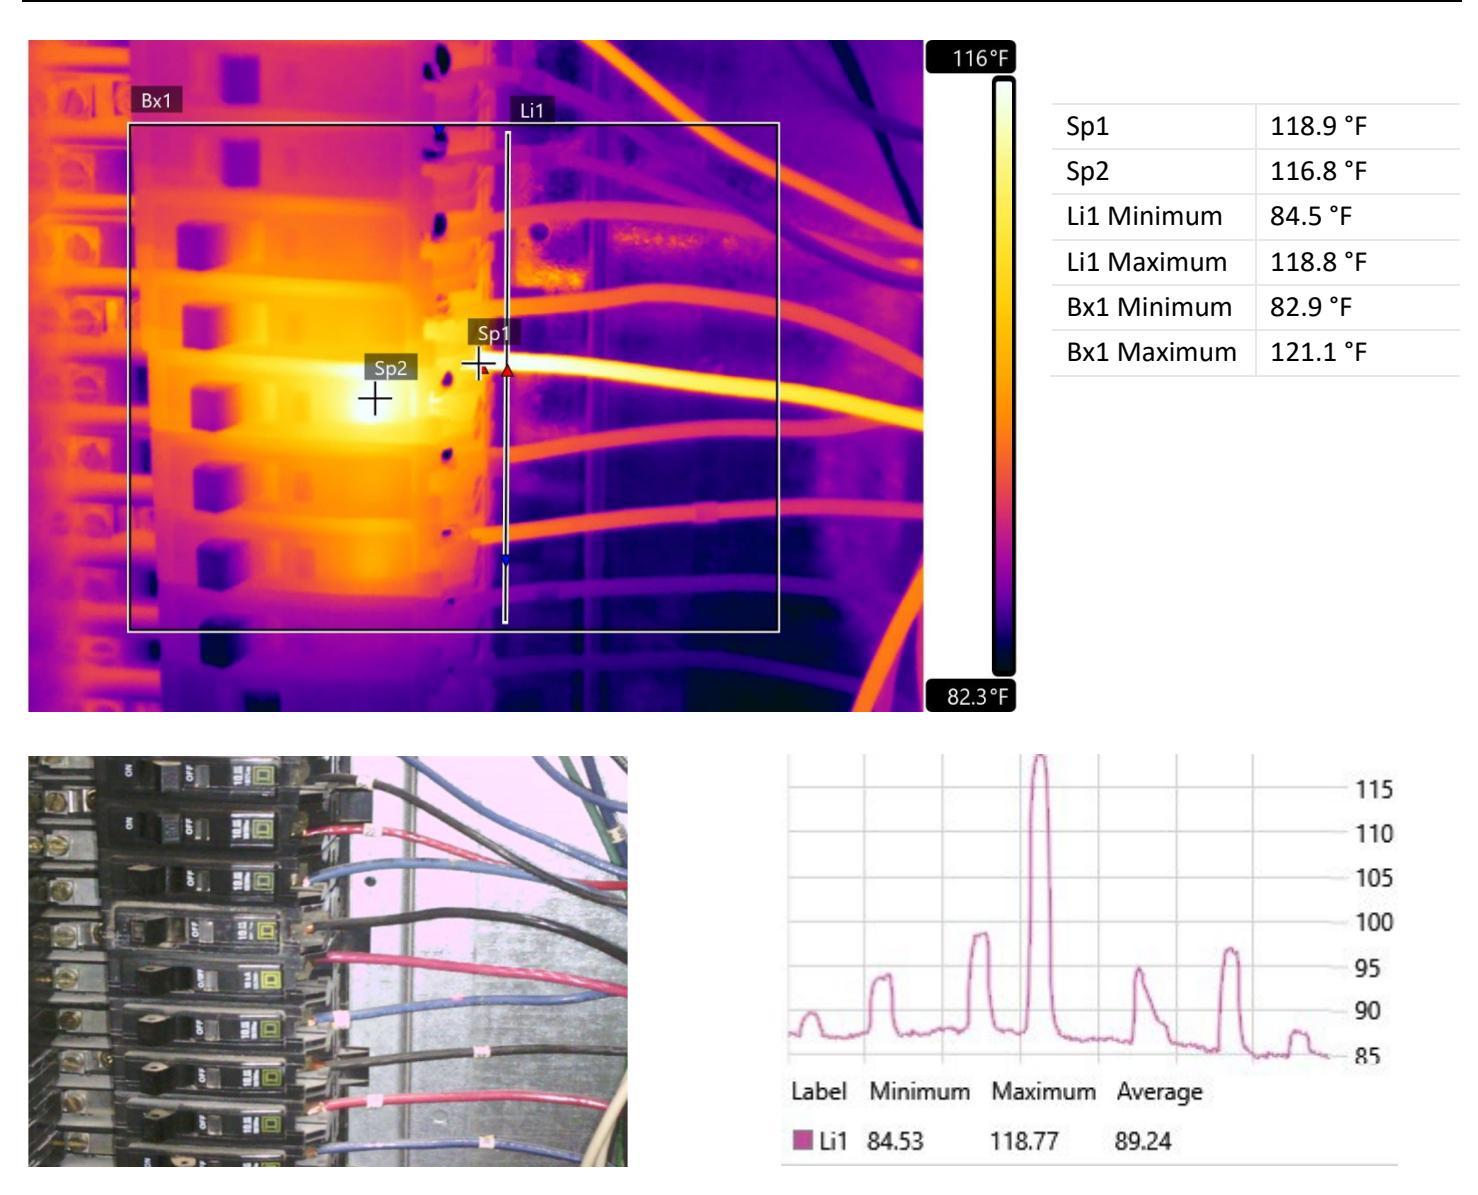
Component	Circuit Breaker	
Equipment/Bucket ID	SA4 panel	Breaker 28

Fault	Load issue/connection issue	
Defect Rating	CLASS I

Breaker 28 likely has a decent load on the circuit. Also, may have some connection issue. Measure load on circuit and ensure connections are clean and tight.

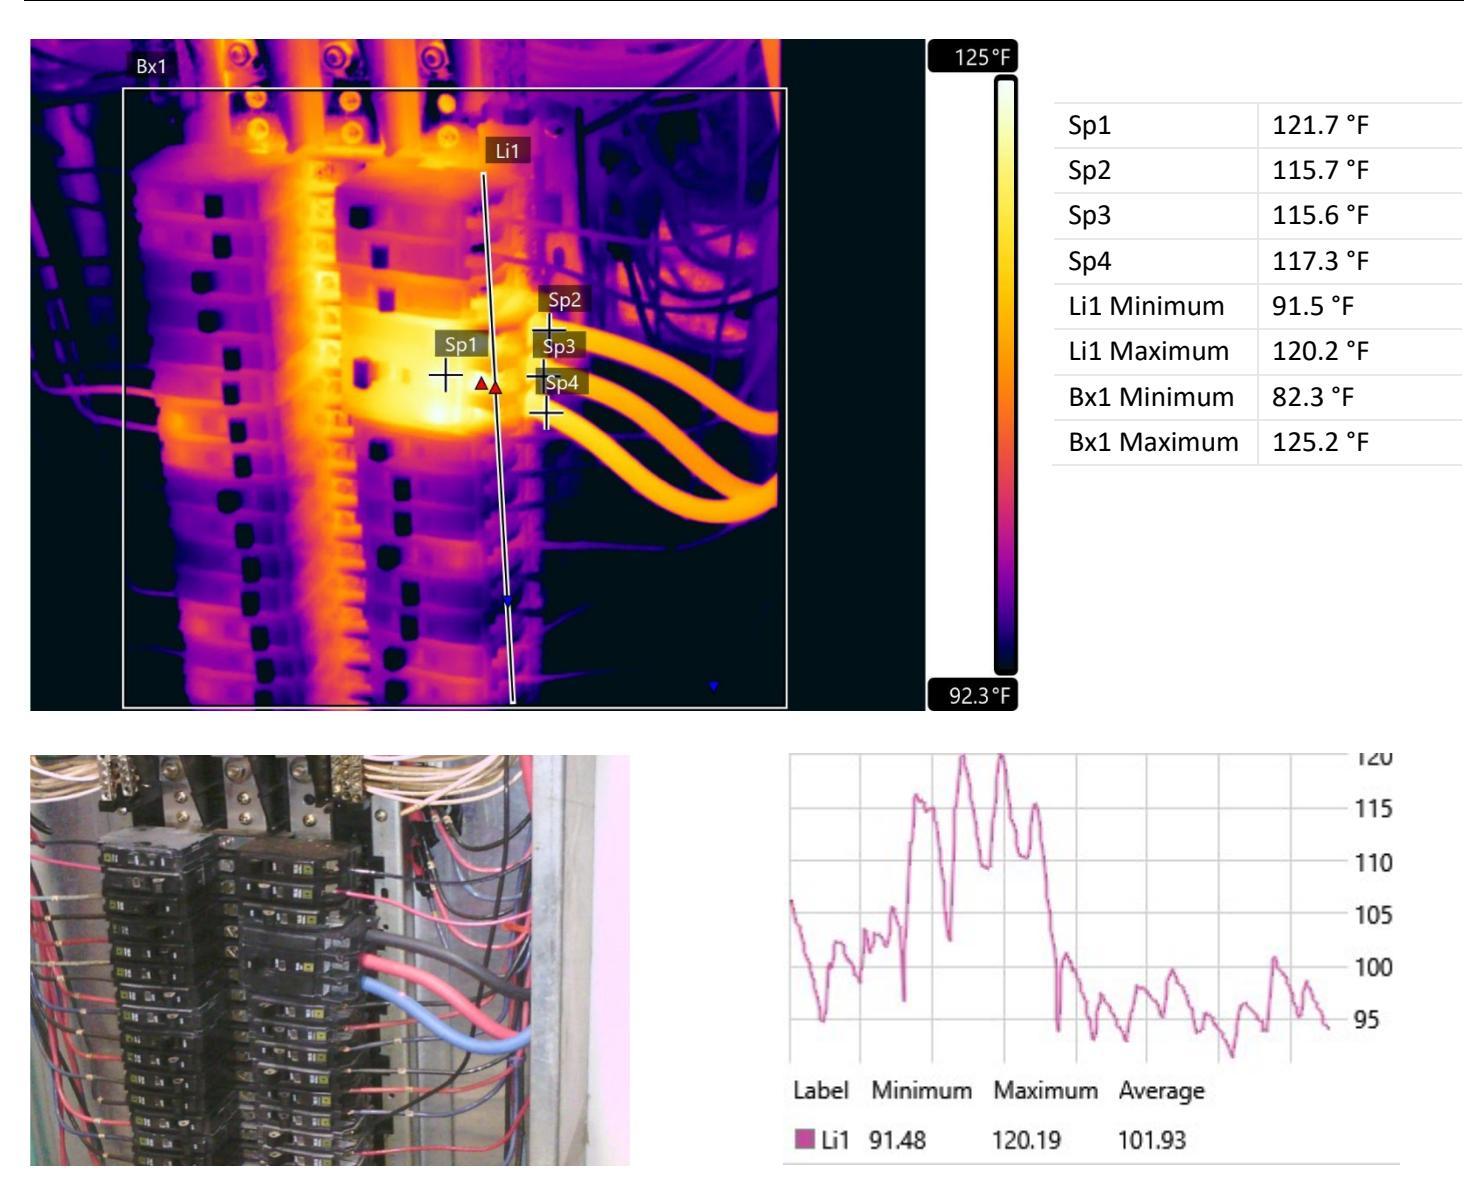
Component	Circuit Breaker	
Equipment/Bucket ID	ER2 SB1 Buffalo Breaker

Fault	Heavy Load	
Defect Rating	CLASS I

IR image shows breaker and leads to have some heat. This is likely a load issue. Load was measured and found to be fairly heavy.

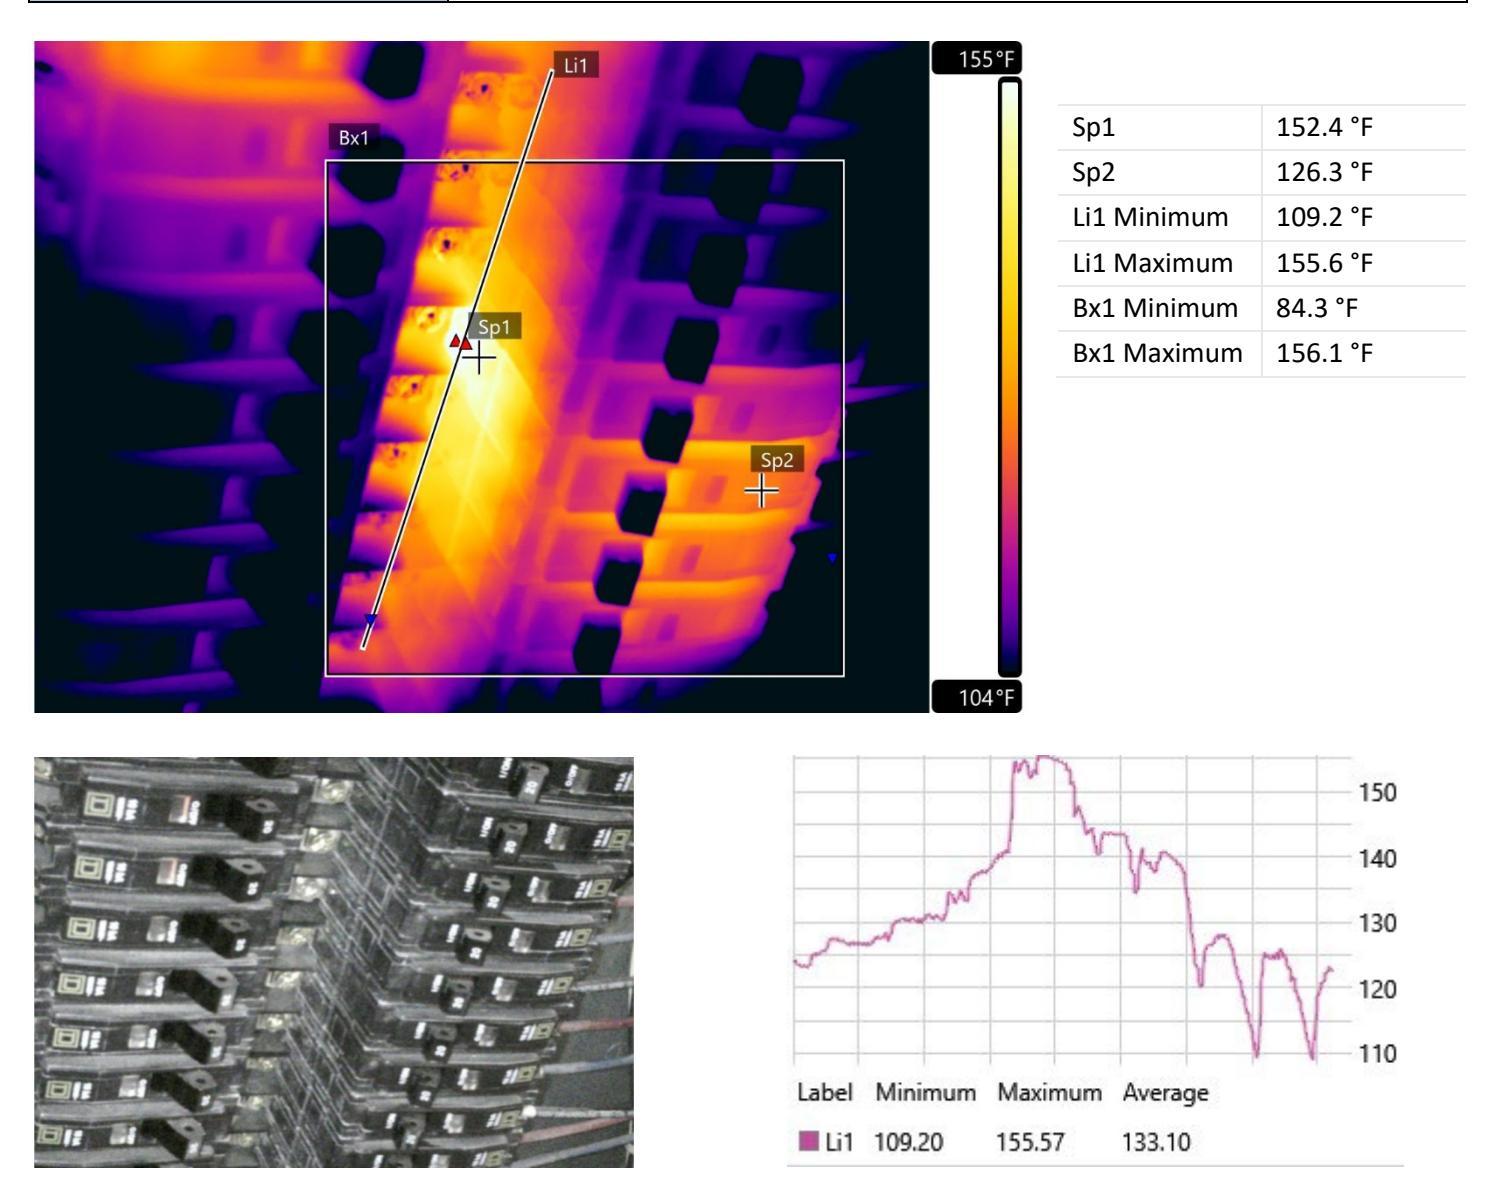
Component	Circuit Breaker	
Equipment/Bucket ID	SB8 Breaker 34 and 36

Fault	Possible internal breaker issue	
Defect Rating	CLASS I

There appears to be some heat at the back of breaker 34 and 36. Load was measured and found to be around 14 amps which is acceptable so there may be an internal issue with the breaker. Recommend replacing both breakers as time allows.

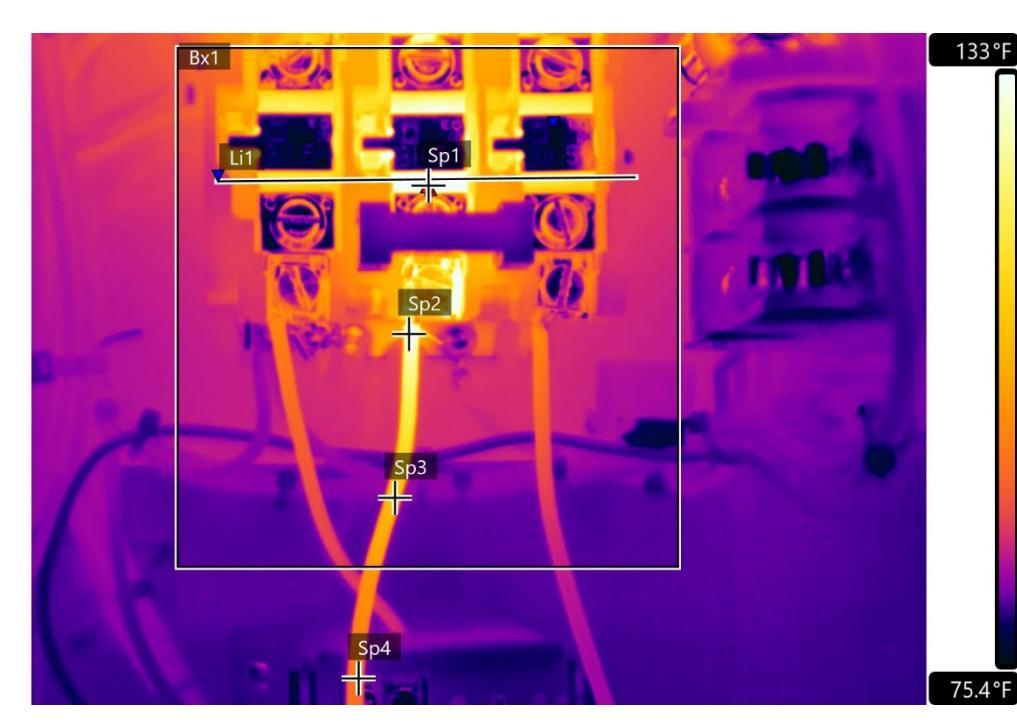
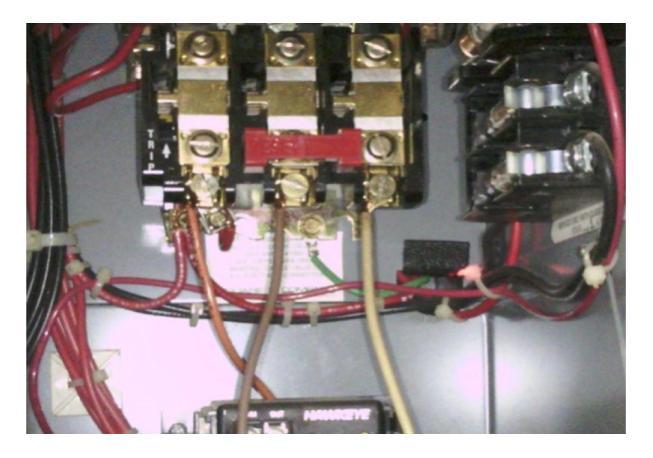
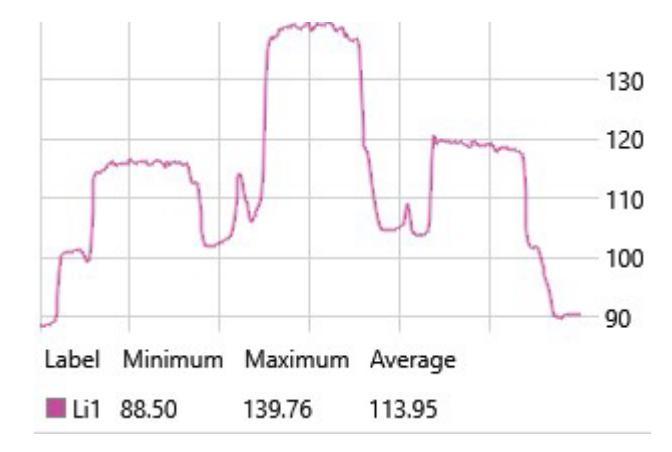
Component	B phase connections			
Equipment/Bucket ID	Mezzanine Elec Room	MCCB1a	KEF8

Fault	Possible loose connection	
Defect Rating	CLASS I

There may be a connection issue with the B phase connections. Inspect connections ensuring they are clean and tight.

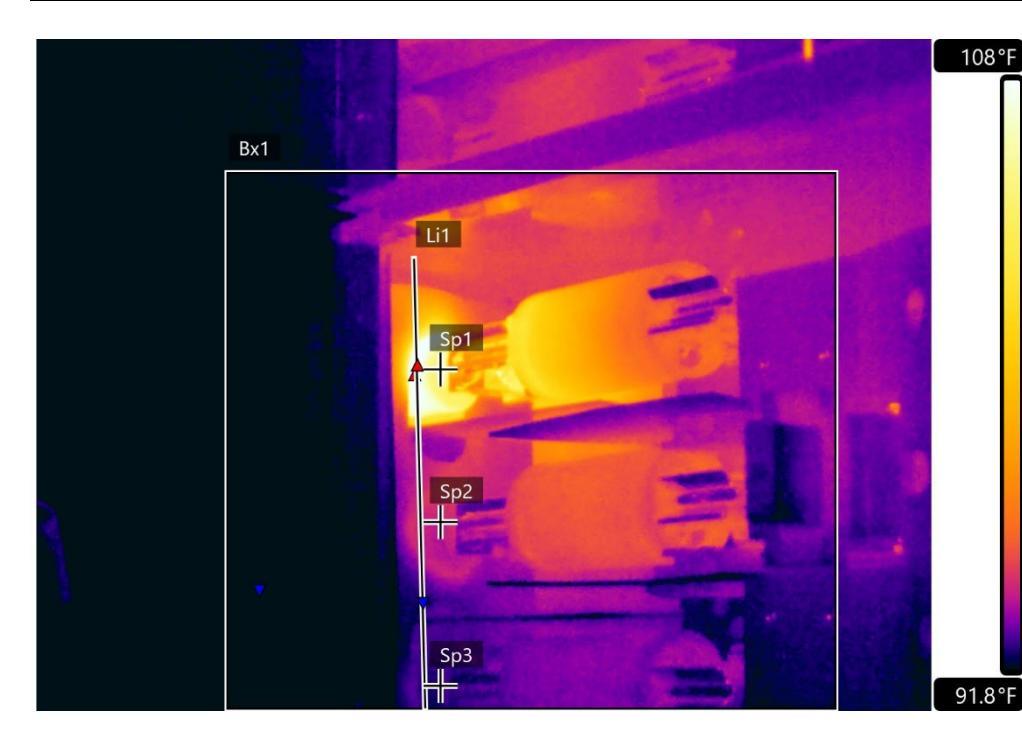
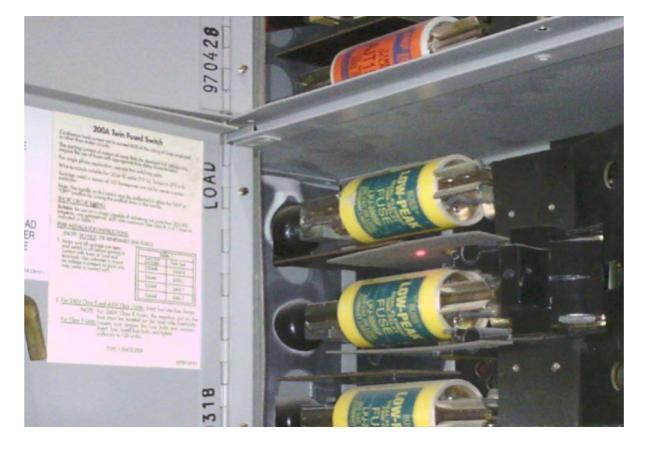
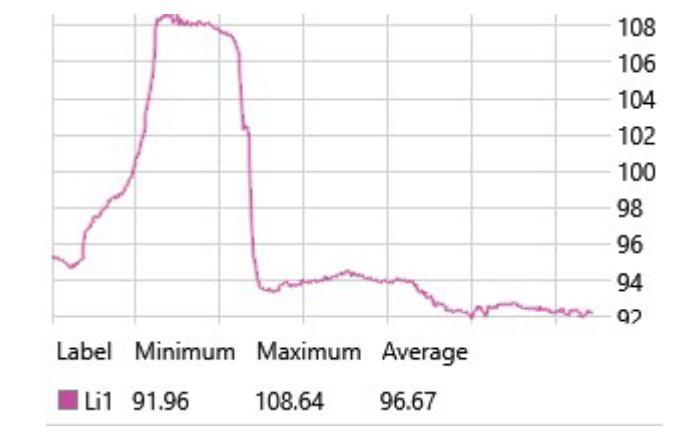
Component	Fuse connection
Equipment/Bucket ID	LSB2 panel T3L

Fault	Fuse connection issue	
Defect Rating	CLASS I

Top fuse appears to have more heat at the insulated connection. For now check load and ensure connection is clean and tight.

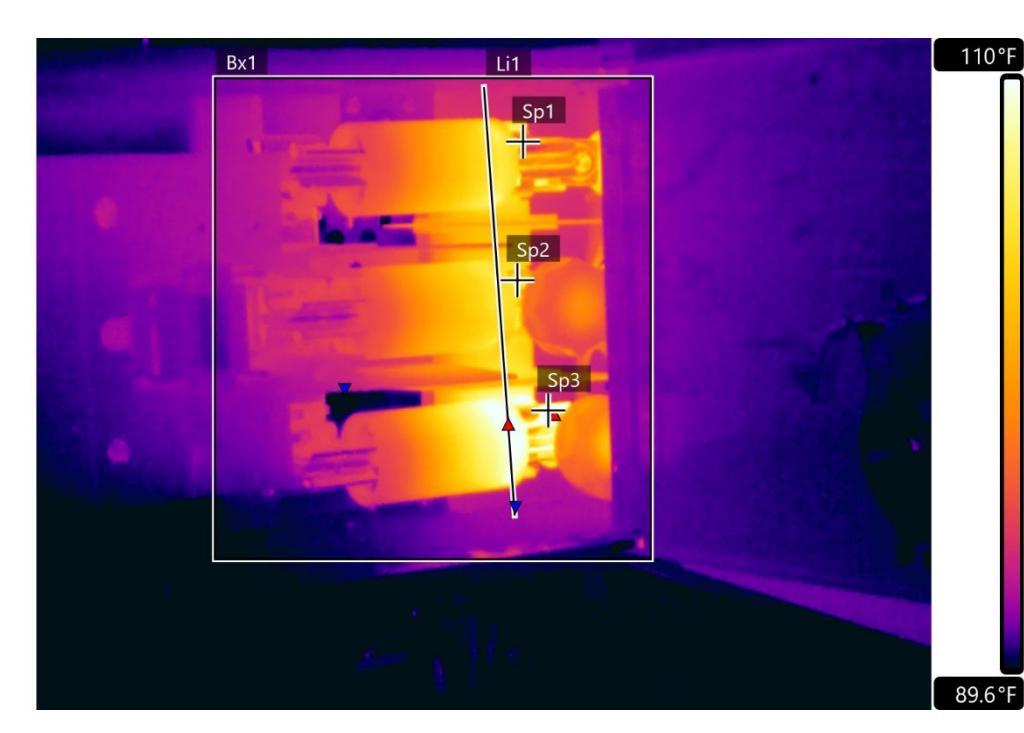
Component	Fuse clip/connection
Equipment/Bucket ID	HSB1 HB-2

Fault	Fuse clip/connection issue	
Defect Rating	CLASS I

There is likely an issue with the bottom fuse connection/clip. Check connections/clip ensuring a tight and clean connection. Ensure clip isn't worn or faulty.
