The following is a summary of findings from the Chiller vibration survey that was performed on October 20, 2023.

Chiller 2 CLASS II

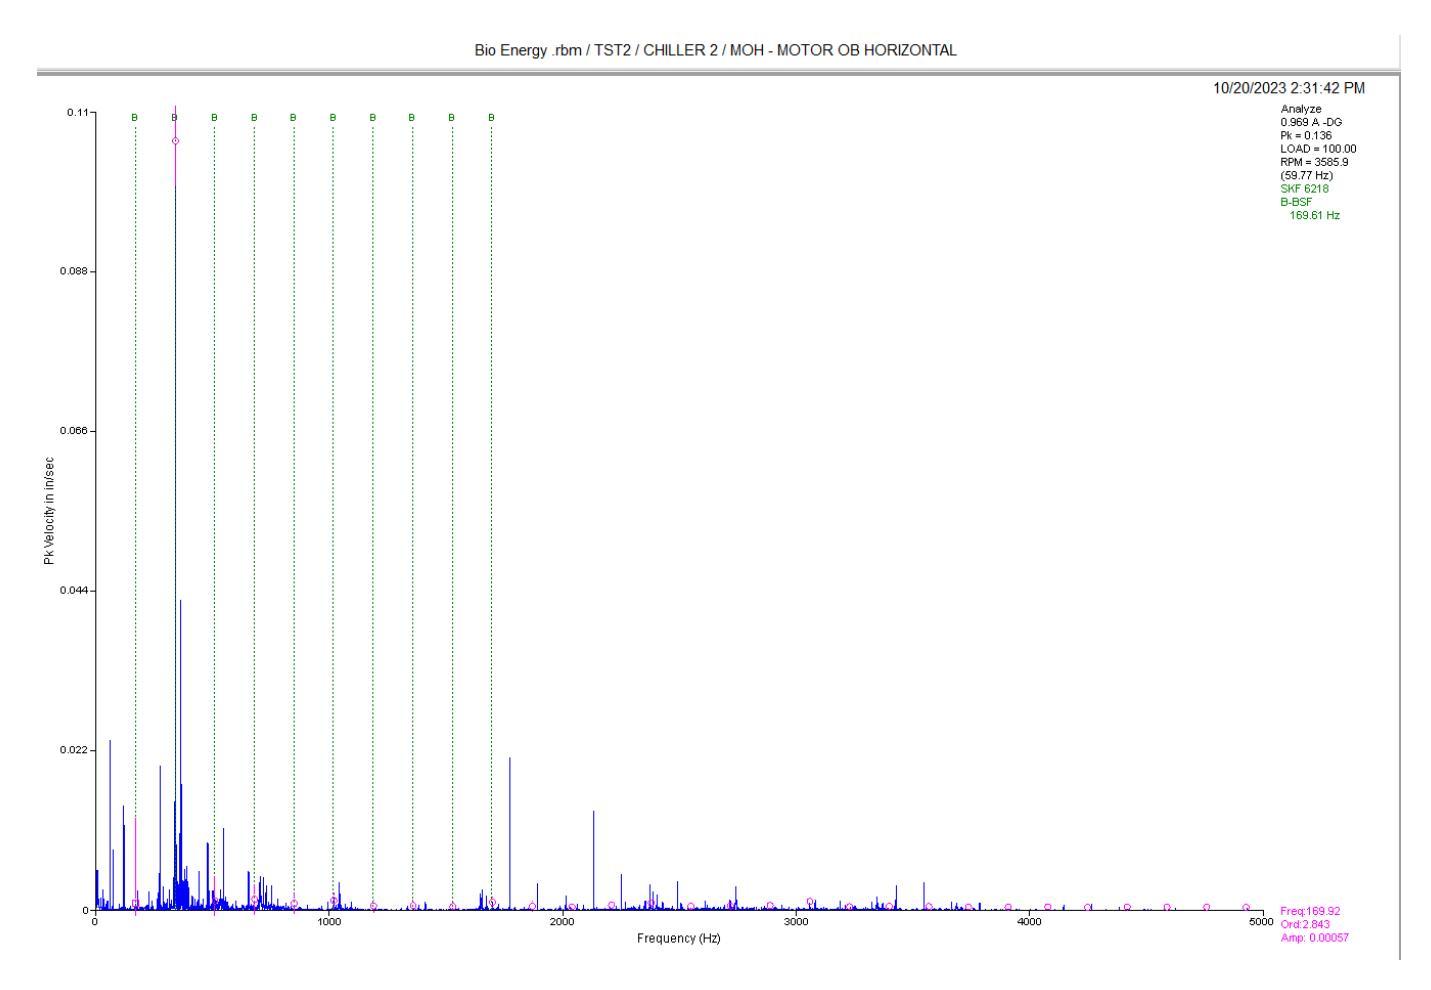
Data above is the outboard motor bearing axial. Notice the cursors marked B. This is the BSF (ball spin frequency) of the ODE bearing. This is an indication of a bearing issue causing a dominant 2 x BSF vibration. Overall vibration amplitudes are low at this time but the presence of these BSF peaks is concerning.

There appears to be an issue with this motor. During our data acquisition we monitored the ODE bearing temperature and noticed that the temperature increased up to 157 degrees F. The #1 Chiller ODE bearing temp was around 95 degrees F. This may be caused by axial thrusting of the ODE bearing. It may also be contributed by the grease. We noticed brown colored grease on the grease fitting. This is not the grease that should be in the motor bearing/end bell. The grease that is being used by this bearing is Polyrex EM grease likely Mobile brand and it is colored blue. Mixing grease types can cause issues such as overheating. The possible thrusting may be due to improper spacing of the coupling spool piece. It is highly recommended to measure the face-to-face distance of the couplings with the spool piece removed. The manufacturer should have this spec. We also recommend to check the alignment during this time just to ensure alignment is within spec. It should be ok considering this is a flange mounted motor, but we have seen some misalignment with York Chillers in the past. This is rare but can occur.

We also noticed that the motor bearing temp sensors are not working properly according to the control panel display.
