The following is a summary of findings from the vibration analysis on Chiller-302 at the FedEx Forum.

Chiller-302 CLASS III

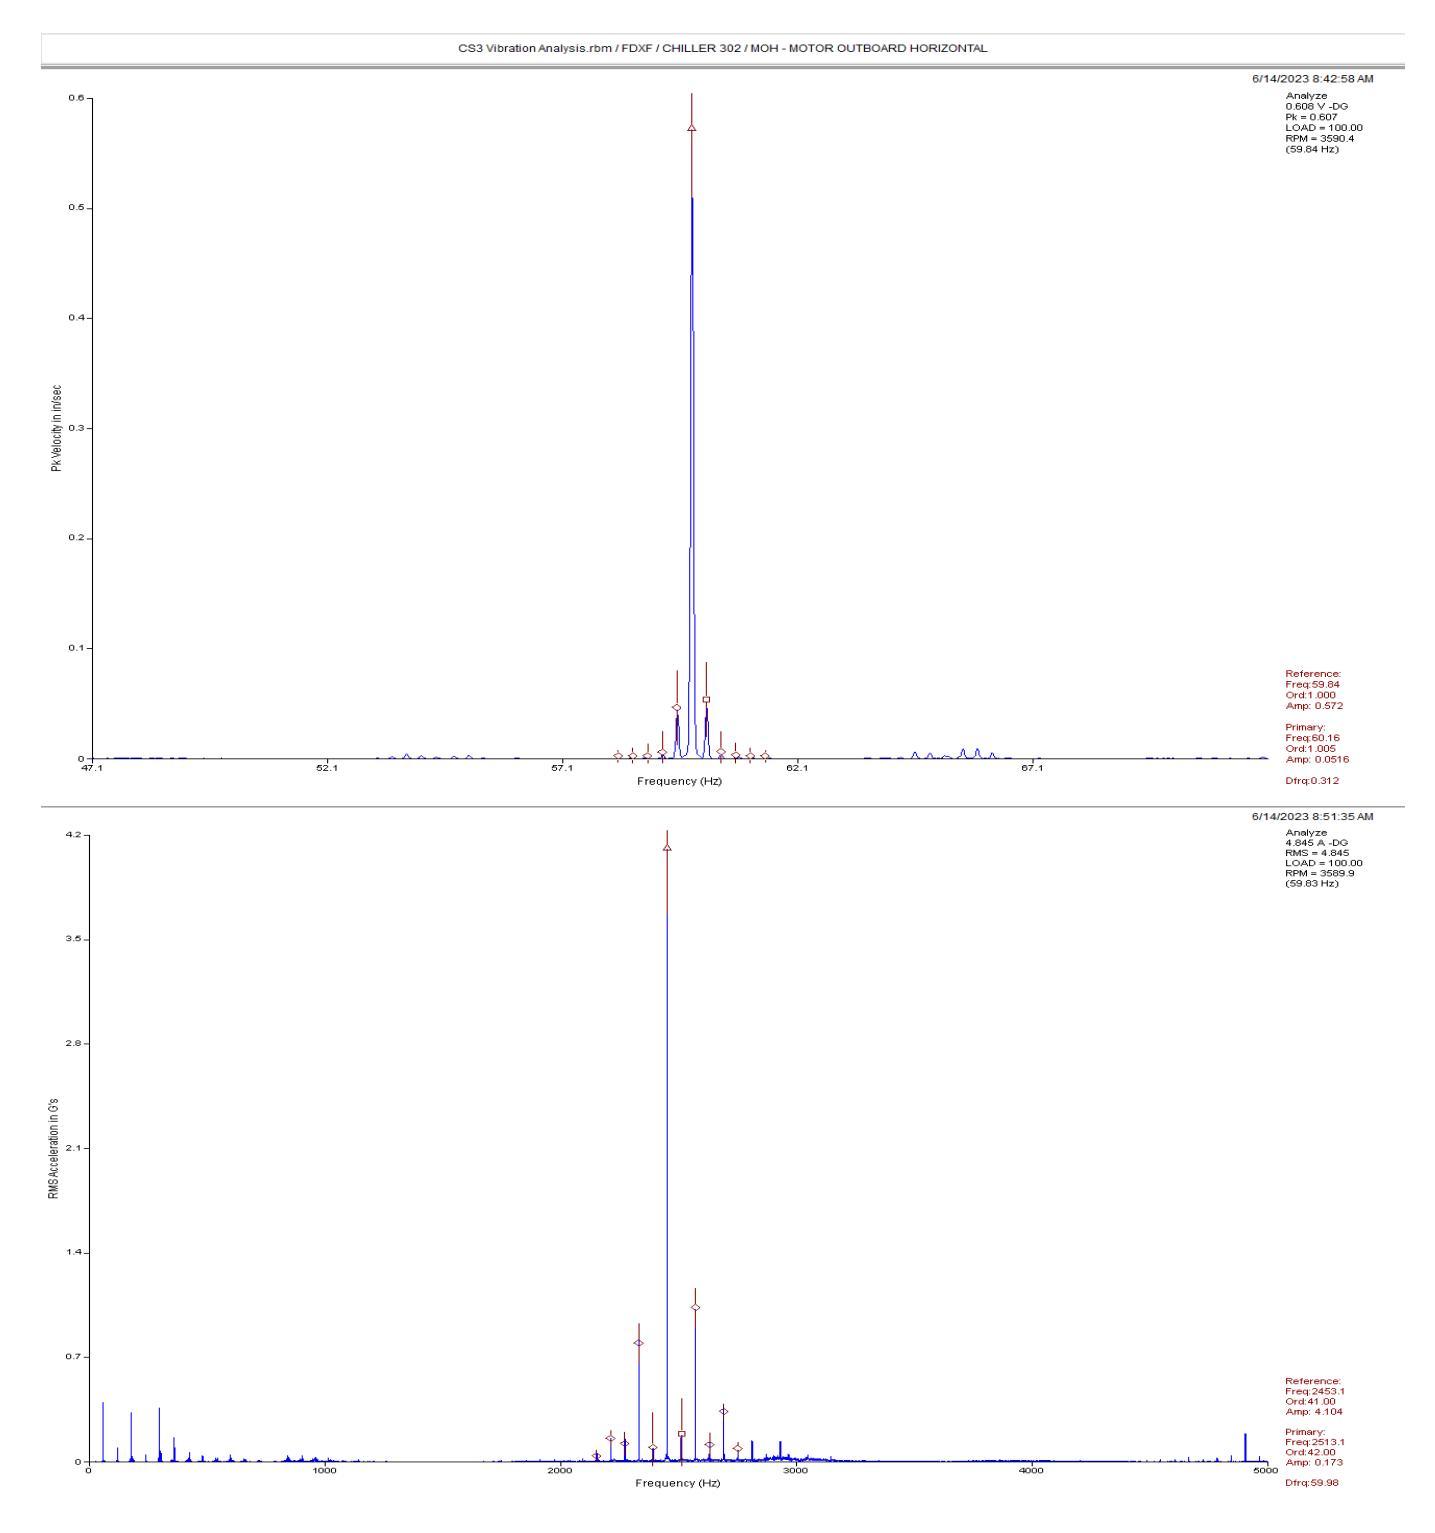
Motor was at 80% load during our testing. Data above is the motor outboard (ODE) horizontal. The first data plot shows a high 1 x rpm vibration with pole pass sidebands. The second data plot shows a large peak at 41 x rpm which is likely Rotor Bar Pass Frequency with rpm sidebands around this peak.

Spectral data plots indicate rotor issues are present in the motor. This is likely a rotor bar or end ring issue and should be addressed soon. Having no history of this machine, it is difficult to determine the severity but due to the evidence of rotor bar problems, this can become severe very quickly due to overheating of the rotor and windings. It was also noticed that there was quite a bit of current imbalance present. This is also another sign of inductance issues due to rotor problems. We recommend swapping over to the other chiller and scheduling this motor for repair.
