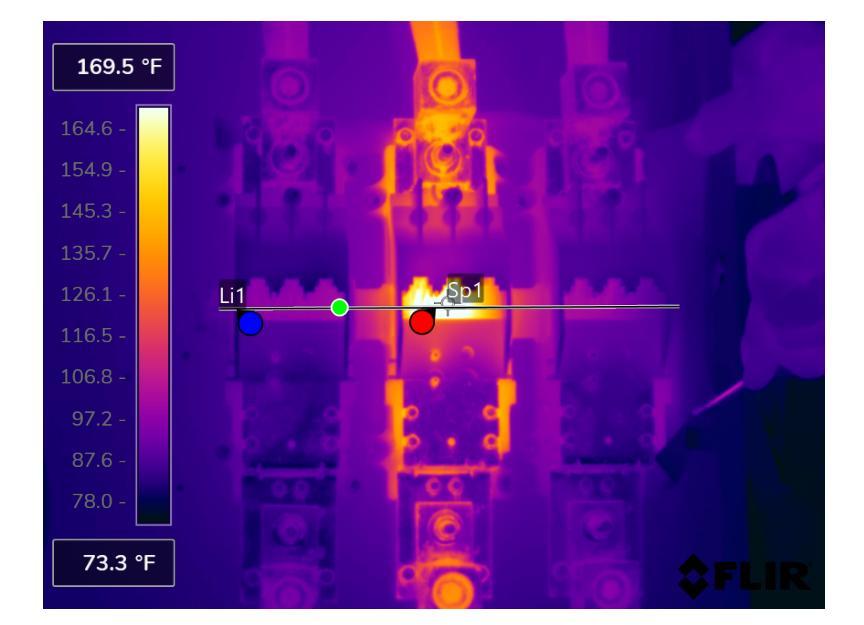
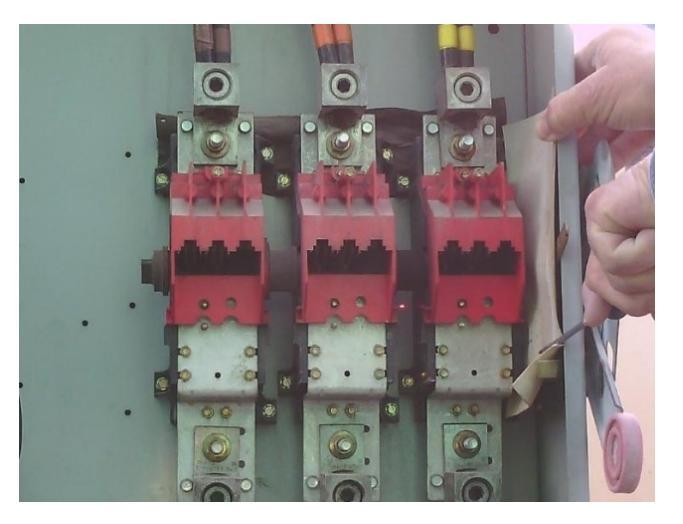
QSI-200 Disconnect

Knife switch

Fault Worn/faulty knife components

> Defect Rating CLASS II

IR image shows heat on B phase. This is likely due to worn knife components. Inspect, repair, and replace components as needed.

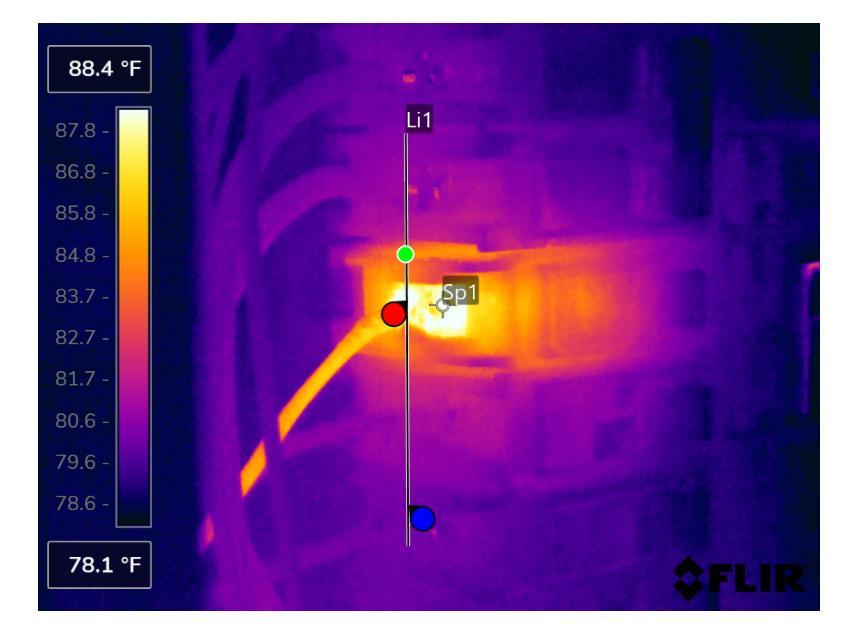
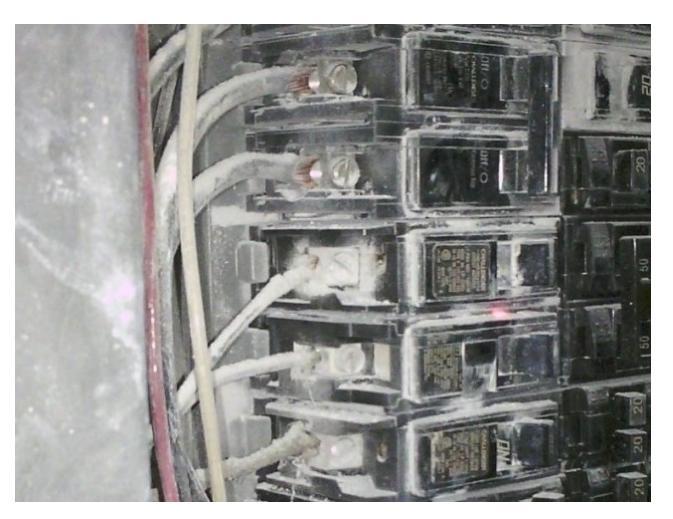
Electric Room near control room Panel 10 Breaker #9 20 amp

20 amp breaker/lead connection

Possible heavy load
 Image: CLASS Ima

Breaker may be near rated load. It is recommended to measure current on circuit. It is also recommended to disconnect, clean, and reconnect lead wire.

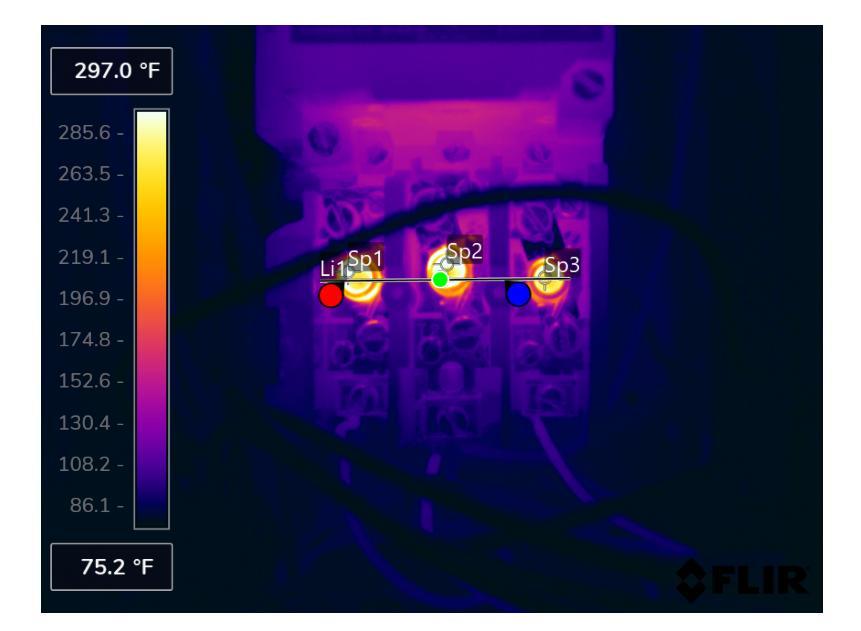
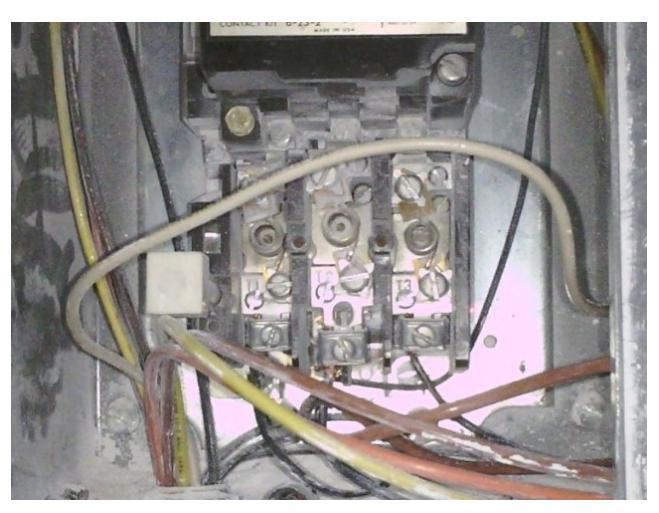
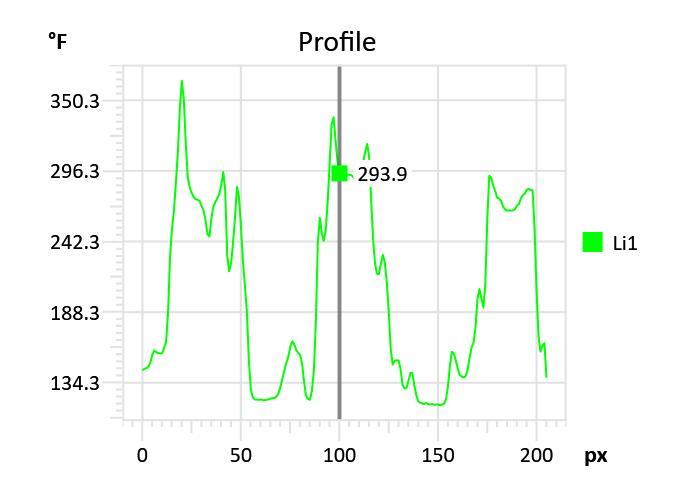
#6 New Furnace Fan

Thermal Overloads

Fault
Weak/Faulty Thermal Overloads
Defect Rating

CLASS III

Thermal overloads have excessive heat. Max temp. is near 380 F. This is indication of weak/defectivecomponents. It is highly recommended to replace the thermal overloads asap.

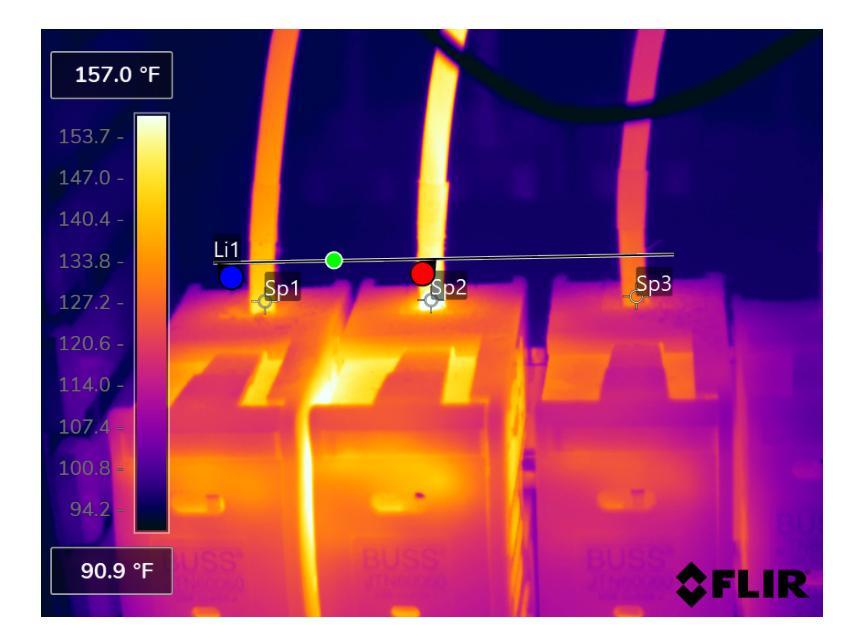
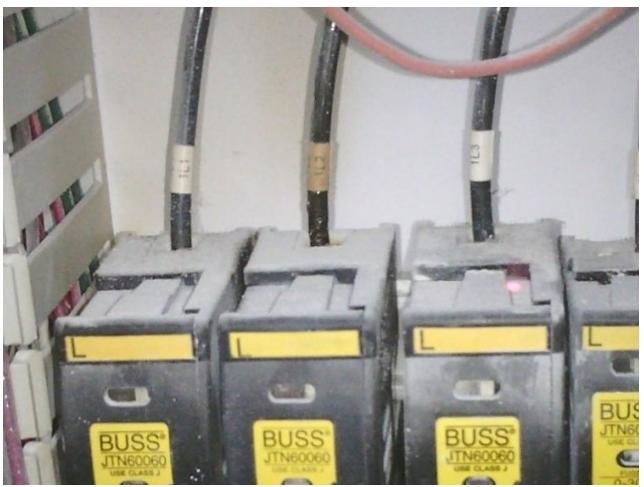
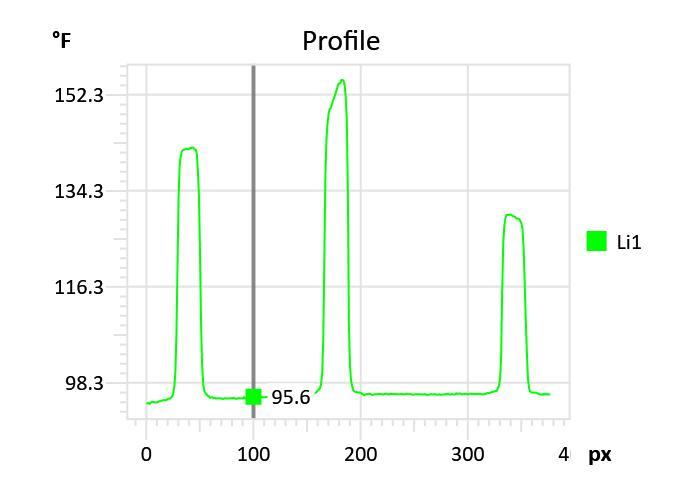
Combustion Air Control Panel 1L2 lead wire

Fault Weak/overloaded circuit Defect Rating

CLASS II

Visual image shows discoloration of the lead wire. This is indication of high heat on circuit. IR image shows highest temp. to be at connection. This may be a connection issue, but could also be heavy load. We recommend replacing wire due to signs of discoloration and likely insulation breakdown. Measure load on circuit and ensure a clean, tight connection.

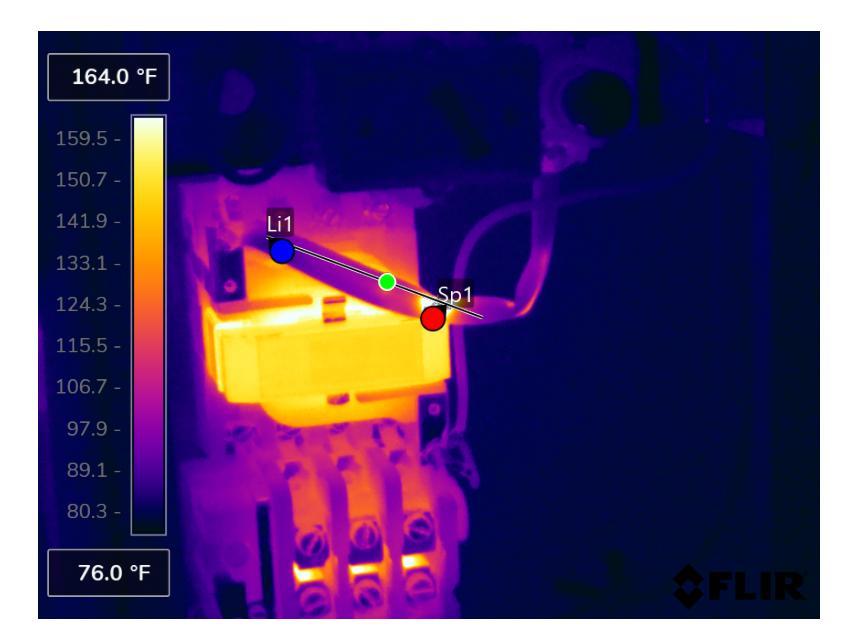
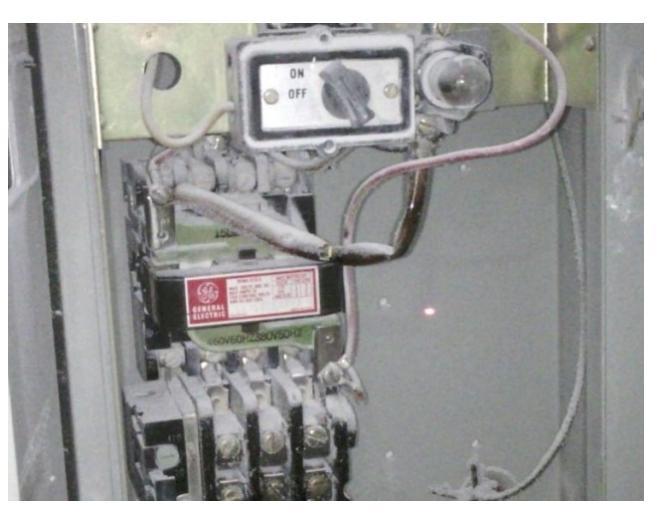
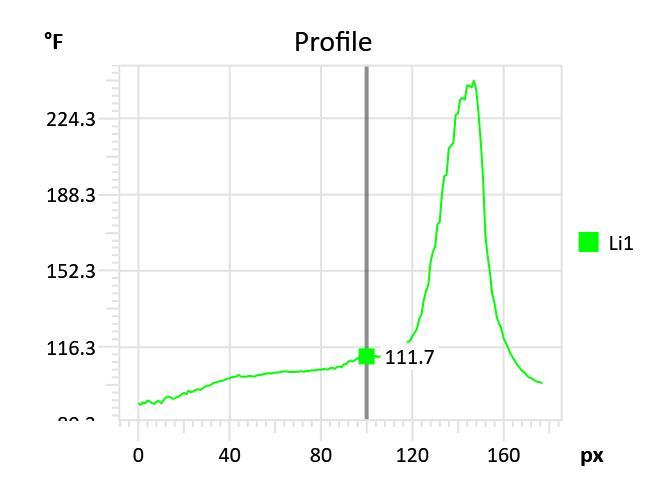
Electrical room in control room Roof exhaust fan panel

Fault
Damaged/faulty wire
Defect Rating
CLASS III

The wire going to the indicator light has a bare spot and is showing over 250 degrees F. It is highly recommended to replace wire asap. Ensure a clean, tight connection.
