All electrical panels were scanned using a **FLIR T865** infrared camera. The following report only contains defects that were found during the survey. Below is our classification system for each defect included in this report. If there are any questions or comments, please feel free to contact us at any time.

HI-SPEED

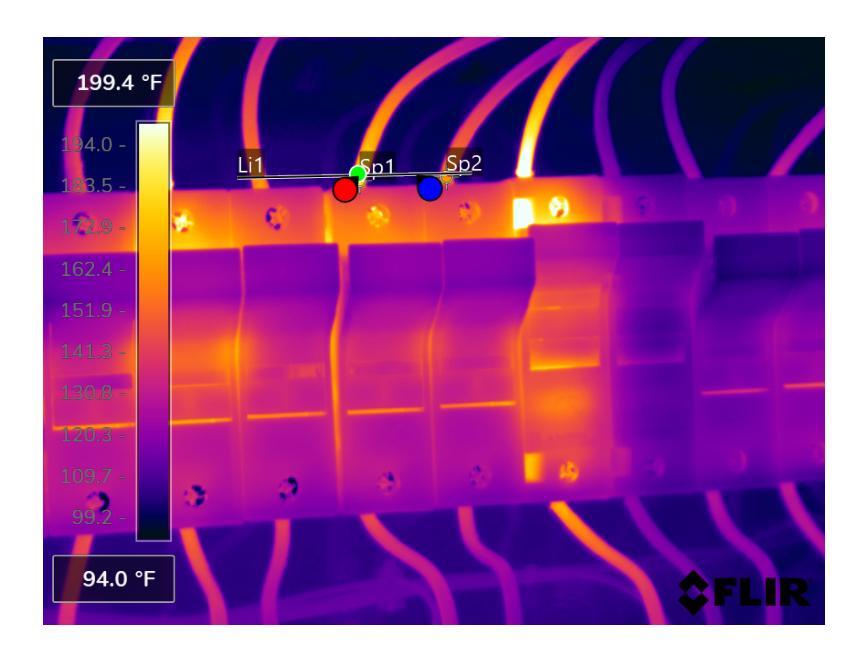
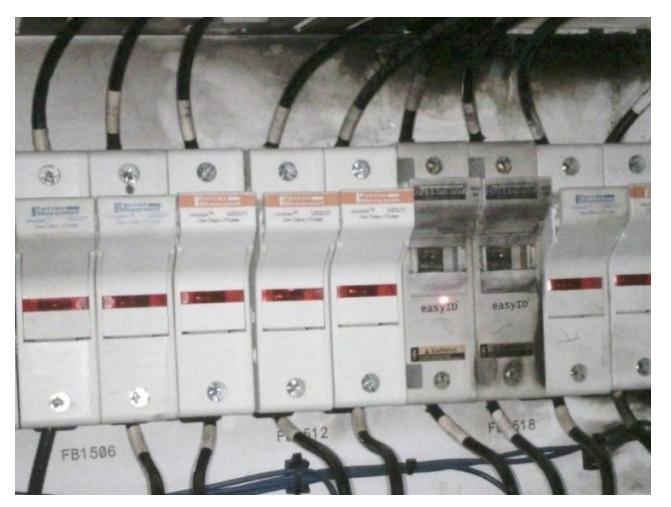
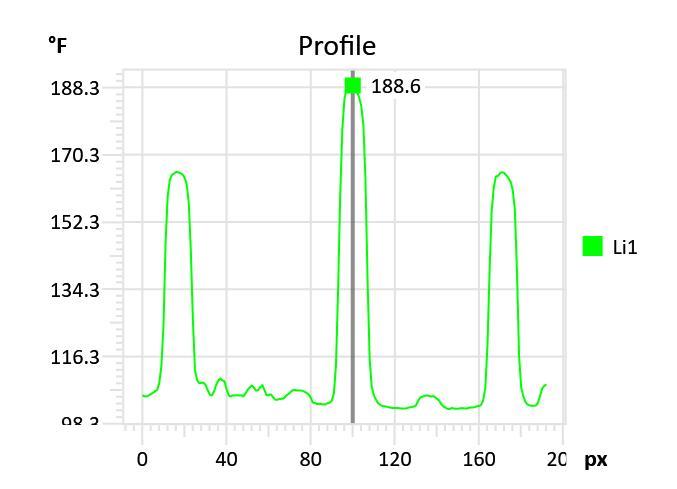
(RECHECK) FB1512

FB1512 VFD11XX Fiberglass

Recheck image for FB1512 shows to be good after repairs. Hot spot in IR image is on the next page.

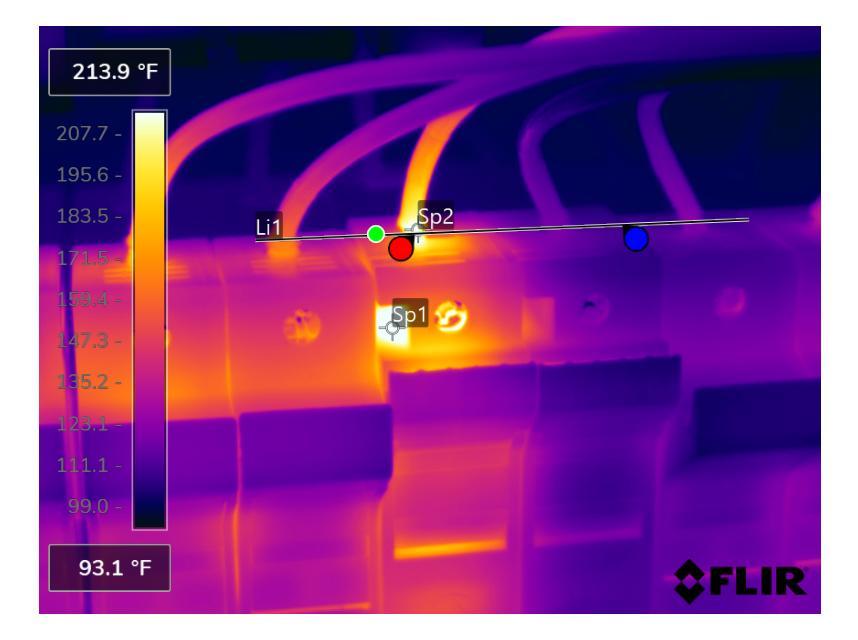
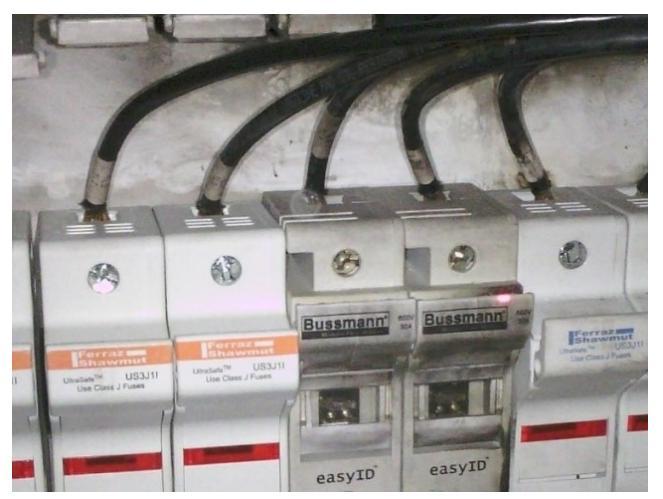
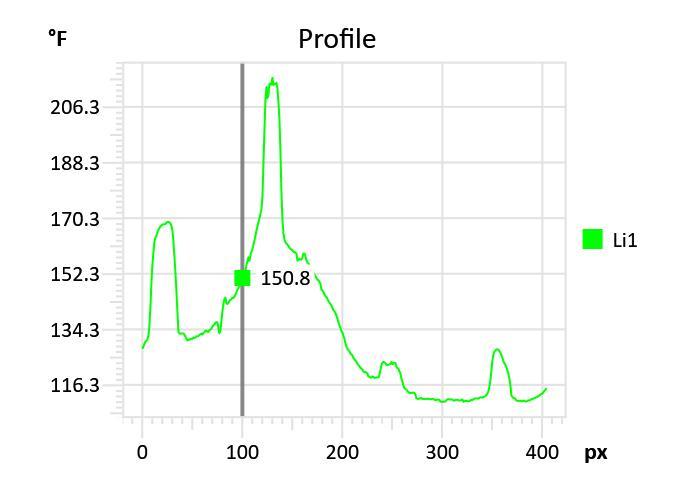
#### (RECHECK) FB518

FB518 VFD11XX Fiberglass

Faulty Connection

CLASS II

IR Image shows an issue with the lead connection and or fuse internal connection for fuse above FB518 label. Fuse may need to be replaced if lead connection is found tight.

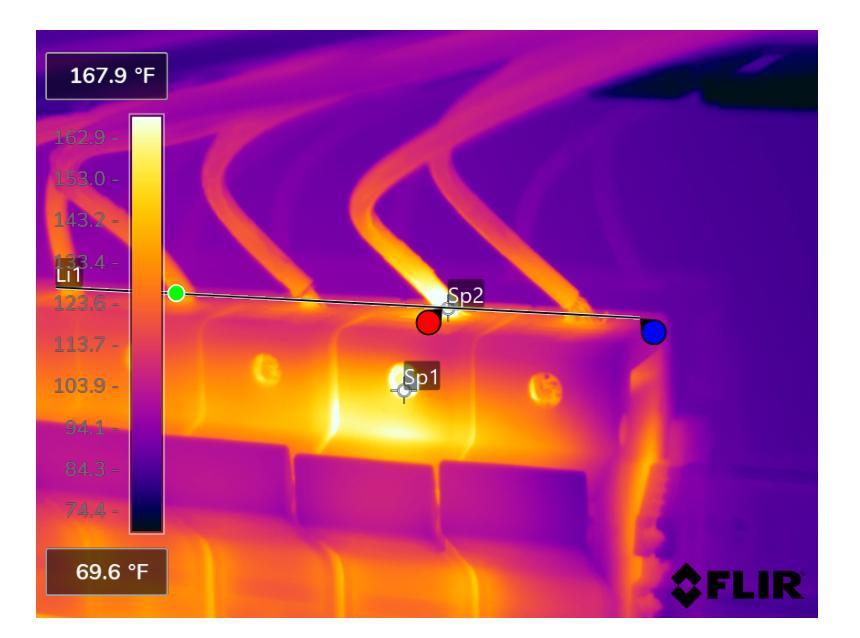
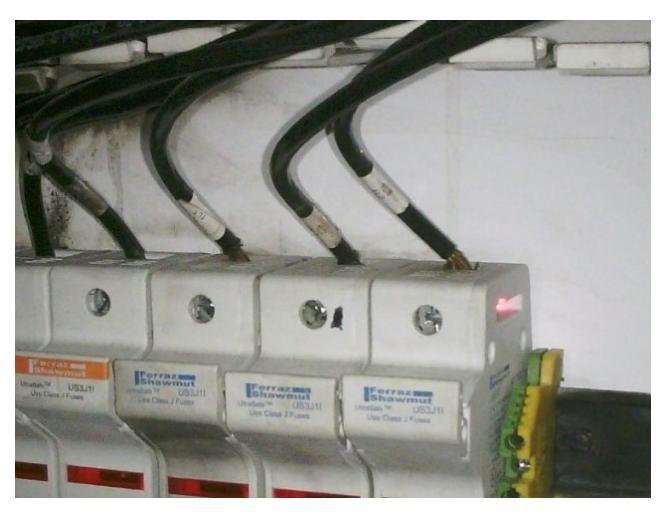
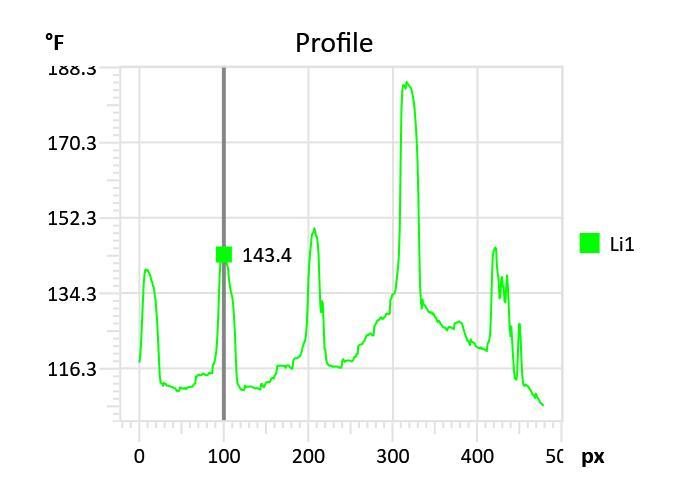
Control relay connection

FB1530 VFD11XX Fiberglass

Faulty connection
 Defect Rating

CLASS I

There appears to be an issue with the lead connection on the control relay FB1530. Ensure that the connection is clean and tight.

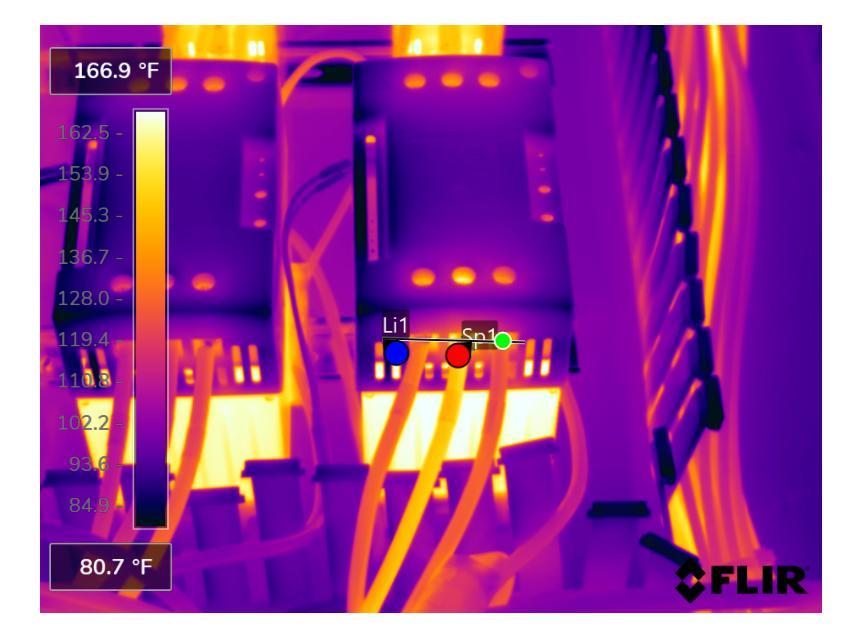
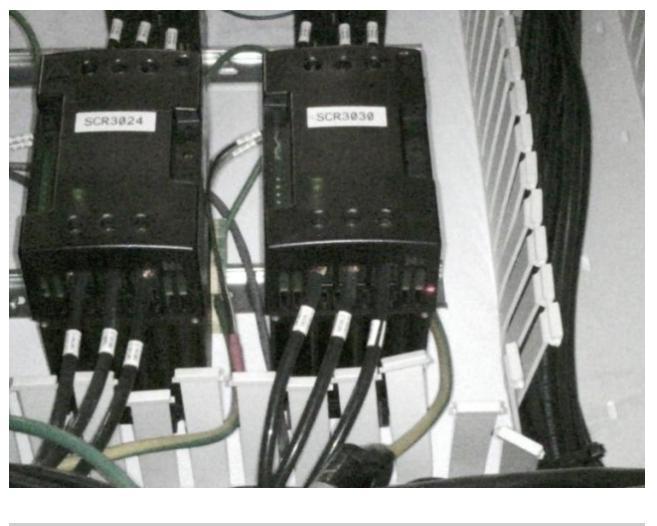
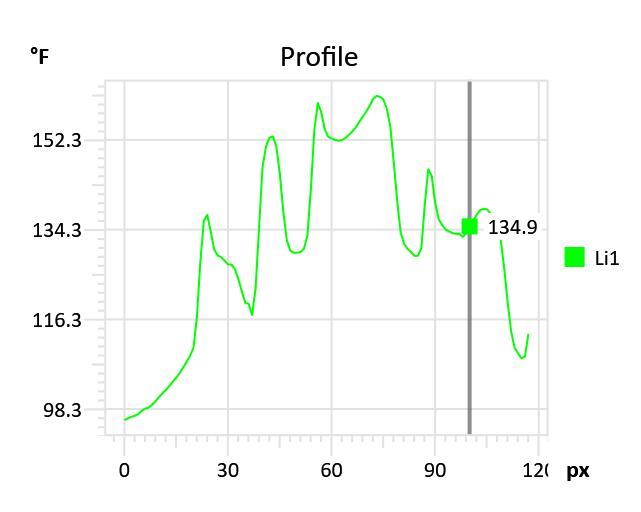
(RECHECK) SCR3030

SCR3030 VFD26XX Fiberglass

Fault None

**Defect Rating** None

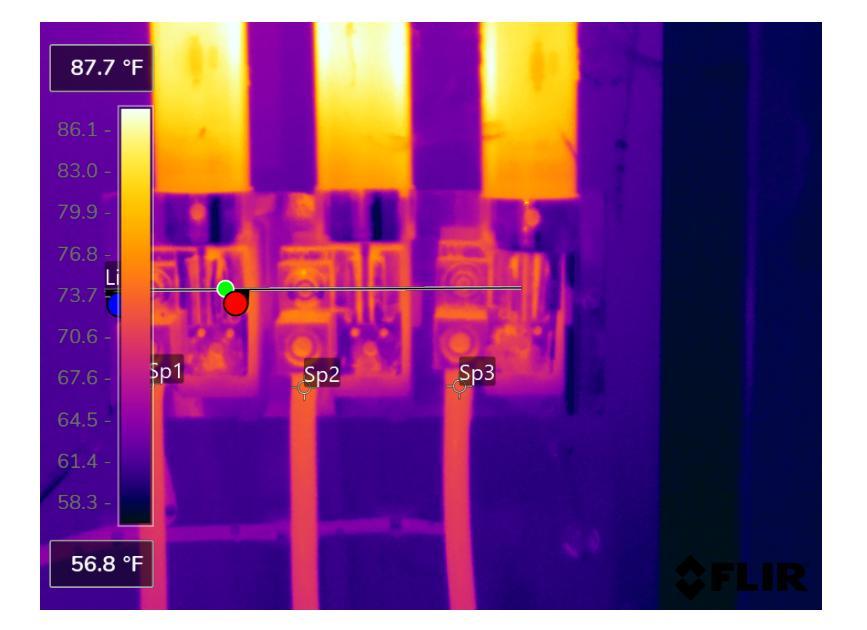
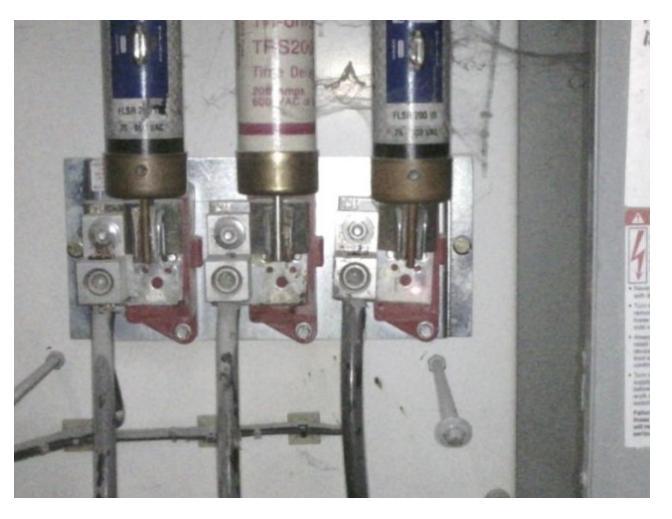
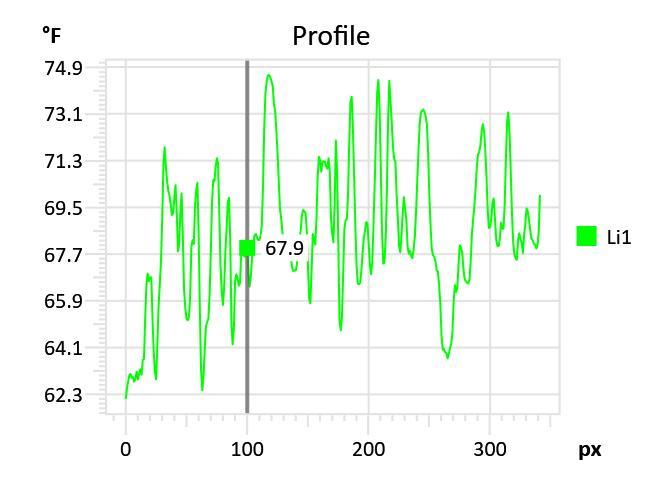
(RECHECK) Fuse Disconnect

Fiberglass Dust Collector Old Line Control Panel

None

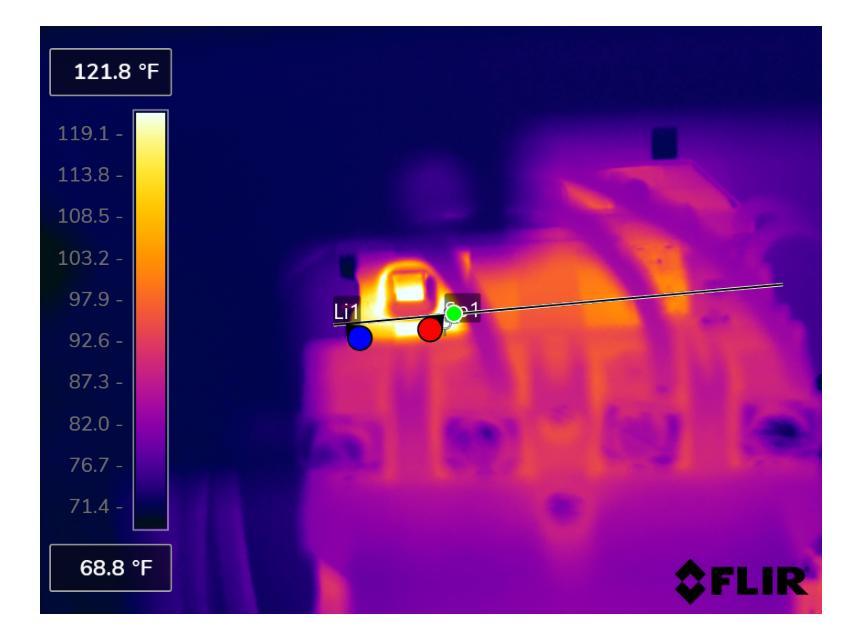
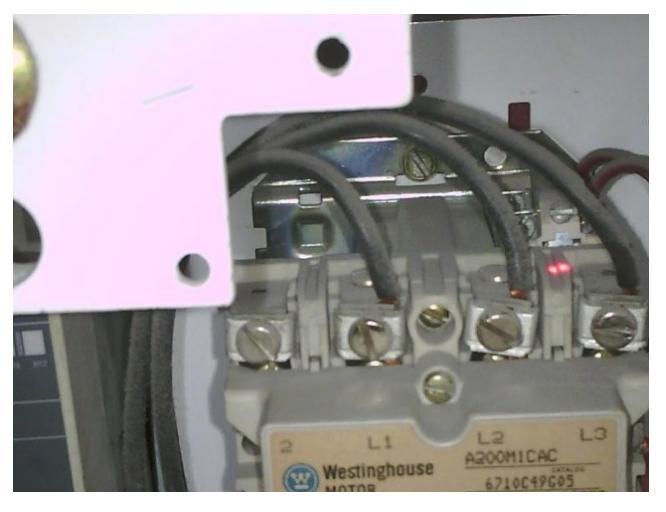
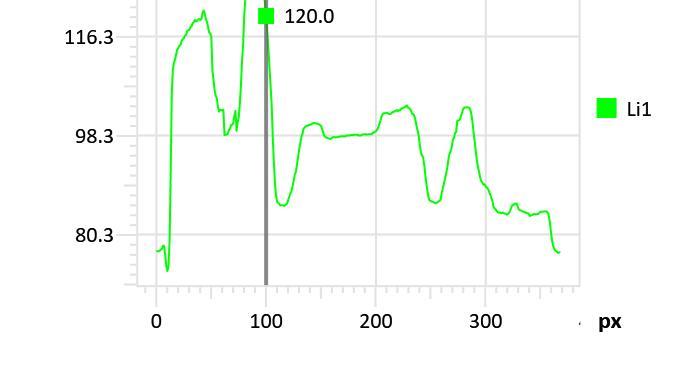
(RECHECK) Motor contactor

MCCFG2 M5378

Fault
Internal contactor issue
Defect Rating
CLASS I

This is a recheck scan. Issue still exists. It appears that the heat is being reflected by the mounting bracket. Contactor may have an internal issue and should be replaced as time allows.

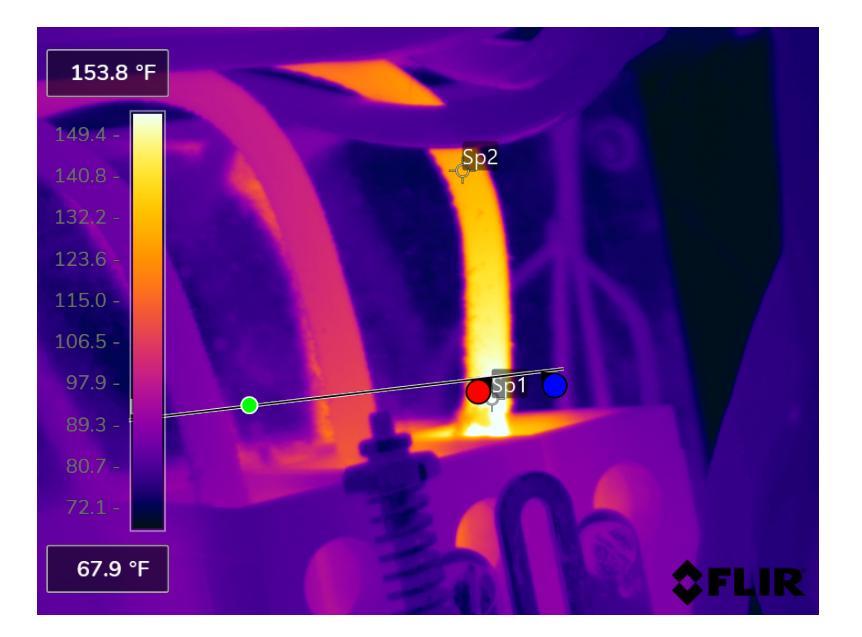
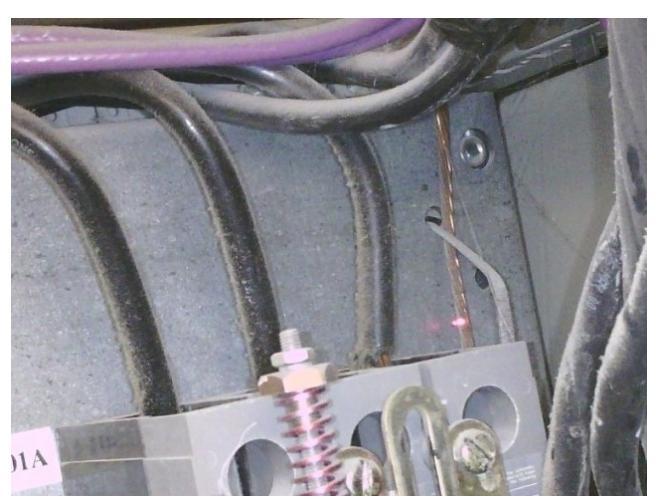
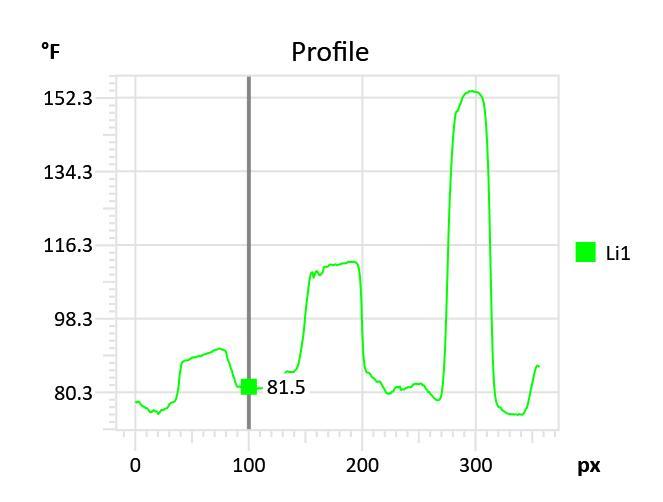
(RECHECK) C Phase Breaker lead connection

Fibergalss VFD Panel D

Recheck scan still shows the same issue. Internal breaker issue may exist if C phase connection is found to be tight.

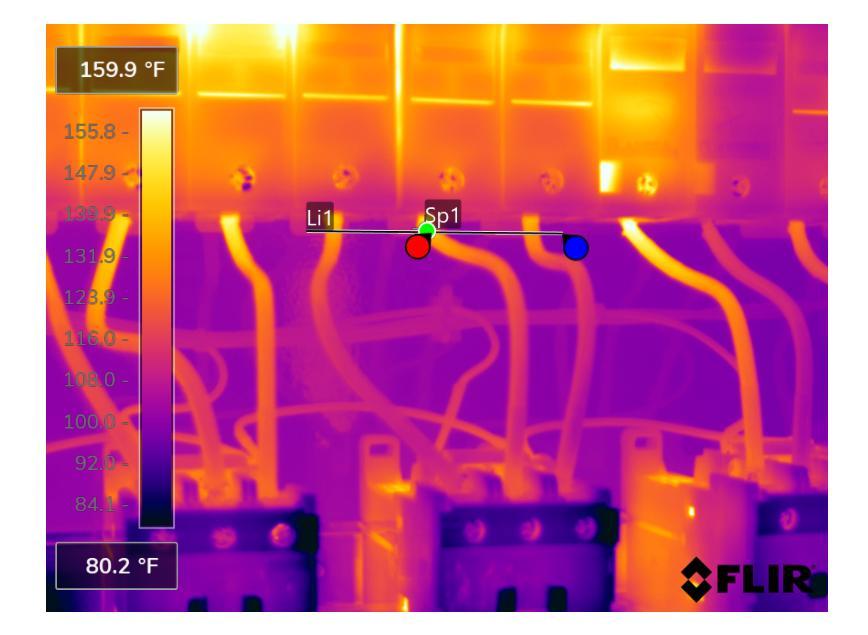
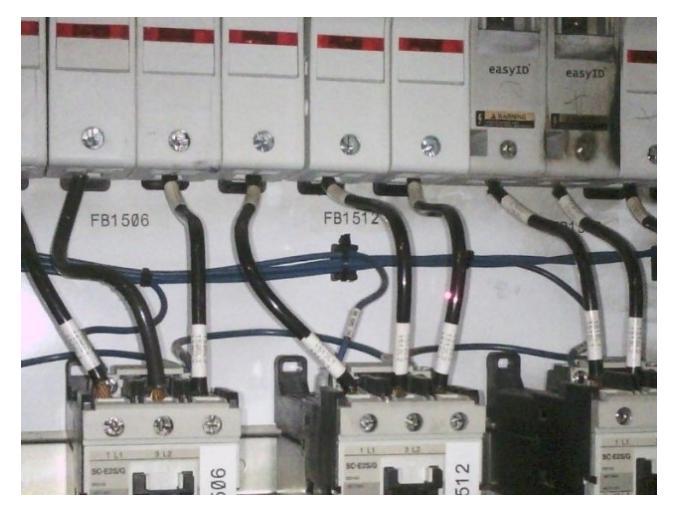
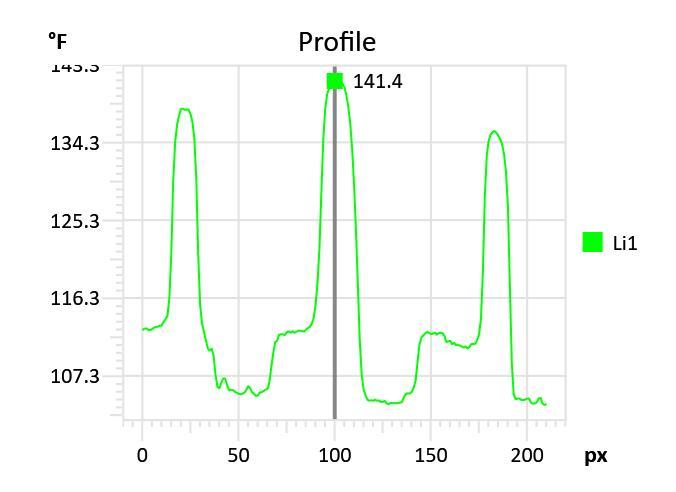
(RECHECK) Control relay connections FB512

VFD12XXfg FB512

None

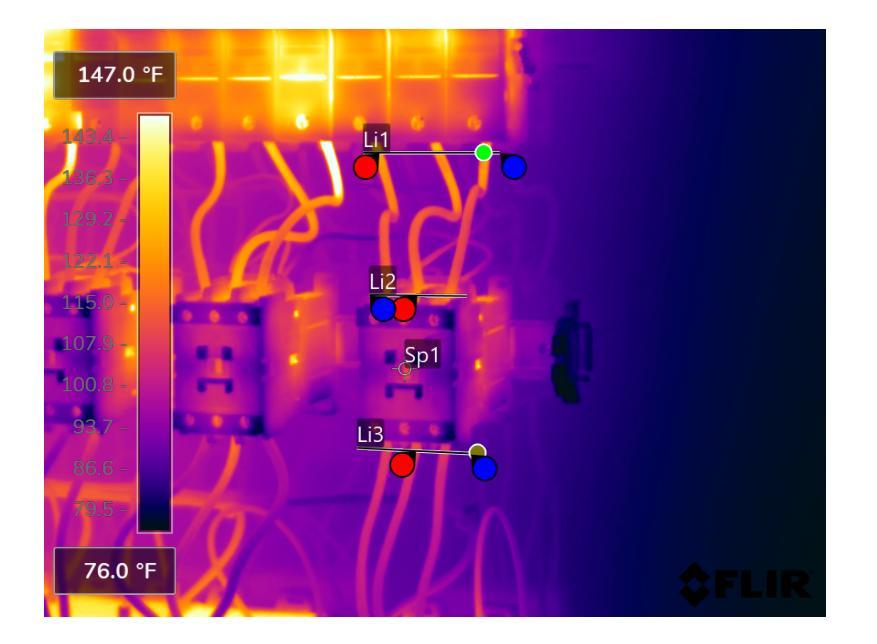
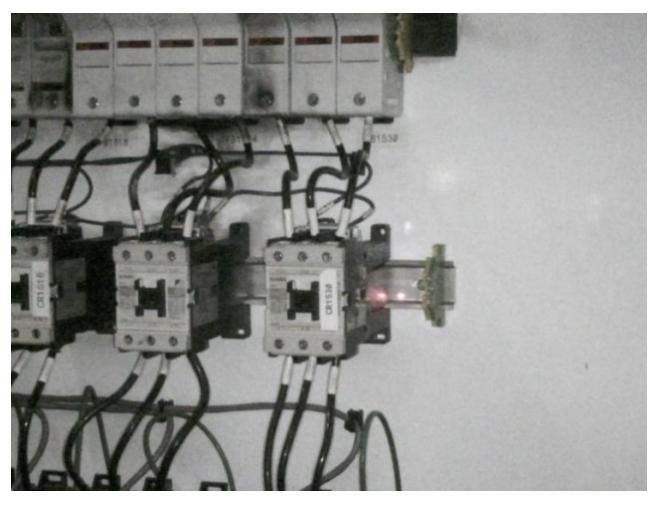
(RECHECK) CR1530

VFD11XX CR1530

**Fault** None

Defect Rating None

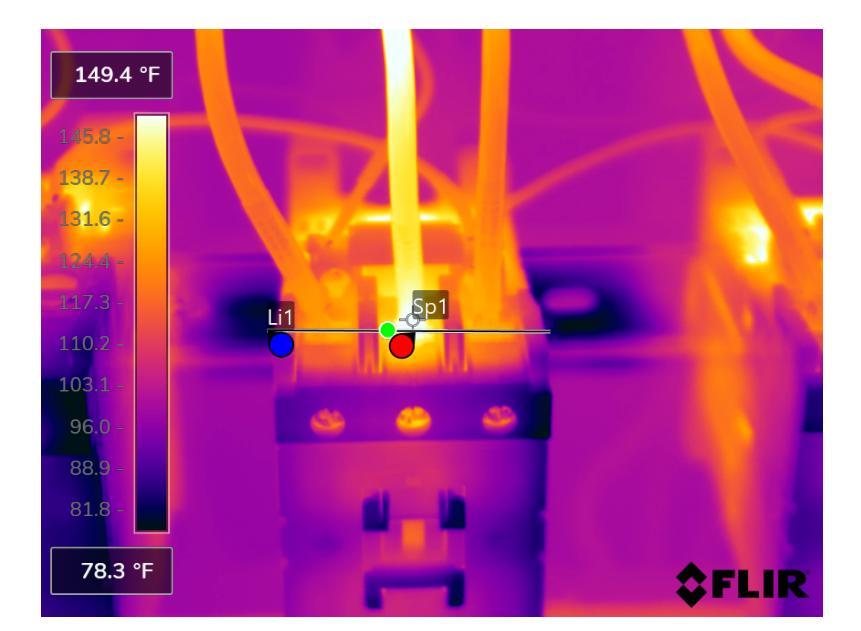
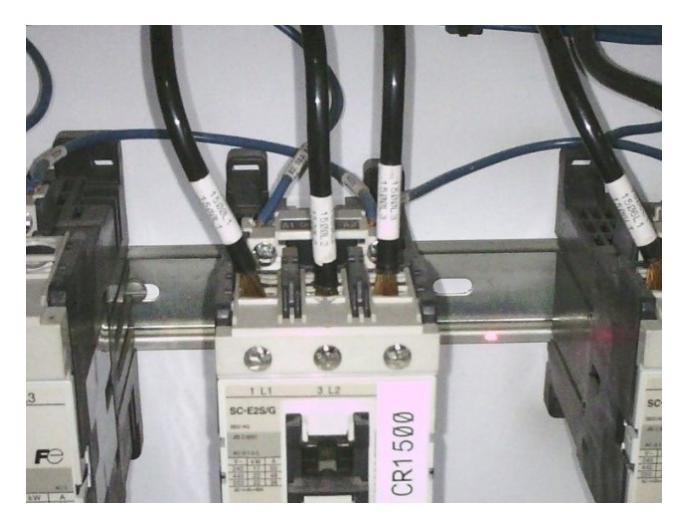
(RECHECK) CR1500

CR1500 VFD11XX Fiberglasss

Faulty connection

CLASS I

Recheck of CR1500 shows an issue still exists with the B phase line connection. Ensure connection is clean and tight. If connection is found tight, then an internal issue may exist with the control relay.

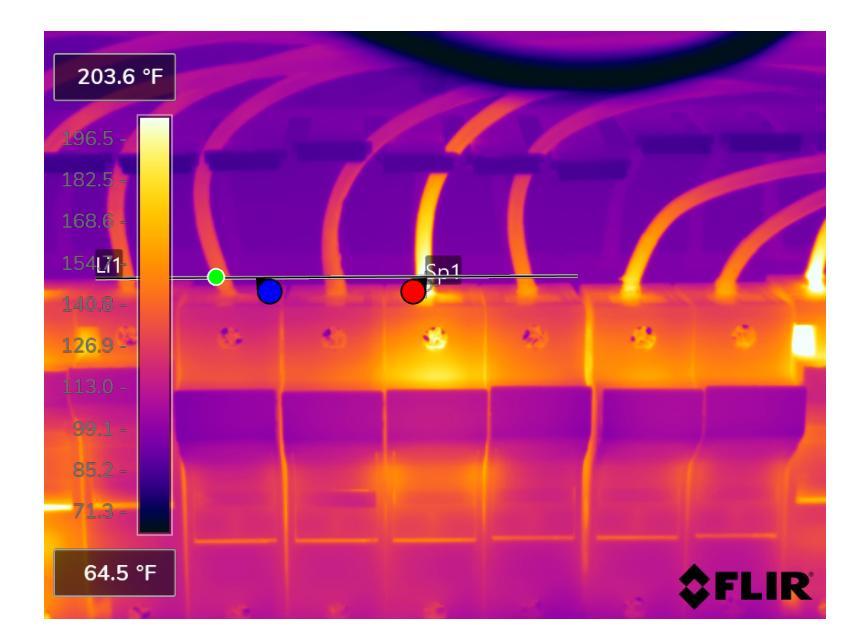
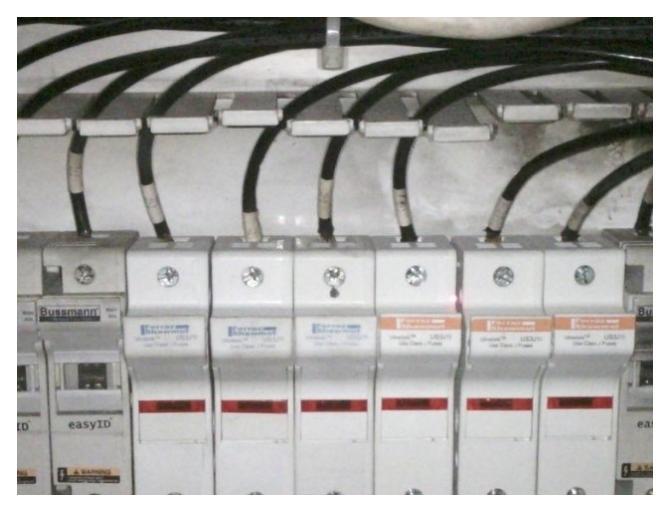
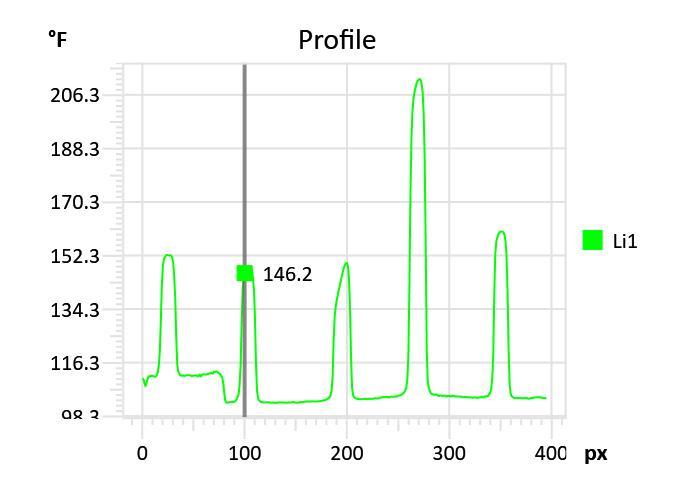
#### Lead connection

FB1506 VFD11XX Fiberglass

IR recheck image shows an issue with the fuse connection on the fuse with the black dot just under the screw. Check connection ensuring a clean and tight connection. If connection is found tight, then the fuse may have internal issue.

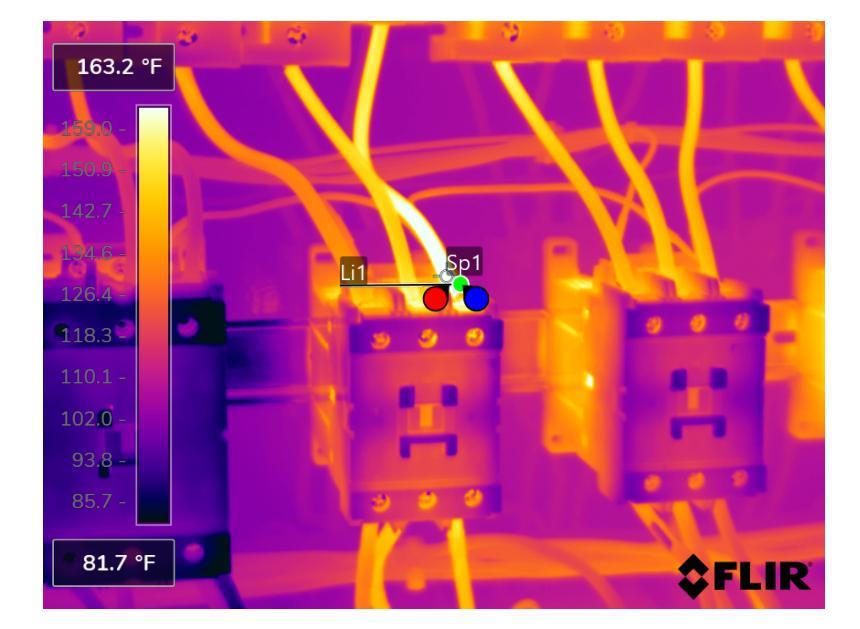
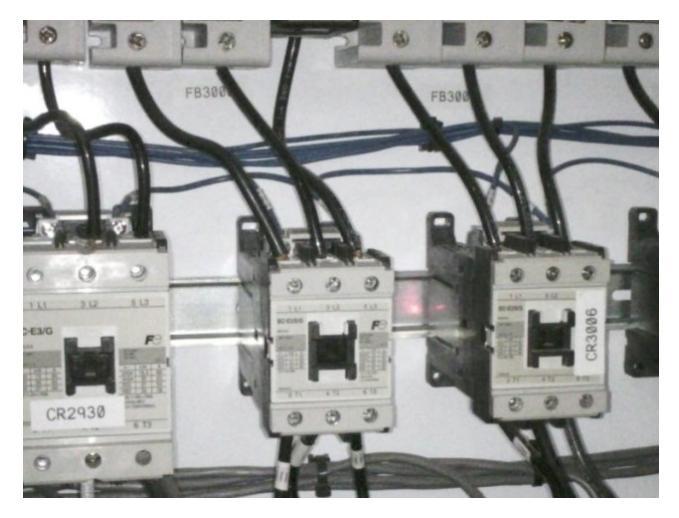
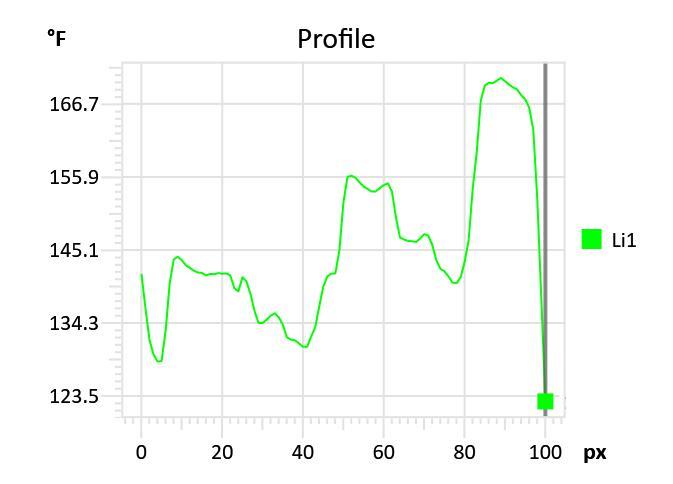
(RECHECK) CR3000

CR3000 VFD26XX Fiberglass

Recheck of CR3000 shows an issue still exists with the C phase line connection. Ensure connection is clean and tight. If connection is found tight, then an internal issue may exist with the control relay.

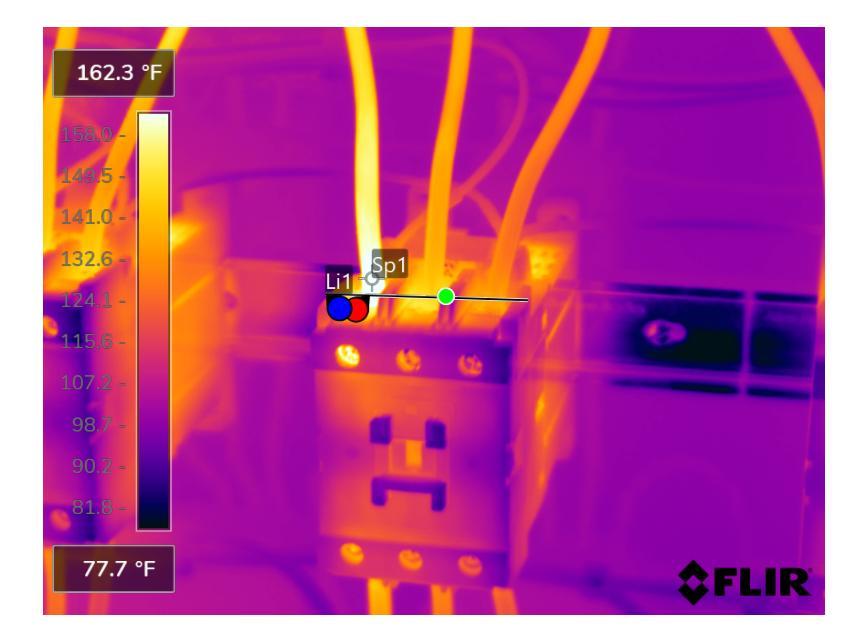
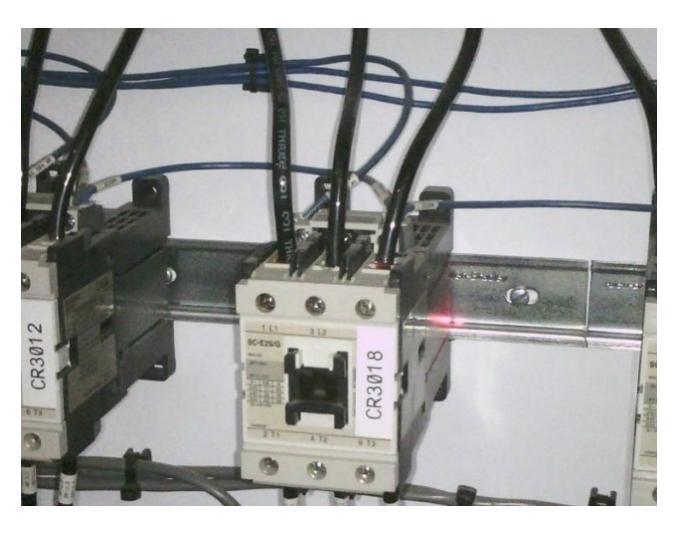
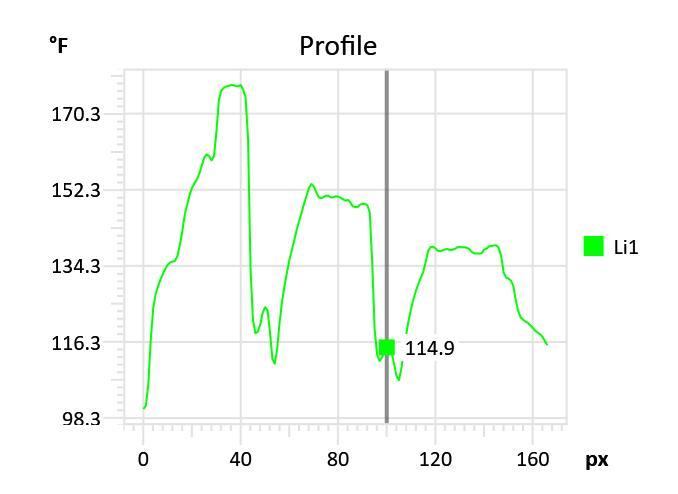
(RECHECK) CR3018

CR3018 2nd Pass Heater Panel

Recheck of CR3000 shows an issue still exists with the A phase line connection. Ensure connection is clean and tight. If connection is found tight, then an internal issue may exist with the control relay.

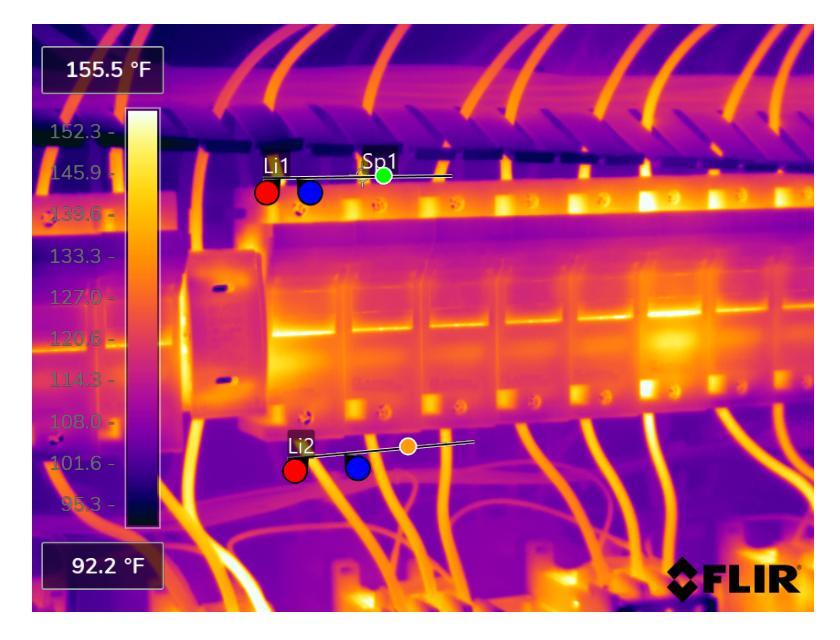
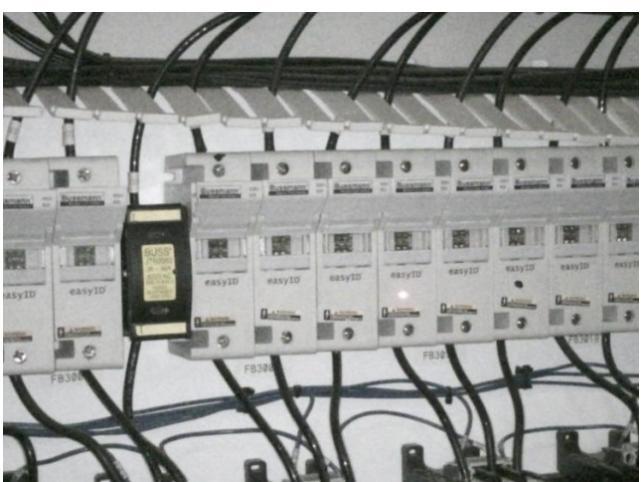
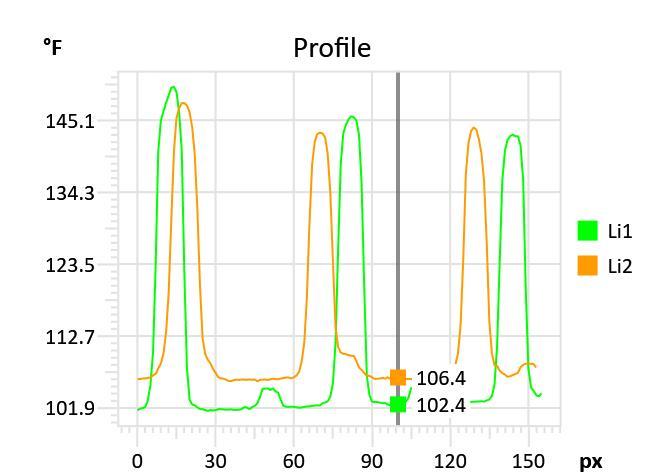
(RECHECK) FB3006

FB3006 2nd Pass Heater Panel Fiberglasss

Recheck scan shows no issues after repairs to FB3006.

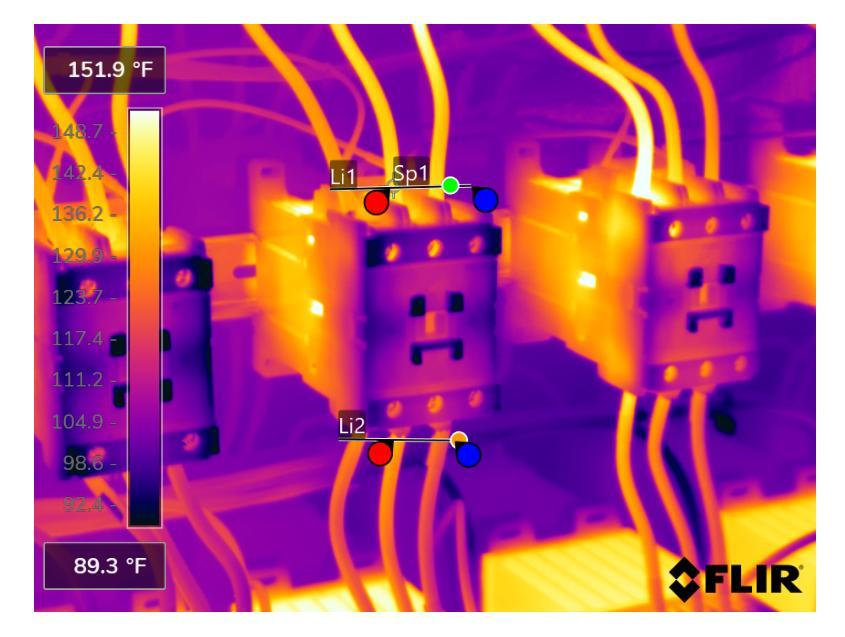
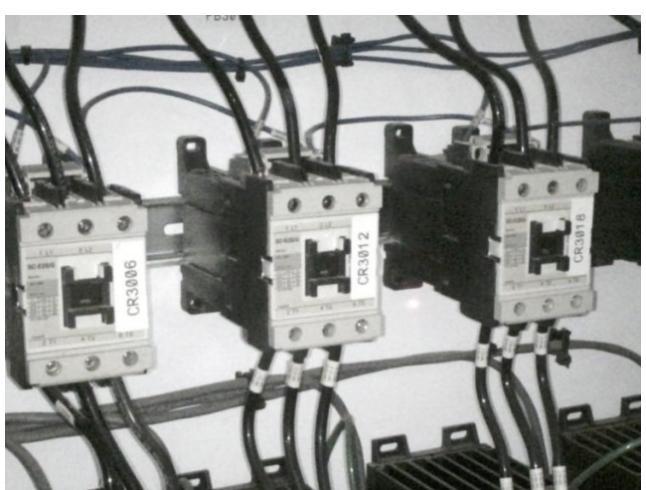
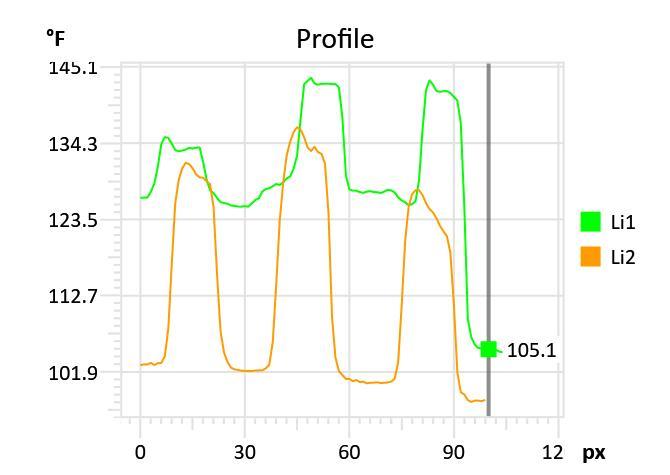
(RECHECK) CR3012

CR3012 2nd Pass Heater Panel Fiberglass

# Fault None Defect Rating None

Recheck scan shows no issues after repairs to CR3012.

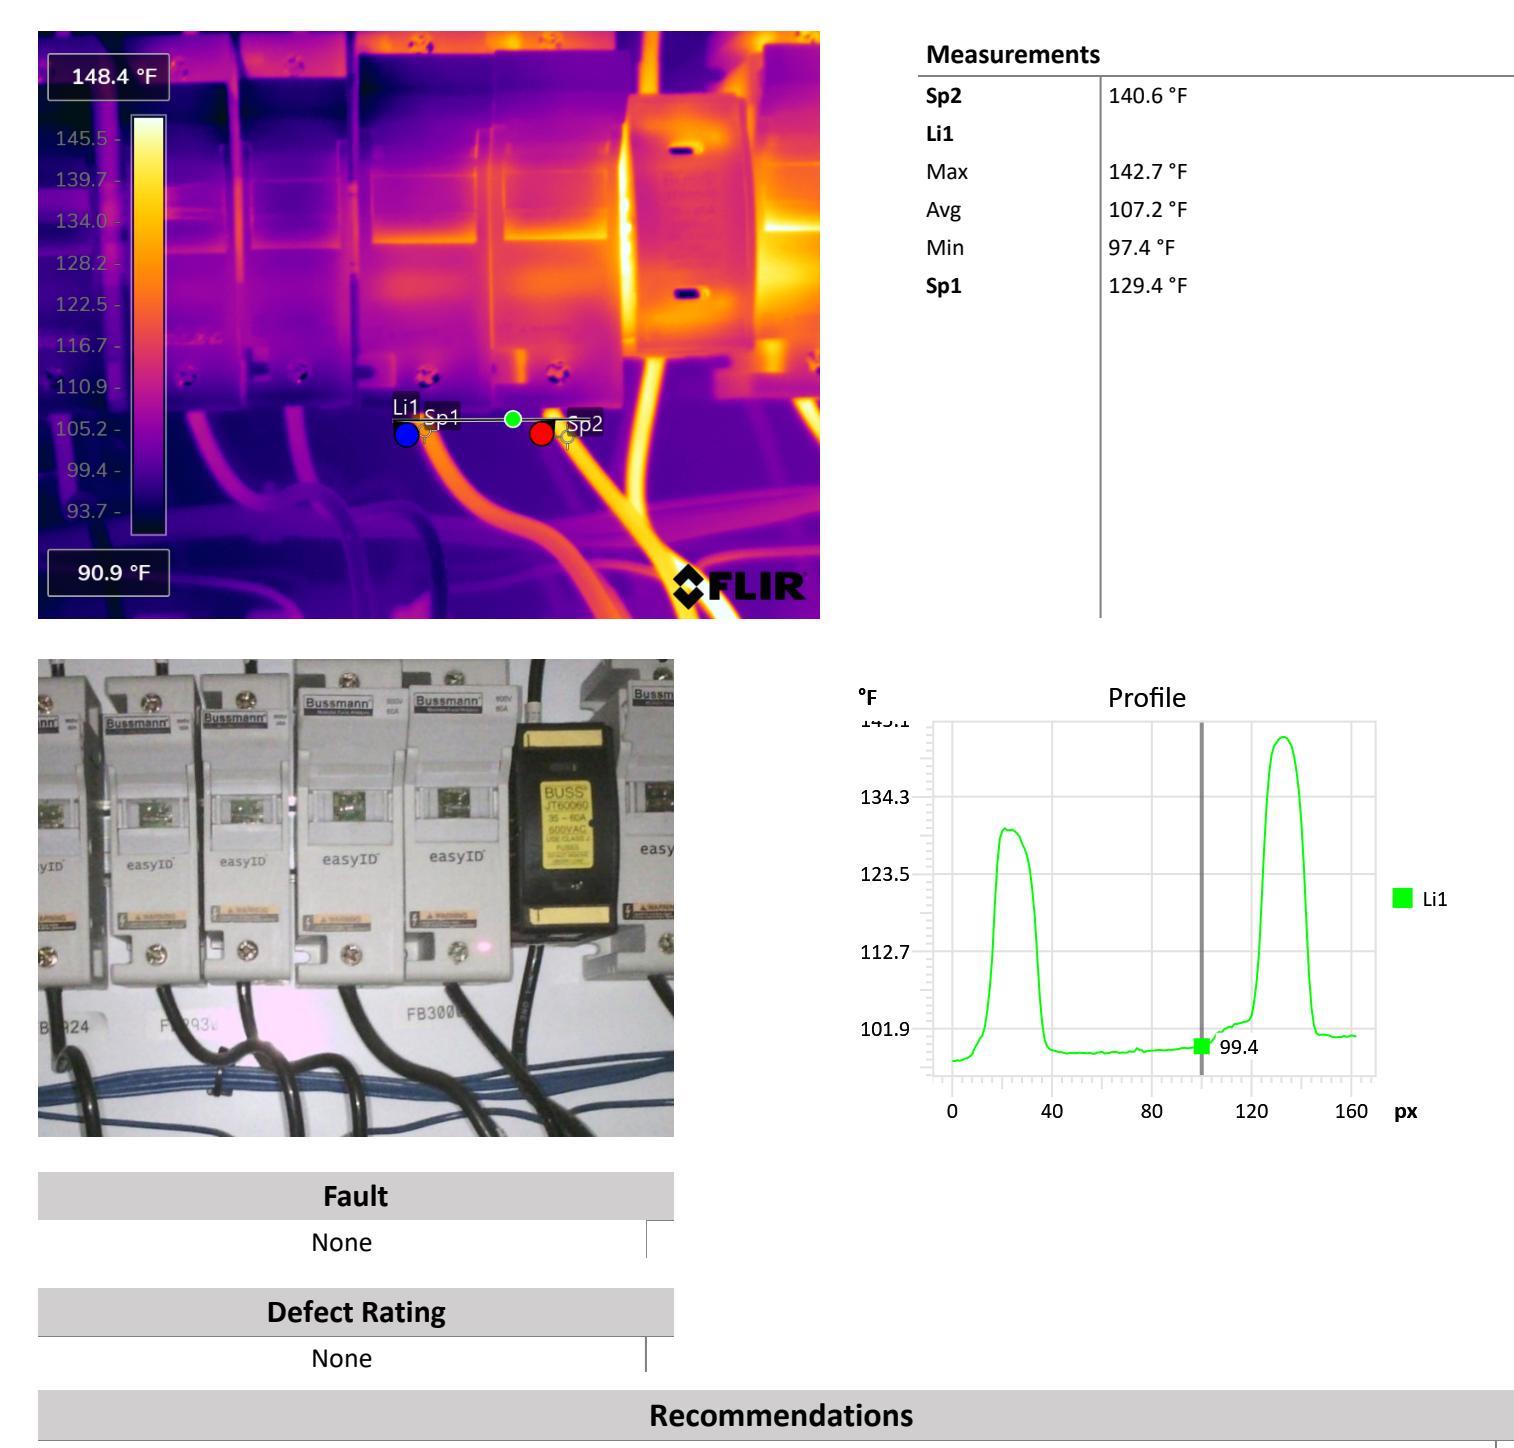
(RECHECK) FB3000

FB3000 2nd Pass Heater Panel Fiberglass

Recheck image for an issue found back in 2021 shows no issues after repairs to FB3000. WO from 8/21 showed component to be labeled 3030, but this was an error on our report from 2021. Issue was on FB3000 and new image shows no issues.
