USG Greenville, MS September 2023 Infrared Survey Report

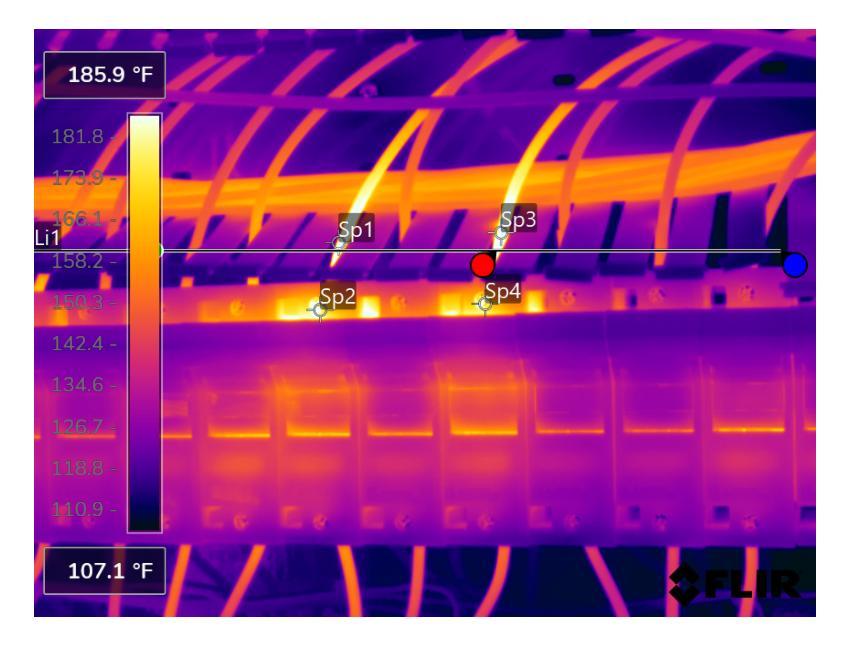
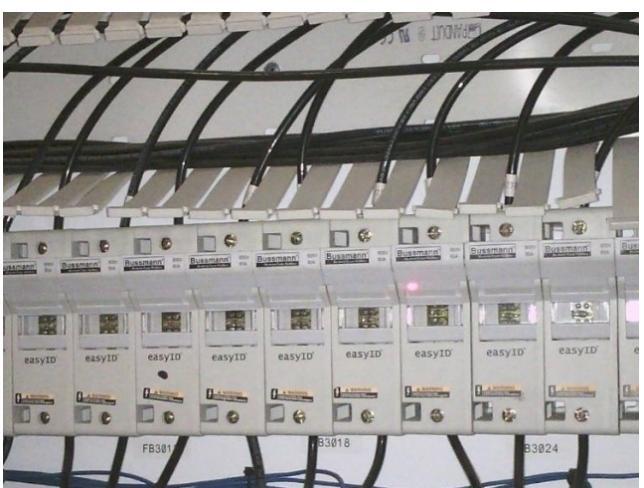
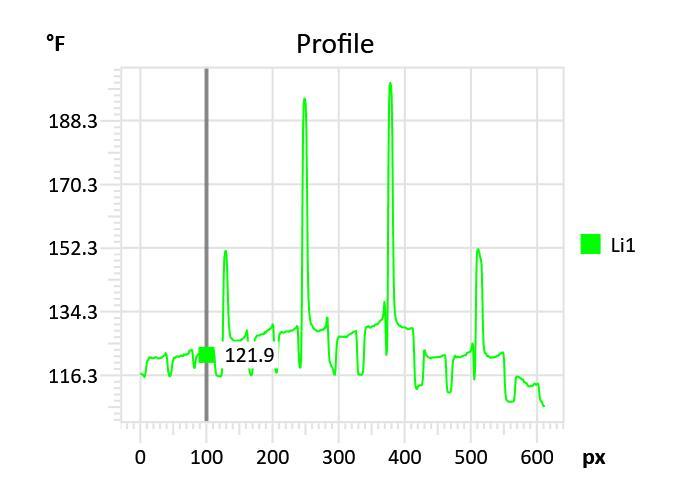
VFD26XX Fiberglass 2nd Pass Paint Heater Panel

Connections

Measurements		
Sp2	180.5 °F	
Sp3	195.4 °F	
Sp4	173.3 °F	
Li1		
Max	199.0 °F	
Avg	125.2 °F	
Min	107.4 °F	
Sp1	189.4 °F

IR shows likely issue with connections. These connections are near FB3018 fused component. Check connections, ensuring a clean and tight connection.

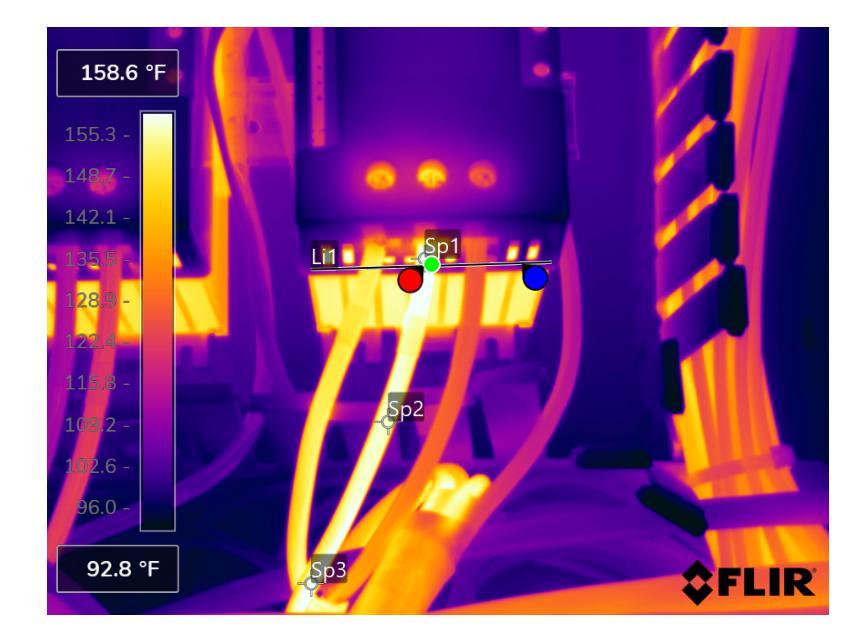
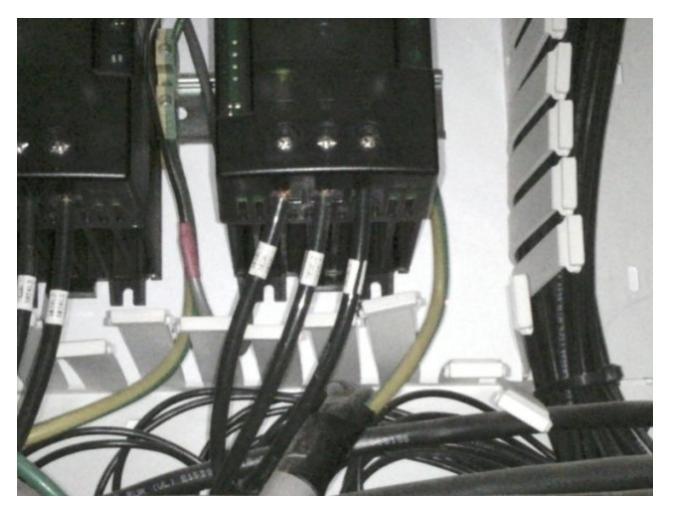
VFD26XX SCR3030

Load side leads

Measurements		
Sp2	156.7 °F	
Sp3	158.4 °F	
Li1		
Max	161.0 °F	
Avg	121.7 °F	
Min	102.4 °F	
Sp1	160.5 °F

Fault Unbalanced load/connection issue

> Defect Rating CLASS I

B phase appears to have higher temp than A and C. C phase appears to have a low temp compared to the other two phases. Check load on each phase and check connections.

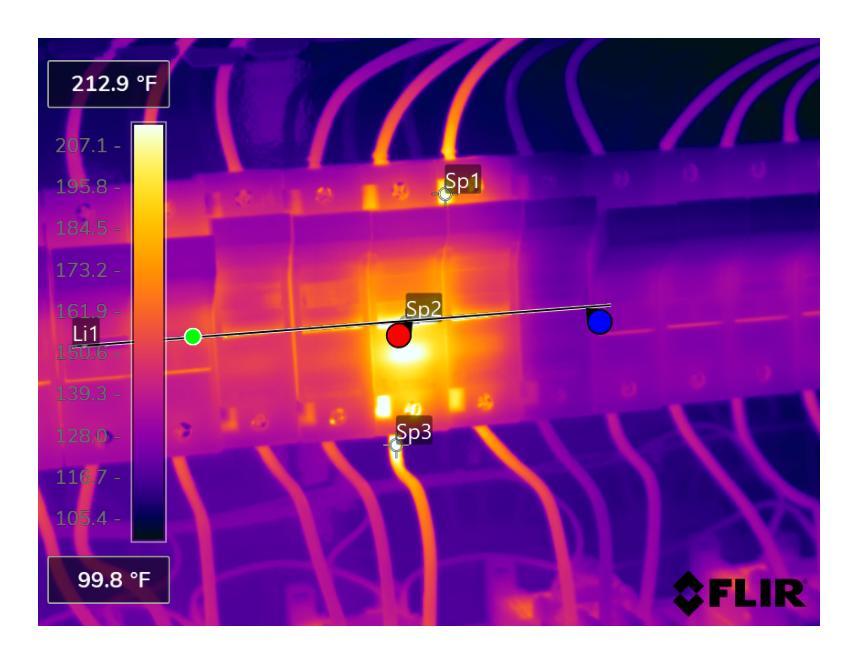
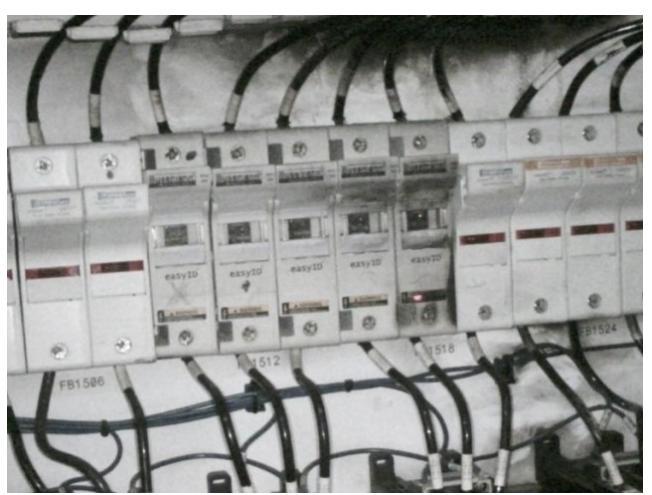
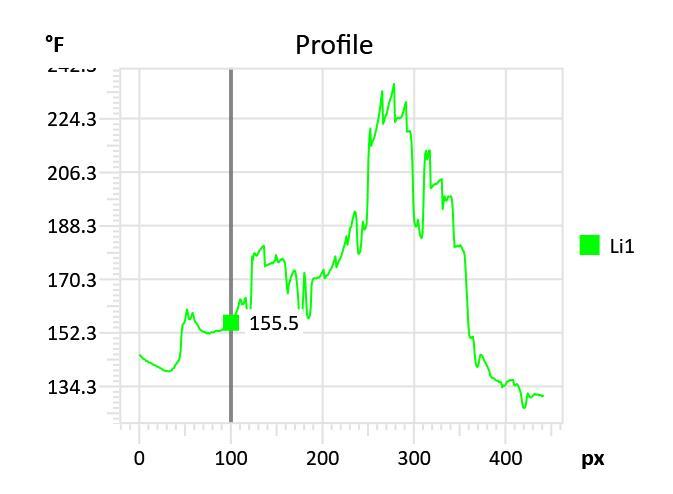
FB1512 VFD11XX

Fused Component

Measurements			
*253.7 °F			
225.9 °F			
236.0 °F			
169.2 °F			
127.1 °F			
211.5 °F			
211.5 °F			
	*253.7 °F 225.9 °F 236.0 °F 169.2 °F 127.1 °F 211.5 °F

Fused component marked FB1512 appears to be bad. Replace component and ensure all conections are good.
