Agitator 741 Motion Amplification Study, West Lake Chemical Aberdeen, MS

1: Executive Summary

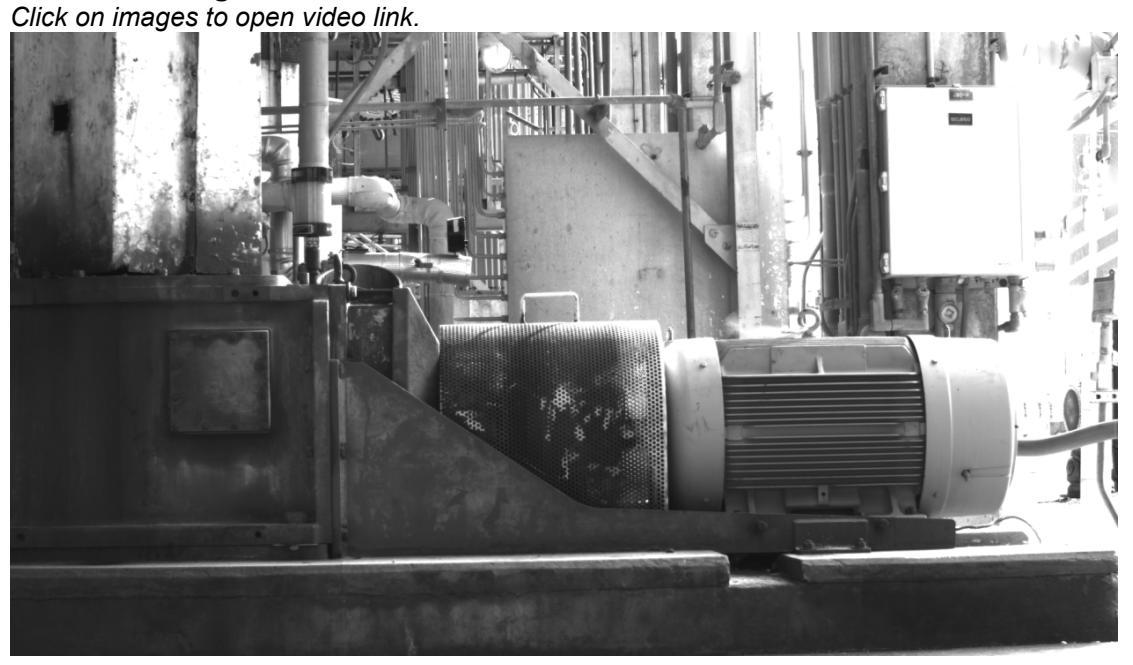
Figure 1: Motion Amplification, Side View of Motor and Gearbox

Figure 1 video link shows excessive motor movement in axial direction. Vibration data below supports MA video.

Motor also excessive movement according to MA video and vibration data helps confirm this. Motor base is also flexing but is likely an effect and not the cause. The excessive motor/base movement may be due to a combination of gearbox issues and issues with fluid coupling such as wear/misalignment. We highly recommend inspecting gearbox internals and fluid coupling for issues as soon as practical, Ensure base is secure and motor is aligned properly.

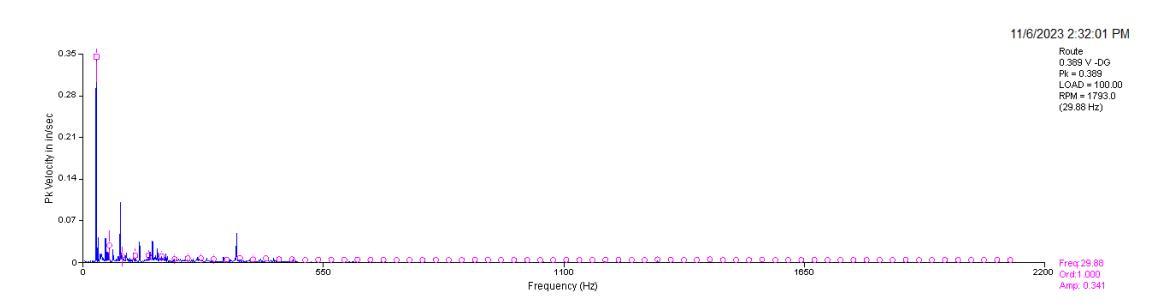
Figure 2: Spectral Data Plot, Motor Drive End Axial (MIA)

Figure 2 shows the MIA spectrum. Dominant vibration in the axial direction is at 1 \ensuremath{x} motor rpm.

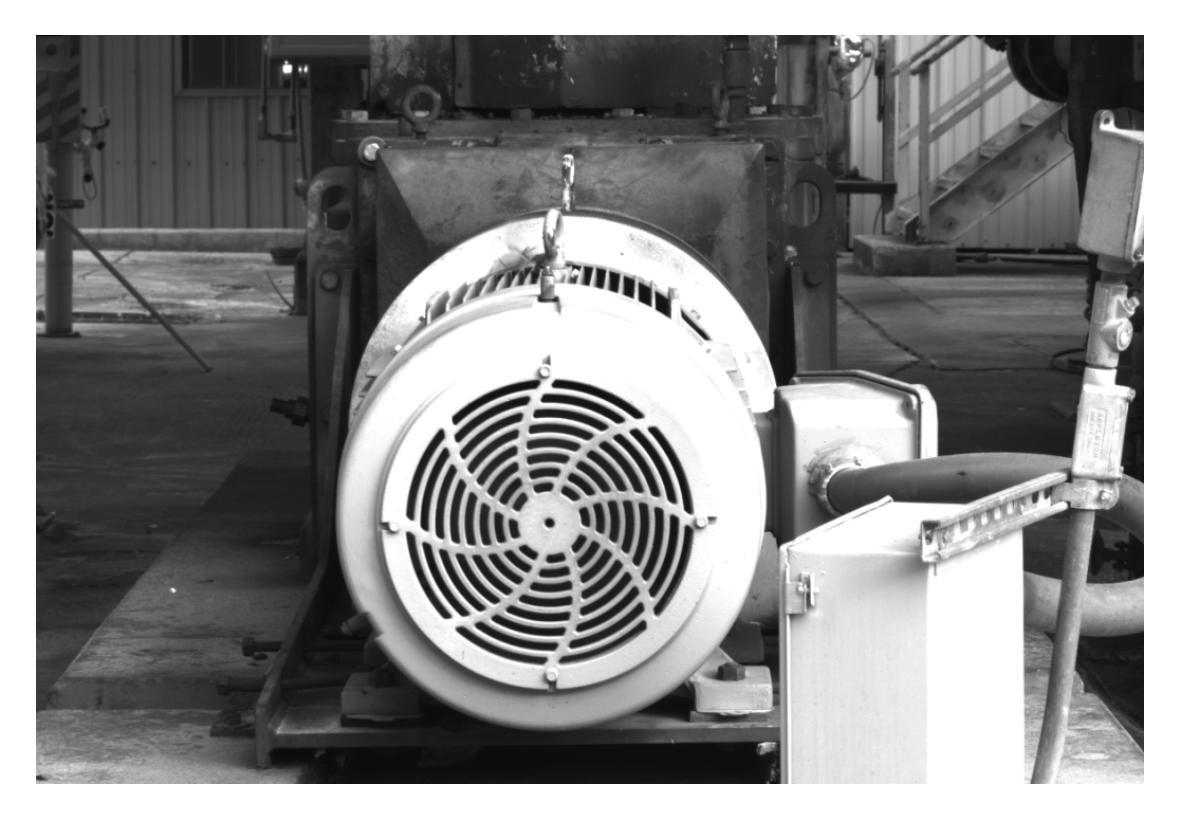
Figure 3: Motion Amplification, Front View of Motor

Figure 3 MA video shows excessive motor and base movement in vertical direction. Vibration data below support MA video.

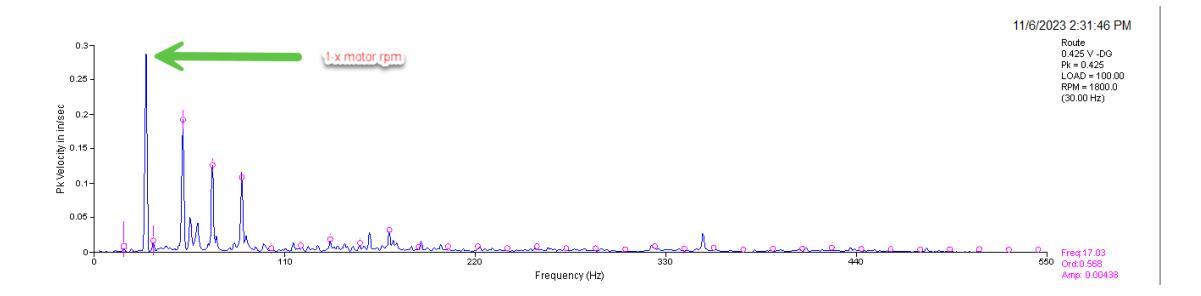
Figure 4: Spectral Data Plot, Motor Drive End Vertical (MIV)

Figure 4 shows the MIV spectrum. Notice that the highest peak of vibration is 1 x motor rpm. There are also several harmonics of 17.03 Hz This is a sub-synchronous frequency that is likely related to the gearbox.

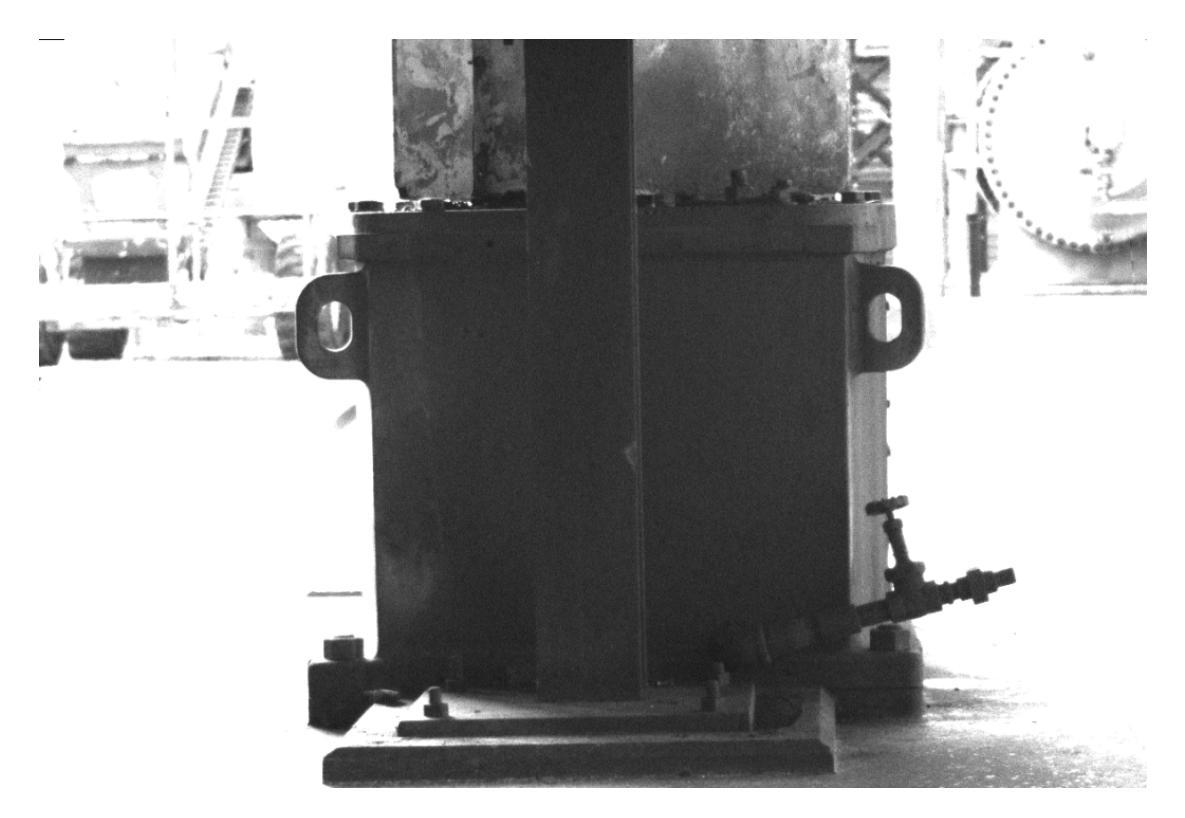
Figure 5: Motion Amplification, Back View of Gearbox

Figure 5 MA video shows some slight 1 x input and out rpm movement of the gearbox. Oil piping/valve shows some excessive movement (not a real issue here). Vibration data below supports MA video.

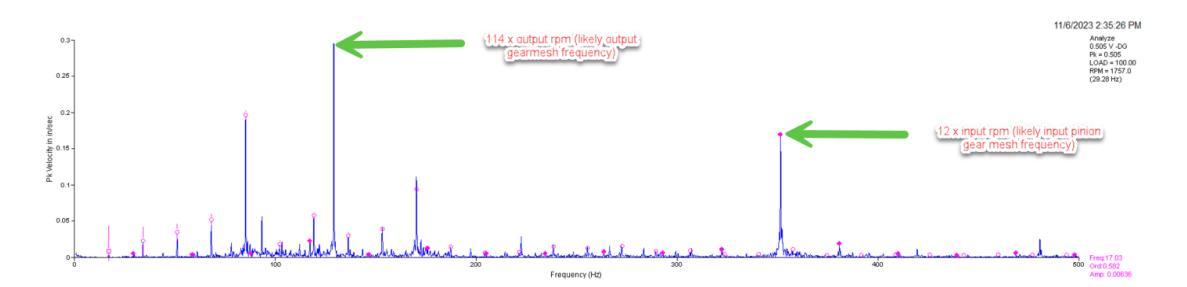
Figure 6: Spectral Data Plot, Gearbox Input Drive End Axial (GIA)

Figure 6 shows the GIA (input drive end axial) spectrum. Several harmonics in this spectrum are related to a speed of 17.03 Hz. This may be an intermediate shaft speed. 17.03 Hz is 15 x output speed and is likely the gear mesh frequency of the gear that is meshing with the output gear.
