Location: MOTOR SHOP LR Serial Number: A03187050800001M0001

Description:25 HP AERATOR

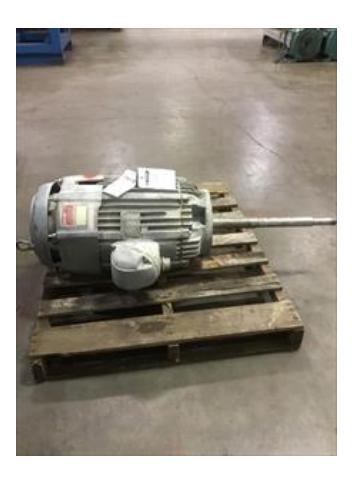
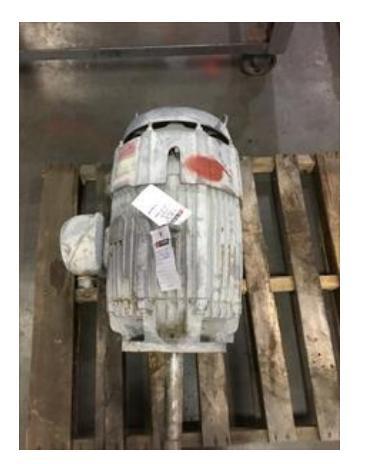
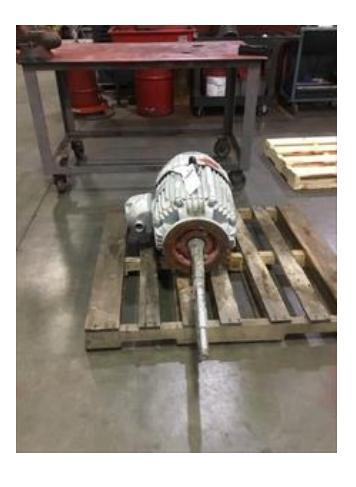
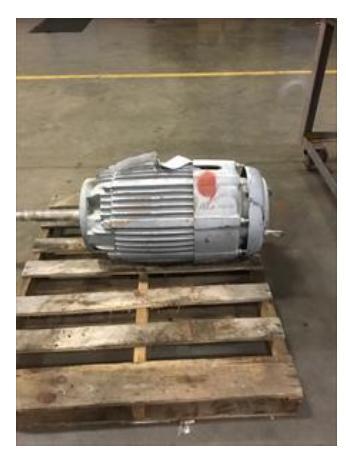
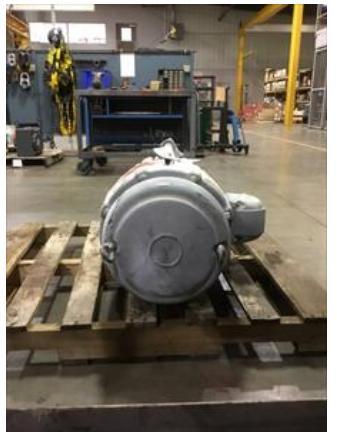
3. Photos of all six sides of the machine.

100 m				
	4.	Describe the Overall Condition of the Equipment as Rec	eived		
		Great condition. Shaft was bent .013" and seal surfaces w	ere wore. Recommended replacing	shaft.	
Ini	tial I	Mechanical/Electrical		0	
	5.	Does Shaft Turn Freely?		(Y) Yes	
	6.	Does the shaft require T.I.R in Lathe to identify additiona	Il repairs?	(No) No	
	7.	Does Shaft Have Visible Damage?		(Yes) Yes	P26
•	8.	Assembled Shaft Runout	due to additional demose on cost of	0.013 Inches	
		existing shaft.	aue to auditional damage on seal SL	ITAGES OF	
	9.	Assembled Shaft End Play		0.002 inches	
	10.	Air Gap Variation <10%	No	Provisions for measurement

62.	Bearing Cap Condition		P52
	Drive End Bearing Cap	Opposite Drive End Bearing Cap	
	Pass	N/A	
63.	End Bell Air Seal Fits		
	Drive End Air Seal	Opposite Drive End Air Seal	
	Pass	Pass	
64.	List Machine Work Needed Below		
	Recommend replacing shaft.		
65.	Technician		Brandon Woodard
Root C	ause of Failure		
66.	Failure locations		
	None		
67.	Root cause of failure		
	None

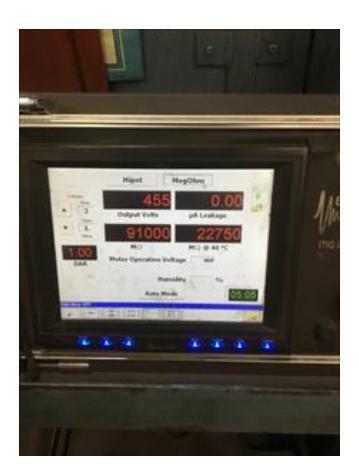
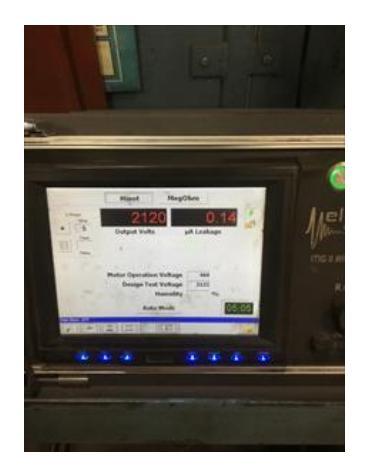
18. Insulation Resistance/Megger

92000 Megohms

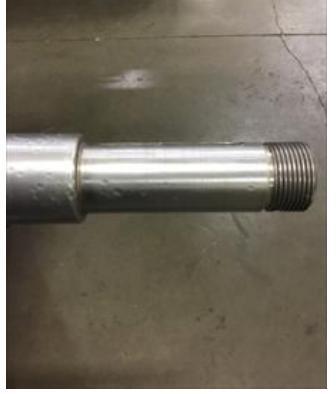
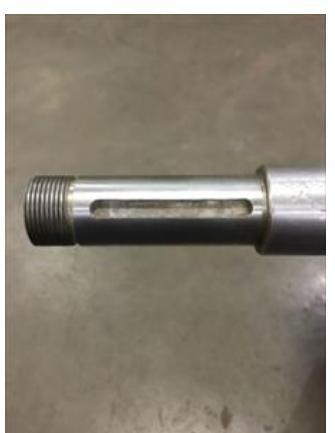
Mechanical Fits- Rotor				
49.	Shaft Runout		0.013 inches	
50.	Rotor Runout			
	Drive End Bearing Fit	Rotor Body	Opposite Drive End Bearing	
	0.002	0.002	0.003	
51.	Coupling Fit Closest to Bearing F	lousing		P33
	0 Degrees	90 Degrees	120 Degrees	
	2.375	2.375	2.375
