# P3, MS2P, MSP, 300 Ton, 800 Ton IFF Memphis April 2024 Infrared Survey Report

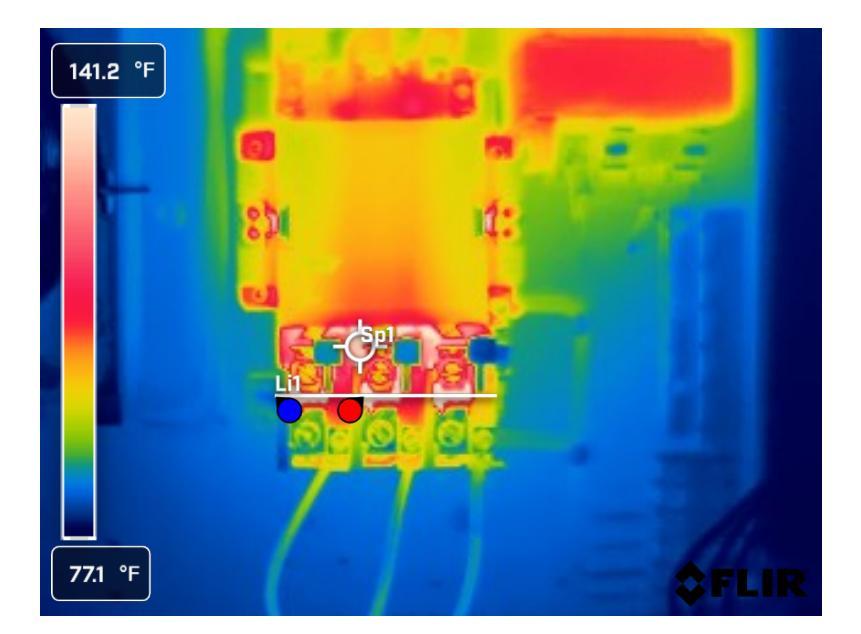
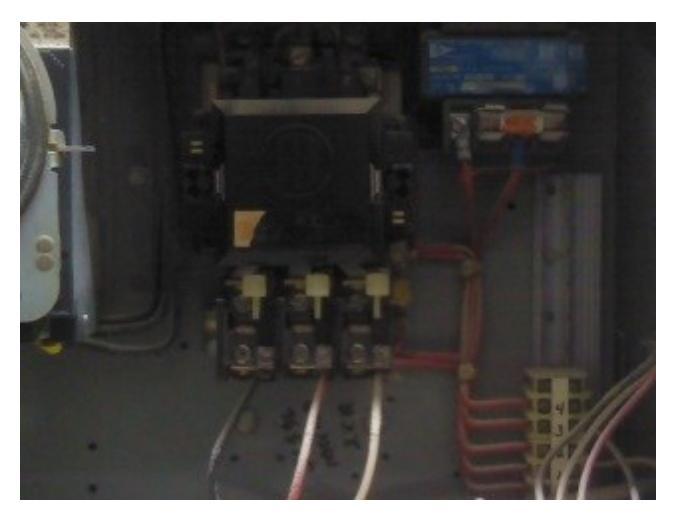
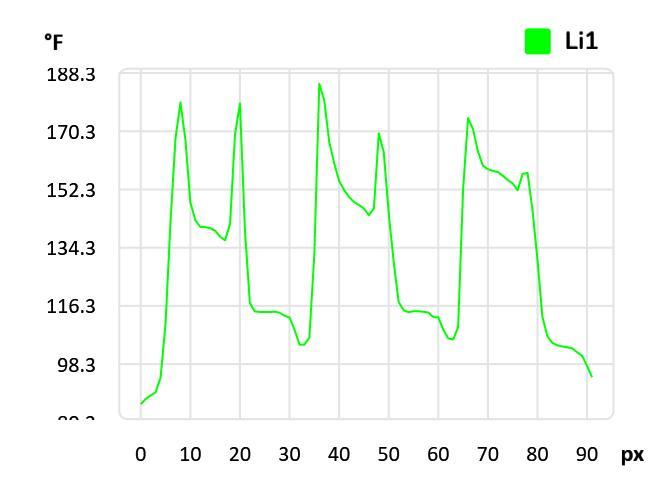
P3 Breaker #58 7283

#### **Thermal Heaters**

Li1		
Max	185.0 °F	
Avg	132.1 °F	
Min	86.0 °F	
Sp1	135.5 °F

Fault Weak Theraml Heaters Defect Rating CLASS I

IR image shows possible weak or undersized thermal heaters. Inspect heaters as time allows.

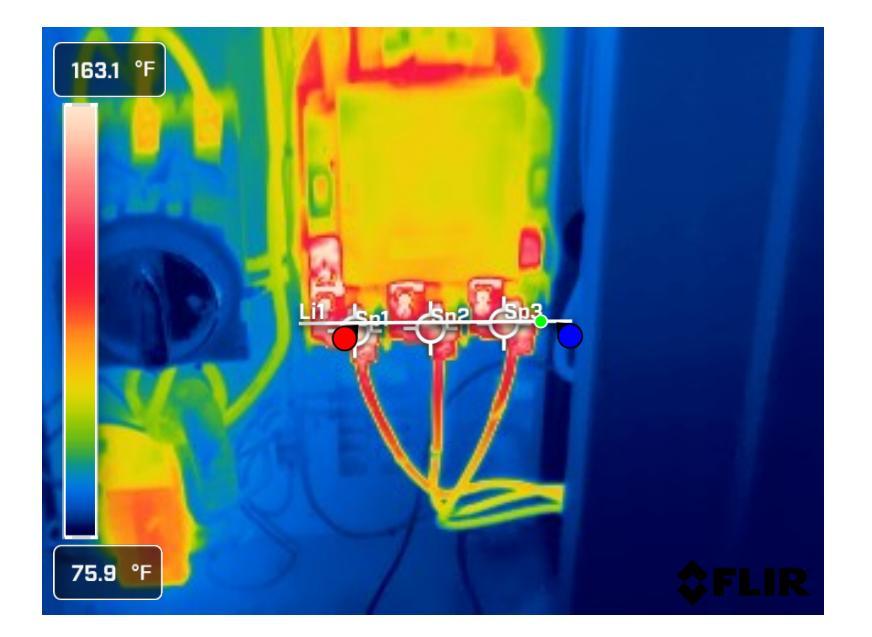
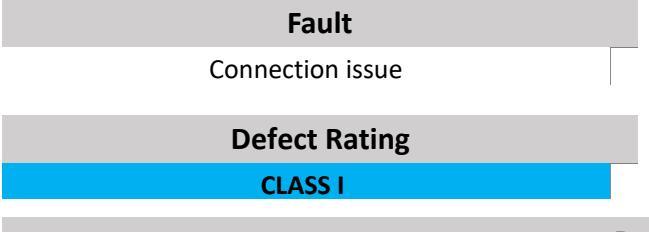
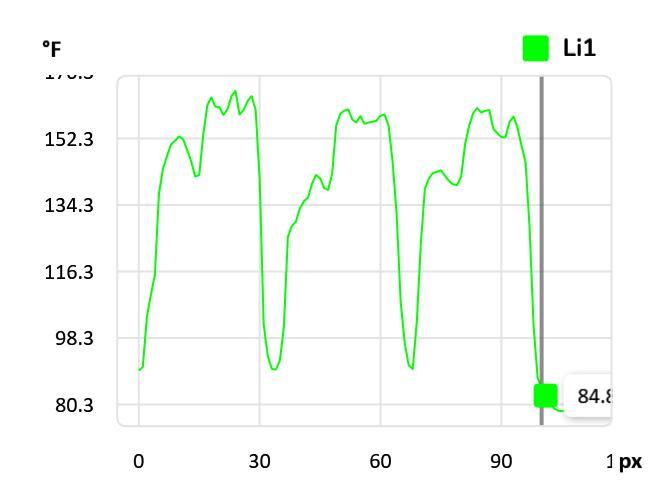
P3 Breaker #41

# Lug connections

Measurements		
165.2 °F		
133.7 °F		
78.5 °F		
166.7 °F		
154.6 °F		
157.3 °F		
	nents 165.2 °F 133.7 °F 78.5 °F 166.7 °F 154.6 °F 157.3 °F

IR image shows a possible issue with the connections at the external lugs or internally within the lugs of the contactor. Check connections ensuring a tight and clean connection.

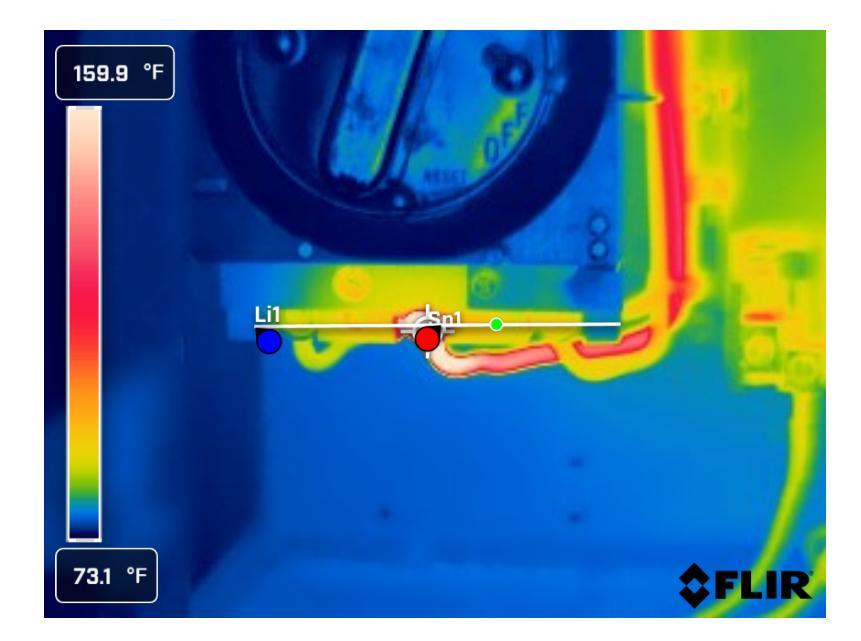
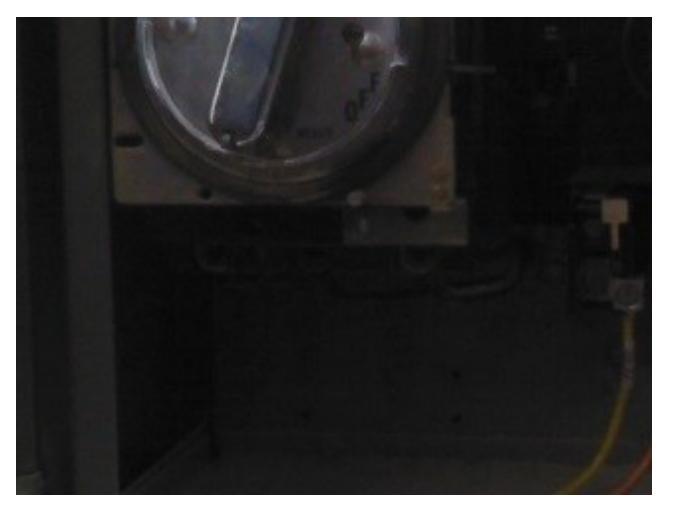
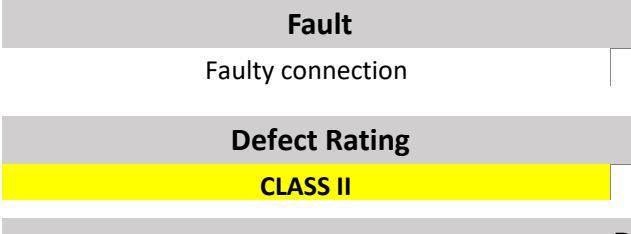
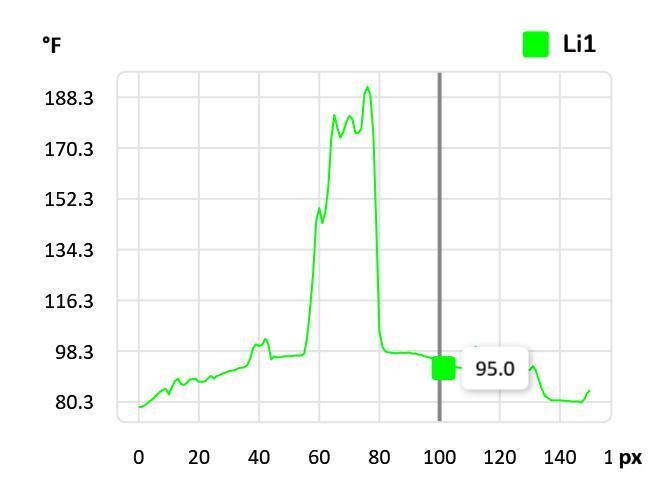
P3 Breaker #2 7246

Lead connection

Measurements		
Li1		
Max	192.0 °F	
Avg	102.9 °F	
Min	78.5 °F	
Sp1	188.0 °F

IR image shows a connection issue with the middle lead connection. Check connection ensuring a clean and tight connection.

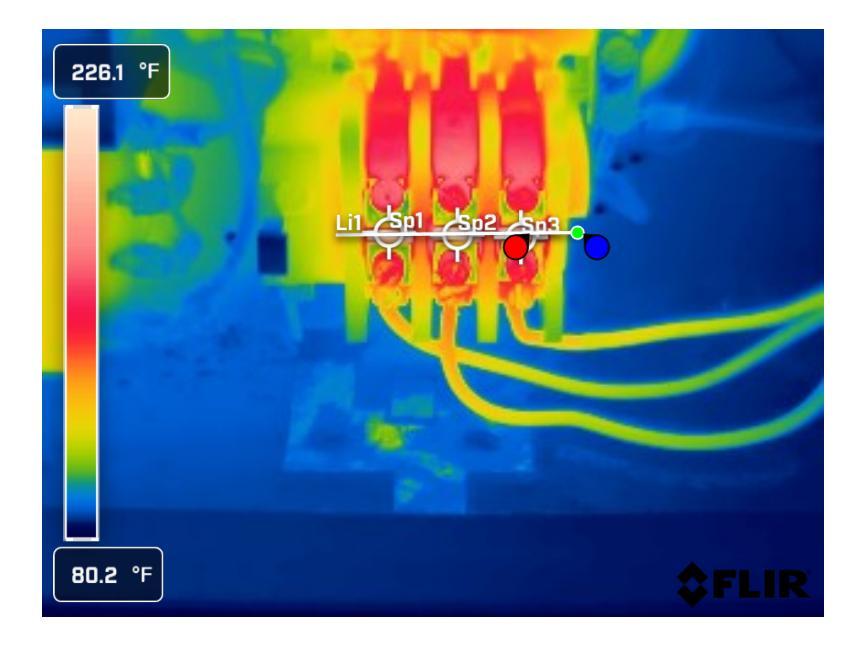
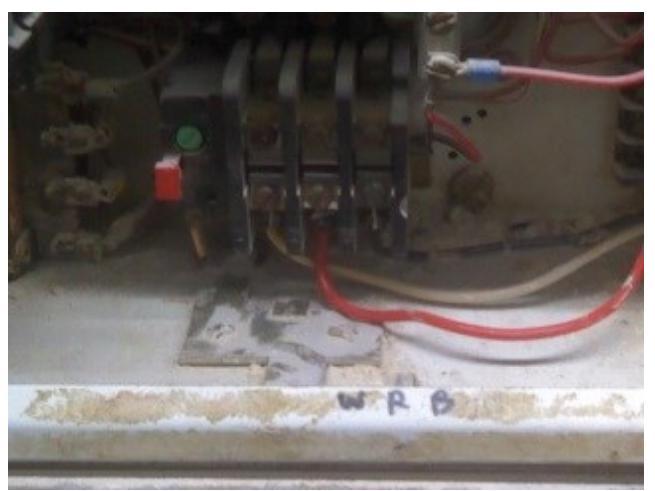
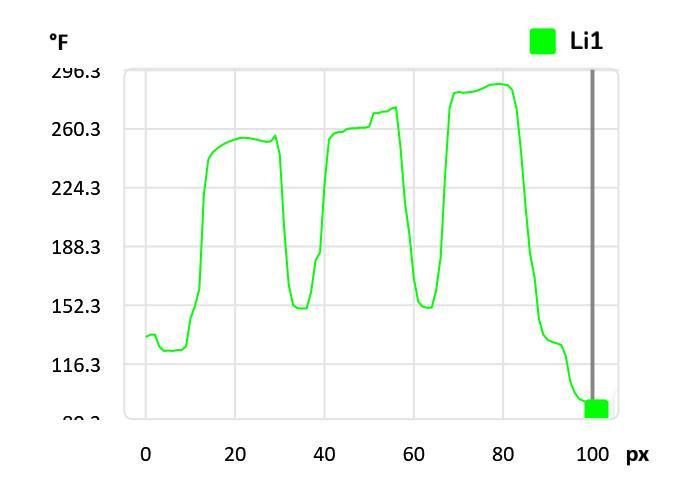
P3 Breaker #9 6378

**Thermal Heaters**

Measurements		
Li1		
Max	*288.0 °F	
Avg	*207.1 °F	
Min	91.8 °F	
Sp1	*260.5 °F	
Sp2	*261.8 °F	
Sp3	208.8 °F

Fault Weak Faulty Heaters Defect Rating CLASS II

IR image shows possible weak or undersized thermal heaters. Inspect heaters as time allows.

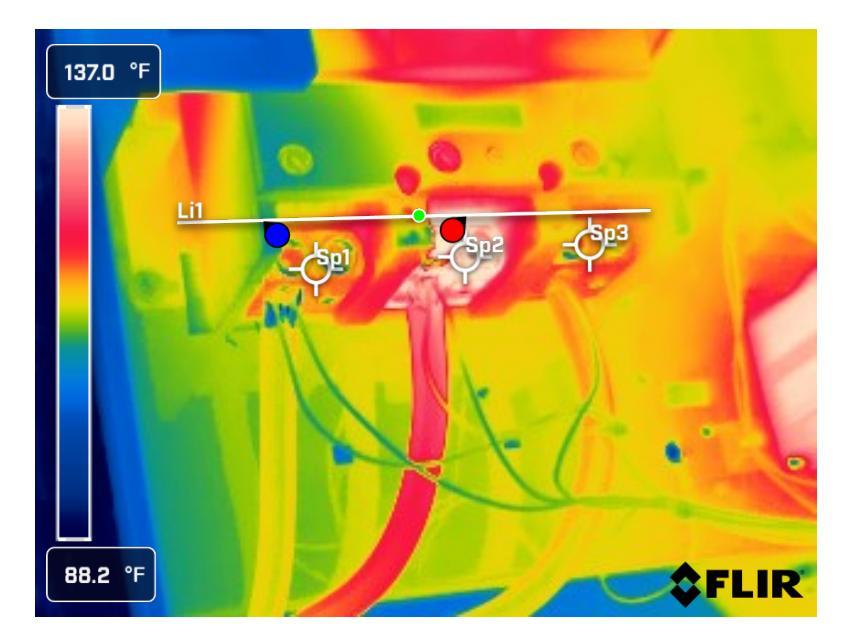
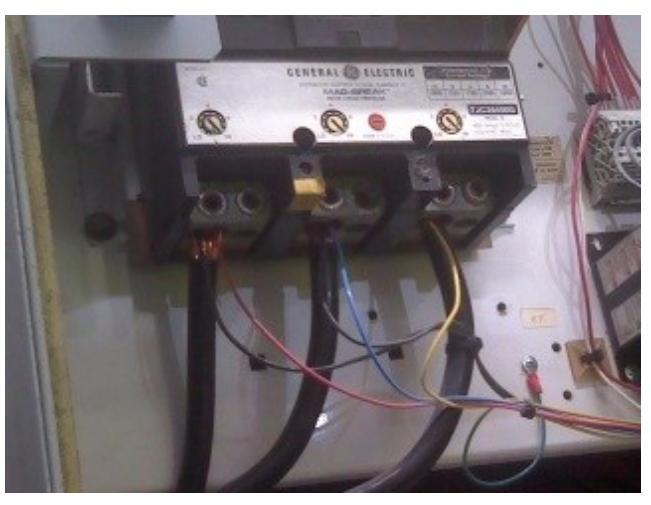
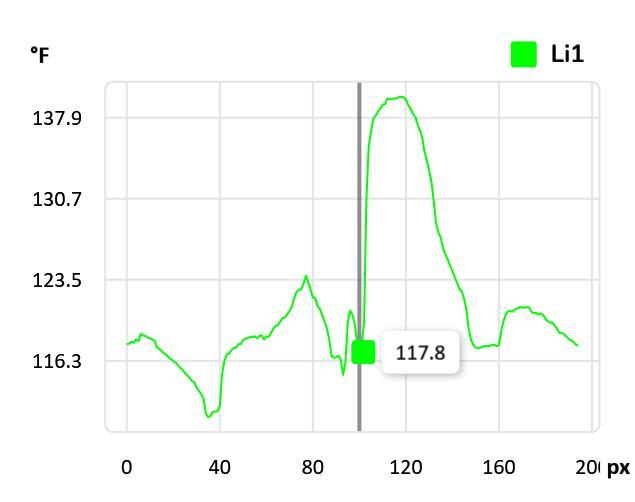
MS2P 141 3304 Breaker

#### Lead/lug connection

Measurements		
Li1		
Max	139.8 °F	
Avg	121.7 °F	
Min	111.3 °F	
Sp1	118.0 °F	
Sp2	136.7 °F	
Sp3	119.2 °F

Fault Faulty connection Defect Rating CLASS I

IR image shows an issue with the B phase connection. Ensure connection is clean and tight

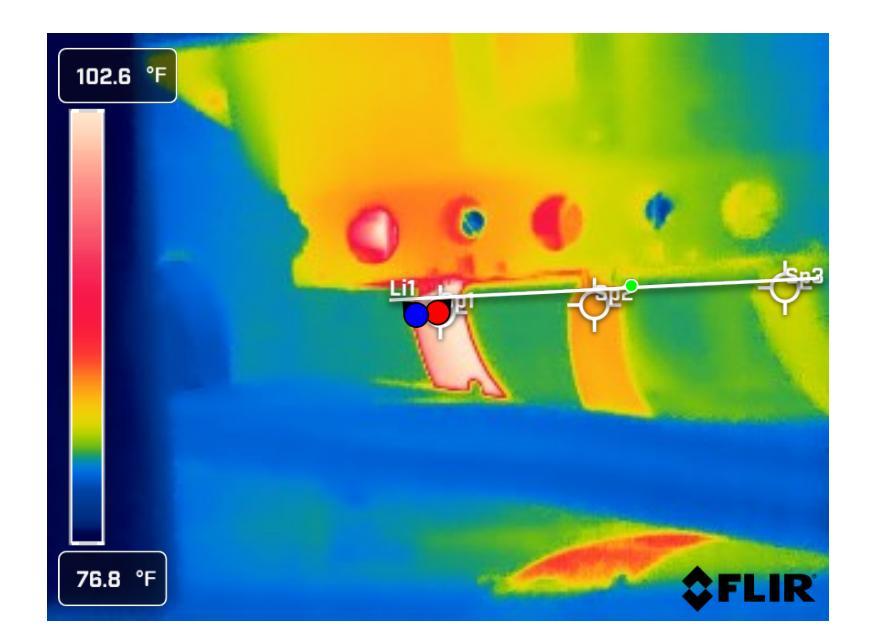
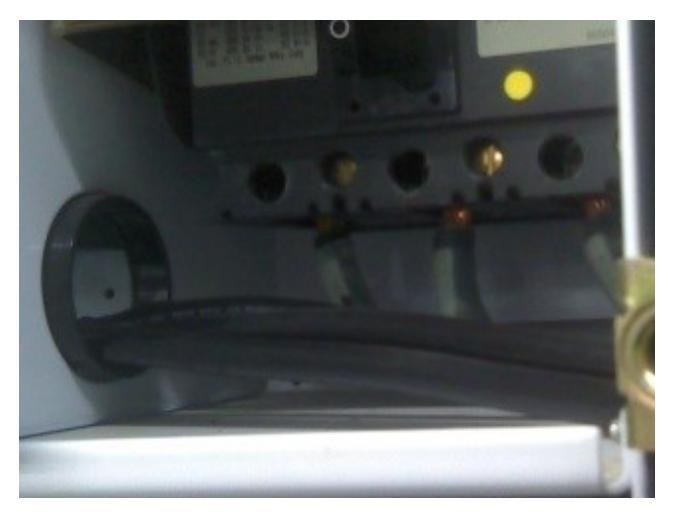
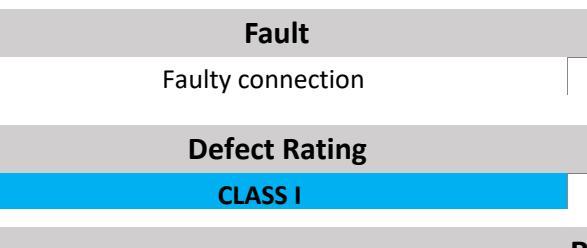
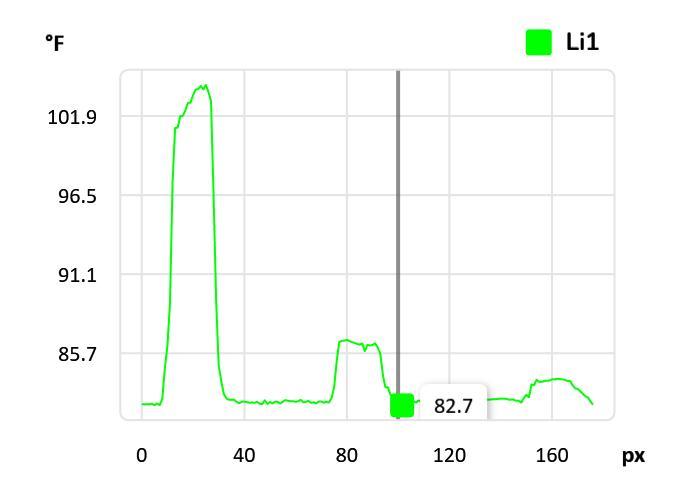
P3 #103

#### Lead connection

Measurer	nents	
Li1		
Max	104.1 °F	
Avg	85.1 °F	
Min	82.2 °F	
Sp1	102.5 °F	
Sp2	86.4 °F	
Sp3	83.9 °F

IR image shows a connection issue with the A phase lead. Check connection, ensuring a clean and tight connection.

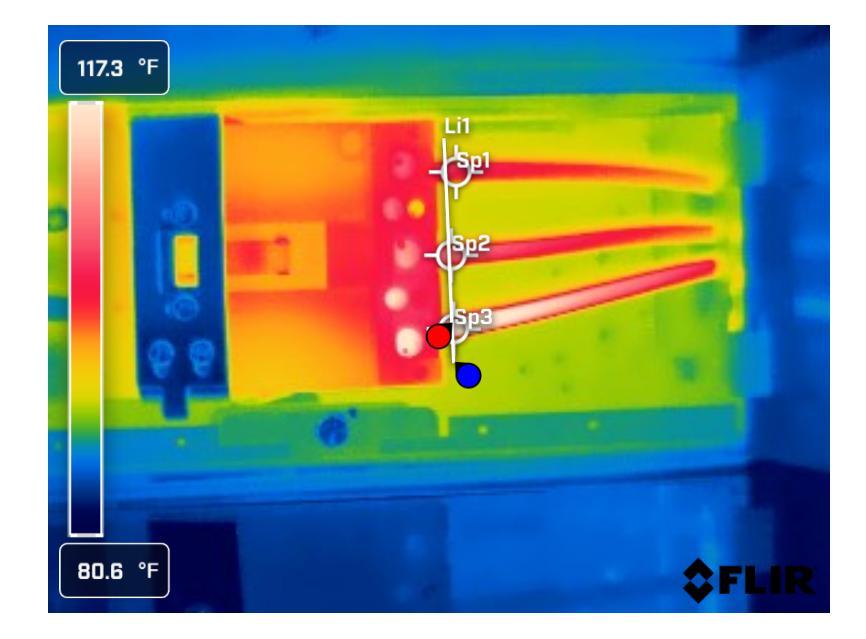
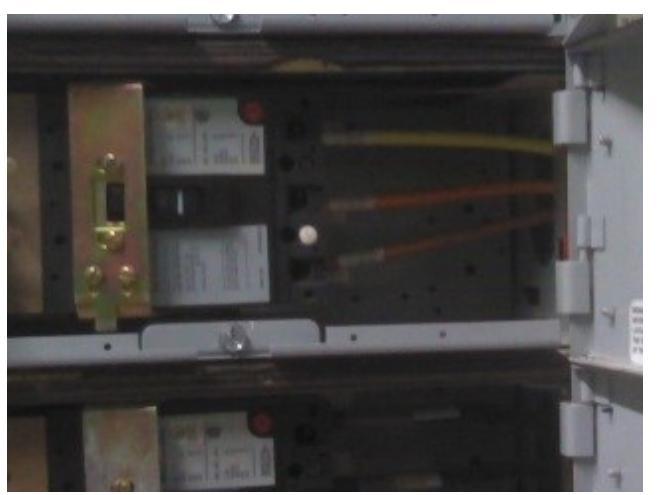
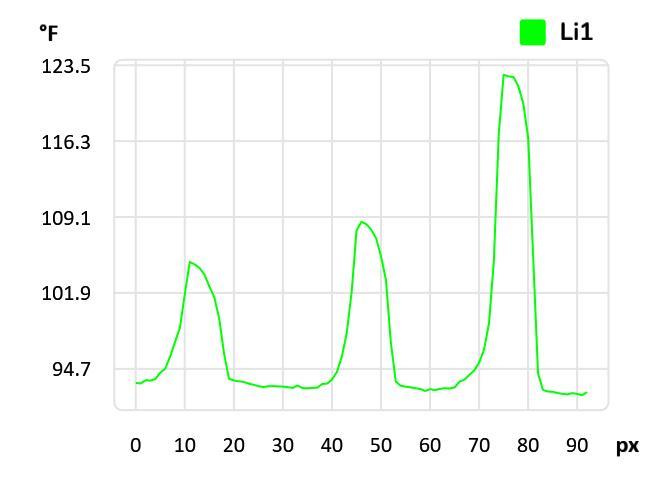
P3 #107

#### Lead connection

Measurements		
Li1		
Max	122.6 °F	
Avg	97.9 °F	
Min	92.2 °F	
Sp1	103.0 °F	
Sp2	107.7 °F	
Sp3	121.1 °F

IR image shows a connection issue with the C phase lead. Check connection, ensuring a clean and tight connection.
