October 2024 Electrical Infrared Survey Report

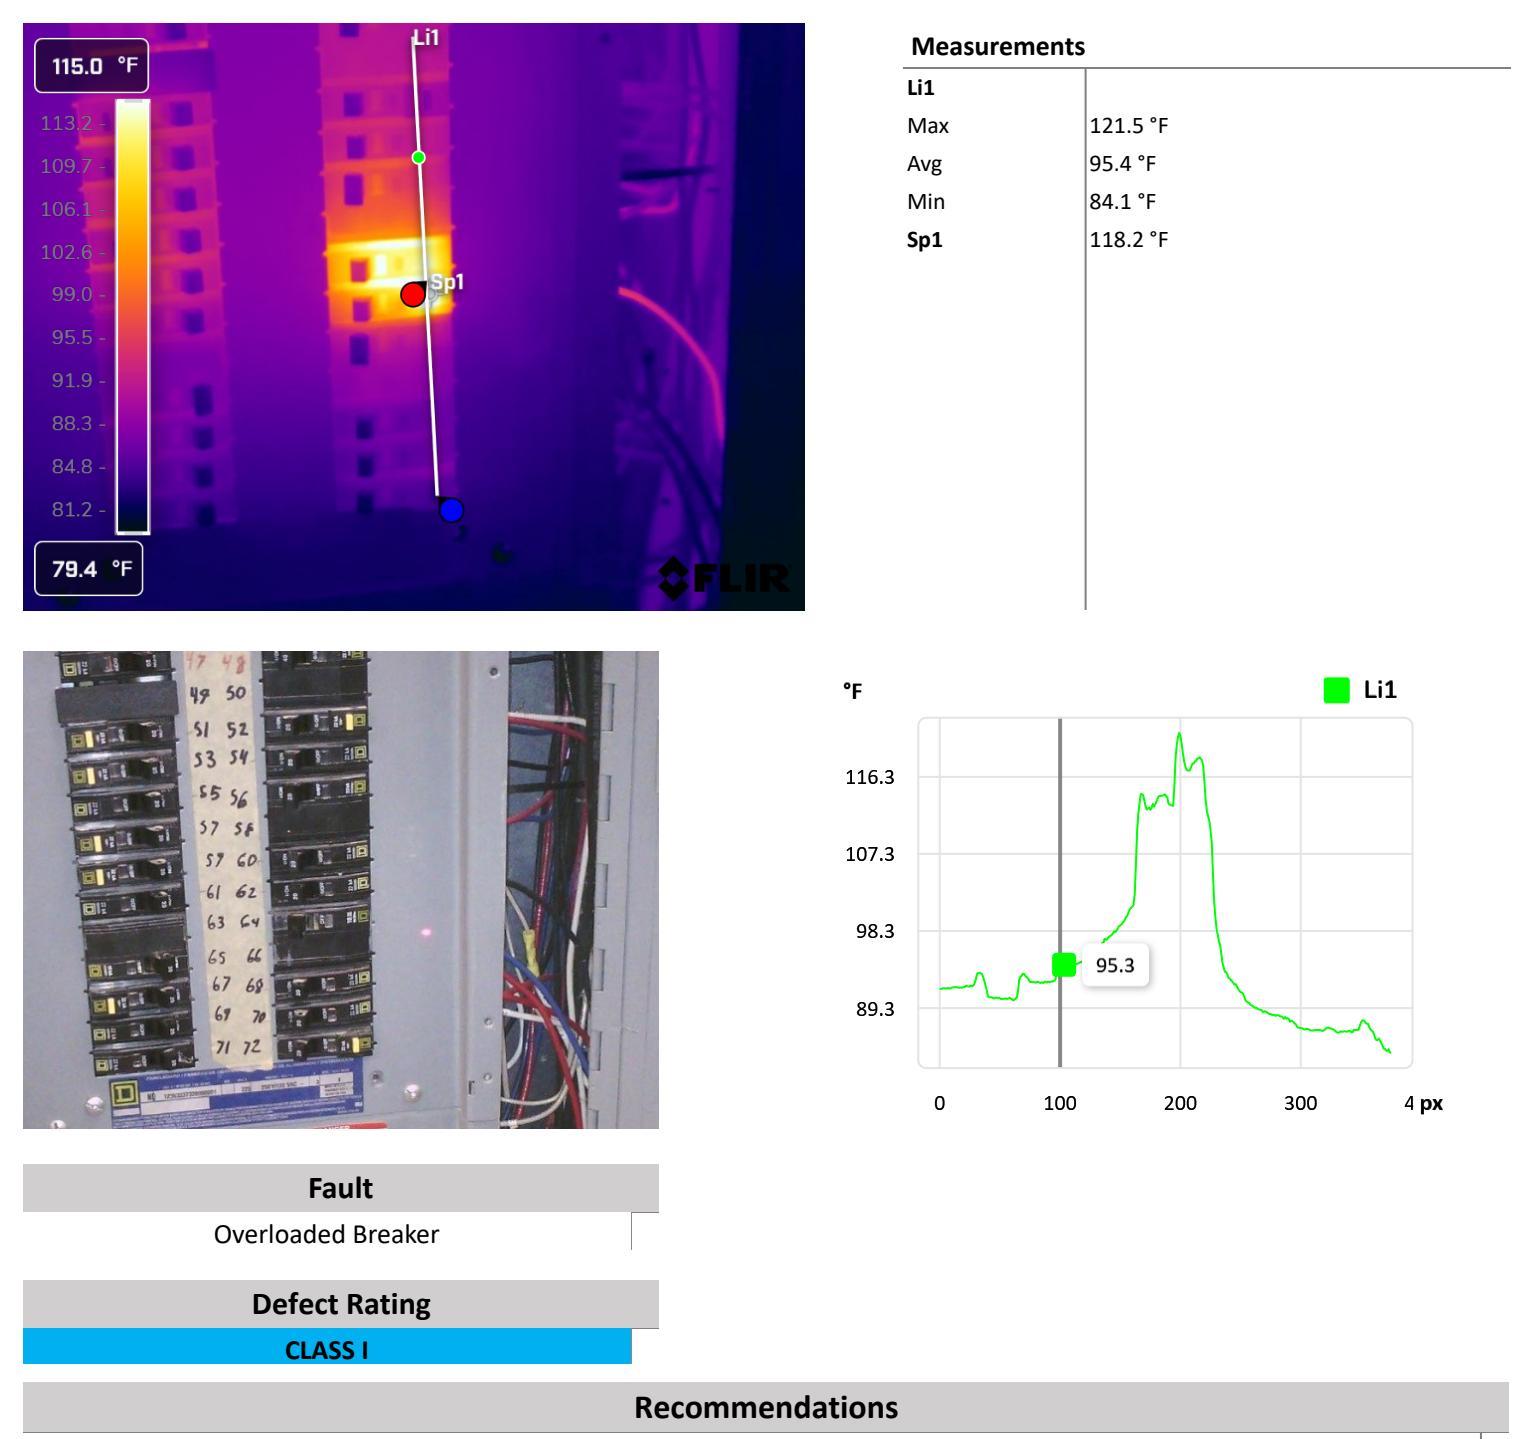
Breaker Circuit 62 B1 KL1

IR image shows heat on breaker 62. Amp load was checked and found to be 23 amp on a 20 amp breaker. It is recommended to investigate and upgrade breaker if circuit components allow.

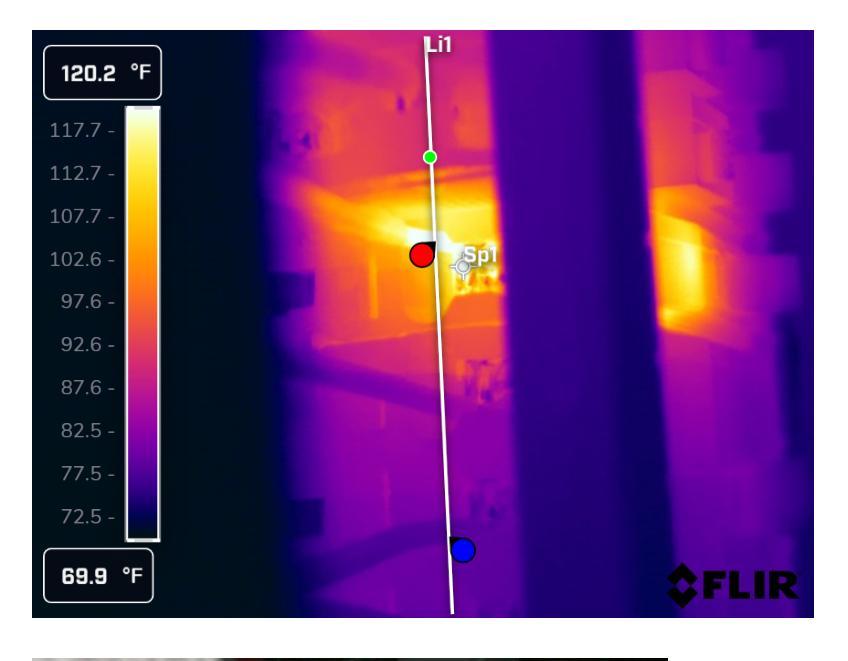
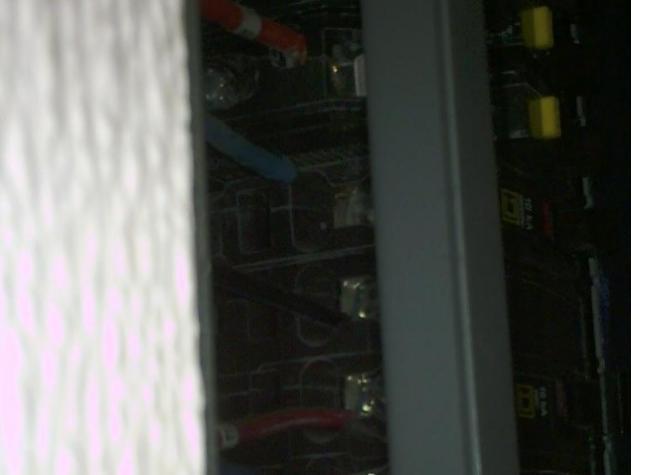
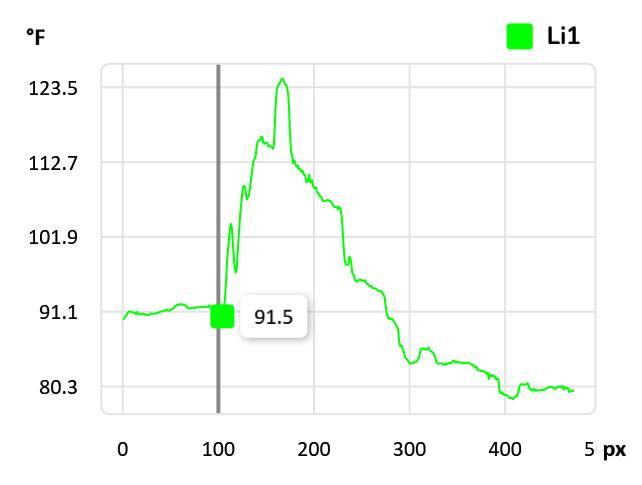
Circuit 41 BL1 KL2

Measurements			
Li1			
Max	124.7 °F		
Avg	93.2 °F		
Min	78.5 °F		
Sp1	123.1 °F

Fault Heavy load/weak breaker Defect Rating CLASS I

IR image shows delta-t on circuit 41. Amp reading showed 19 amps on 20 amp breaker. Breaker may also have internal connection issue. It is recommended to investigate high amp load and replace breaker as time allows.
