ADI Brandon, MS Ammonia Compressor MCC Quarterly Infrared Survey Report September 2024

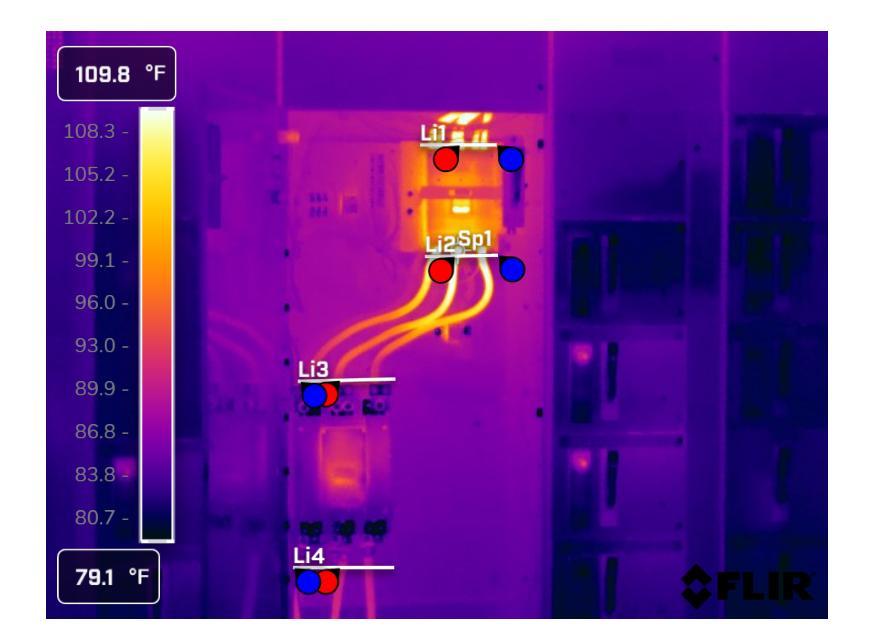
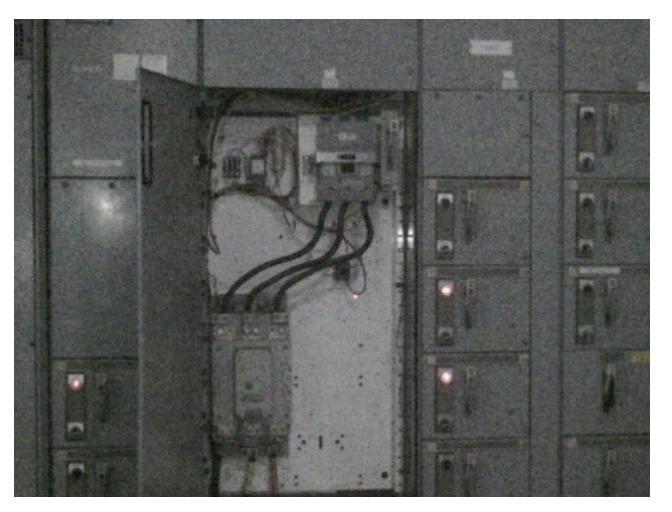
CM-1

Measurem	Measurements			
Li1				
Max	120.9 °F			
Avg	107.5 °F			
Min	94.7 °F			
Li2				
Max	115.2 °F			
Avg	98.5 °F			
Min	88.6 °F			
Li3				
Max	92.7 °F			
Avg	89.7 °F			
Min	86.6 °F			
Li4				
Max	90.8 °F

Fault None Defect Rating N/A

IR image shows no issues to note at this time.

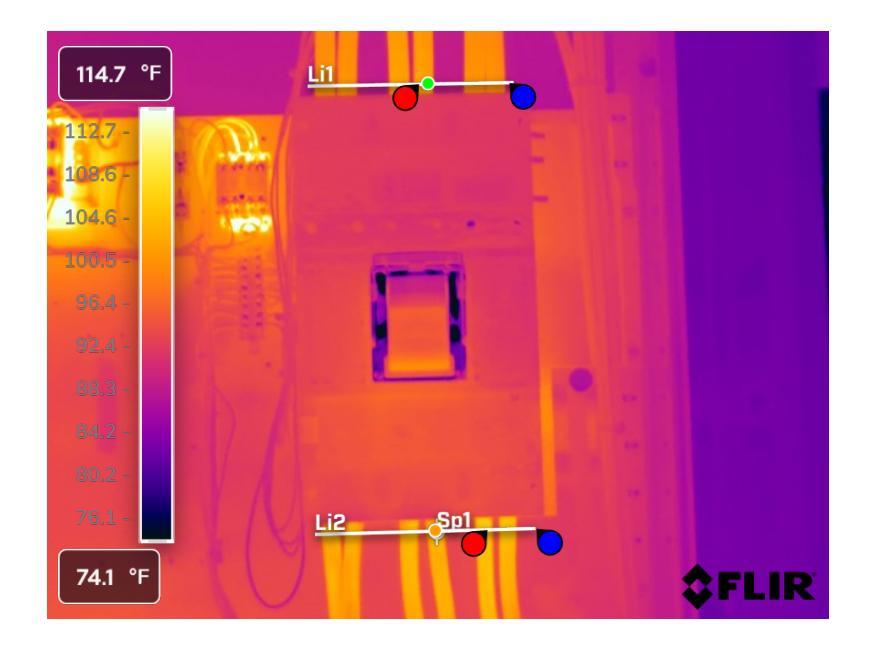
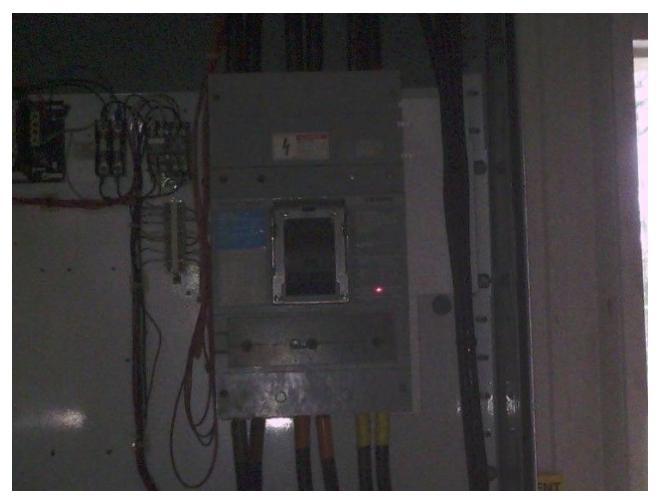
CM-2

Measurements			
Li1			
Max	103.1 °F		
Avg	96.7 °F		
Min	88.8 °F		
Li2			
Max	106.5 °F		
Avg	99.2 °F		
Min	93.4 °F		
Sp1	104.6 °F

Fault
None
Defect Rating
N/A

No issues to note at this time.

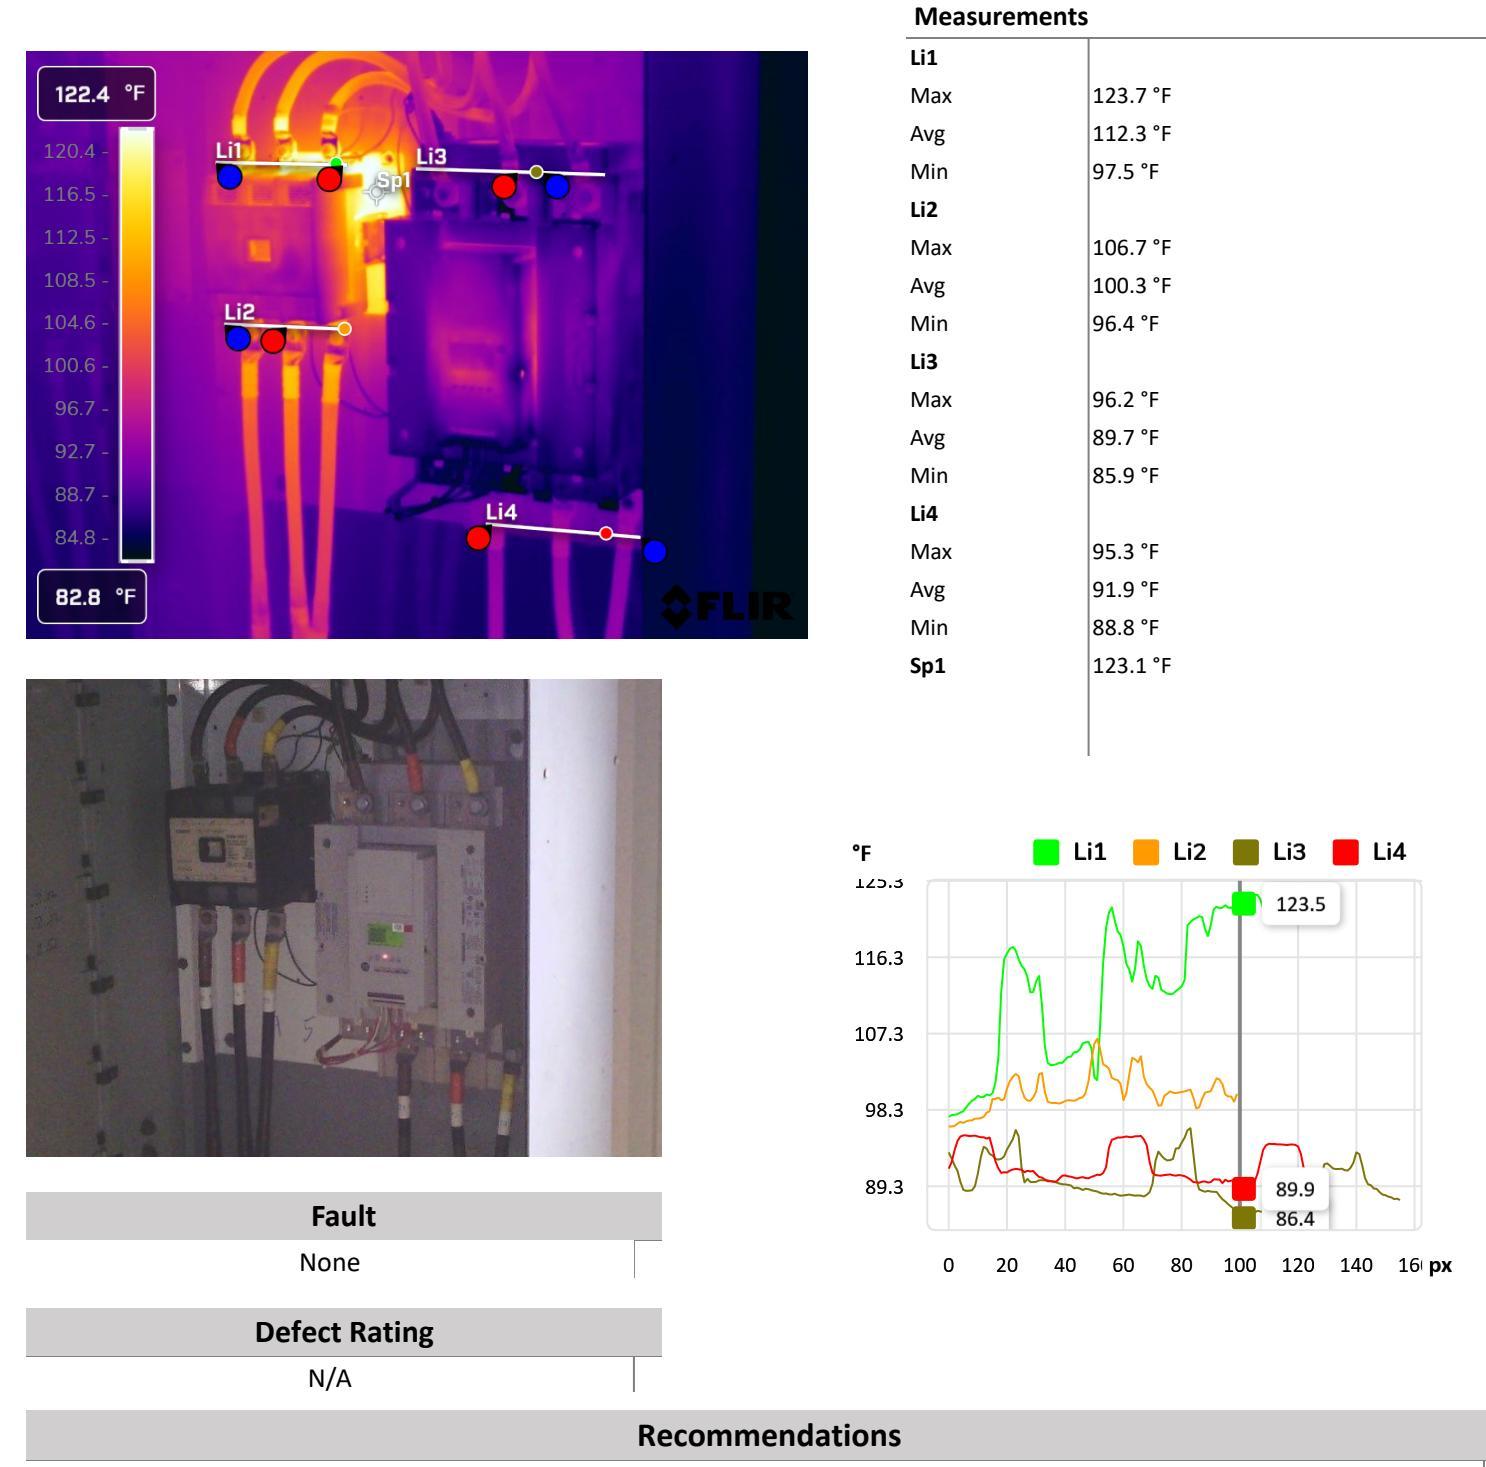
CM-2

NO issues to note at this time. Some slight heat can be seen on back of starter, but this seems normal for this unit.

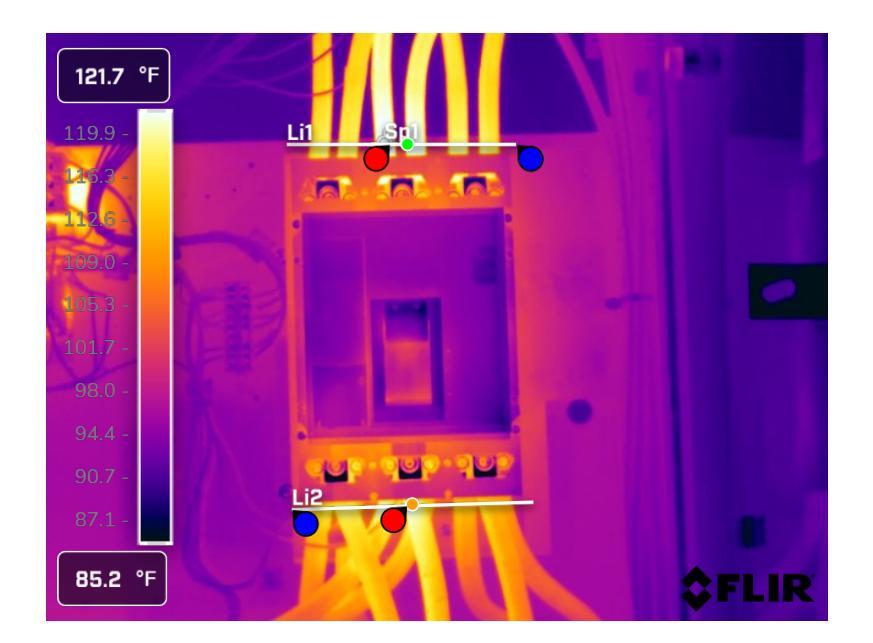
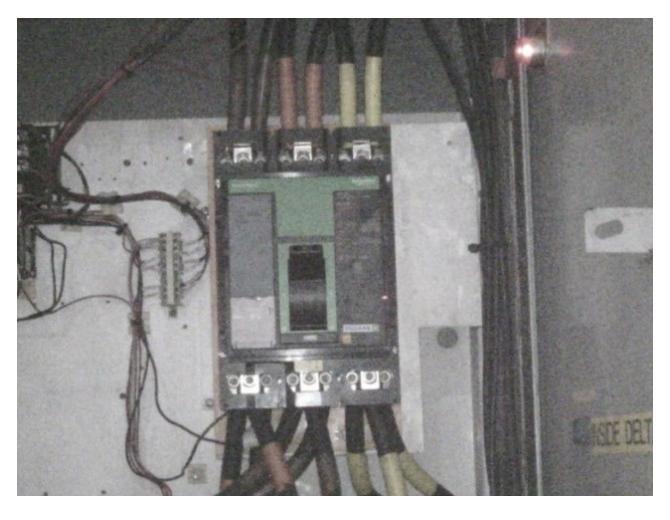
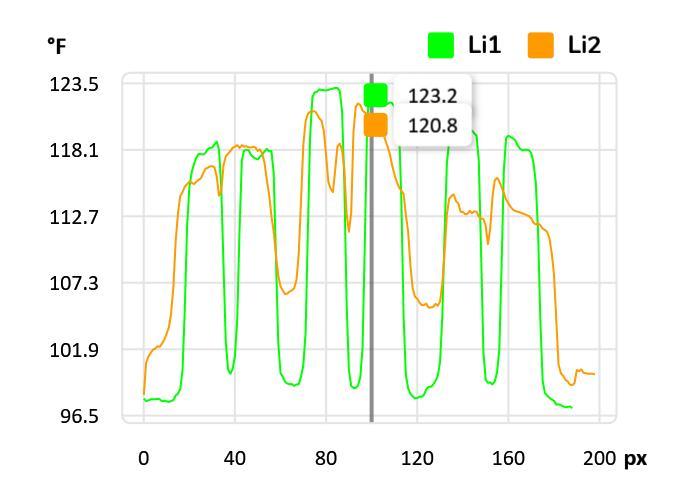
CM-3

Measurements		
Li1		
Max	123.2 °F	
Avg	109.7 °F	
Min	97.1 °F	
Li2		
Max	121.9 °F	
Avg	112.2 °F	
Min	98.2 °F	
Sp1	122.9 °F

Fault
None
Defect Rating
N/A

NO issues to note at this time.

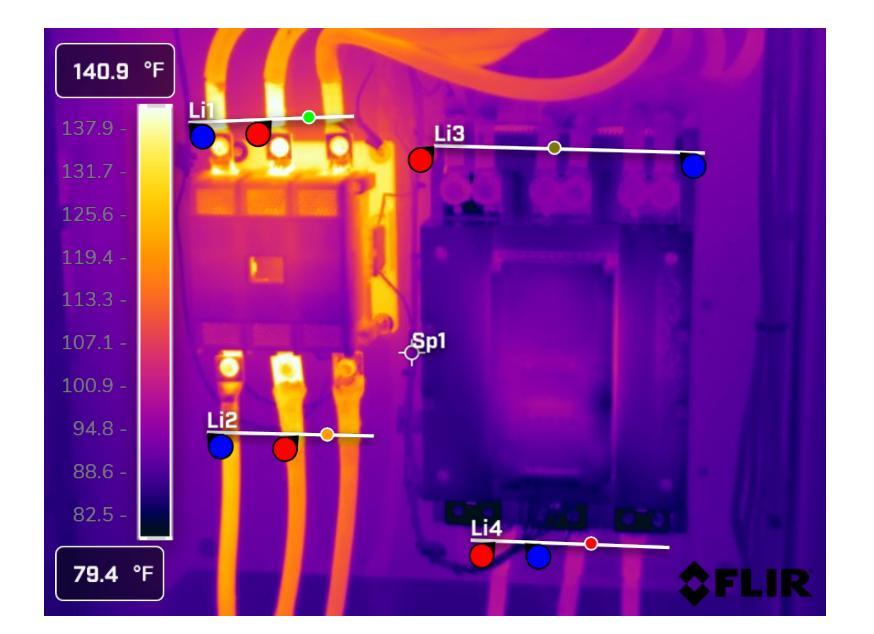
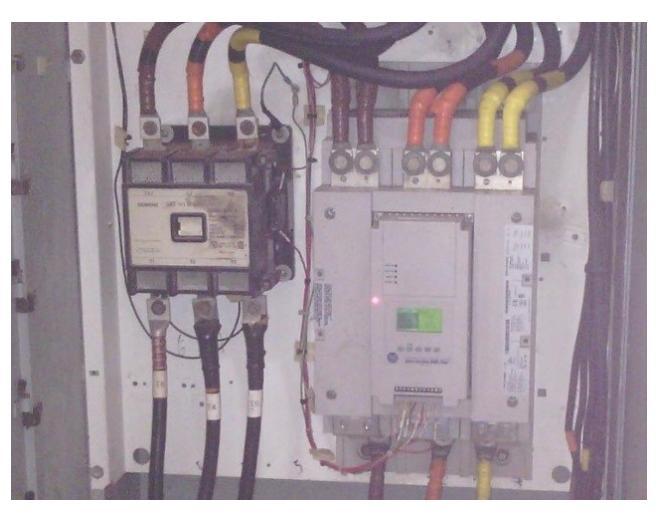
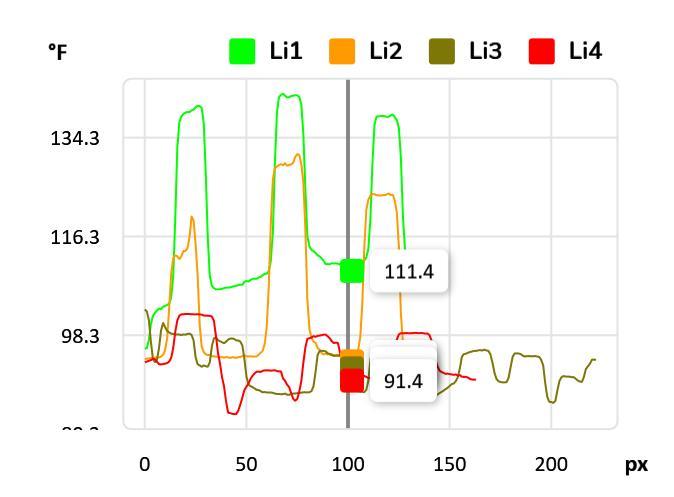
CM-3

Measureme	nents		
Li1			
Max	142.3 °F		
Avg	118.9 °F		
Min	95.9 °F		
Li2			
Max	131.3 °F		
Avg	105.2 °F		
Min	94.0 °F		
Li3			
Max	103.0 °F		
Avg	92.4 °F		
Min	86.0 °F		
Li4			
Max	102.2 °F

Fault None Defect Rating N/A

No issues to note at this time.
