On February 26-28, 2024, all electrical panels throughout the Olive Branch Plant were scanned using a **FLIR T865** infrared camera. The following report only contains defects that were found during the survey. Below is our classification system for each defect included in this report. If there are anyquestions or comments, please feel free to contact us at any time.

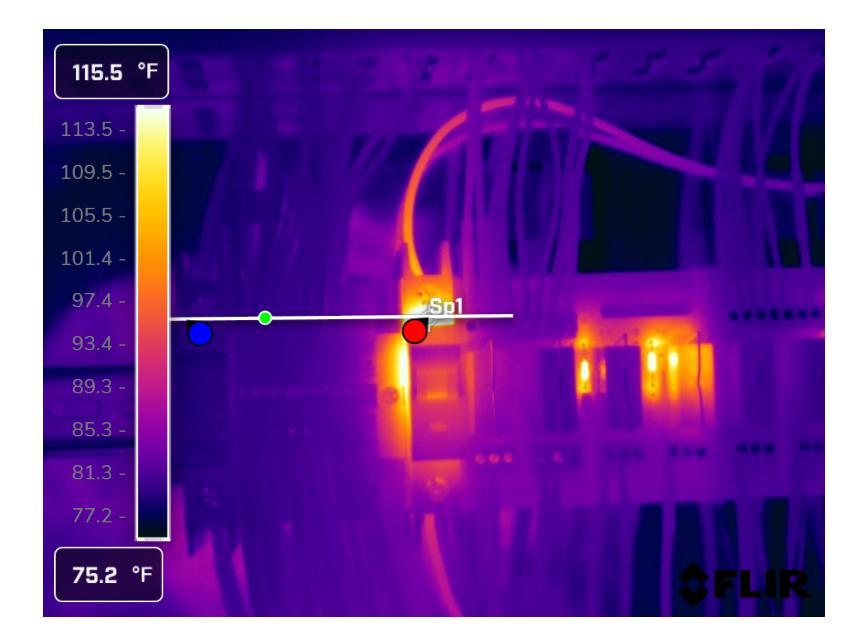
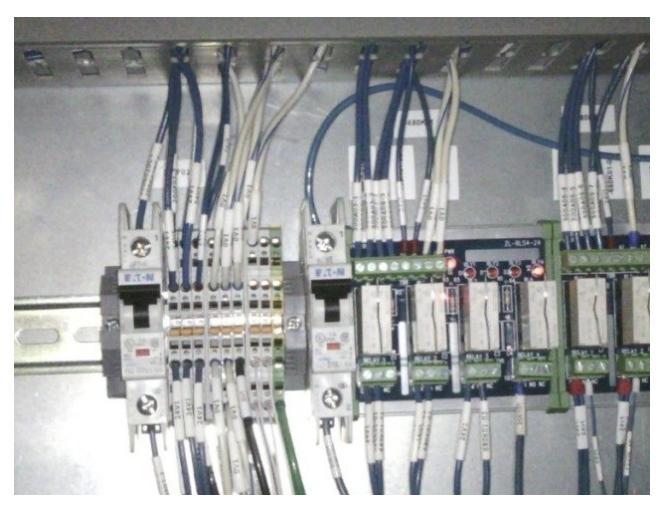
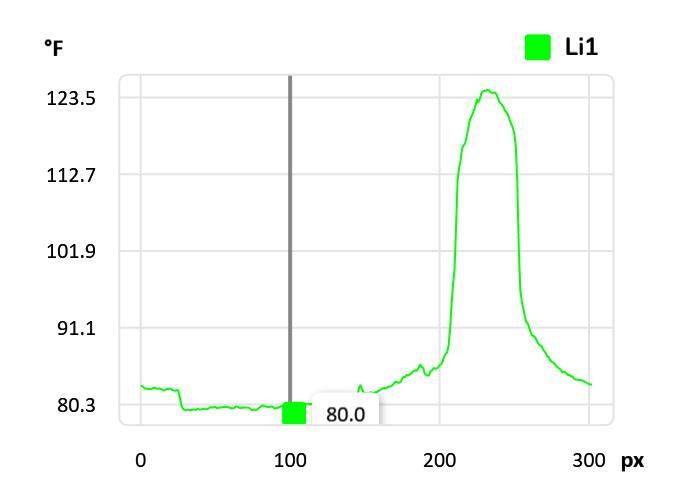
206x01 in cabinet at trailer door 13

Measurements				
Li1				
Max	124.6 °F			
Avg	88.1 °F			
Min	79.5 °F			
Sp1	125.8 °F

Fault
Possible issue with switch/connection
Defect Rating

CLASS I

IR image shows some heat on the switch. This may be due to load but may also be due to weak contact within the switch. For now, check amp reading and ensure all connections at switch are tight.

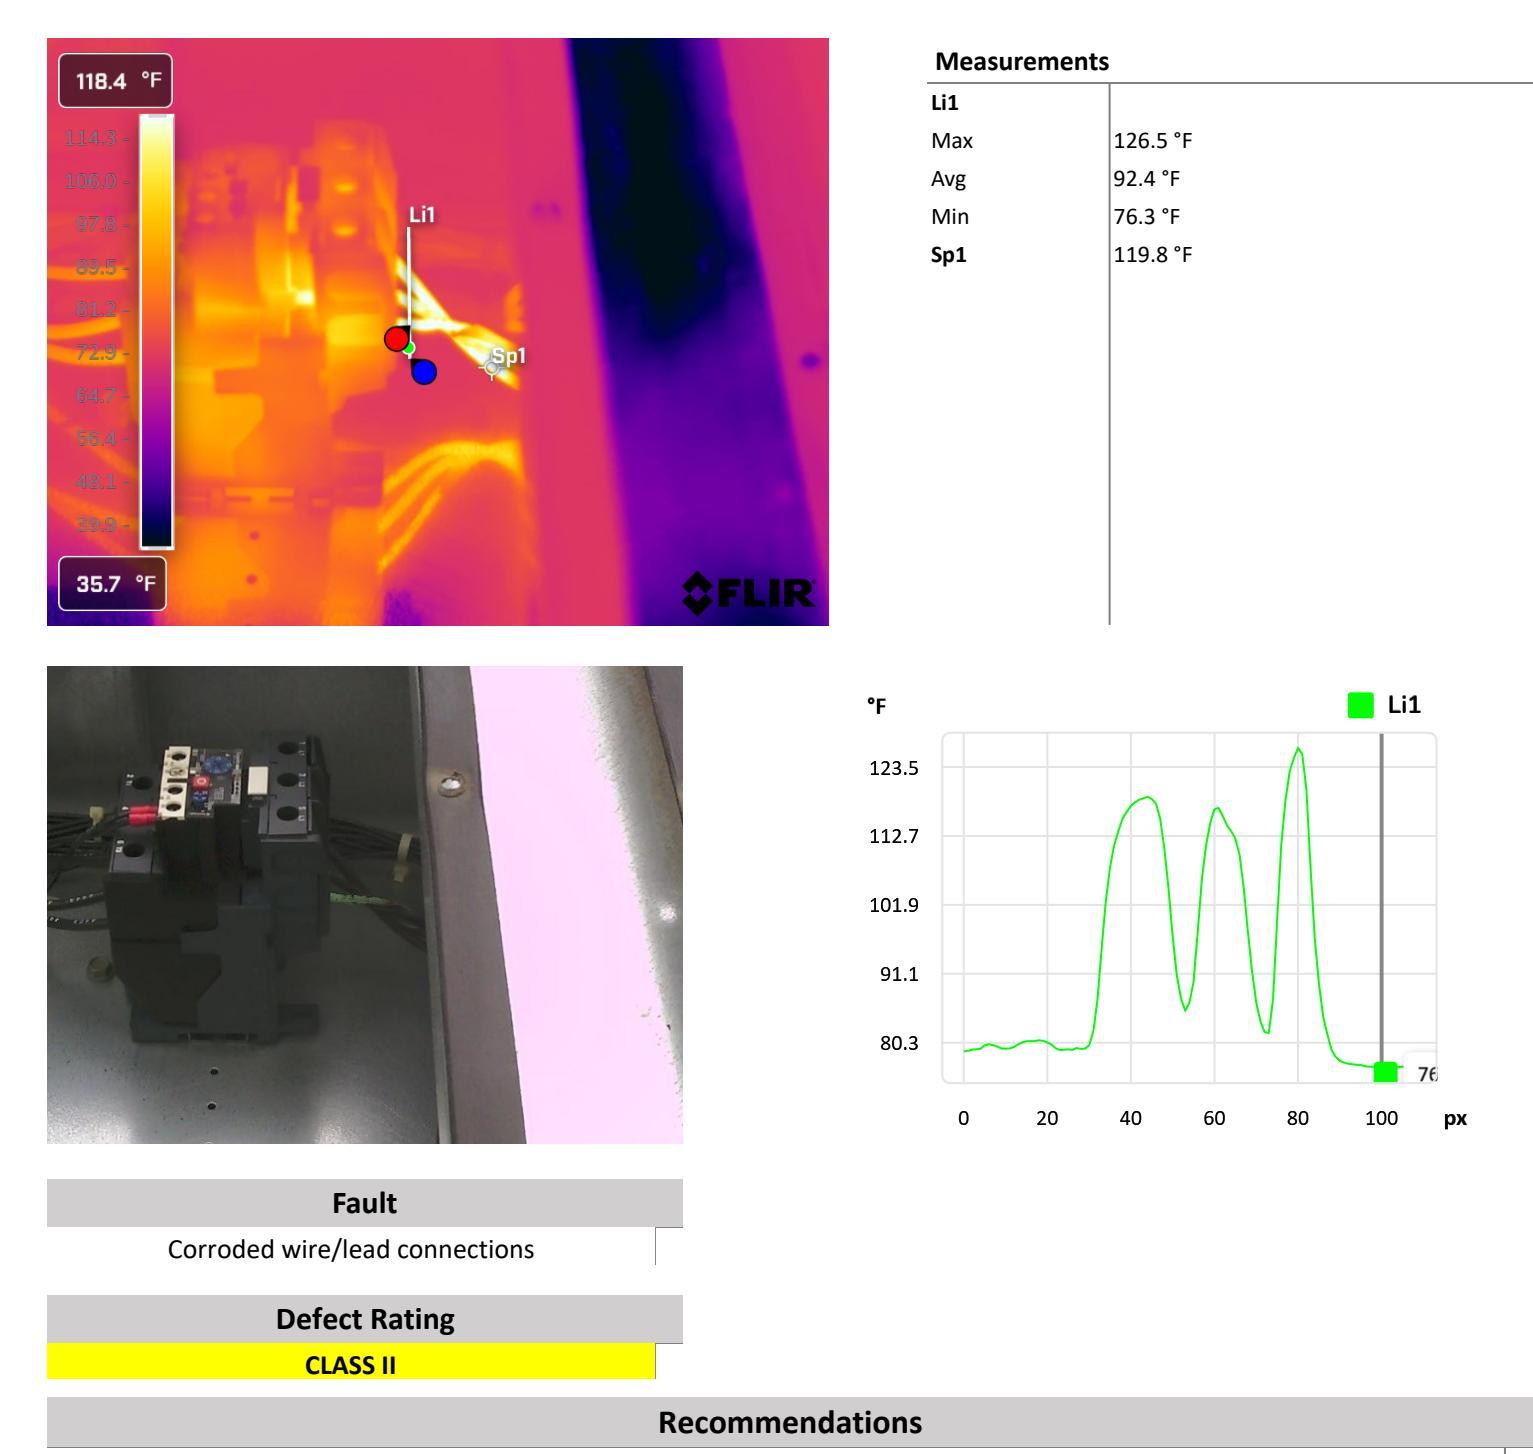
RTU 20 on roof

Wire is corroded and IR image does show some elvated heat at the smaller wires. Check amp reading ensuring wires are properly sized for the load. Replace bad wire and ensure all connections are tight.

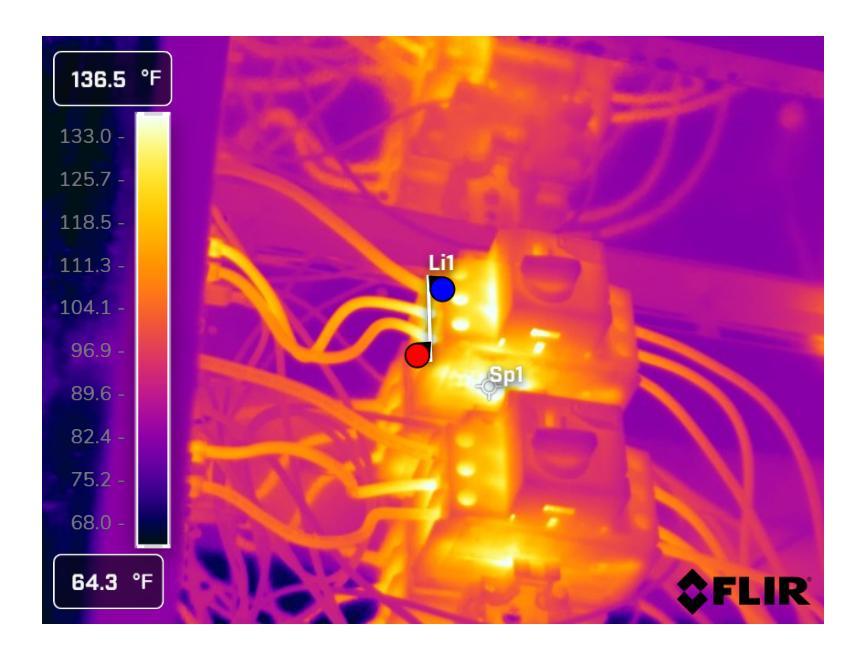
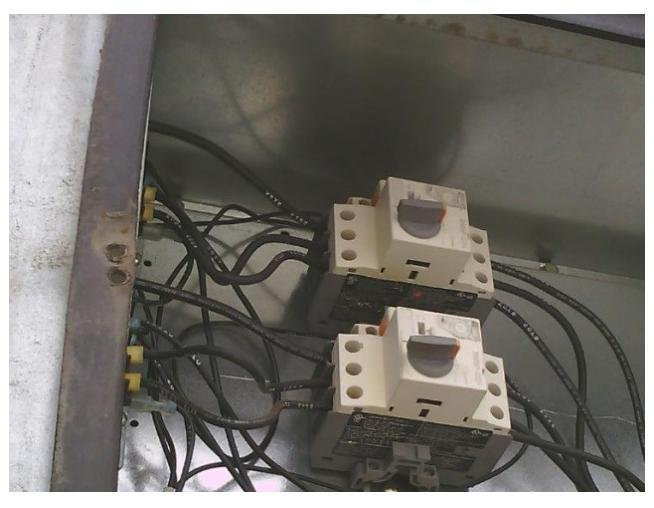
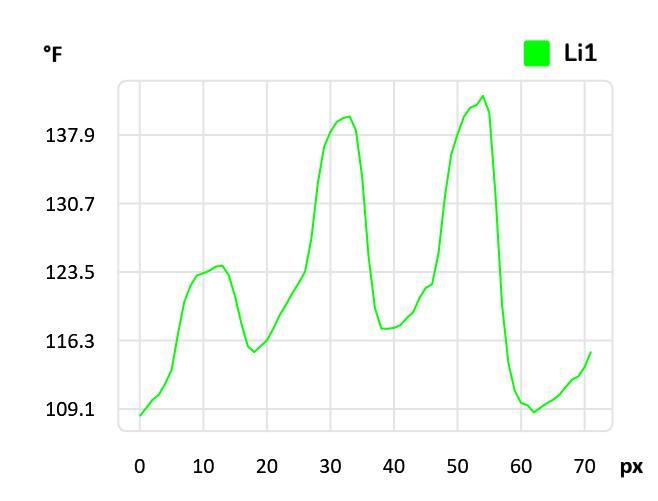
Wire 209a in Unit RTU1

Measurer	nents	
Li1		
Max	142.1 °F	
Avg	121.9 °F	
Min	108.4 °F	
Sp1	150.7 °F

Fault Connection issues Defect Rating CLASS I

IR image shows some possible issues with the lead connections on top switch and middle wire on bottom switch. Check all connections, ensuring a clean and tight connection.

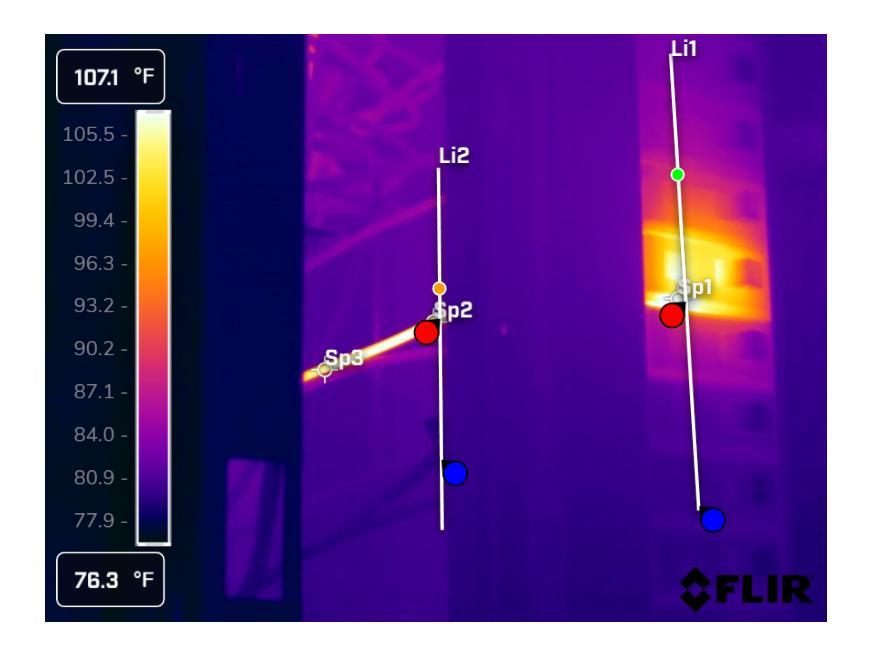
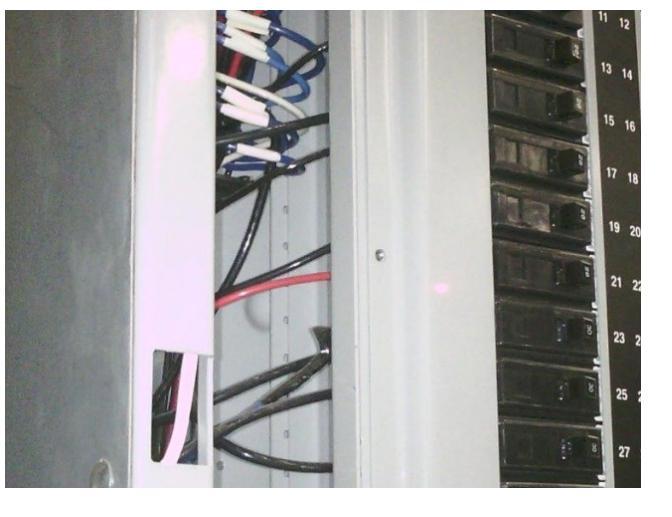
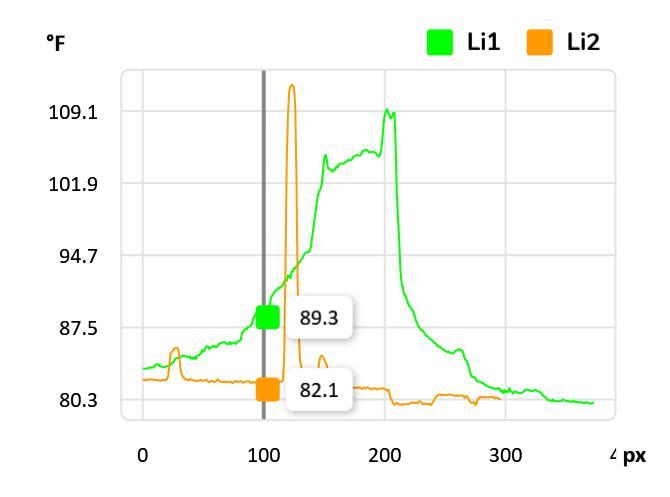
LG10-1

LI1		
Max	109.3 °F	
Avg	88.8 °F	
Min	79.9 °F	
Li2		
Max	111.7 °F	
Avg	82.6 °F	
Min	79.8 °F	
Sp1	110.5 °F	
Sp2	111.6 °F	
Sn2	106.3 °F

Fault
Loaded breaker/conenctions
Defect Rating

CLASS I

Breaker 15 may have heavy load or connection issue. Check load on circuit ensuring load is within rating. Ensure breaker is tight to the buss and ensure lead connection going into the breaker is clean and tight.

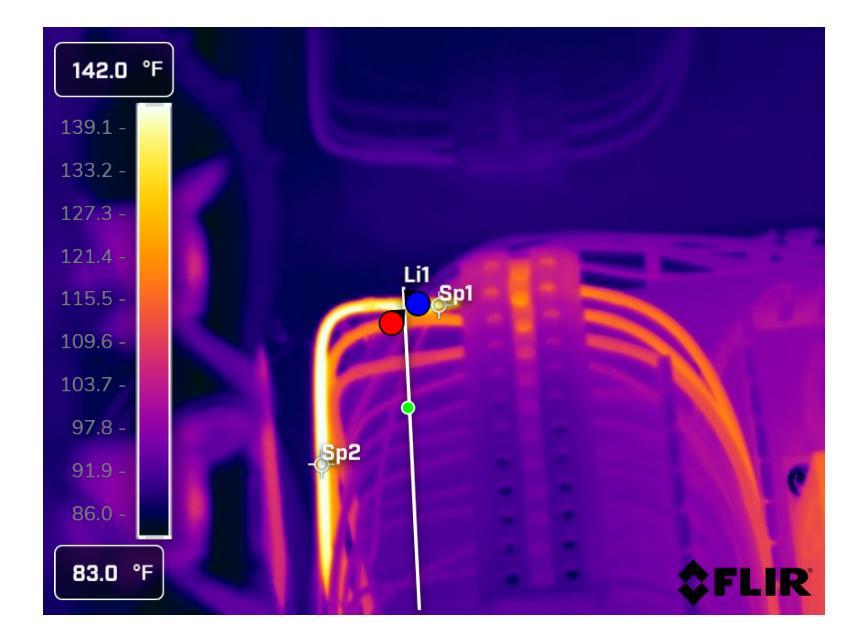
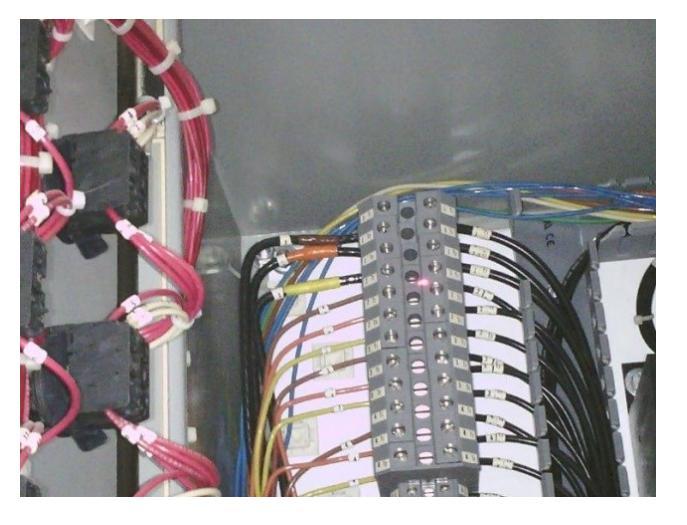
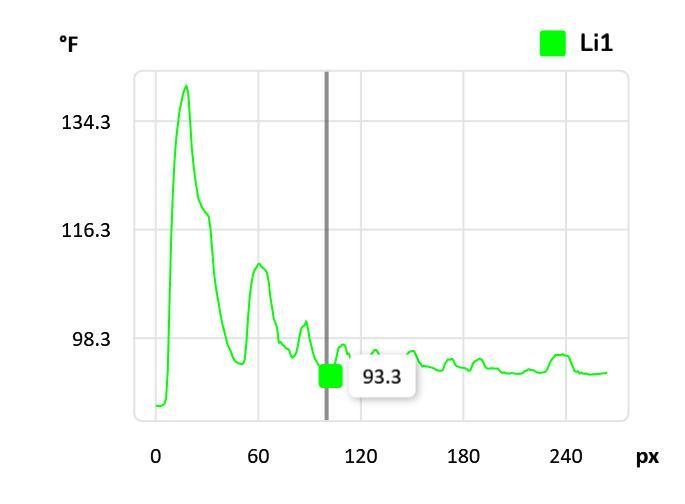
Sandblast room empire

Li1		
Max	140.2 °F	
Avg	98.4 °F	
Min	87.0 °F	
Sp1	139.3 °F	
Sp2	143.0 °F

Fault
Loaded wire/connection
Defect Rating

CLASS I

Top lead with brown tape shows some delta-t. This may be heavy load. Check amperage on wire ensuring the wire is rated for the load. Check connection ensuring a clean and tight connection.

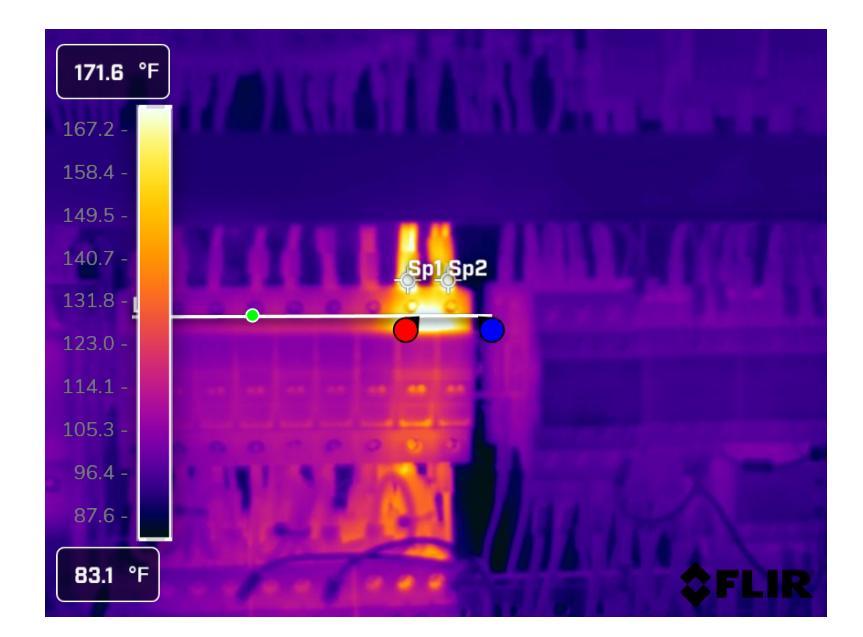
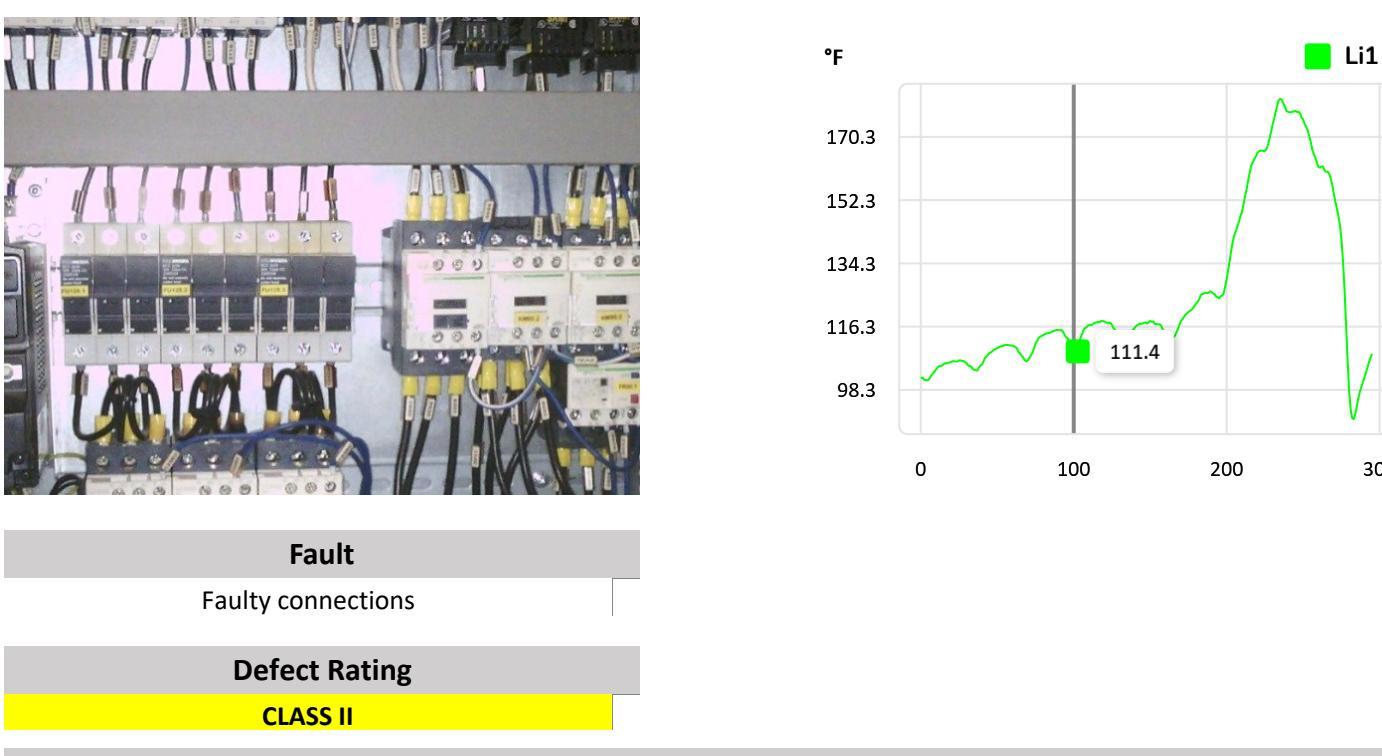
Grinding Line Panel

Measurements			
Li1			
Max	181.2 °F		
Min	90.0 °F		
Sp1	189.1 °F		
Sp2	177.8 °F

Leads going into fuse block are showing some heat. Fuse block also has some heat present. This may be a connection issue in fuse block. Check connections ensuring a clean and tight conection.

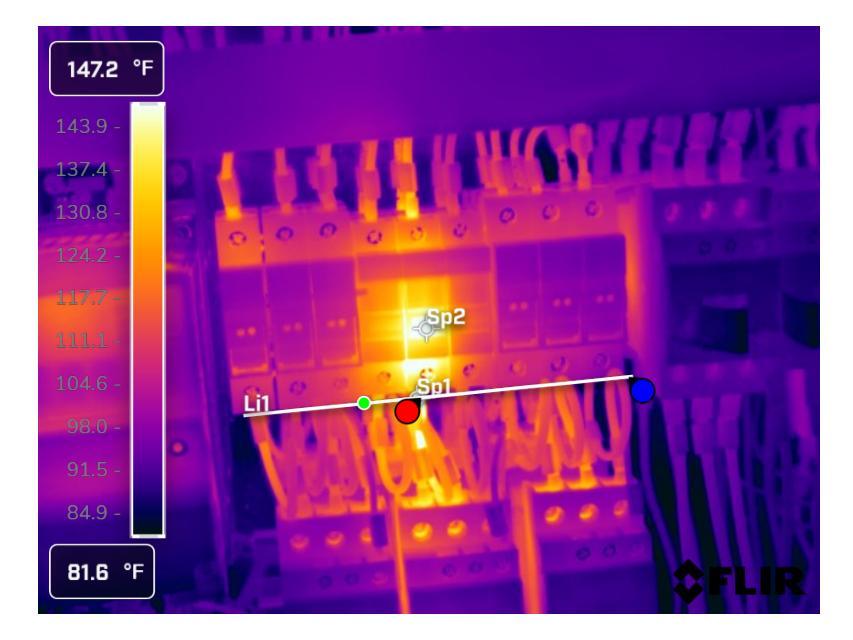
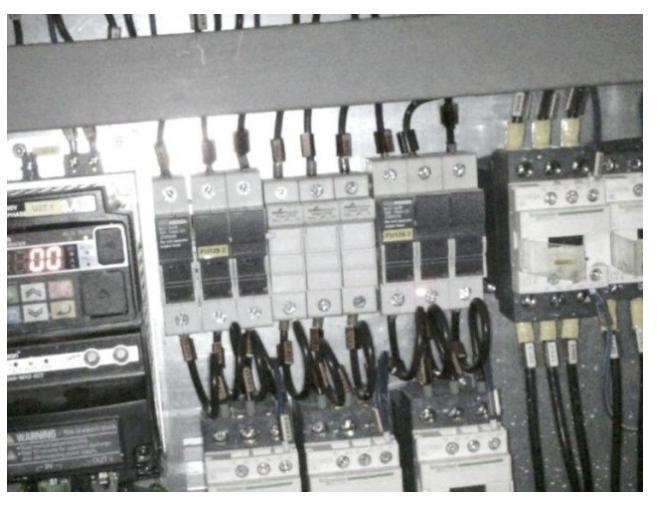
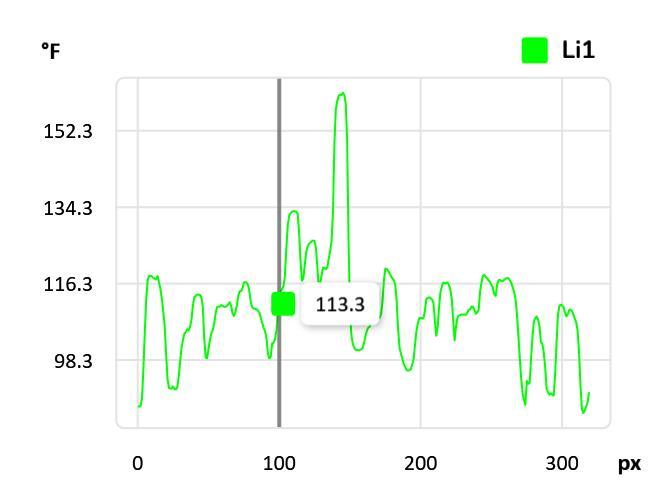
Vertical edge washer 04

Measurements				
Li1				
Max	161.3 °F			
Avg	110.6 °F			
Min	85.8 °F			
Sp1	160.5 °F			
Sp2	147.2 °F

Fault Faulty Connection

Defect Rating CLASS I

Wire 105 shows some heat. Check connection ensuring a clean and tight connection.

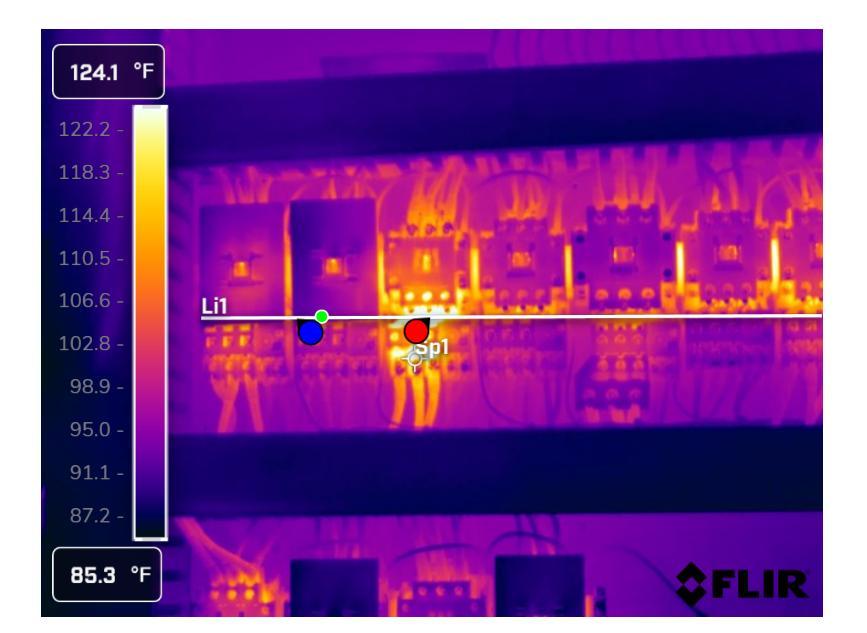
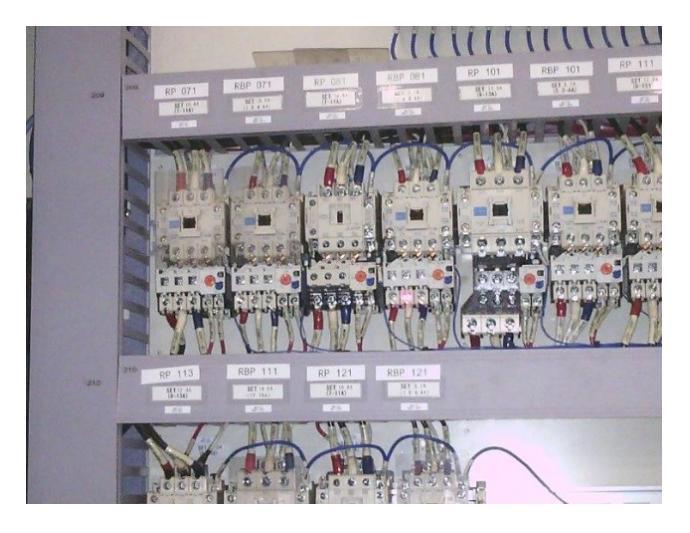
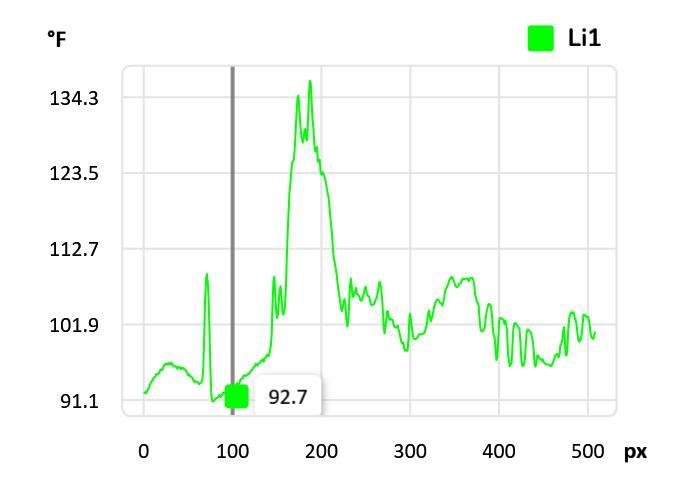
COP2 RP081

Li1		
Max	136.7 °F	
Avg	102.9 °F	
Min	91.0 °F	
Sp1	121.3 °F

Check connections ensuring a clean and tight connection.

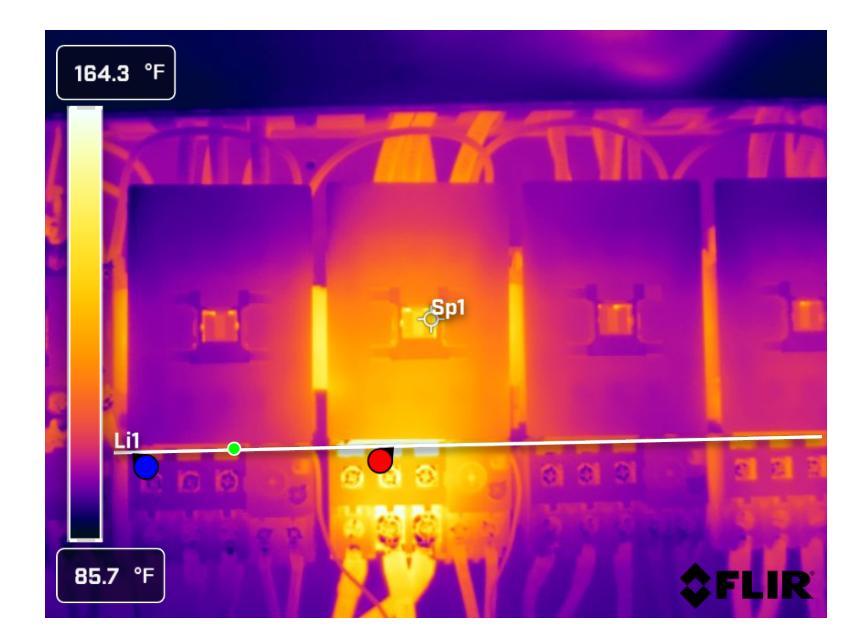
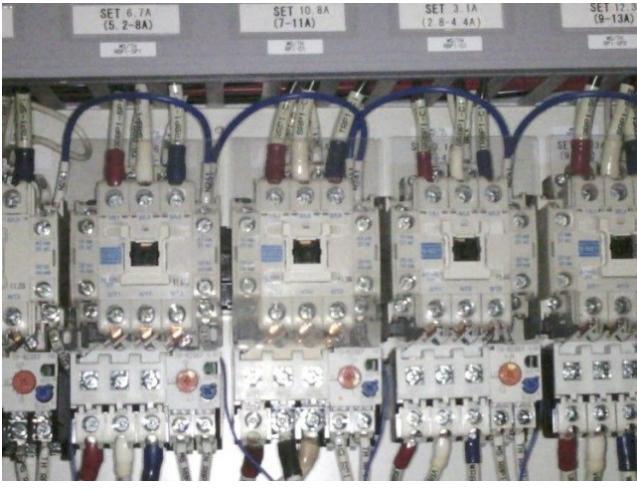
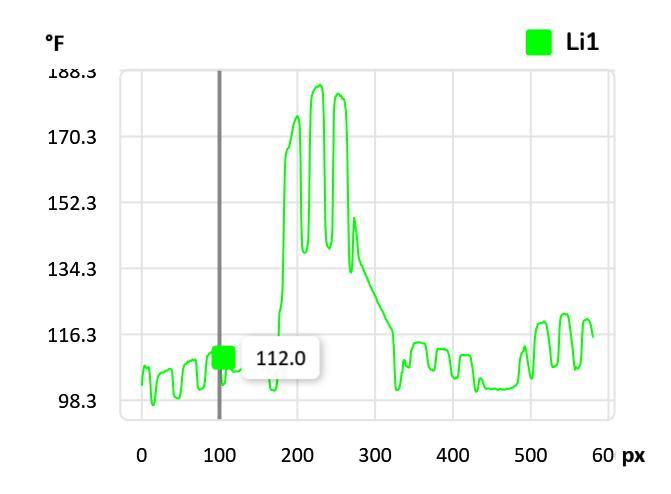
COP1 RP051

Li1		
Max	184.4 °F	
Avg	119.0 °F	
Min	97.0 °F	
Sp1	134.2 °F

Check all connections ensuring a clean and tight connection. It is unlcear if there are thermal heaters equipped. If so, these may need to be changed out.

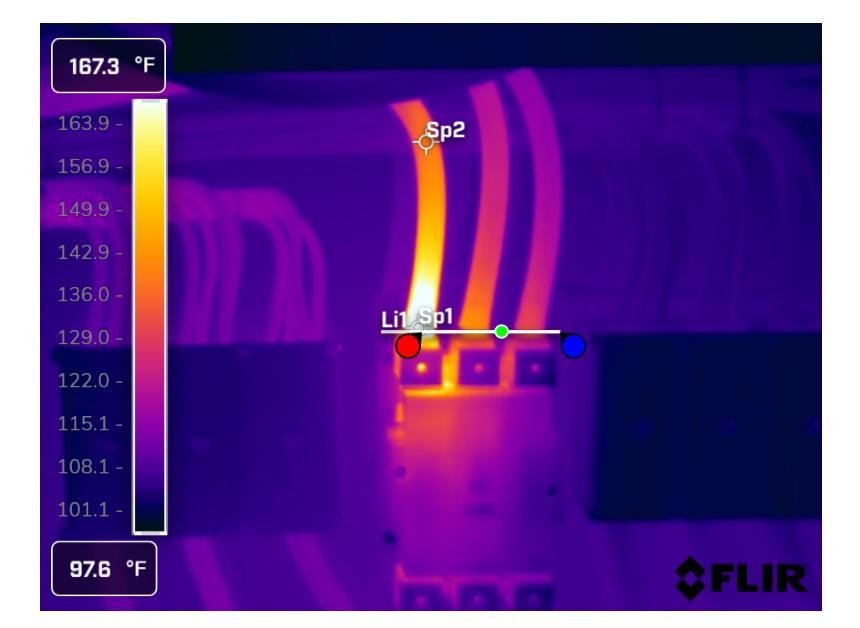
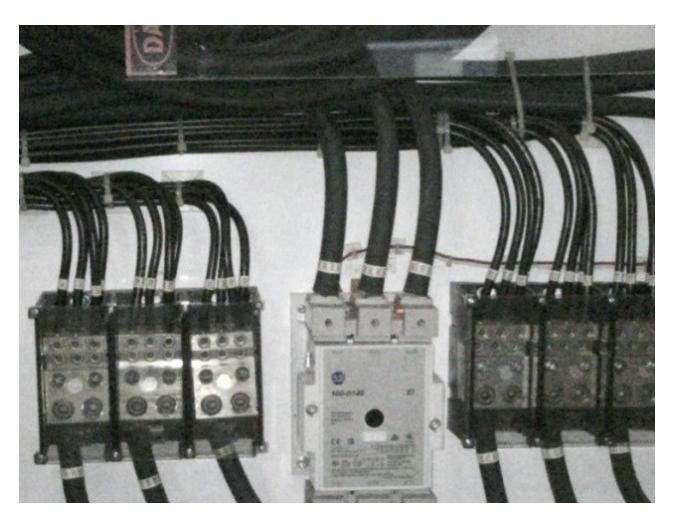
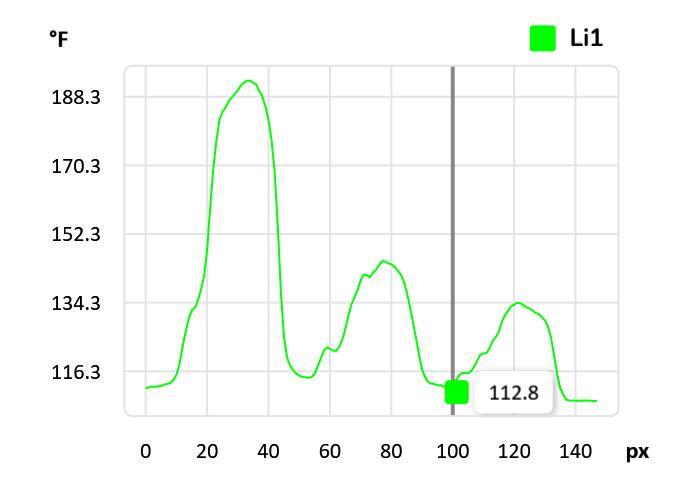
Wisconsin Oven Cabinet

1:1		
LI 1		
Max	192.5 °F	
Avg	132.9 °F	
Min	108.5 °F	
Sp1	187.2 °F	
Sp2	140.7 °F

Fault Faulty connection Defect Rating CLASS II

IR image shows some delta-t on wire 240. Check connection ensuring a clean and tight connection.
