MOST Inc. Jackson, TN Infrared Survey Report June 2025

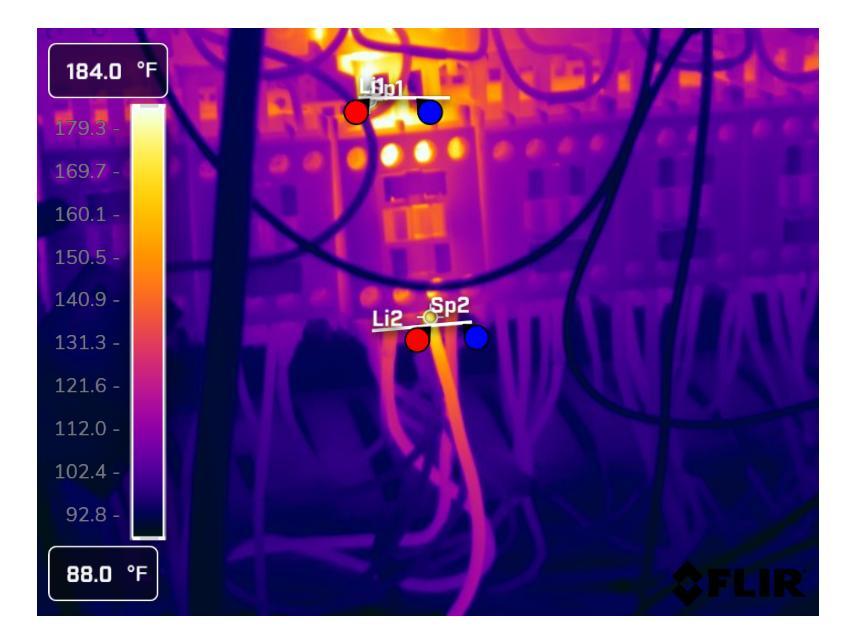
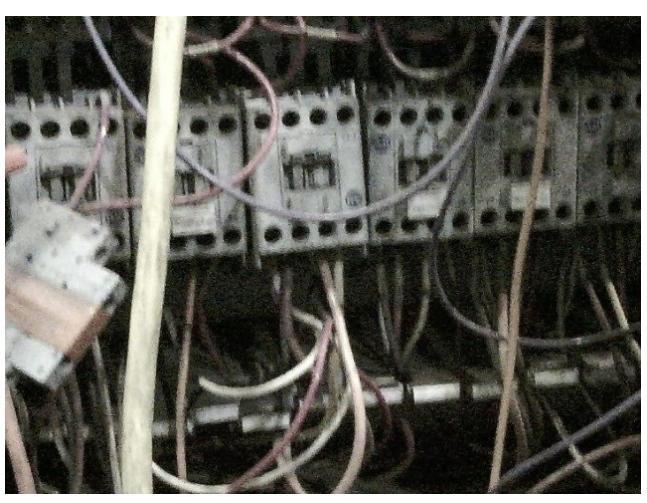
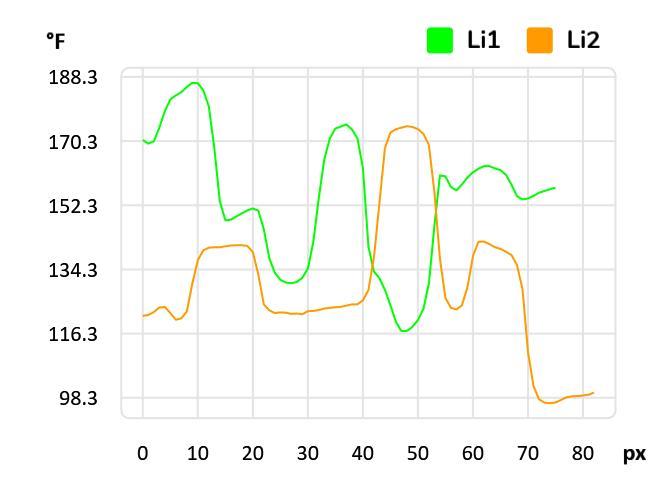
ES-MP contactor between cooling fan and Ferr Con

lead connections

Measurements		
LI1				
Max	186.7 °F			
Avg	154.2 °F			
Min	117.0 °F			
Li2				
Max	174.5 °F			
Avg	130.3 °F			
Min	96.8 °F			
Sp1	187.1 °F			
Sp2	177.8 °F

Fault Faulty connections Defect Rating CLASS II

A phase on line side and B phase on load side show to have issues with lead connections. Ensure each lead has a clean and tight connection. Inspect lugs also.

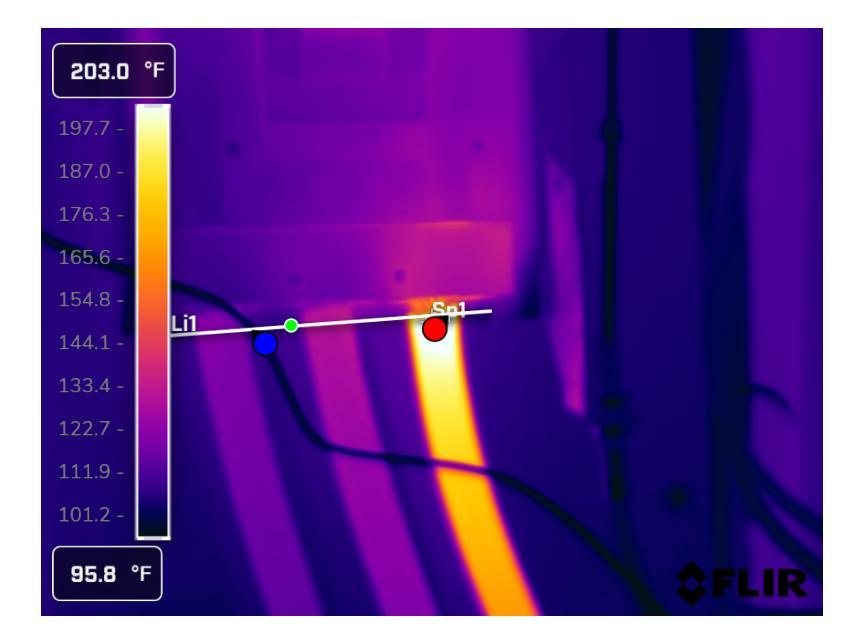
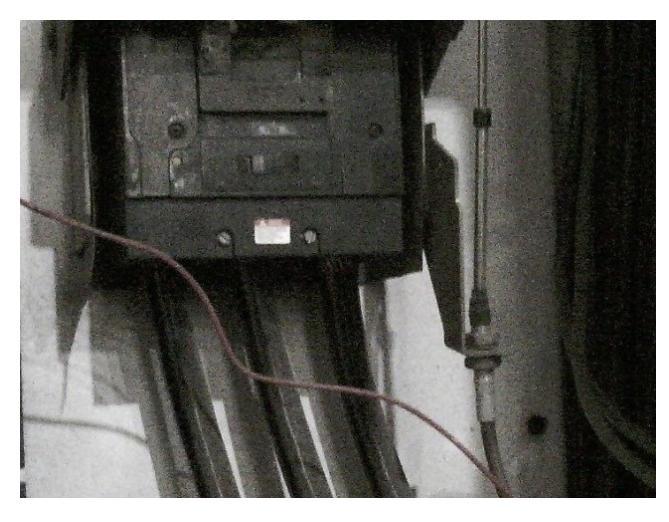
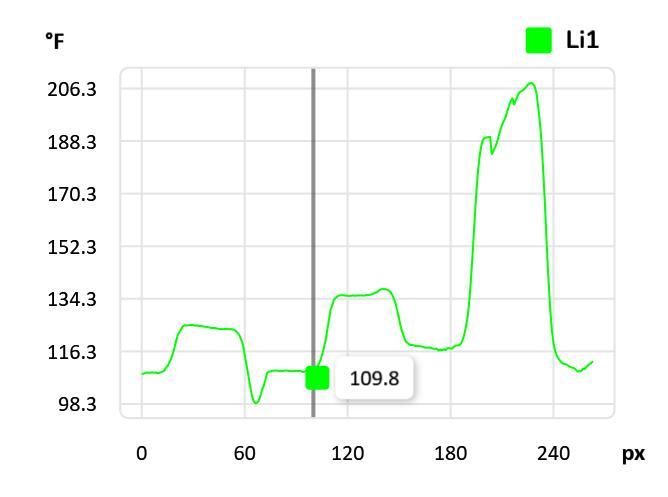
Shredder CP1 Main Disconnect

C phase load side

Measurements		
Li1		
Max	208.3 °F	
Avg	131.6 °F	
Min	98.6 °F	
Sp1	209.4 °F

Fault
Faulty connection/possible load imbalance
Defect Rating

CLASS II

C phase shows to have high delta-T. This may be a bad connection but could also be caused by some load imbalance. Check C phase lead connection ensuring a clean and tight connection. Check amps on each leg to ensure a balanced load.

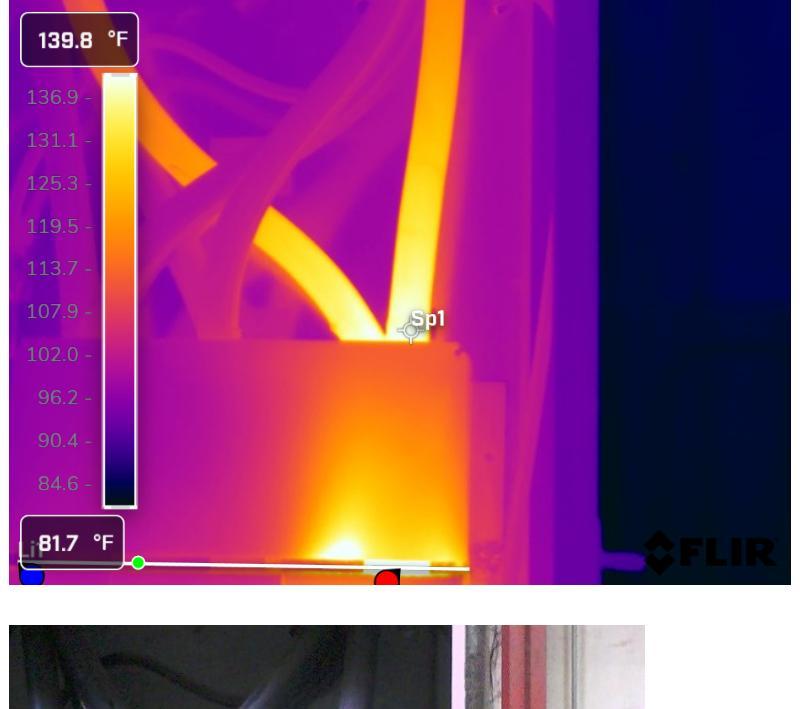
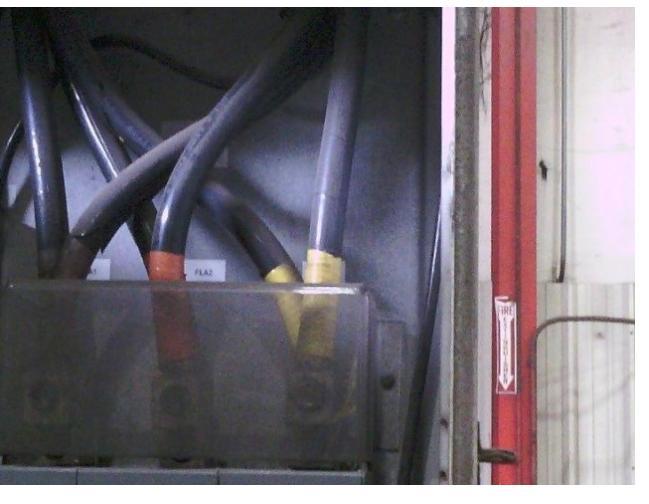
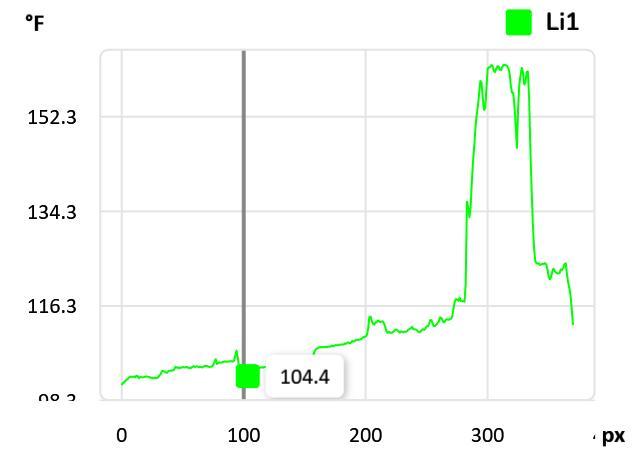
Stripper Cabinet FLA 3

C phase line side

Li1		
Max	162.2 °F	
Avg	116.0 °F	
Min	101.3 °F	
Sp1	139.1 °F

Fault Faulty connection Defect Rating CLASS II

C phase line side appears to have a connection issue. This may be a loose connection at the breaker but could be an internal issue with the breaker itself. Inpsect lug on leads and on breaker and ensure C phase has a clean and tight connection.

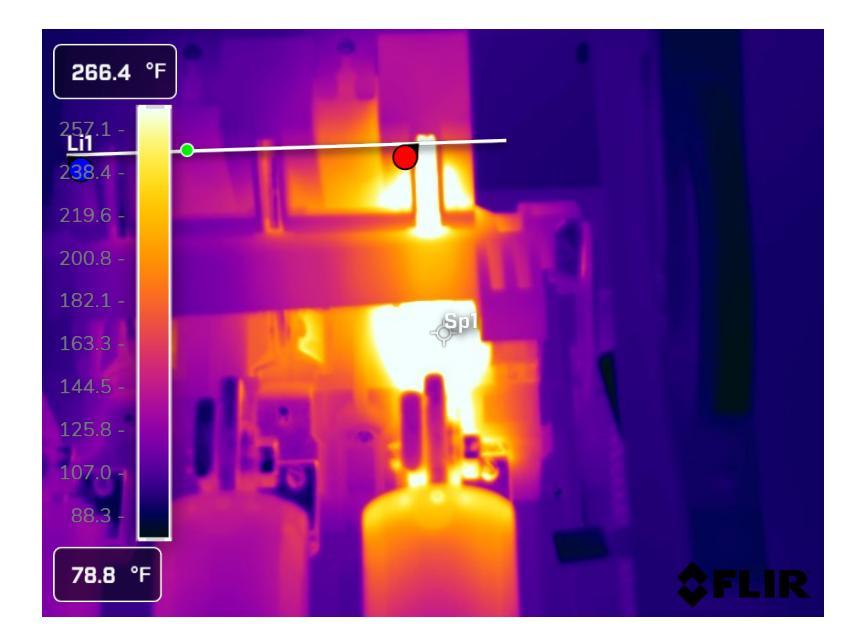
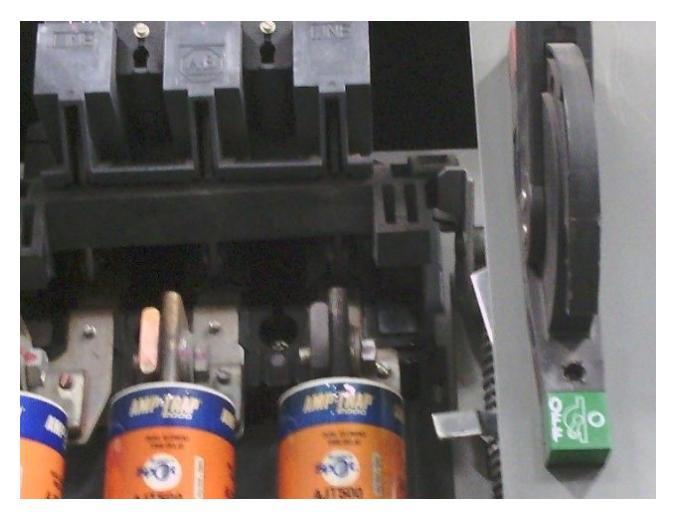
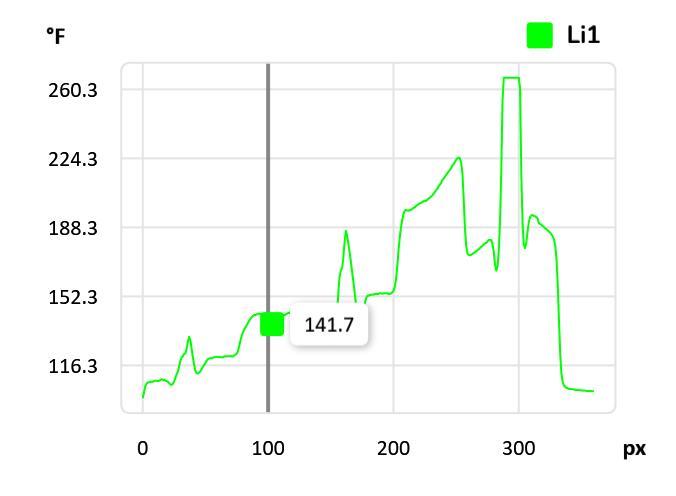
Dust collector exhaust fan WB-2

C phase fuse connections

Measurements		
Li1		
Max	>266.4 °F	
Avg	*156.0 °F	
Min	99.2 °F	
Sp1	>266.4 °F

Fault
Faulty fuse connections
Defect Rating

CLASS III

There is significant heat (over 266 F) on C phase fuse knife switch connections. Check all fuse components for loose connections and replace worn components as needed. Perform ASAP.

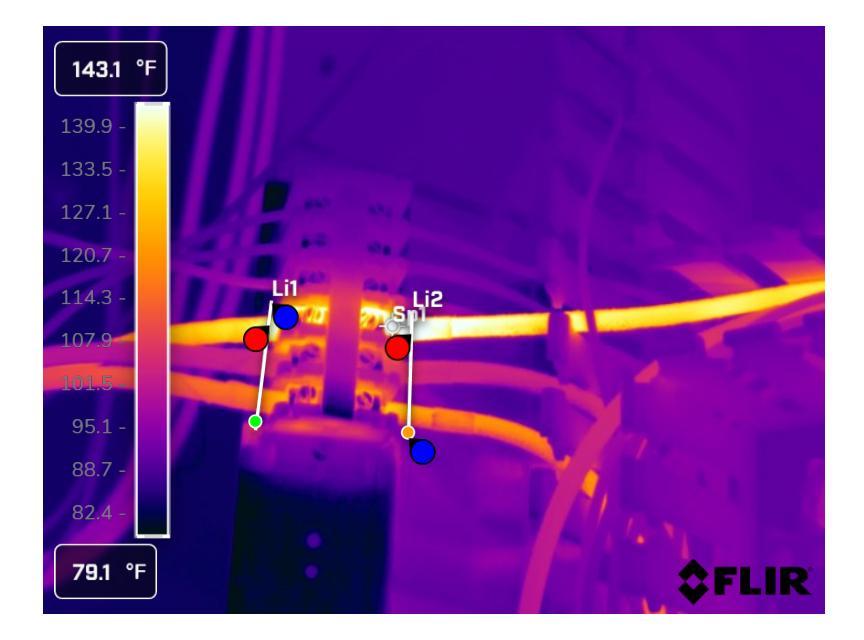
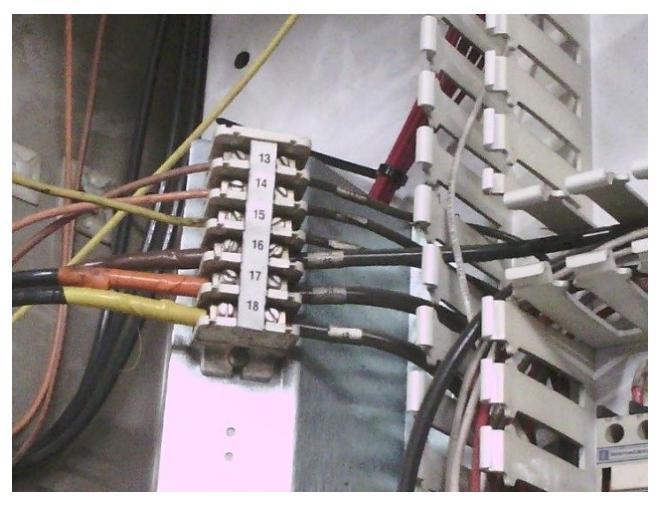
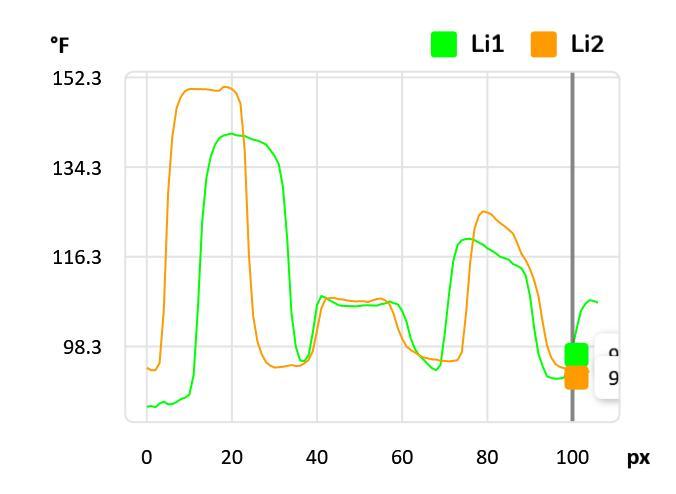
Melter #2 Block #16

Lead connections

Measurements		
Li1		
Max	141.1 °F	
Avg	109.7 °F	
Min	86.1 °F	
Li2		
Max	150.5 °F	
Avg	111.4 °F	
Min	93.3 °F	
Sp1	159.8 °F

Fault Faulty connections Defect Rating CLASS I

Lead connections marked #16 appear to have some possible connection issues. There could also be some load imbalance. Check connections ensuring a clean and tight connection. Ensure leads are not deteriorating. Check amp load to ensure balanced load.
