NuVasive Memphis, TN March 2025 Infrared Survey Report

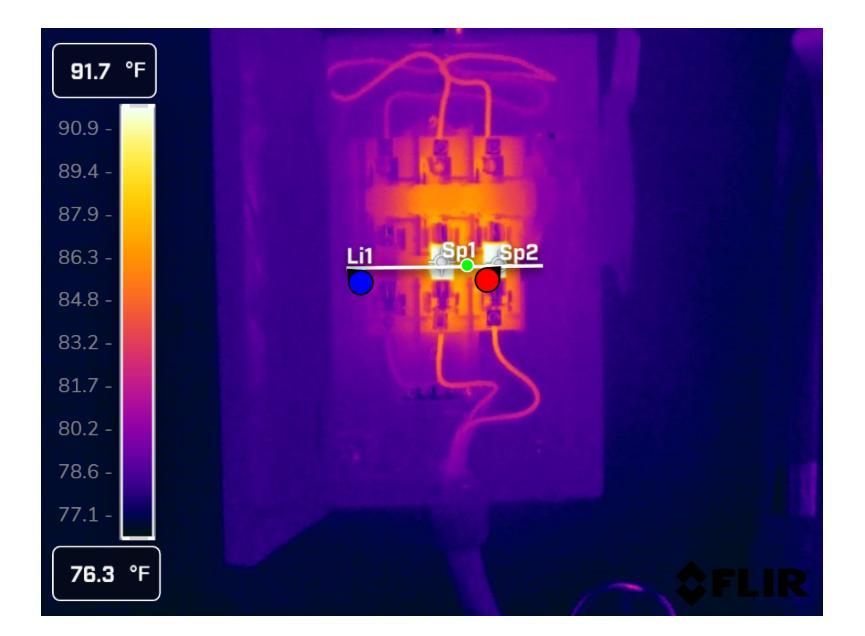
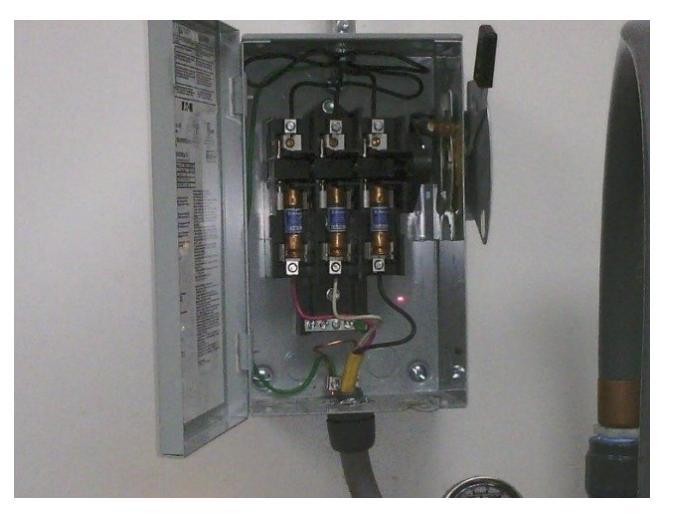
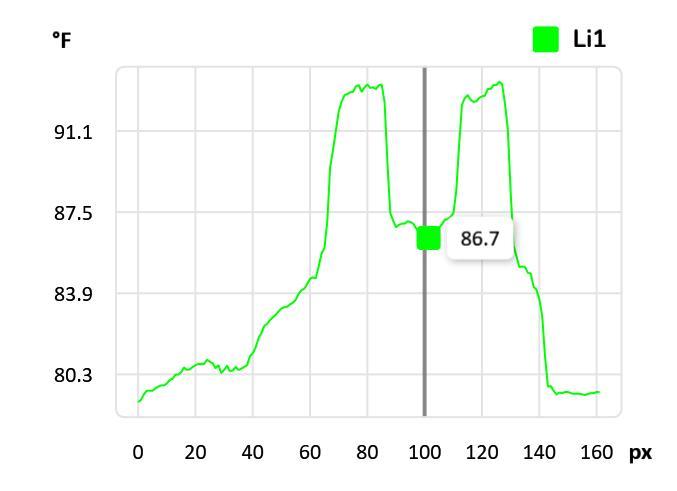
Panel A5 distribution pump ckt 26/28/30

Measurements			
Li1			
Max	93.3 °F		
Avg	85.0 °F		
Min	79.1 °F		
Sp1	92.6 °F		
Sp2	93.2 °F

Fault
Possible load issue
Defect Rating
CLASS I

IR image shows no heat on far left fuse circuit. Amp load was checked while on site by Gephart tech. We found zero current on the far left fuse. There is a balanced load on the other two fuses. This may or may not be an issue. We recommend further investigation to determine why no load exists on this circuit.
