Job Information

Name:	Hershey foods		Reason:	Motor inspection	
Contact:	Neil Adams	Motor#:		PO#:	
Application:	Direct Drive	Special notes:

Mechanical Inspection

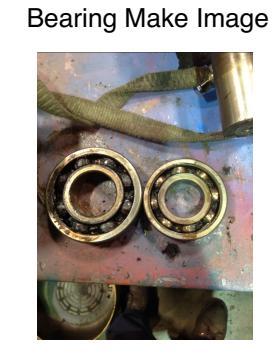
Bearing Type Image

Does the shaft turn freely?:	Yes	Contaminant(s):	Grease
Shaft rotation:	Bi-directional	Contaminant(s) Amt:	Cup
Shaft grounding device present?:	No	Contaminant Image:	and a
Type of grounding device:			
Shaft runout(TIR-Inbound):	.001		
Bearings DE:	Worn	Bearings DE make:	SKF
Insulated:	No	Bearing DE Size:	
Bearings ODE:	Worn	Bearings ODE make:	SKF
Bearing Type:	Ball	Bearing ODE Size:	
Bearings Retainer:	Yes	Thermal Protection:	No
Retainer condition:	Good	Thermal Protection Type:	_

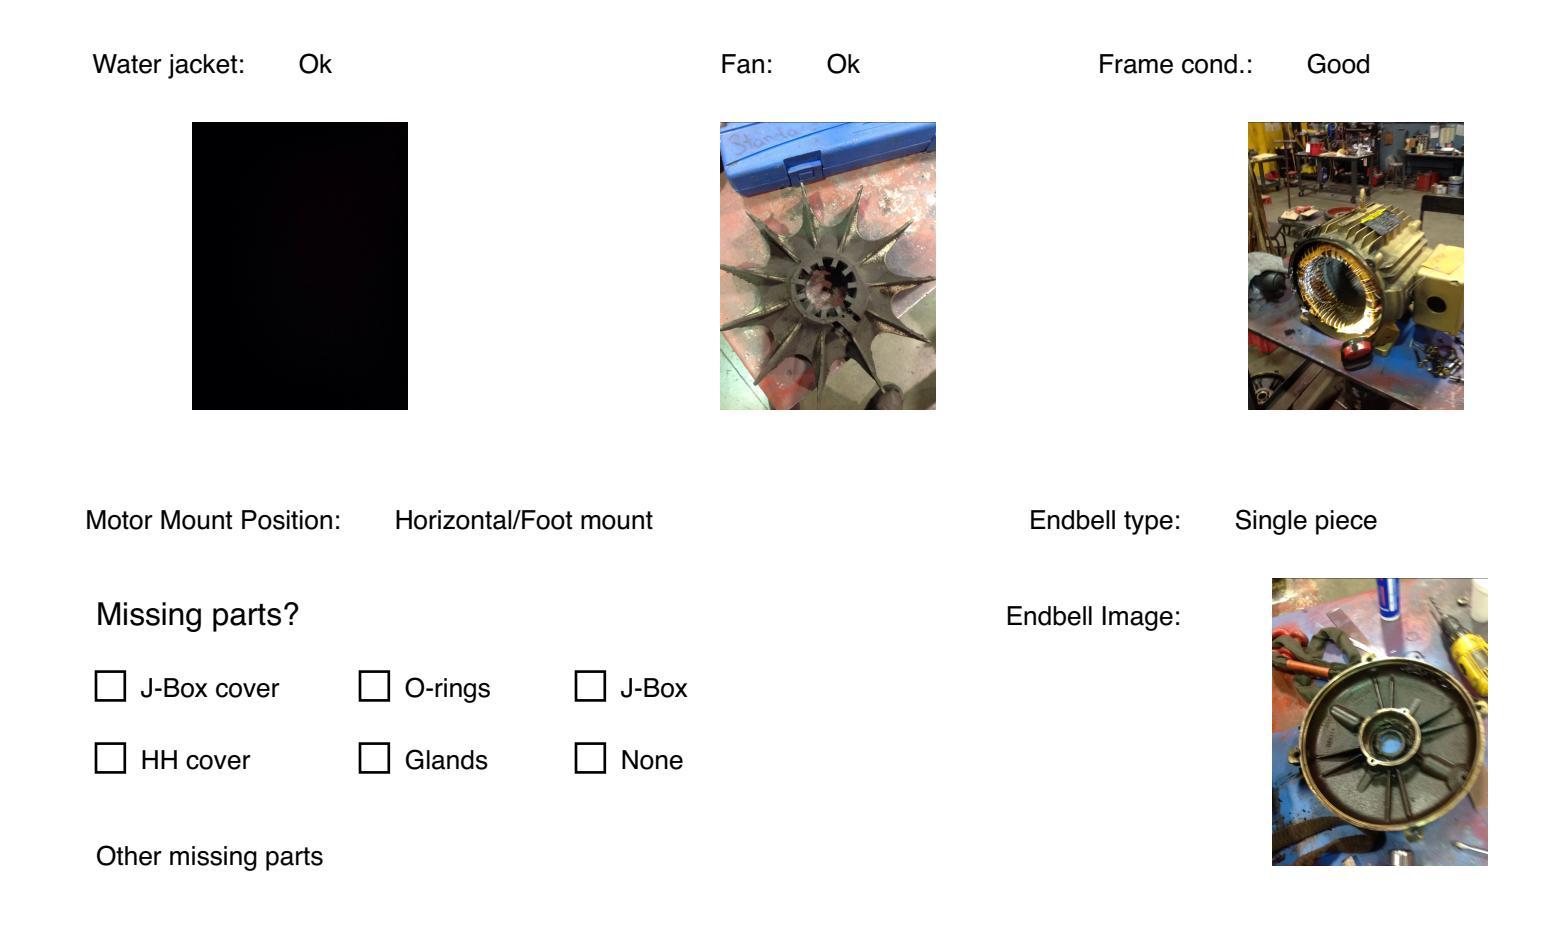
Brg. Image:

#2 end journal went bad causing iron to iron drag which caused windings to blow in between the slot.

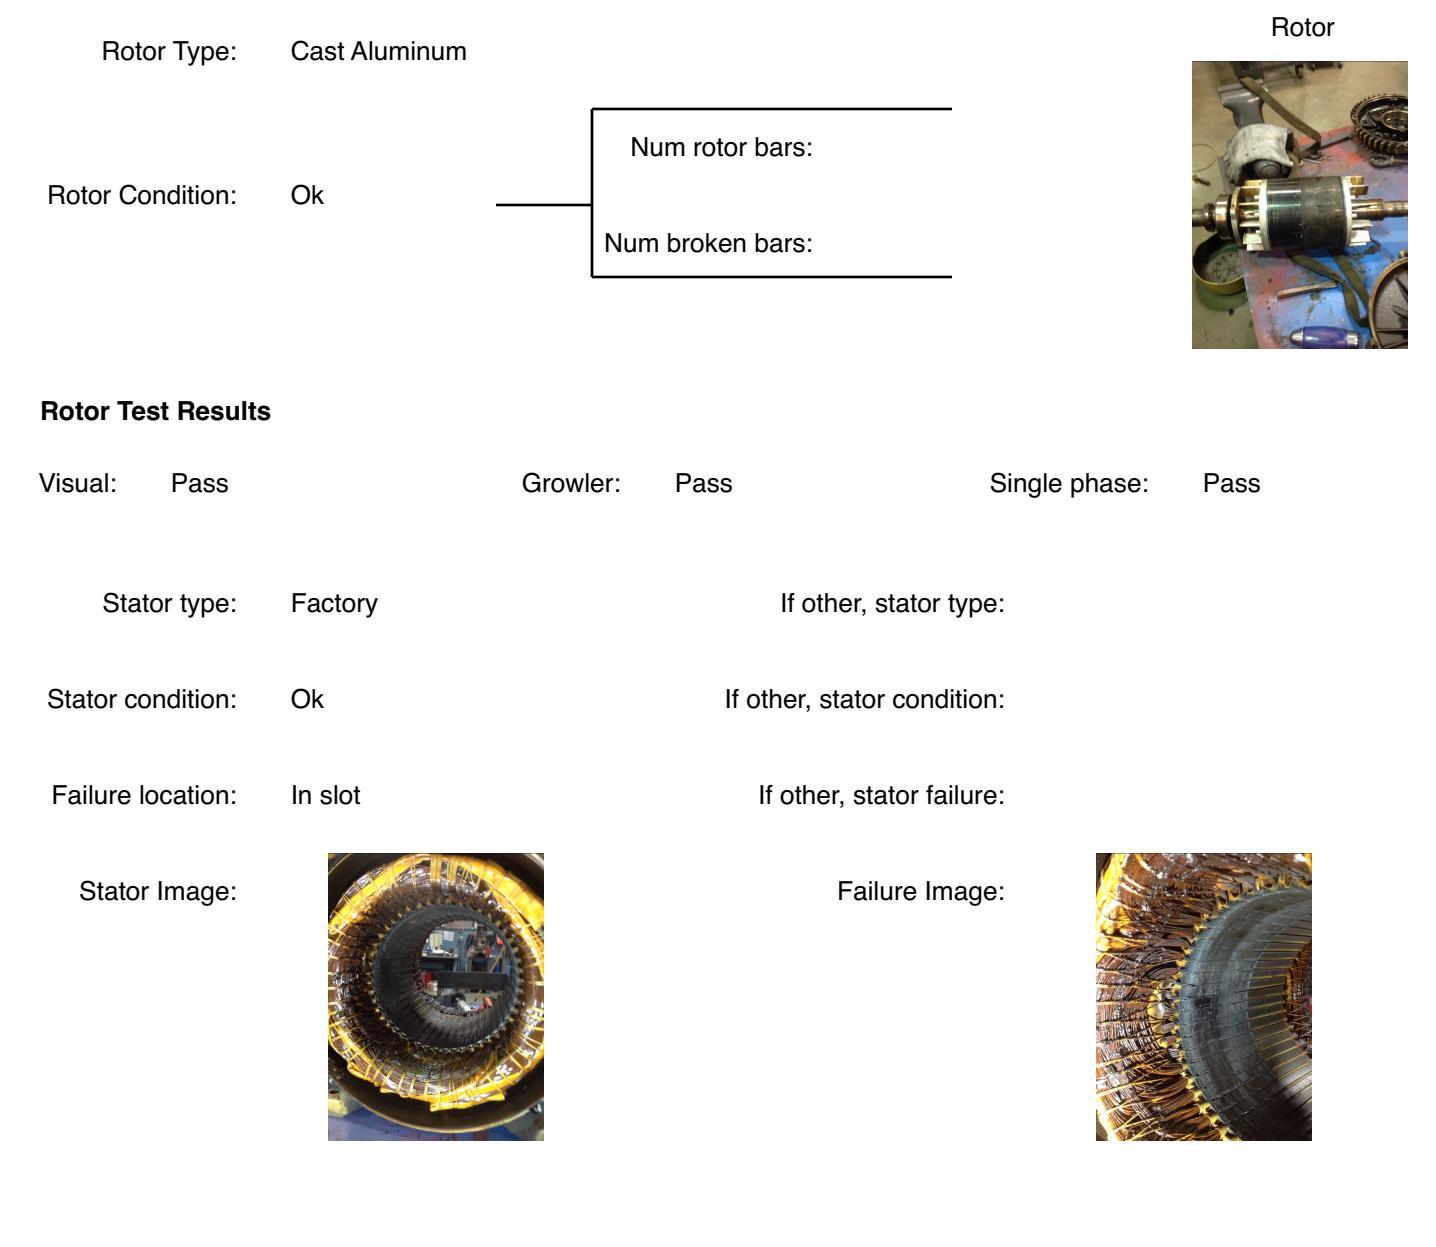
Winding color:	Like new	Winding in	nage Windir	ng Thermal Protection:	Yes
Winding condition :	Solid	A CONTRACTOR			
Winding Thermal Protection DE:	_				
Winding Thermal Protection ODE:	_				
Stator test results:	Rewind				
Megs incoming: Bad		Surge incoming: B	ad	Hi-pot incoming:	Bad
Winding Resistance In	coming				
Phase	es A to B	Phases B to C	Phases C to /	A Resistive in	mbalance
Incoming					
Leads/jumpe	ers: Ok		Lead jumper Im	age. :	2
If other, leads/jumpe	ers:

Windings blown in slot
