Job Information

Job #:	141404				Date:	January 3, 2020
Priority:	-	Authorized OT:	No	Authorized by:

Name:	HSLR			Reason:	
Contact:		Motor#:	141404		PO#:
Application:	Radial Load	Special not	es:

Manufacturer:	Worldwide	Enclosure :	Open Drop Proof (ODP)
Serial#:	10015 GHJ	Model#:	WWB4001858677 UZ
Service Factor:	1.15	Frame:	586/7uz
Horsepower/kW:	00	Rated RPM:	1790
Rated Amps:	430	Rated Voltage:	460
Phase:	3	Cycles:	60
Special design:	No

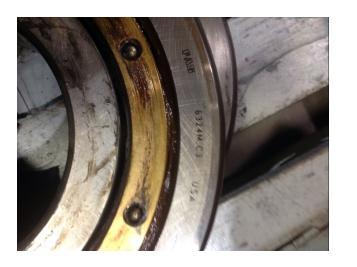
Bearing Type Image

Bearings DE:	Locked up	Bearings DE make:	FAG
Insulated:	No	Bearing DE Size:	NU326
Bearings ODE:	Worn	Bearings ODE make:	FAG
Bearing Type:	Ball	Bearing ODE Size:	6324
Bearings Retainer:	Yes	Thermal Protection:	No
Retainer condition:	Bad	Thermal Protection Type:	_

REWIND STATOR TWO NEW BEARINGS 6324 /NU6326 NEW D.E.INSIDE BEARING RETAINER REPAIR D.E.OUTSIDE BEARING RETAINER REPAIR D.E.JRL
