Job Informatio

Job #:	141575				Date:	January 10, 2020
Priority:	_	Authorized OT:	No	Authorized by:

Manufacturer:	: Baldor	Enclosure :	Open Drop Proof	Enclosure Type image	
Serial#:	K1203280011	Model#:			
Service Factor:	1.15	Frame:	23eb5010dz		
Horsepower/kW:	350	Rated RPM:	1789		
Rated Amps:	45	Rated Voltage:	4160	No. 1	
Phase:	3	Cycles:			
Special design:	No

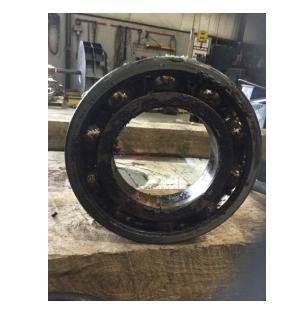
Bearing Type Image

Bearings DE:	Fell Apart	Bearings DE make:	SKF
Insulated:	No	Bearing DE Size:	6222
Bearings ODE:	Other	Bearings ODE make:	SKF
Bearing Type:	Ball	Bearing ODE Size:	6222
Bearings Retainer:	Yes	Thermal Protection:	Yes
Retainer condition:	Bad	Thermal Protection Type:	_
