Job Information

Job #:	94193				Date:	April 30, 2018
Priority:	_	Authorized OT:	No	Authorized by:

Name:	Welspun	Reason:		
Contact:		Motor#:		PO#:
Application:	_	Special notes:

Manufacturer:	Zoeller	Enclosure :	Open Drop Proof (ODP)
Serial#:	19313	Model#:	G641-A
Service Factor:		Frame:	
Horsepower/kW:	3	Rated RPM:	1750
Rated Amps:	4.8	Rated Voltage:	460
Phase:	3	Cycles:	60
Special design:	No

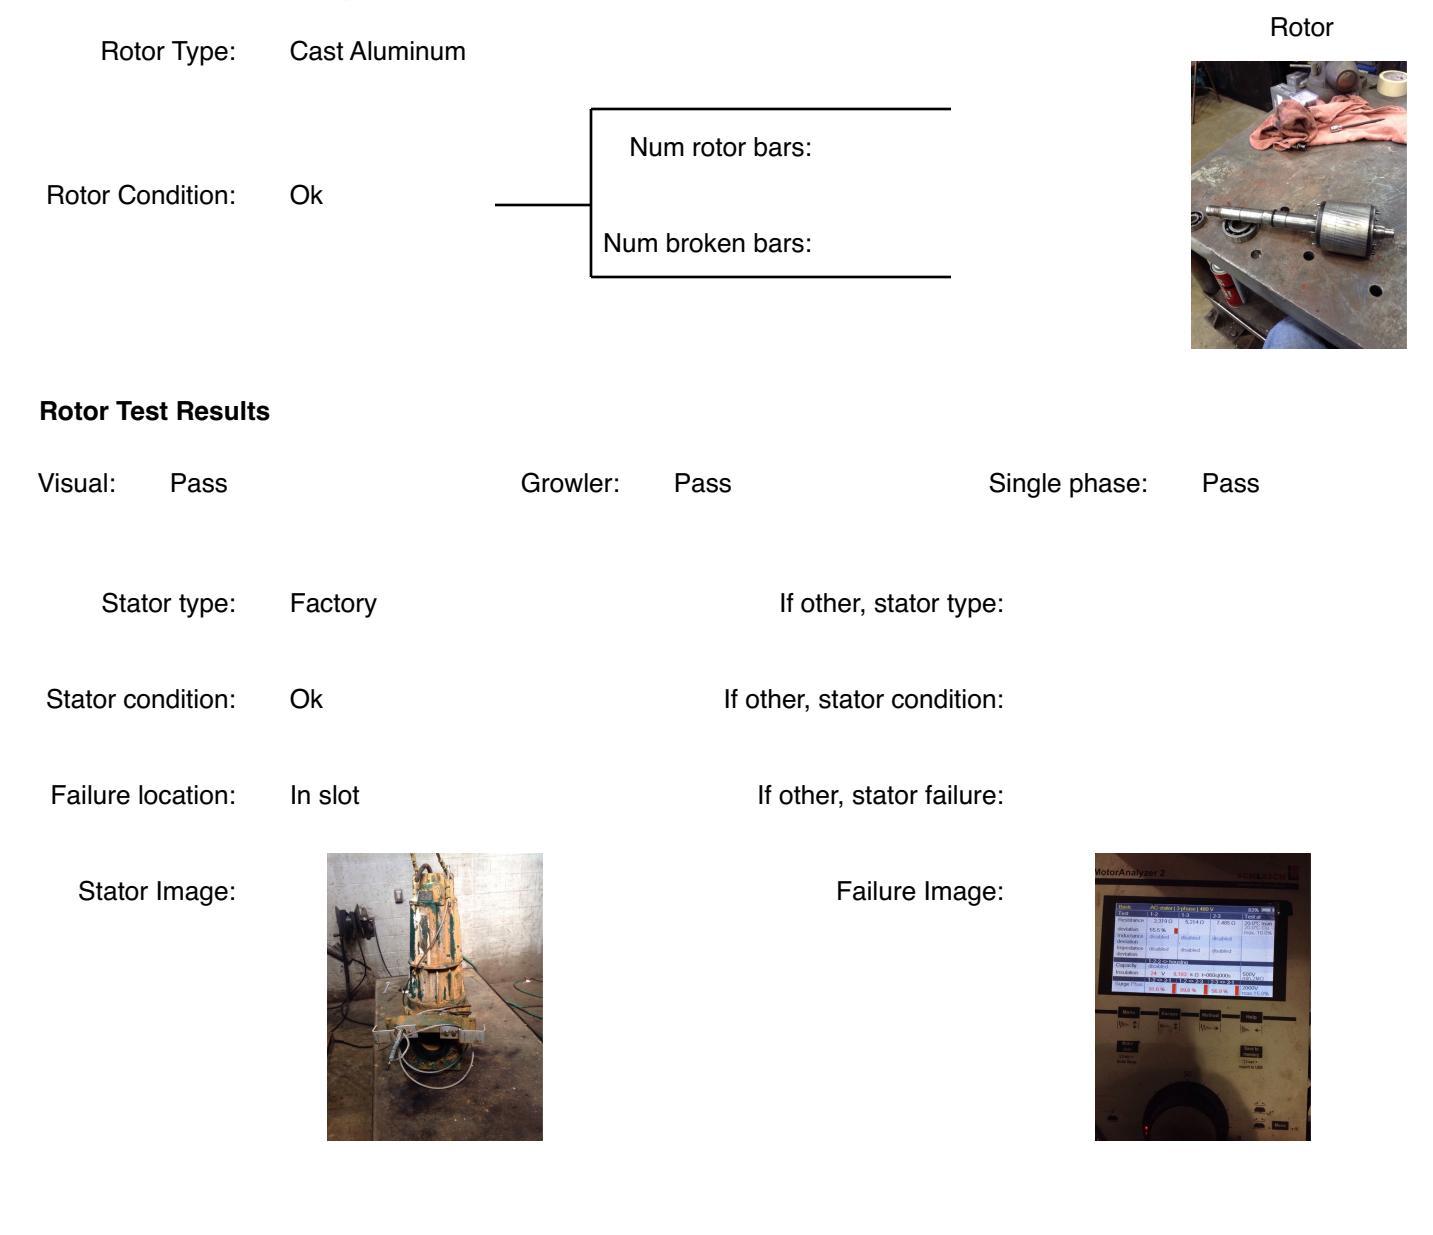
AC Electrical Inspection (Continued)

Winding co	olor:	Dull black	Winding	g image	Winding Thermal	Protection:	No
Winding conditi	on :	Mushy				HotorAnalyzor z	100 V 074 (mm) . 100 V 074 (m
Winding Ther Protection	mal DE:	_					1-020-0000 SQUY UTS 3-95 CFS 3- SQUY UTS
Winding Ther Protection O	mal DE:	_				10 kg	
Stator test rest	ults:	Rewind					
Megs incoming:	Bad		Surge incoming:	Bad	Hi-pot inc	coming: Ba	ad
Winding Resista	ince Inc	coming					
	Phase	es A to B	Phases B to C	Phase	s C to A	Resistive imb	alance
Incoming	2.3		5.2	7.4		55	
Leads	s/jumpe	rs: Ok

Power cord and sensor cord were cut, and overloads and sensors were apparently not being used. Both bearings were worn and the seal failure allowed water to contaminate the stator. Also the lower seal plate has excessive amounts of corrosion and needs to be replaced. Recommend rewind of stator, replacement of all o-rings and seals as well as new power and sensor cord assemblies.
