Job Information

Job #:	94498				Date:	July 11, 2018
Priority:	_	Authorized OT:	No	Authorized by:

Name:	Ryerson		Reason:	
Contact:		Motor#:		PO#:
Application:	_	Special notes:

Conclusion

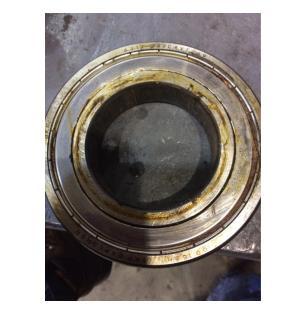
Bearing Make Image

Bearings DE:	Worn	Bearings DE make:	SKF
Insulated:	No	Bearing DE Size:	NU 6212
Bearings ODE:	Worn	Bearings ODE make:	SKF
Bearing Type:	Ball	Bearing ODE Size:	6212-2Z/C4
Bearings Retainer:	Yes	Thermal Protection:	No
Retainer condition:	Good	Thermal Protection Type:	_
