# **Job Information**

Job #:	94779				Date:	October 4, 2018
Priority:	_	Authorized OT:	No	Authorized by:

Manufacturer:	Siemens	Enclosure :	Totally Enclosed Fan Cooled
Serial#:	E120818165472300 6	Model#:	1LA9166-4KA99- ZT00
Service Factor:		Frame:	
Horsepower/kW:	30 kW	Rated RPM:	4170
Rated Amps:	70	Rated Voltage:	370
Phase:	3	Cycles:	60
Special design:	No

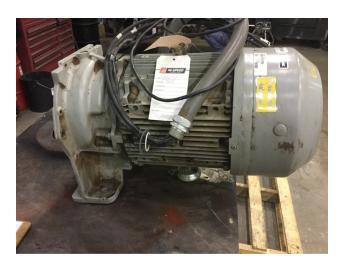
Water jacket: N/A Fan:

Broken

Frame cond.: Good

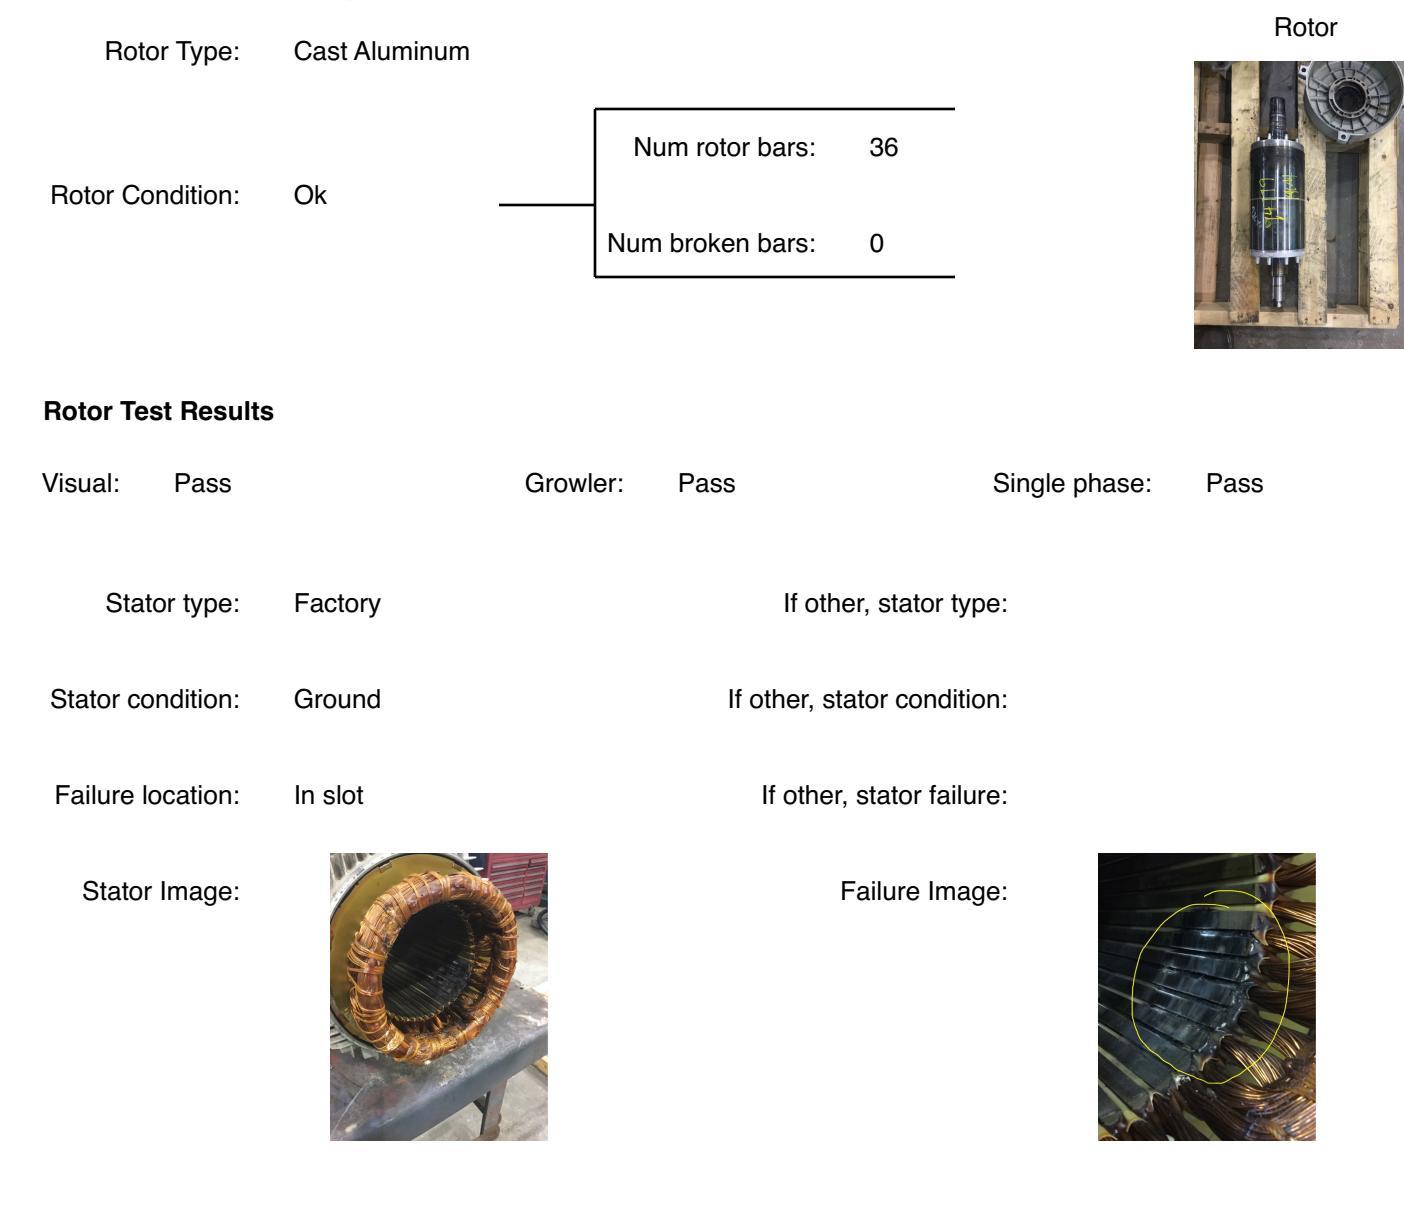
### **AC Electrical Inspection (Continued)**

ODE bearing failed, ODE bearing journal is bad, windings grounded

ODE bearing failed from lack of lubrication. ODE has no grease zert to add grease to lube the bearing
