## **Job Information**

Job #:	94524			Date:	July 19, 2018	
Priority:	_	Authorized OT:	No	Authorized by:

Name:	Process & Power		Reason:	
Contact:		Motor#:		PO#:
Application:	_	Special notes:

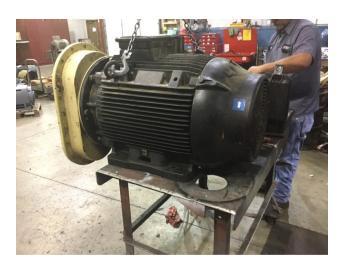
Fan:

Ok
