Infrared Thermography Report

ARCOSA INFRARED 2020

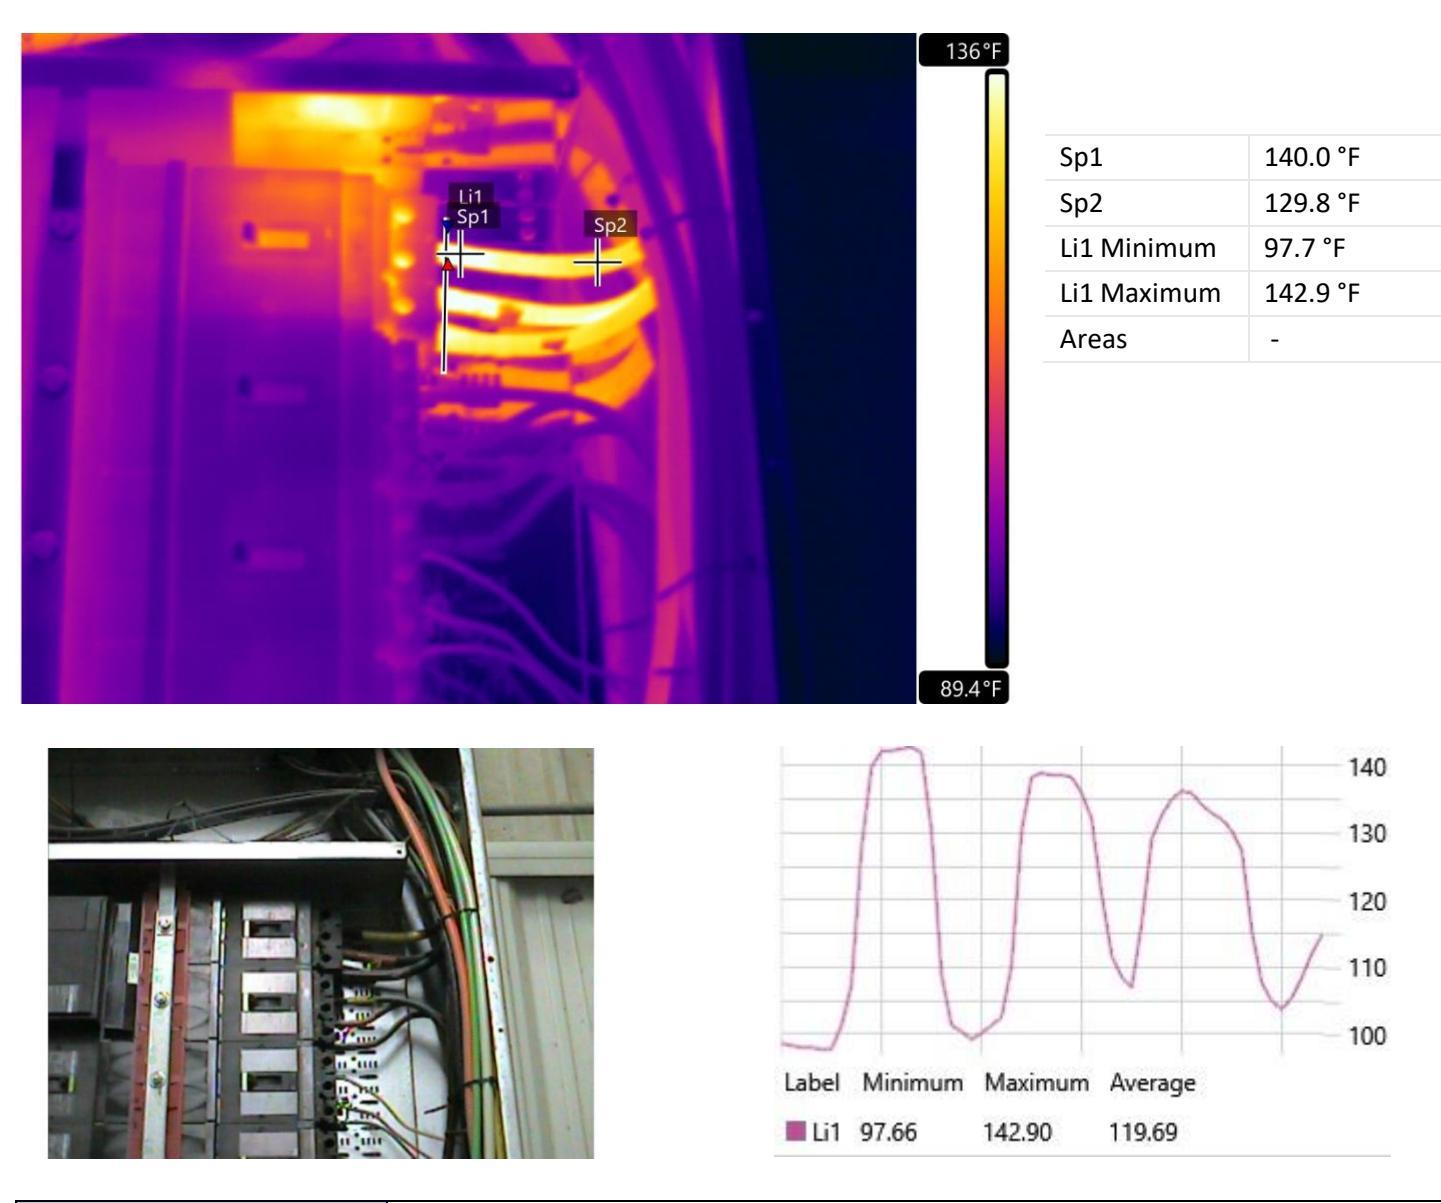
Component	Top Right Circuit Breaker for Quincy Compressor
Equipment/Bucket ID	Main Panel DP1

Fault	Localized hot spot and possible over current
Defect Rating	Class I

Clean and inspect the buss and breaker connections. Replace as needed. Retorque all fasteners. Perform an amp draw test to confirm proper conductor sizing or over current condition.

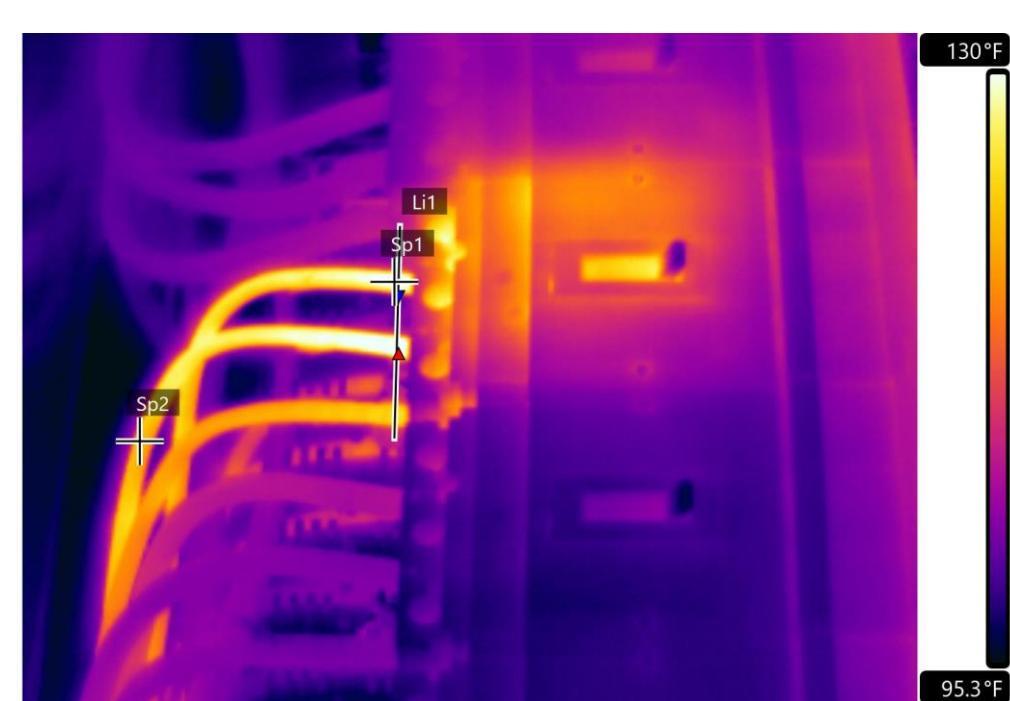
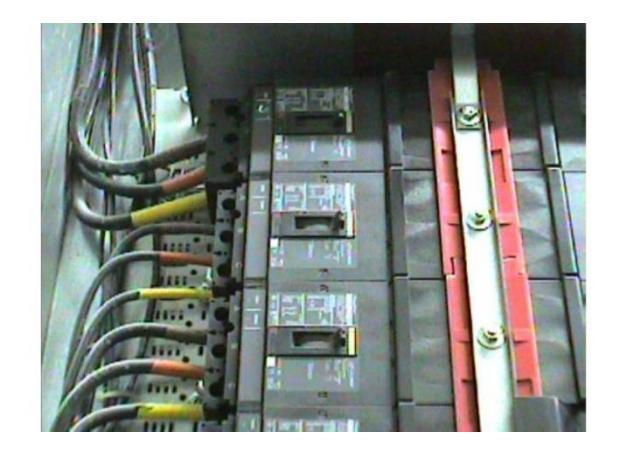
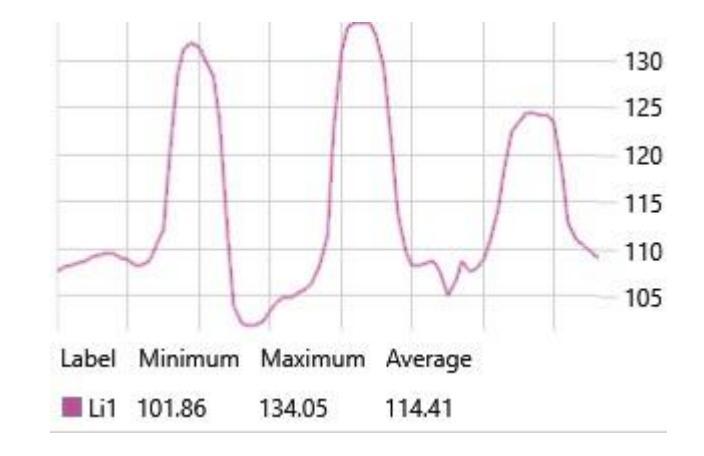
Component	2nd Down on Left Circuit Breaker Final Trim Panel
Equipment/Bucket ID	Main Panel DP2

Sp1	131.2 °F
Sp2	121.3 °F
Li1 Minimum	101.9 °F
Li1 Maximum	134.1 °F
Areas	-

Fault	Localized hot spots
Defect Rating	Class I

Recommendations	
Clean and inspect the buss and breaker connections. Replace as needed. Retorque all fasteners.

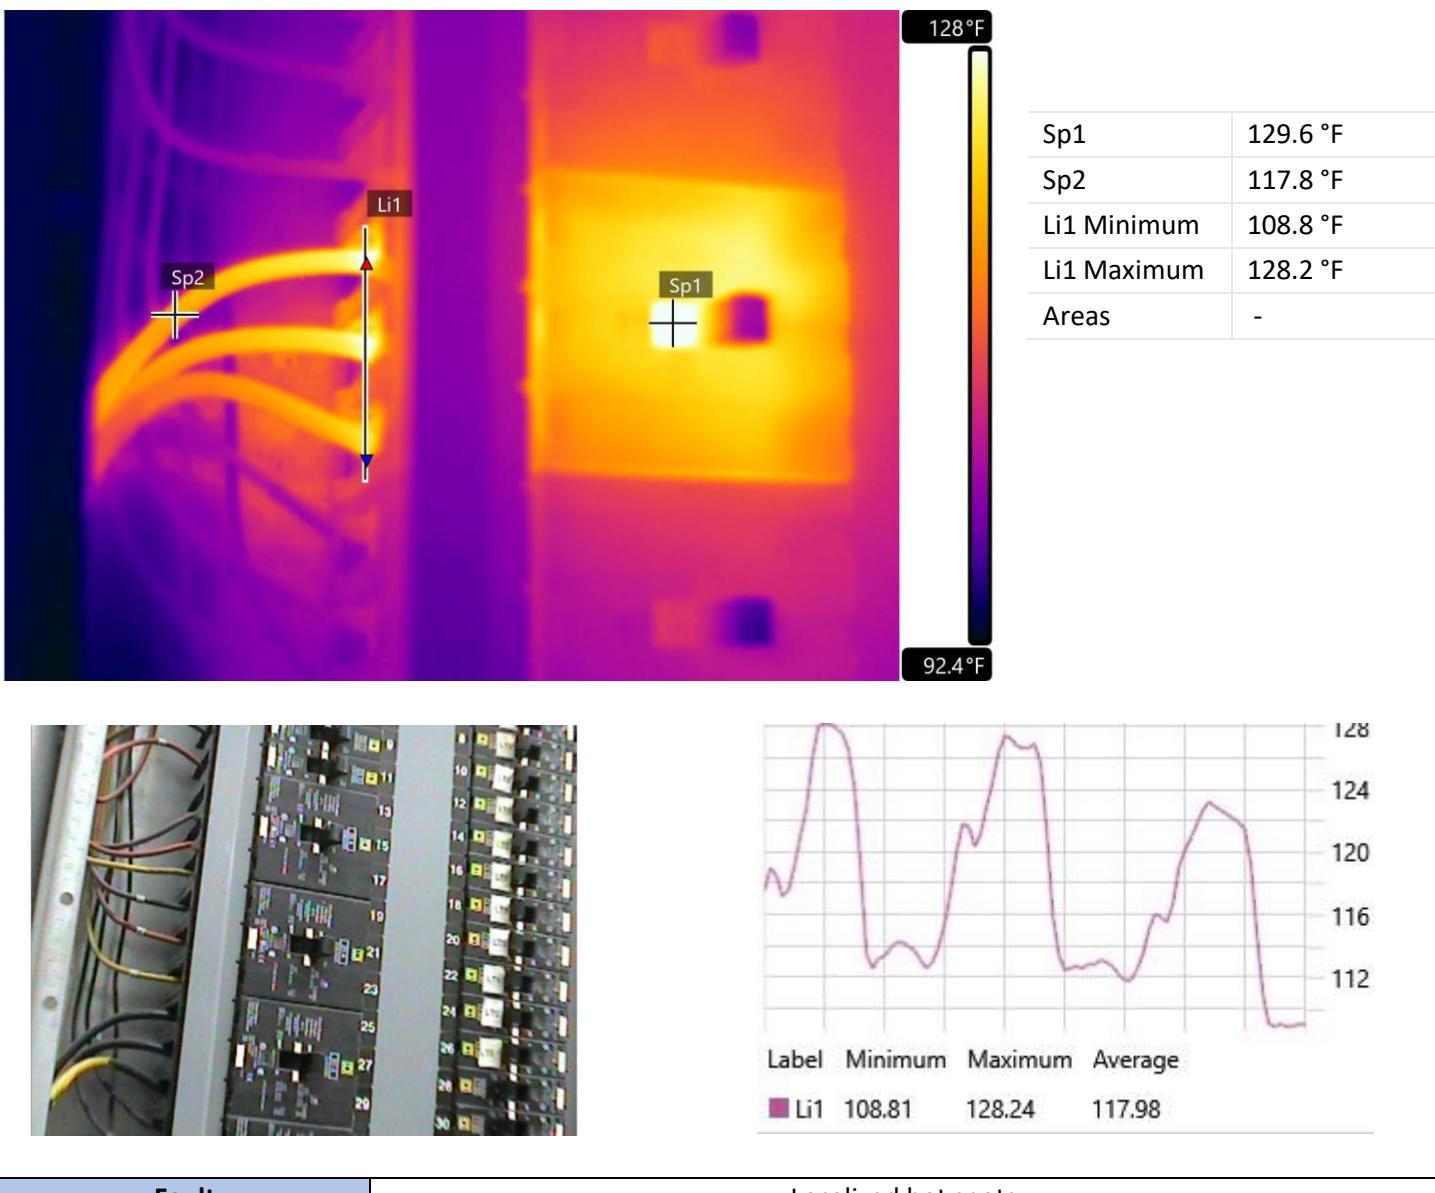
Component	3 rd Up on Left Circuit Breaker slots 25/27/29
Equipment/Bucket ID	H1 Main Panel

Fault	Localized hot spots
Defect Rating	Class I

Clean and inspect the buss and breaker connections. Replace as needed. Retorque all fasteners. Perform an amp draw test to confirm proper conductor sizing or over current condition.

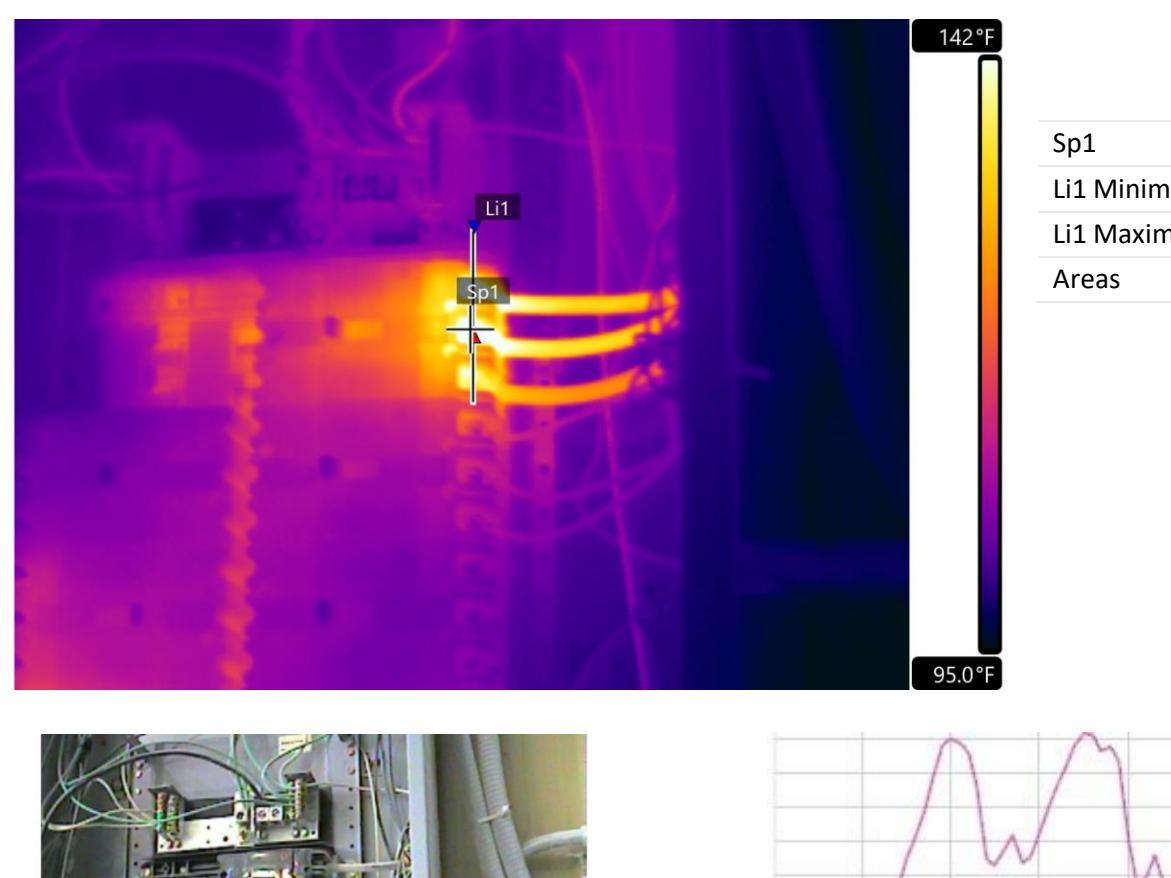
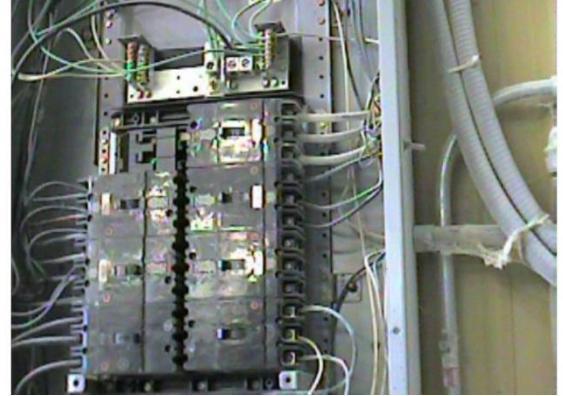
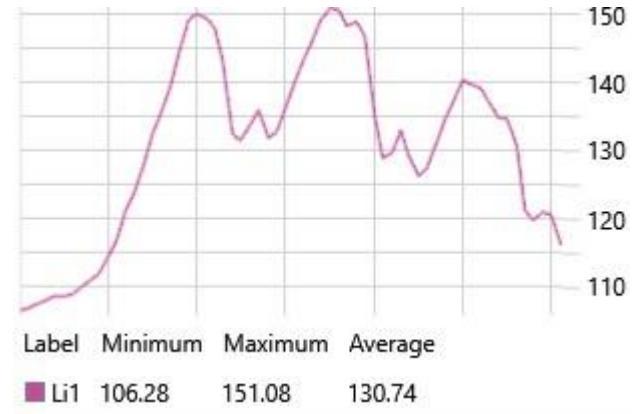
Component	Main Circuit Breaker Top Right
Equipment/Bucket ID	Trim Panel

Sp1	151.4 °F
Li1 Minimum	106.3 °F
Li1 Maximum	151.1 °F
Areas	-

Fault	Localized Hot Spots and possible overcurrent issue.
Defect Rating	Class I

Clean and inspect the buss and breaker connections. Replace as needed. Retorque all fasteners. Perform an amp draw test to confirm proper conductor sizing or over current condition.

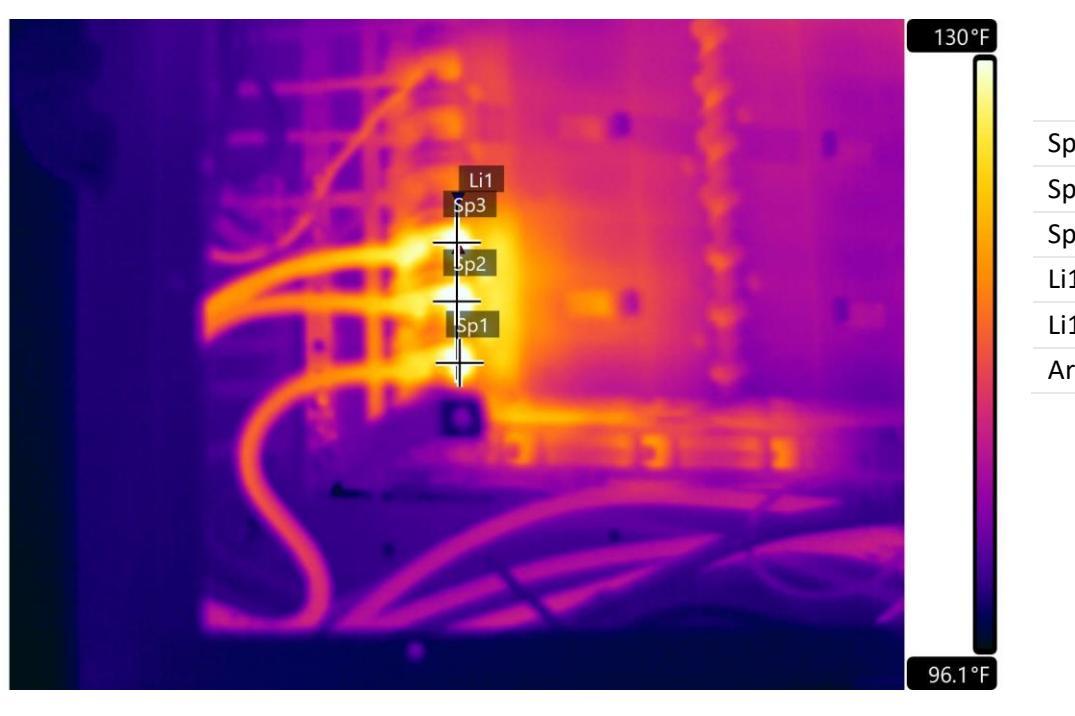
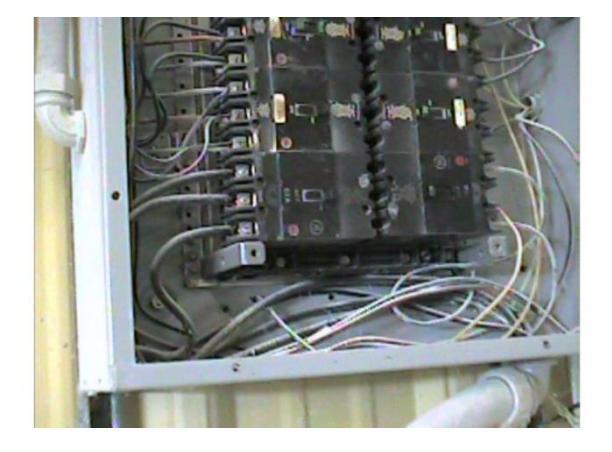
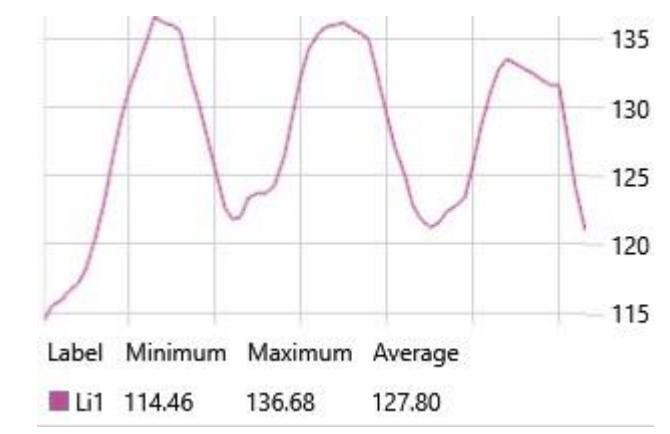
Component	Bottom Left Circuit Breaker
Equipment/Bucket ID	Trim Panel Dust Collector system

Sp1	134.2 °F
Sp2	136.1 °F
Sp3	136.1 °F
Li1 Minimum	114.5 °F
Li1 Maximum	136.7 °F
Areas	-

Fault	Localized Hot Spots. Possible over curreny
Defect Rating	Class I

Recommendations	
Clean and inspect the buss and	d breaker connections. Replace as needed. Retorque all fasteners. Perform an amp draw
test to confirm proper conduc	tor sizing or over current condition.
