Infrared Thermography Report

Gold Strike Hotel and Casino July 2020

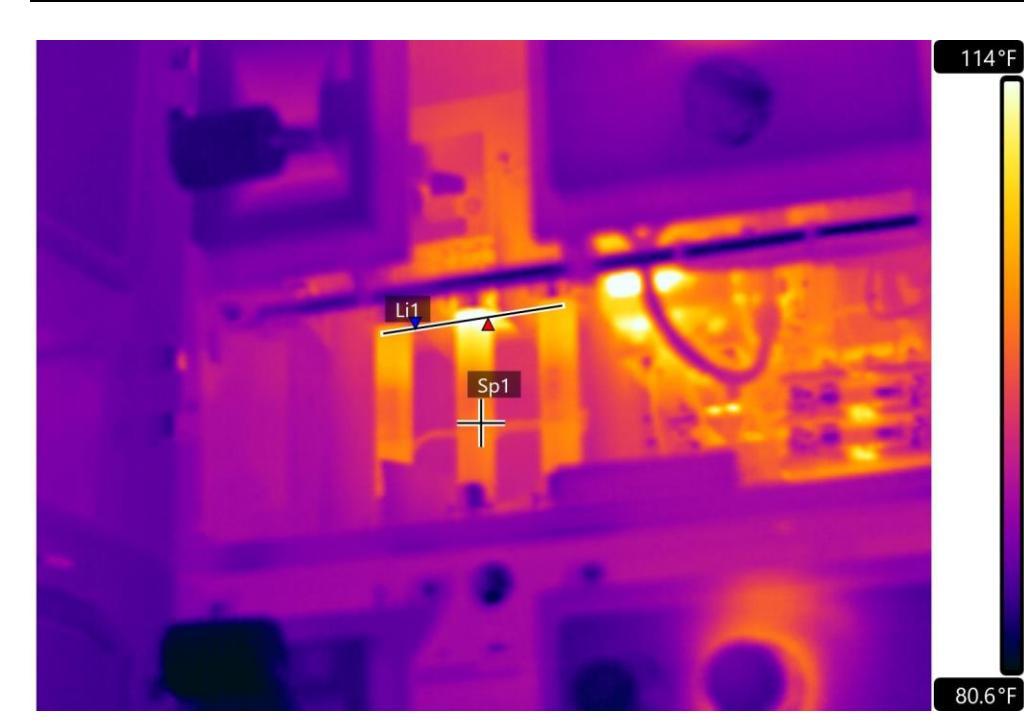
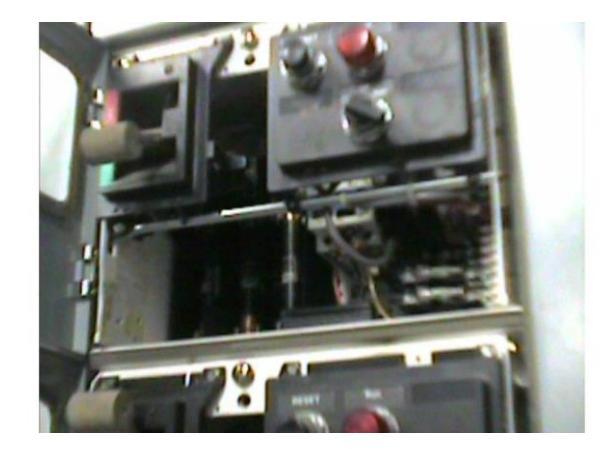
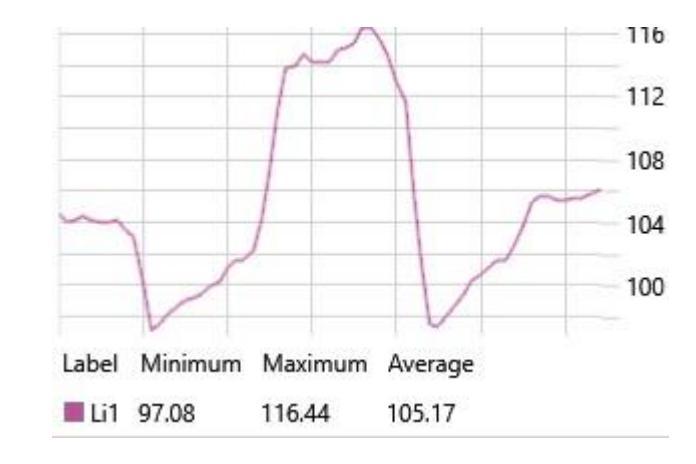
Component	Buffet left/east side vent hood
Equipment/Bucket ID	Kitchen Mezzanine XMCCB Bucket

Sp1	101.1 °F
Li1 Minimum	97.1 °F
Li1 Maximum	116.4 °F
Areas	-

Fault	Poor connection at center top fuse clip
Defect Rating	Class I

Recommendations	
Clean and inspect the fuse clip	s. Replace if necessary. Replace the fuses if possible.

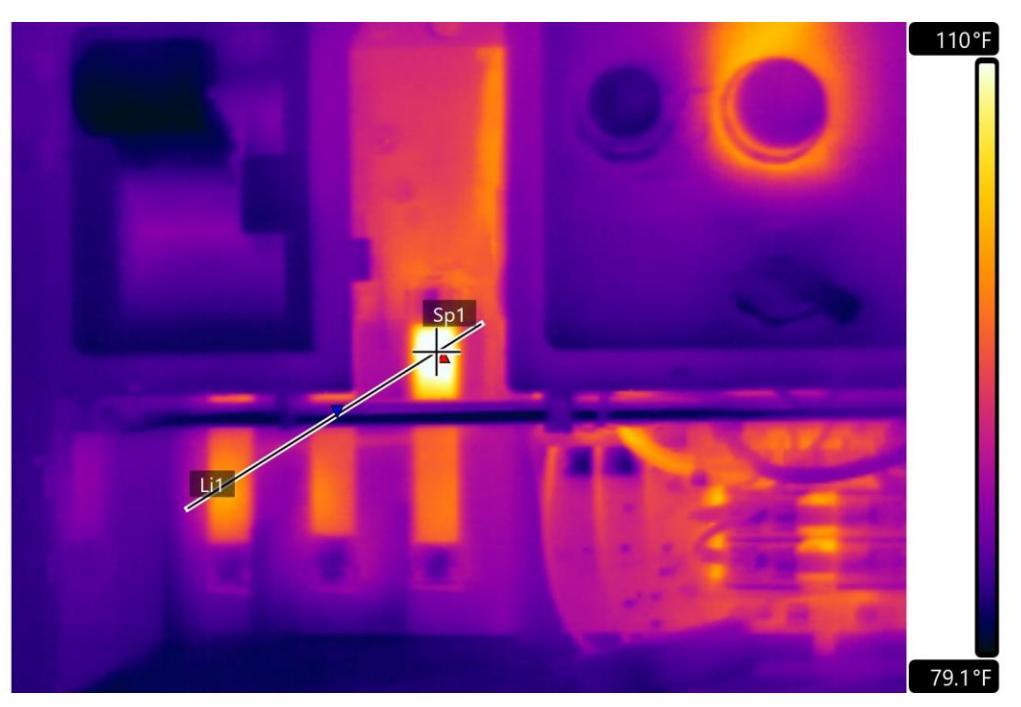
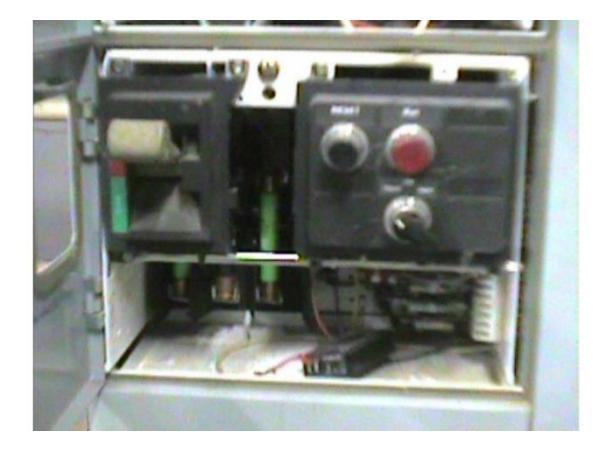
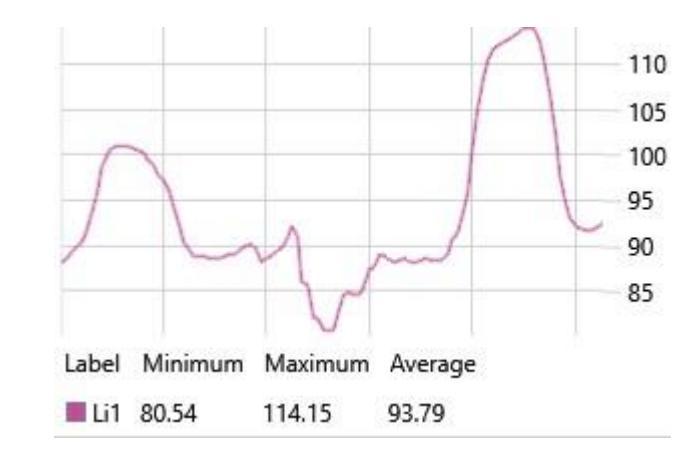
Component	Buffet #3 right KEF-3
Equipment/Bucket ID	Kitchen Mezzanine XMCCB Bucket

Sp1	113.5 °F
Li1 Minimum	80.5 °F
Li1 Maximum	114.1 °F
Areas	-

Fault	Poor connection at top right fuse.
Defect Rating	Class I

Recommendations	
Clean and inspect the fuse clip	s. Replace if necessary. Replace the fuses if possible.

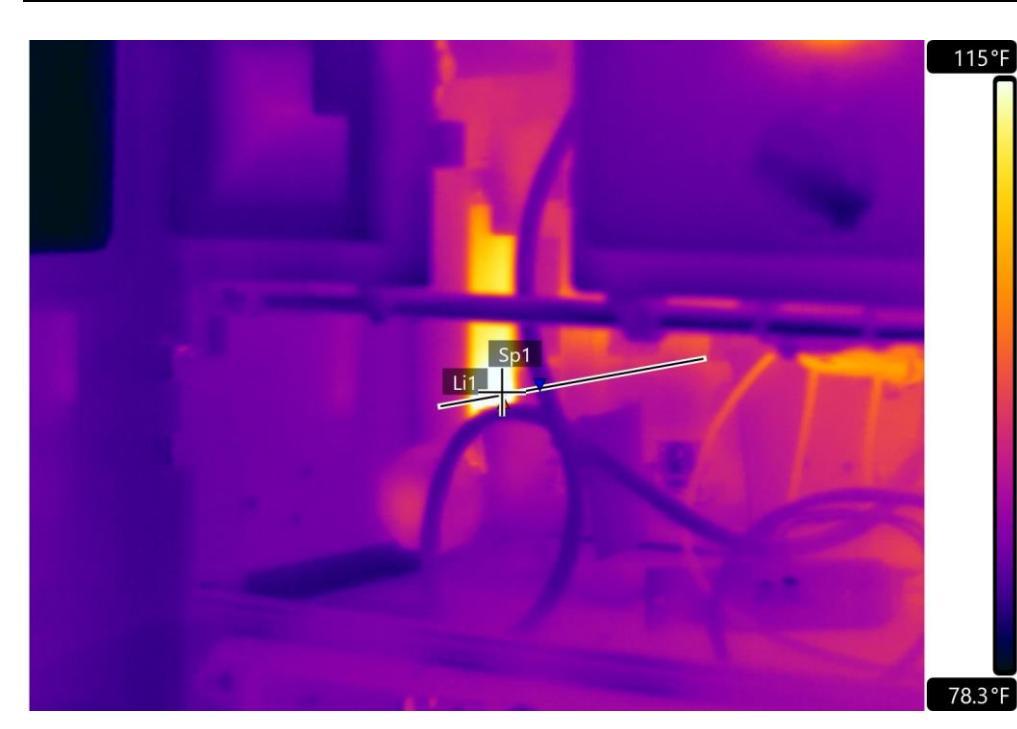
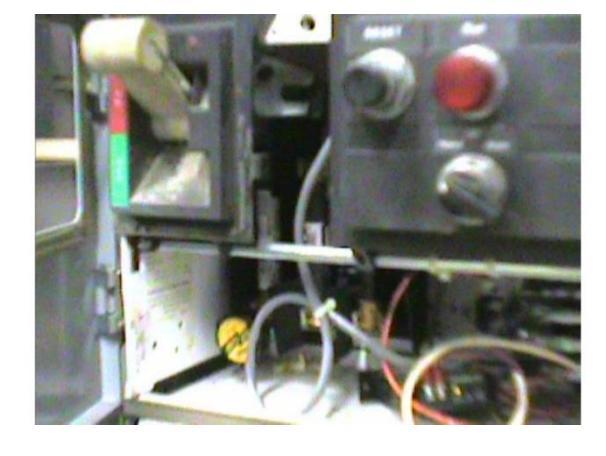
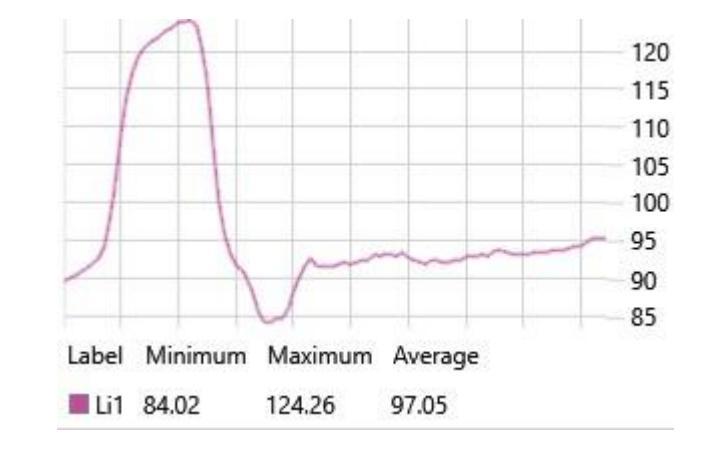
Component	Steak house right KEF2B
Equipment/Bucket ID	Kitchen Mezzanine XMCCB Bucket

Sp1	123.8 °F
Li1 Minimum	84.0 °F
Li1 Maximum	124.3 °F
Areas	-

Fault	Poor connection at lower left fuse connection.
Defect Rating	Class I

Recommendations	
Clean and inspect the fuse clip	s. Replace if necessary. Replace the fuses if possible.

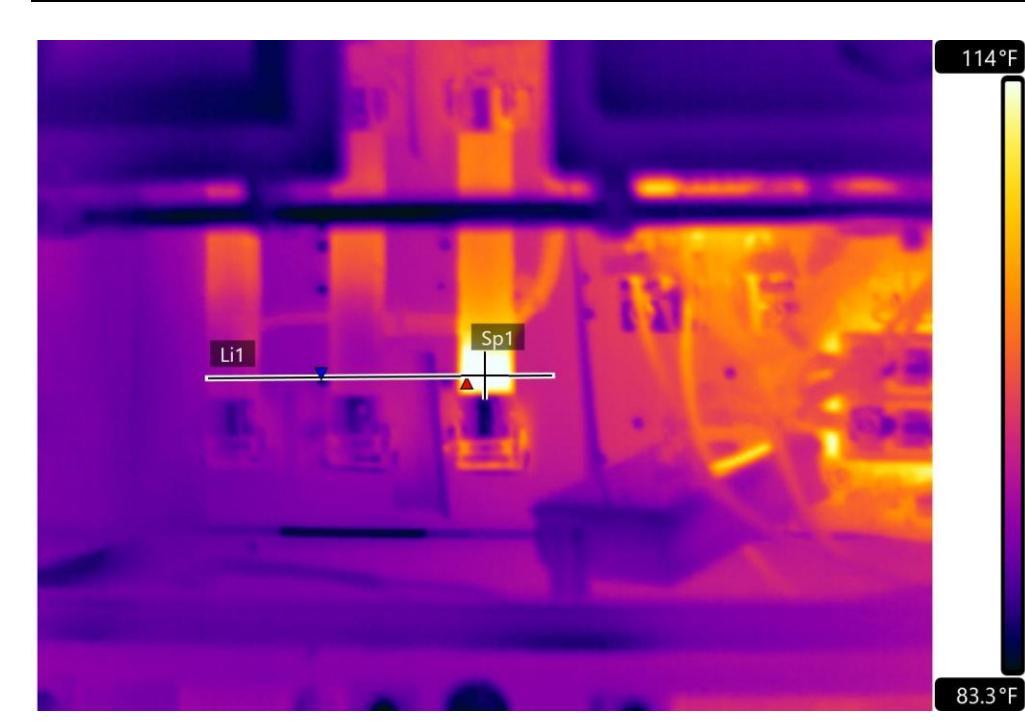
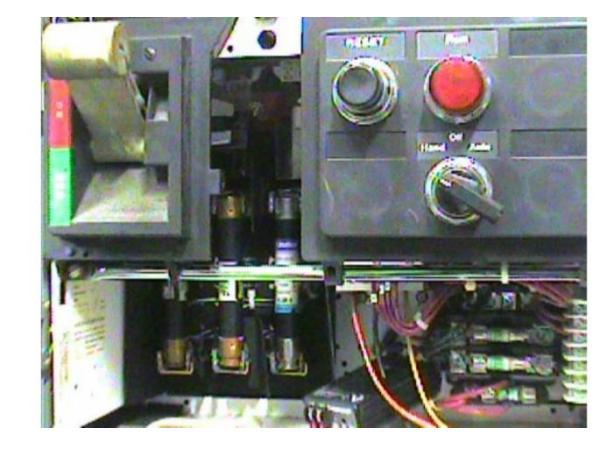
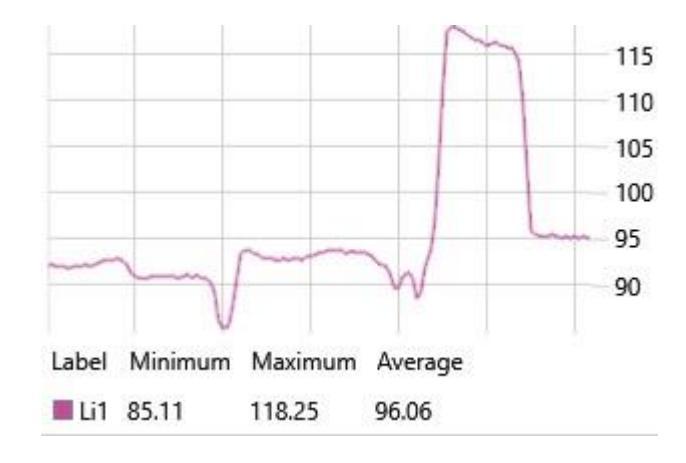
Component	Steak house left KEF-2B
Equipment/Bucket ID	Kitchen Mezzanine XMCCB Bucket

Sp1	116.4 °F
Li1 Minimum	85.1 °F
Li1 Maximum	118.3 °F
Areas	-

Fault	Poor connection at lower right fuse
Defect Rating	Class I

Recommendations		
Clean and inspect the fuse clips. Replace if necessary. Replace the fuses if possible.

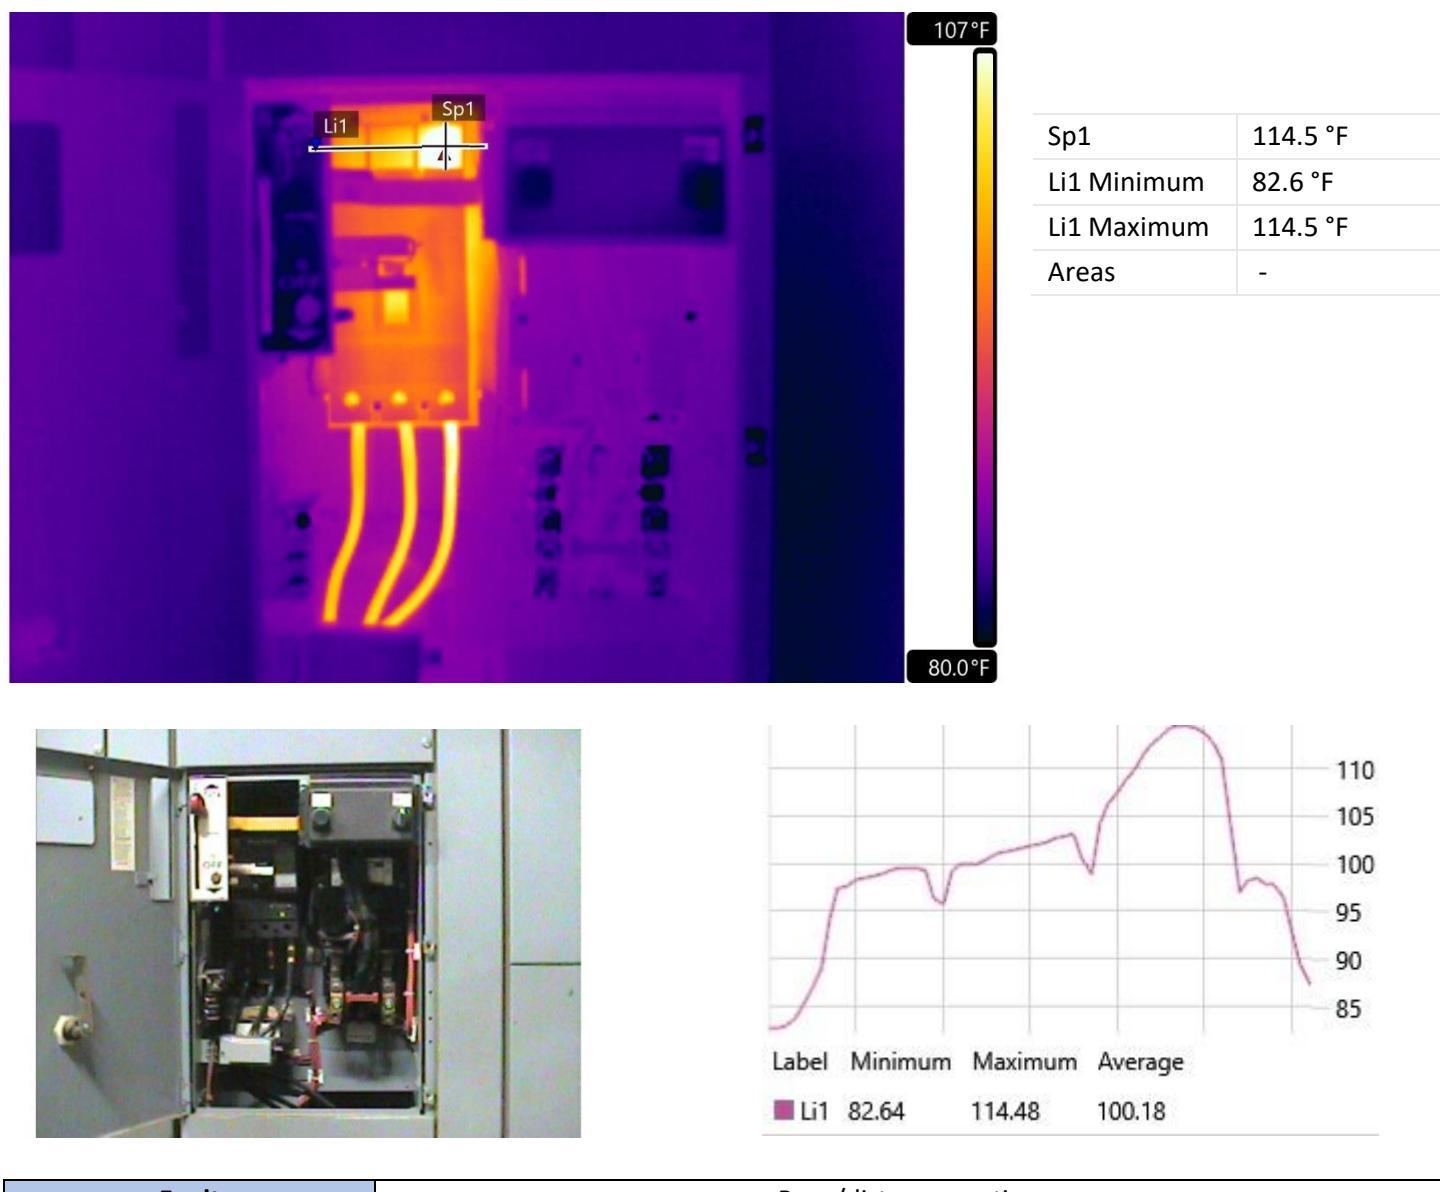
Component	Condenser Pump 6 C/B Switch
Equipment/Bucket ID	Chiller Room

Fault	Poor/dirty connection
Defect Rating	Class I

It appears the "C" phase of the switch has a poor connection and is generating some heat. Inspect the unit and either clean or replace as necessary to eliminate the weak connection.

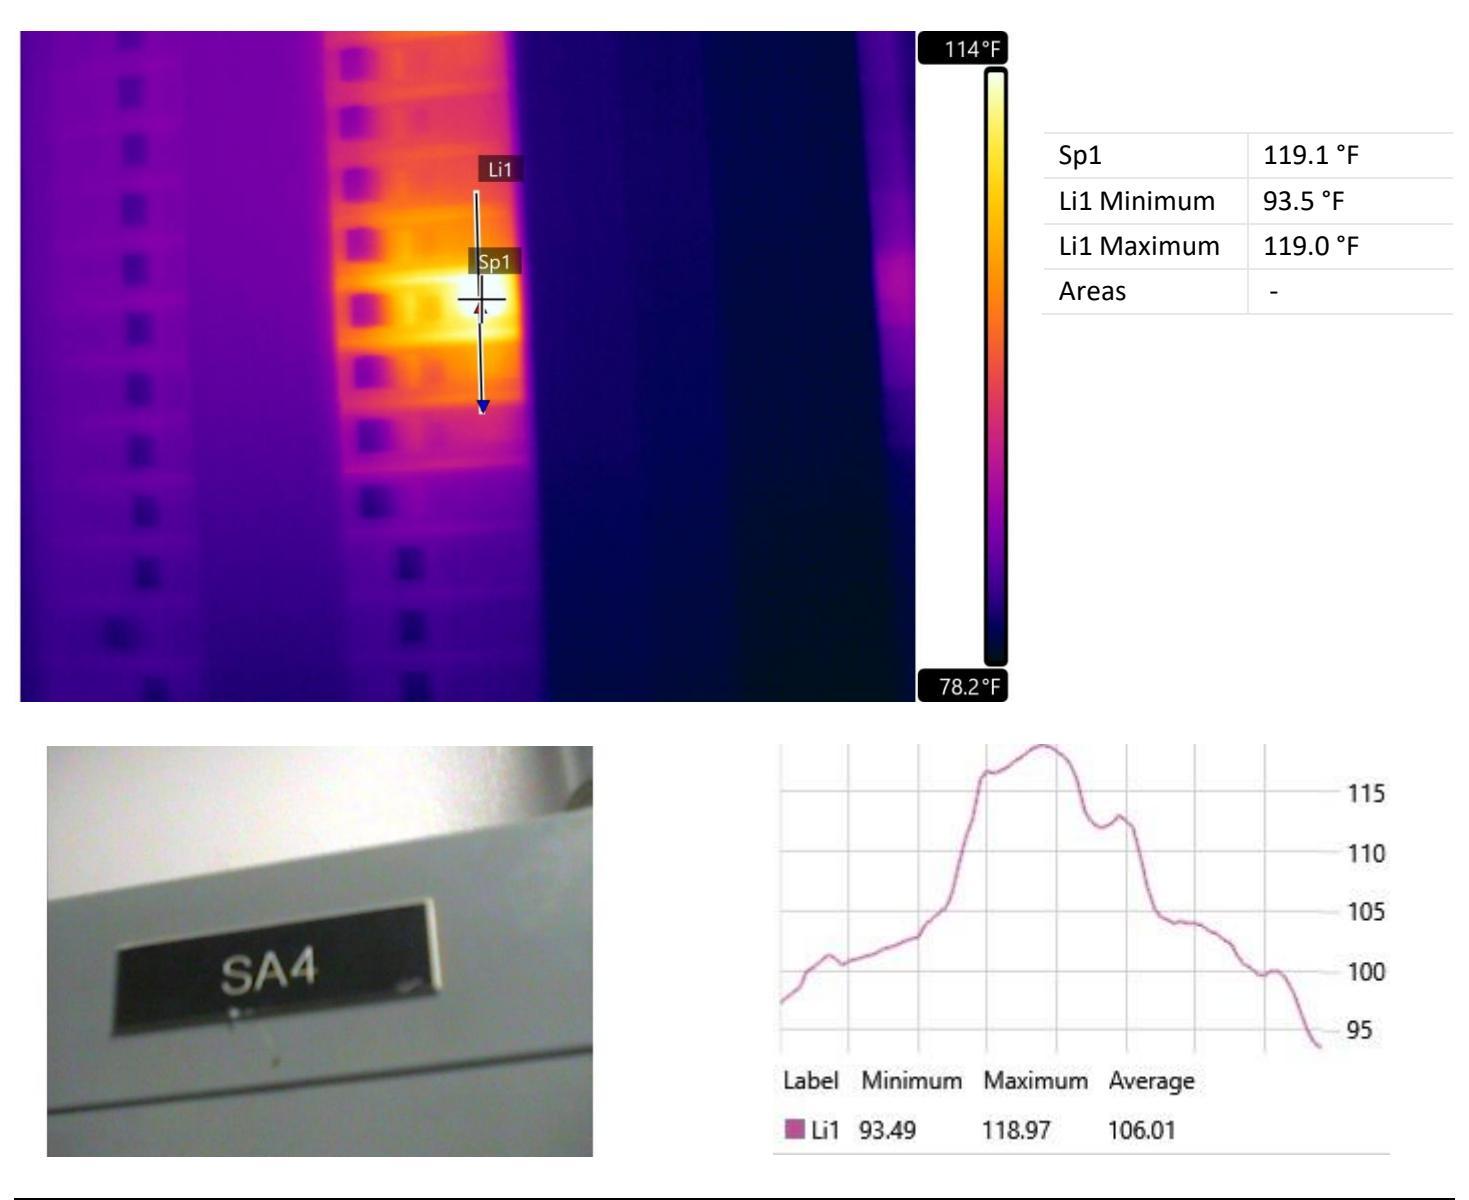
Component	Breaker 28
Equipment/Bucket ID	Small slot room SA4

Fault	Weak or oxidized connections, overloaded or worn breaker.
Defect Rating	Class I

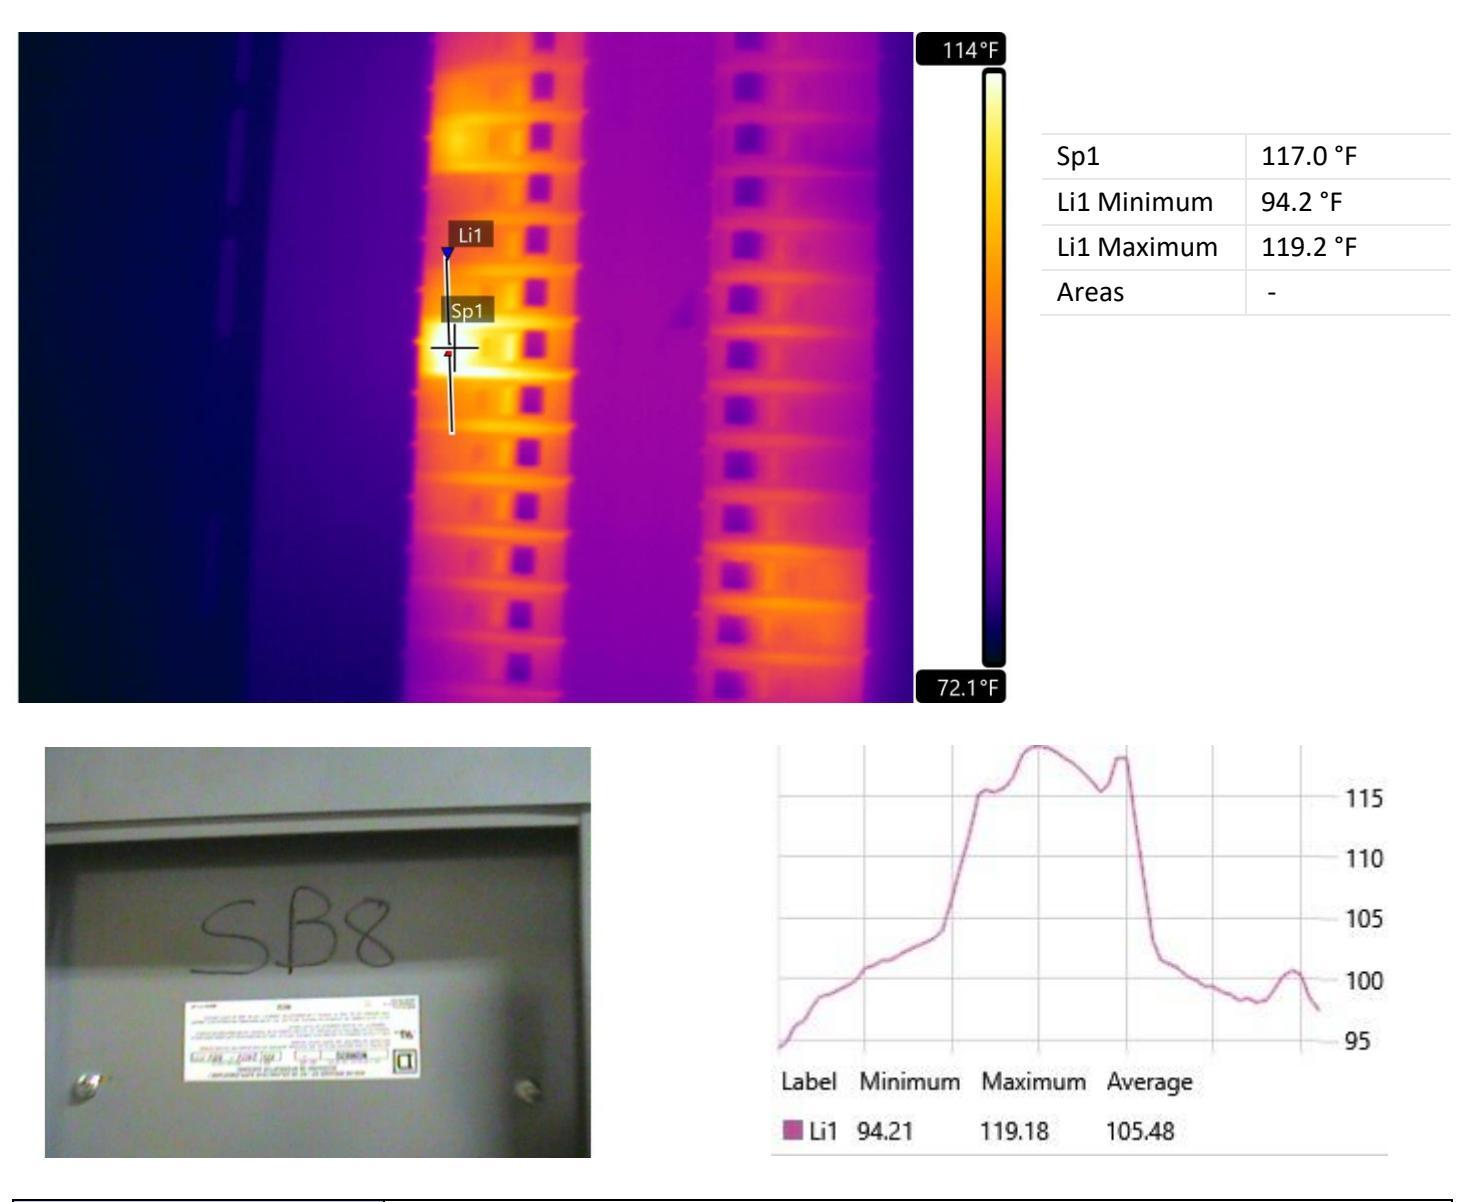
Component	Breaker 21
Equipment/Bucket ID	Main Slot Electrical Room SB8

Fault	Weak or oxidized connections, overloaded or worn breaker.
Defect Rating	Class I

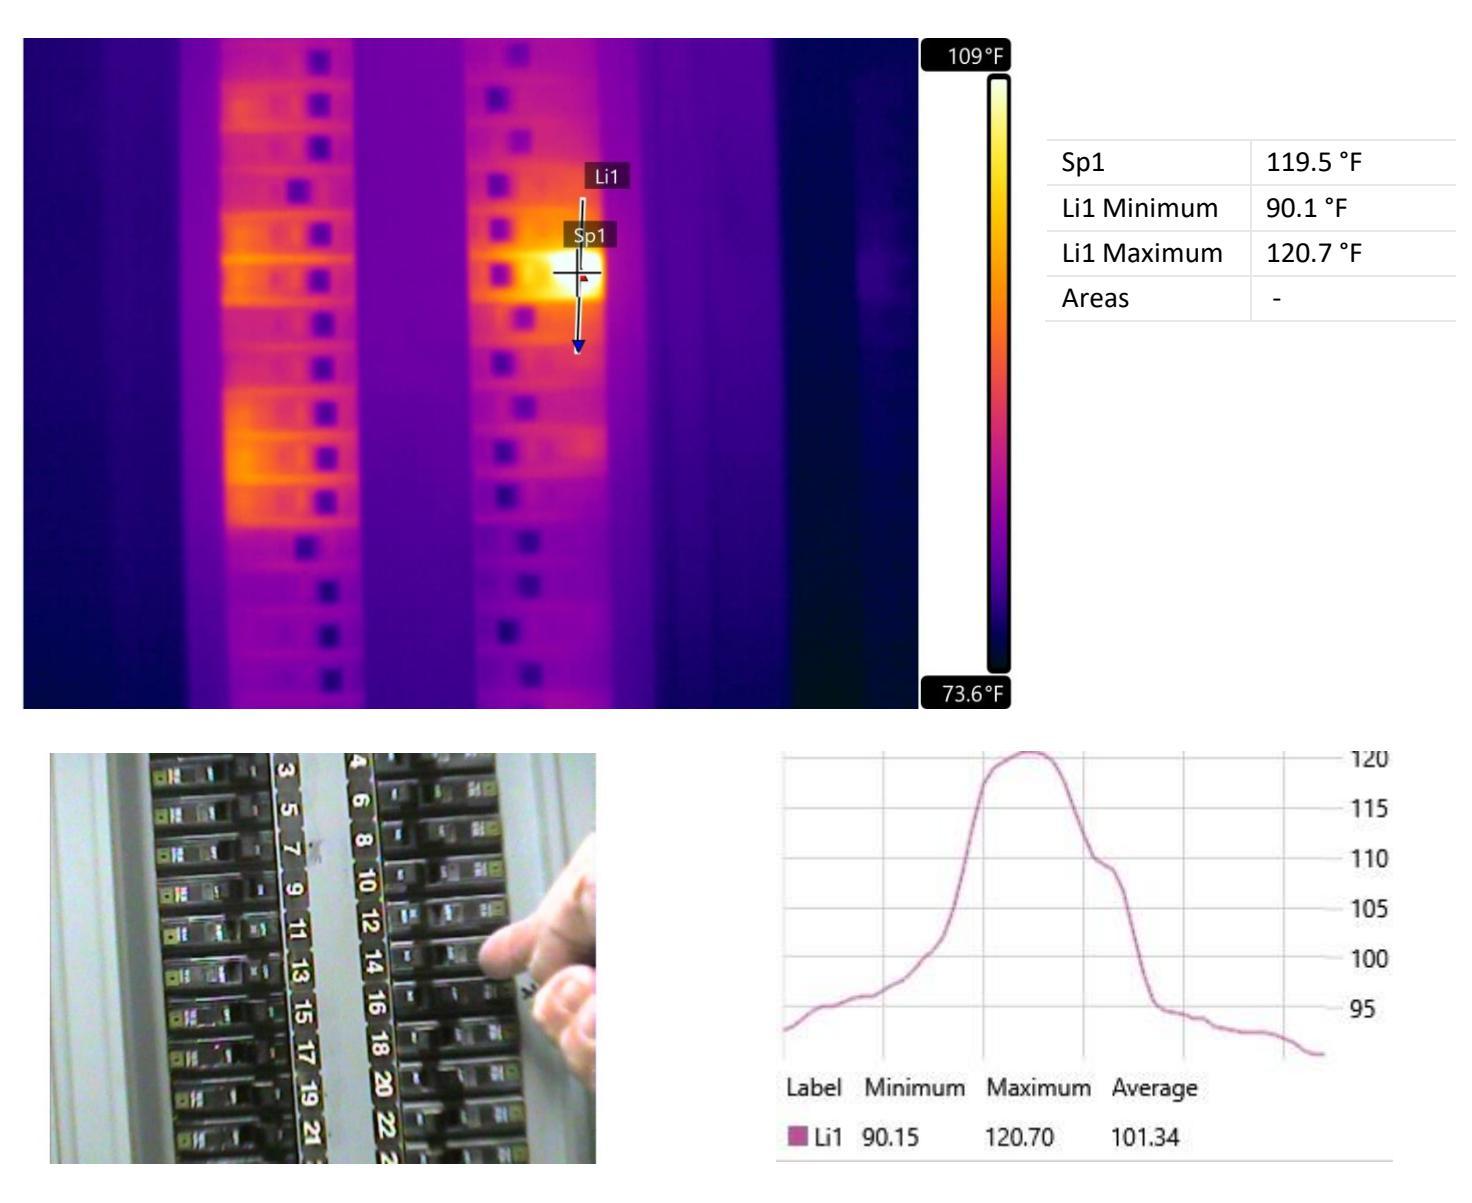
Component	Breaker 14
Equipment/Bucket ID	Main Slot Electrical Room SB3

Fault	Weak or oxidized connections, overloaded or worn breaker.
Defect Rating	Class I

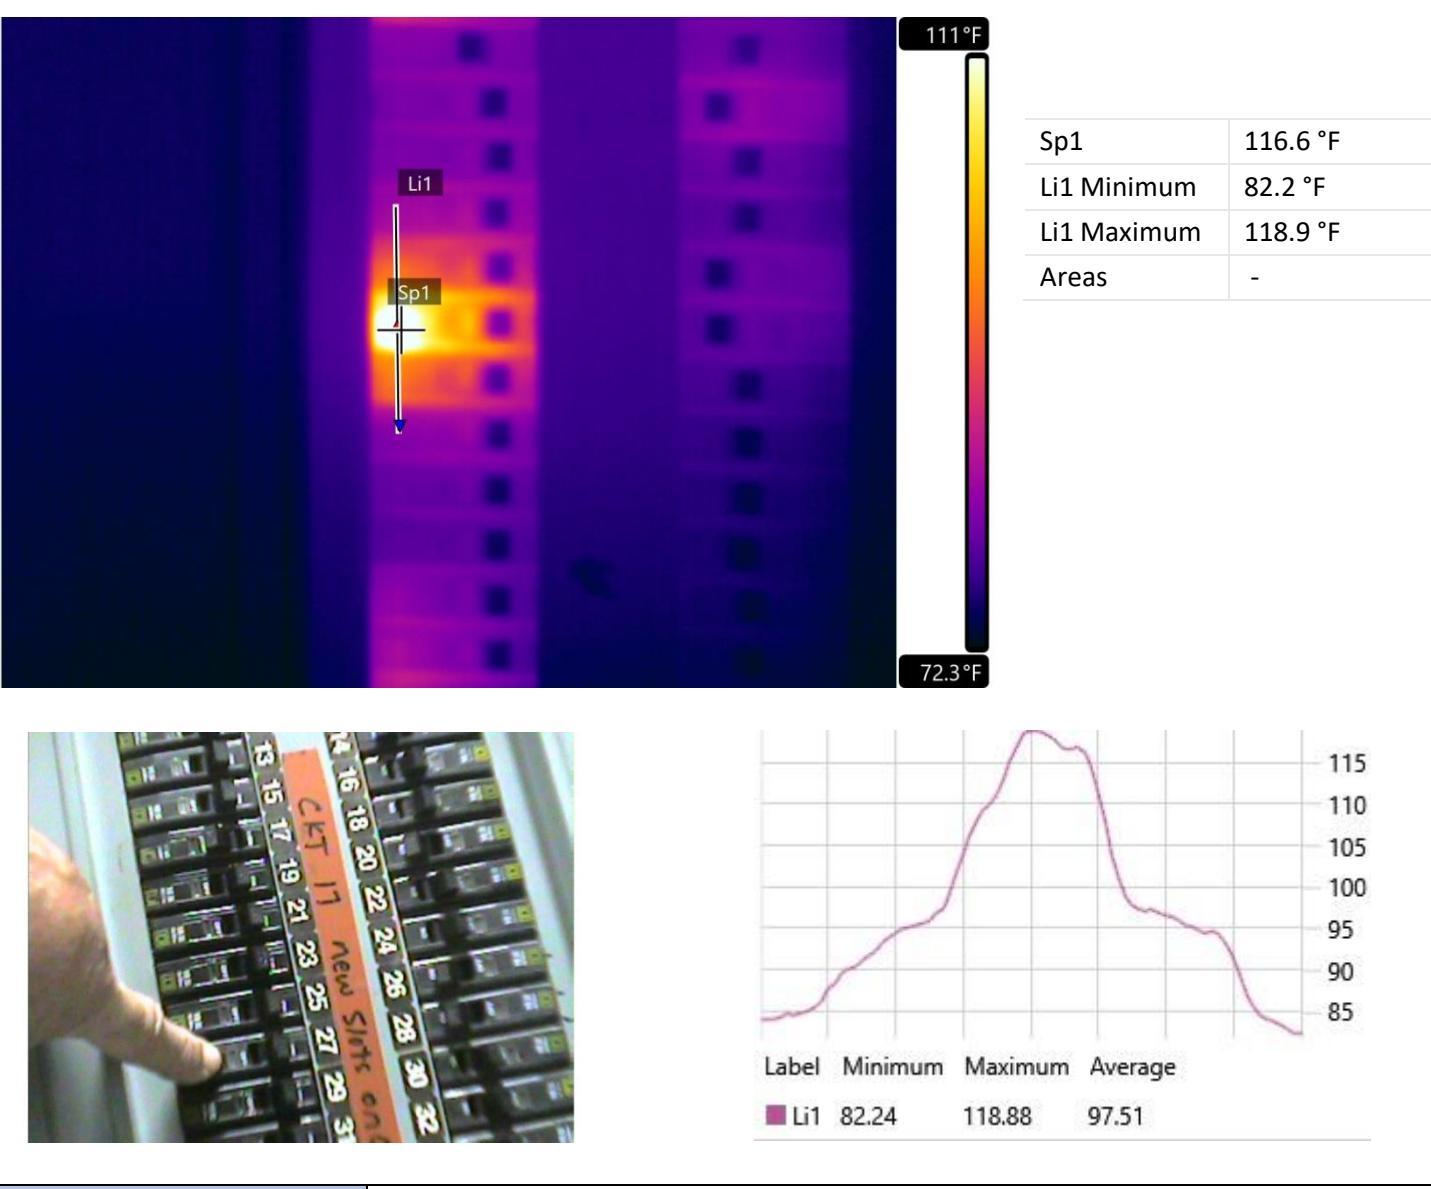
Component	Breaker 27
Equipment/Bucket ID	Main Slot Room SB1

Fault	Weak or oxidized connections, overloaded or worn breaker.
Defect Rating

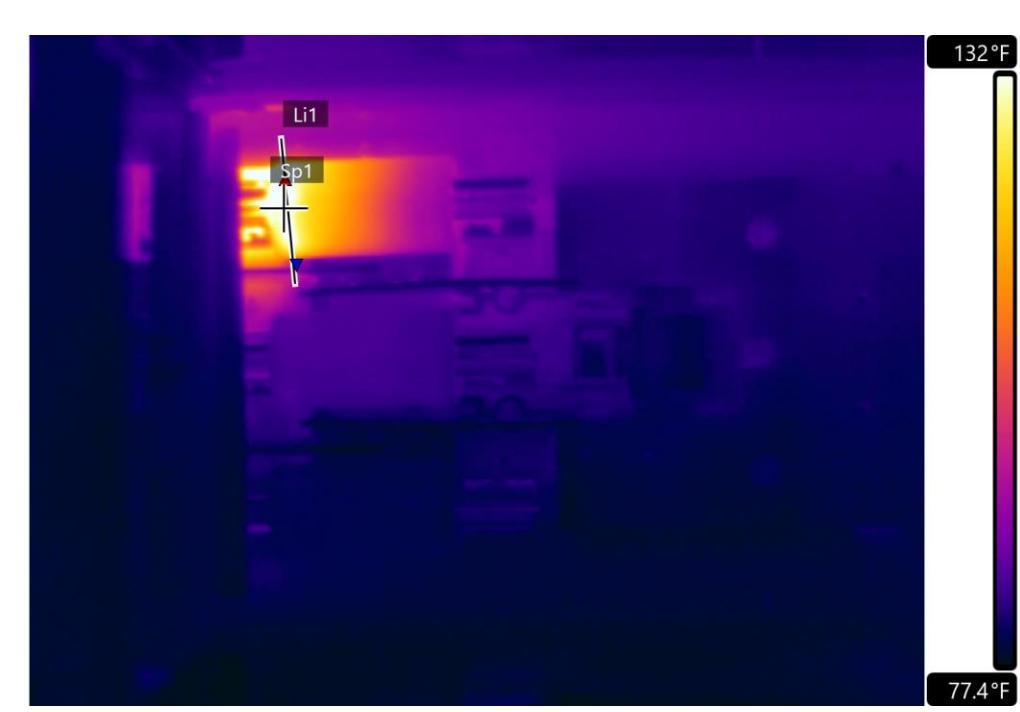
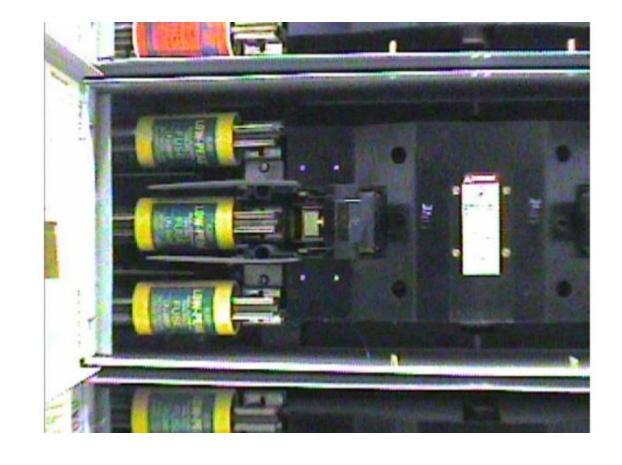
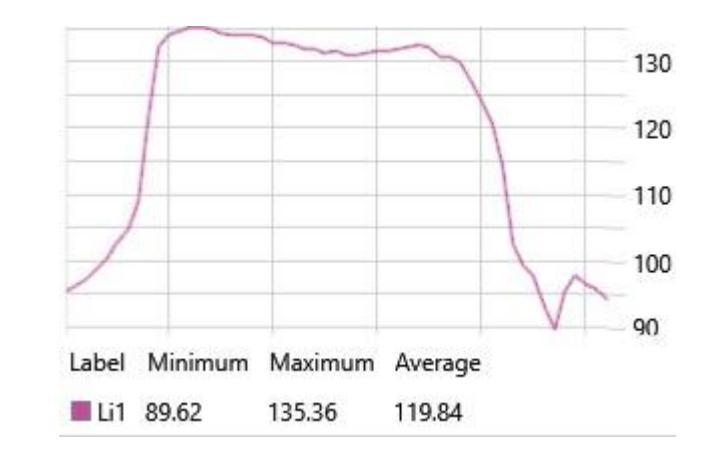
Component	
Equipment/Bucket ID	Main Hotel Electrical panel LSB2 Bucket T3L

Sp1	131.8 °F
Li1 Minimum	89.6 °F
Li1 Maximum	135.4 °F
Areas	-

Fault	Weak connection at top fuse
Defect Rating	Class I

Recommendations	
Clean and inspect the fuse clip	. Replace if necessary. Replace the fuse if possible.

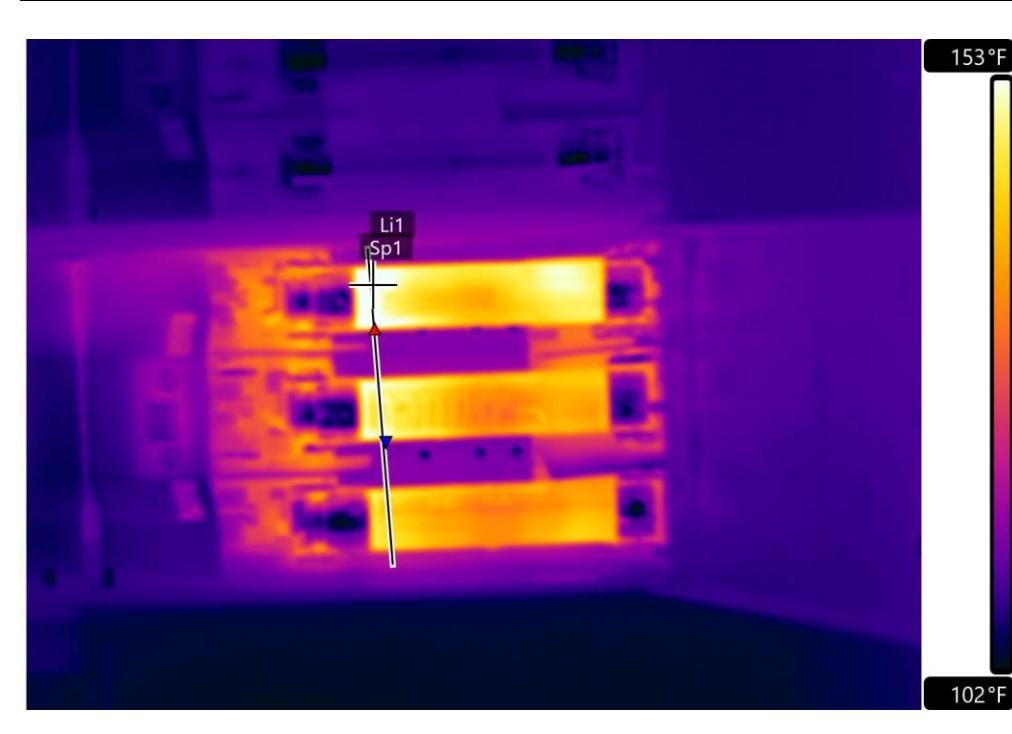
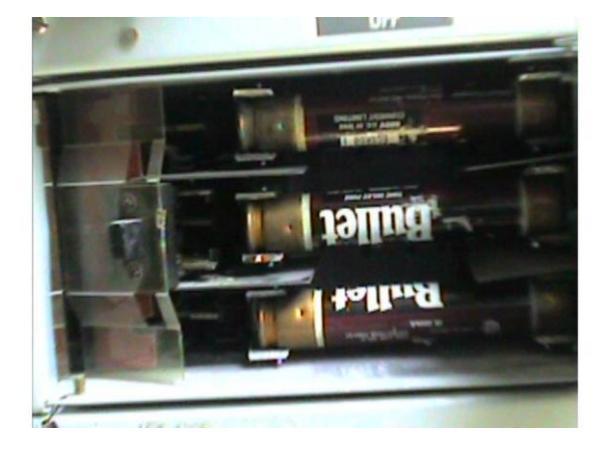
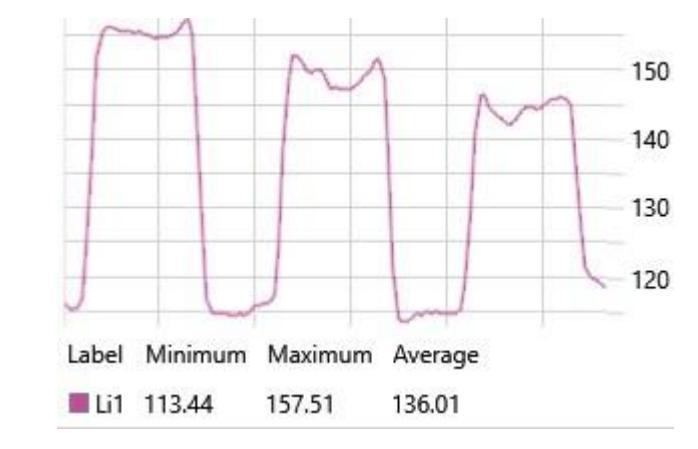
Component	Fuse Clip
Equipment/Bucket ID	Roof Distribution Board EHDBR AHU 1

155.3 °F
113.4 °F
157.5 °F
-

Fault	Possible high loading
Defect Rating	Class II

Clean and inspect the fuse clips and fuses. Perform an amp draw test before and after cleaning. Ensure equipment is sized properly for the given load.
